# Old Gaol Wall Damage

## Structural Inspection Report

26 June 2024

**Infrastructure Damage – Old Goal, Albany's historical precinct, corner of Parade Street and Stirling Terrace on the foreshore of the Albany CBD, WA, 6330**

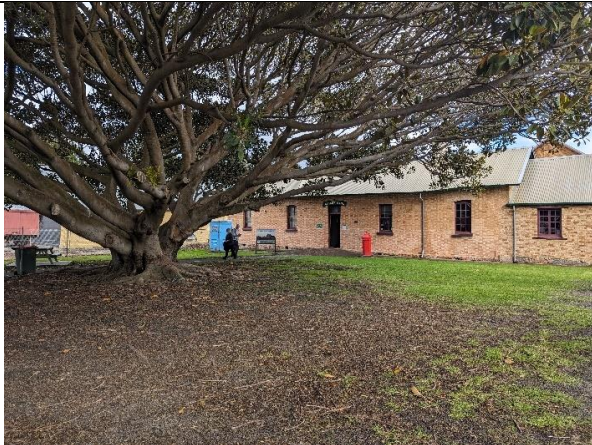
- Similar cracking is also present in the internal walls that abut the external wall on the eastern side of the building.
- Two Moreton Bay Fig Trees are located to the east of the building. The closest tree is approximately 16 m from the eastern wall and is estimated to be 12 m tall with a 28 m diameter canopy. Staff members at the Old Gaol Museum suggested that the trees are roughly 40 years old.

Photograph 1: Proximity of Moreton Bay fig to building

In our opinion, the Moreton Bay fig trees are responsible for damaging the walls at the Old Gaol. Moreton Bay figs are highly invasive, and it is not generally recommended to plant them near buildings due to their extensive lateral root spread. In some climates, Moreton Bay fig trees can grow to 60 m in height with a crown spread of up to 76 m.

- Permanently remove the Moreton Bay fig trees growing in the vicinity of the Old Gaol building.
- Repair the cracked and damaged masonry. All repair work to be completed by a specialist contractor experienced with heritage restoration and lime mortar construction. All repair works shall be compatible with the existing materials and shall comply with any existing heritage requirements for the building. Contractor to prepare mortar test samples to ensure accurate colour matching with existing mortar.

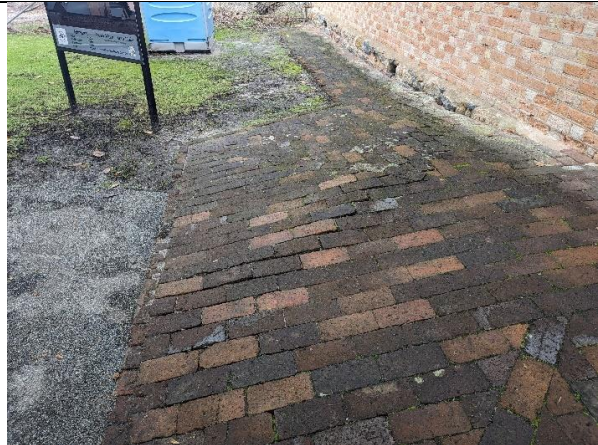
- The paved area in front of the building entrance is damaged due to localised lifting of the pavers. The lifted pavers extend along a line from the fig trees to the building footings.

Photograph 2: Lifting pavers near building entrance

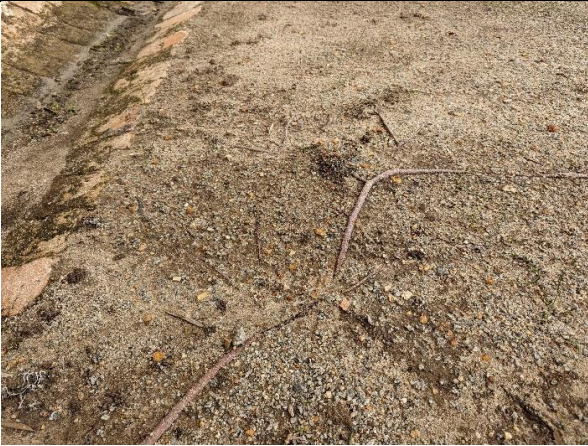
- Tree roots are also visible in the courtyard to the west of the convict prison cells, suggesting that the roots are growing under the entire building.

| <p>Photograph 3: Roots visible in rear courtyard</p> | <p>Photograph 4: Crack to mortar joints in external wall face</p> |

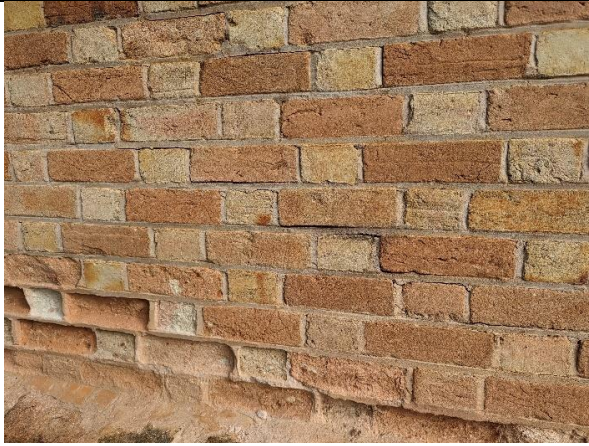
- Numerous cracks are present in the brick walls on the east side of the building.
- On the external face of the eastern wall, stepwise diagonal cracks propagate from the top and bottom corners of the windows through the bed joints and perpend. The cracks are reflected through the plastered wall finish on the internal face of the walls.

The mechanism by which tree roots damage buildings is twofold. Firstly, roots growing under building foundations create upward pressure on the footings causing them to lift or crack. Furthermore, roots absorb moisture from the soil under the building which exacerbates the seasonal shrink-swell cycle of clay soils. Ultimately, both mechanisms can lead to excessive foundation movement resulting in damage to building footings and overlying walls.

- All cracks in mortar joints > 1 mm wide shall be repaired by crack stitching with a suitable stainless-steel repair system such as Helifix Helibars and Helibond grout. Contractor to confirm compatibility of repair system with lime mortar prior to ordering materials and install in strict accordance with the manufacturer's requirements. Provide crack stitching to every third bed joint along the length of each crack and chase 40 mm into bed. Extend bars 500 mm beyond crack on either side and grout in prior to repointing over with lime mortar to match the existing.

- All cracks in mortar joints > 0.2 mm wide and < 1 mm wide shall be repaired by removing all loose material and chiselling out to full depth of crack prior to repointing with lime mortar to match the existing.

- All cracks in mortar joints < 0.2 mm wide require no structural remedial treatment but should be smoothed over with lime mortar prior to application of lime plaster.

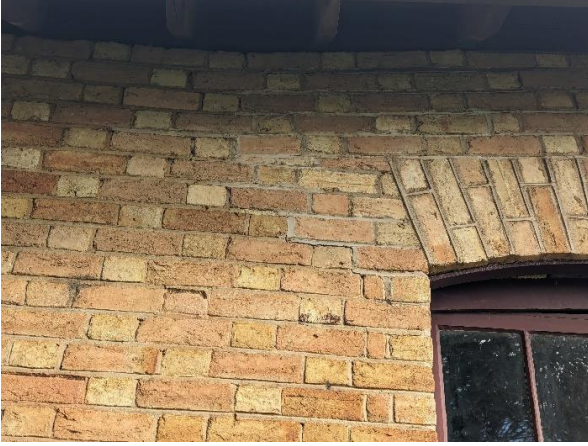
- Evidence of previous localised repairs to the external mortar joints were observed.

| <p>Photograph 5: Crack to mortar joints in external wall face and evidence of previous repairs</p> | <p>Photograph 6: Crack to mortar joints in external wall face</p> |

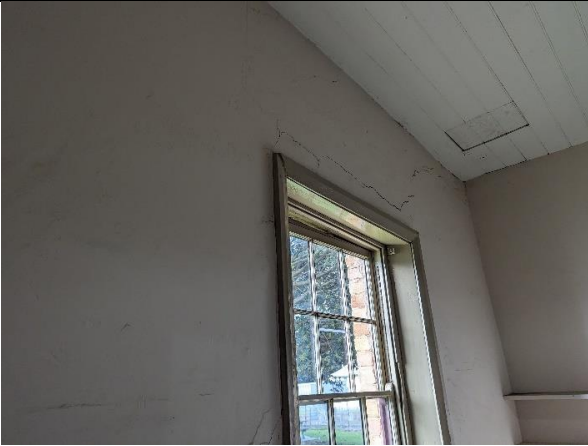
| <p>Photograph 7: Crack to plastered wall finish inside building</p> | <p>Photograph 8: Crack to plastered wall finish inside building</p> |

- Remove all cracked and damaged plaster to expose the damaged masonry walls.
- Any bricks found to be cracked shall be removed and replaced with new bricks matching the existing.

- Reinstate surface treatments to repaired internal walls using suitable lime plaster and paint to match existing walls.
- Allow for ongoing repairs as the building stabilises. Please note that some ongoing wall damage may occur as the soil moisture levels stabilise and the severed tree roots decay under the building. This may take several years.

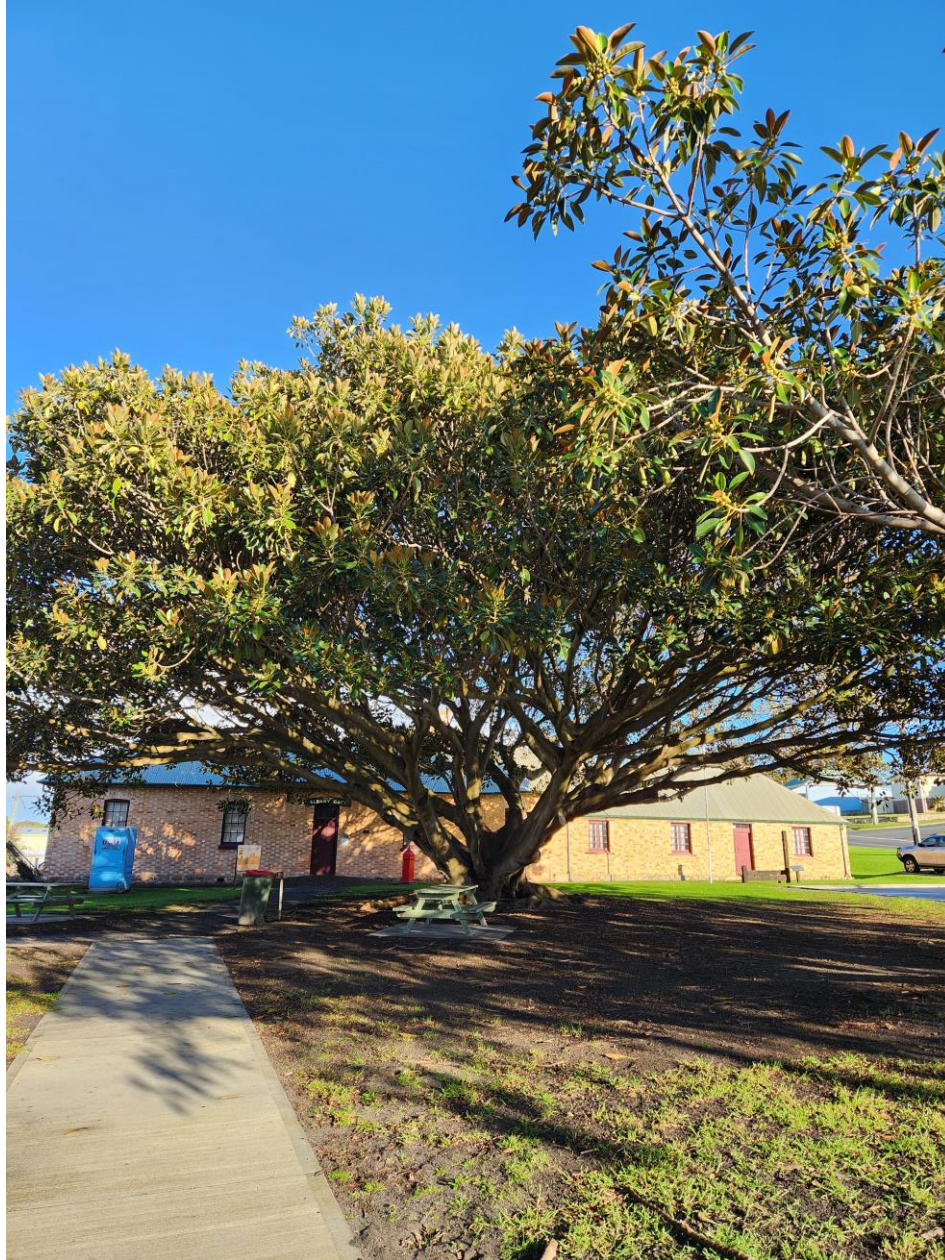
Fig.1 - View of the large Morton Bay fig tree situated on the east side and in front of the main pedestrian entrance into the Old Goal building on the foreshore of Albany, WA (photo taken 10/7/2024).

It was observed that both trees were vigorous and in good condition.

The tree was situated within 16m of the Old Goal building, the building thus falling well within the AS recommended TPZ of the tree at its extent at the time of the authors VTA (10/7/2024)

This report recommends the complete removal of the large Morton Bay fig tree situated +/-16m to the east of the Old Goal building in Albany and that this tree be replaced with a tree species that has the potential to develop a similar stature and significance but with a growth habit better suited to the site and less likely to develop invasive roots with the potential to cause structural damage to adjacent structurally vulnerable buildings.

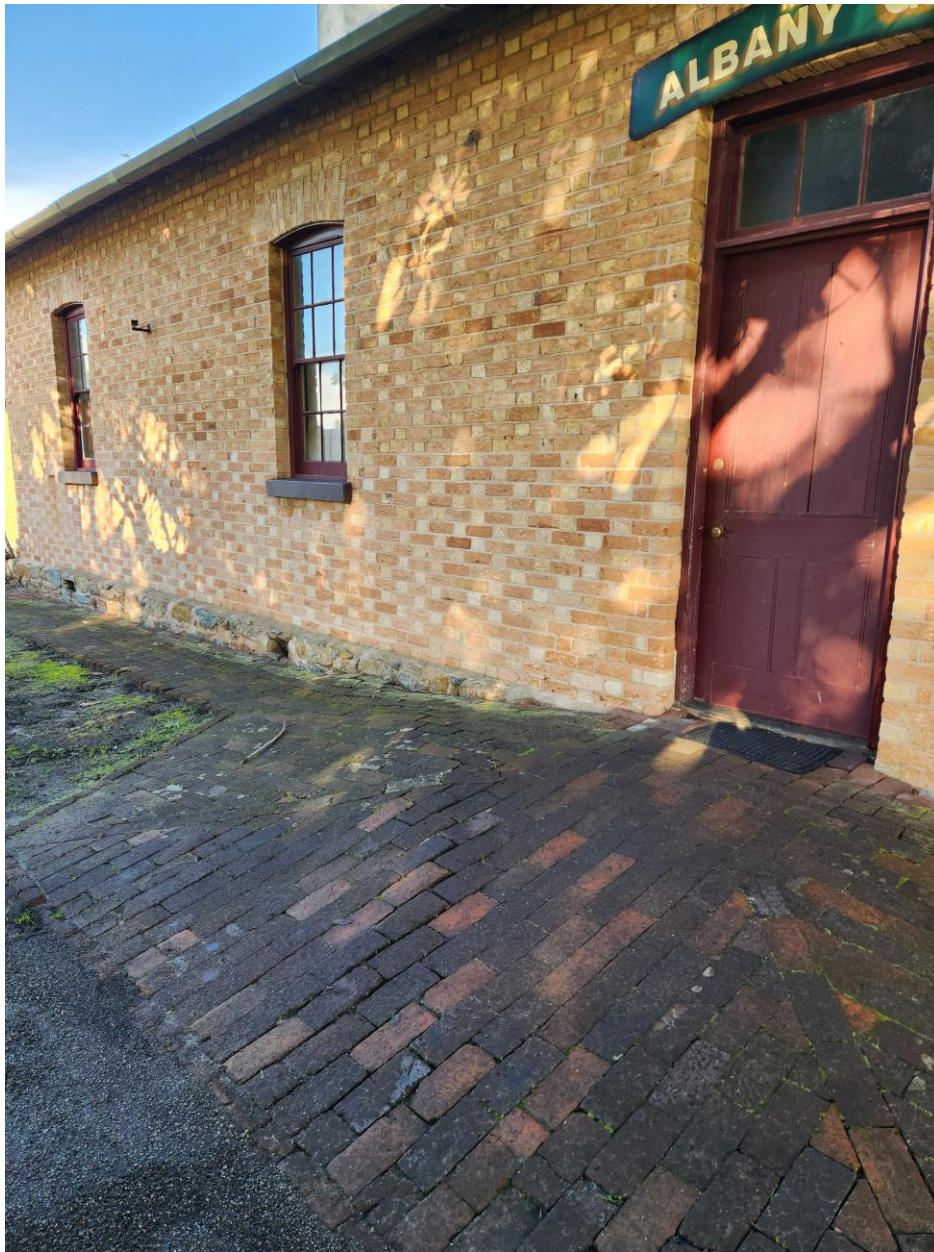
At his 10/7/2024 VTA the author observed obvious evidence of invasive root development, arising from the subject tree, lifting paving near to the front pedestrian entrance to the Old Goal building, and as such believed protection against rood damage derived from the previously installed root barrier had been compromised.

Fig.2 - View of the stem of the font (main) pedestrian entrance to the Old Goal building in Albany showing brick paving displaced by root development (photo taken 10/7/2024).
