### Data Review and 5 Year Plan

### Structure Condition Survey

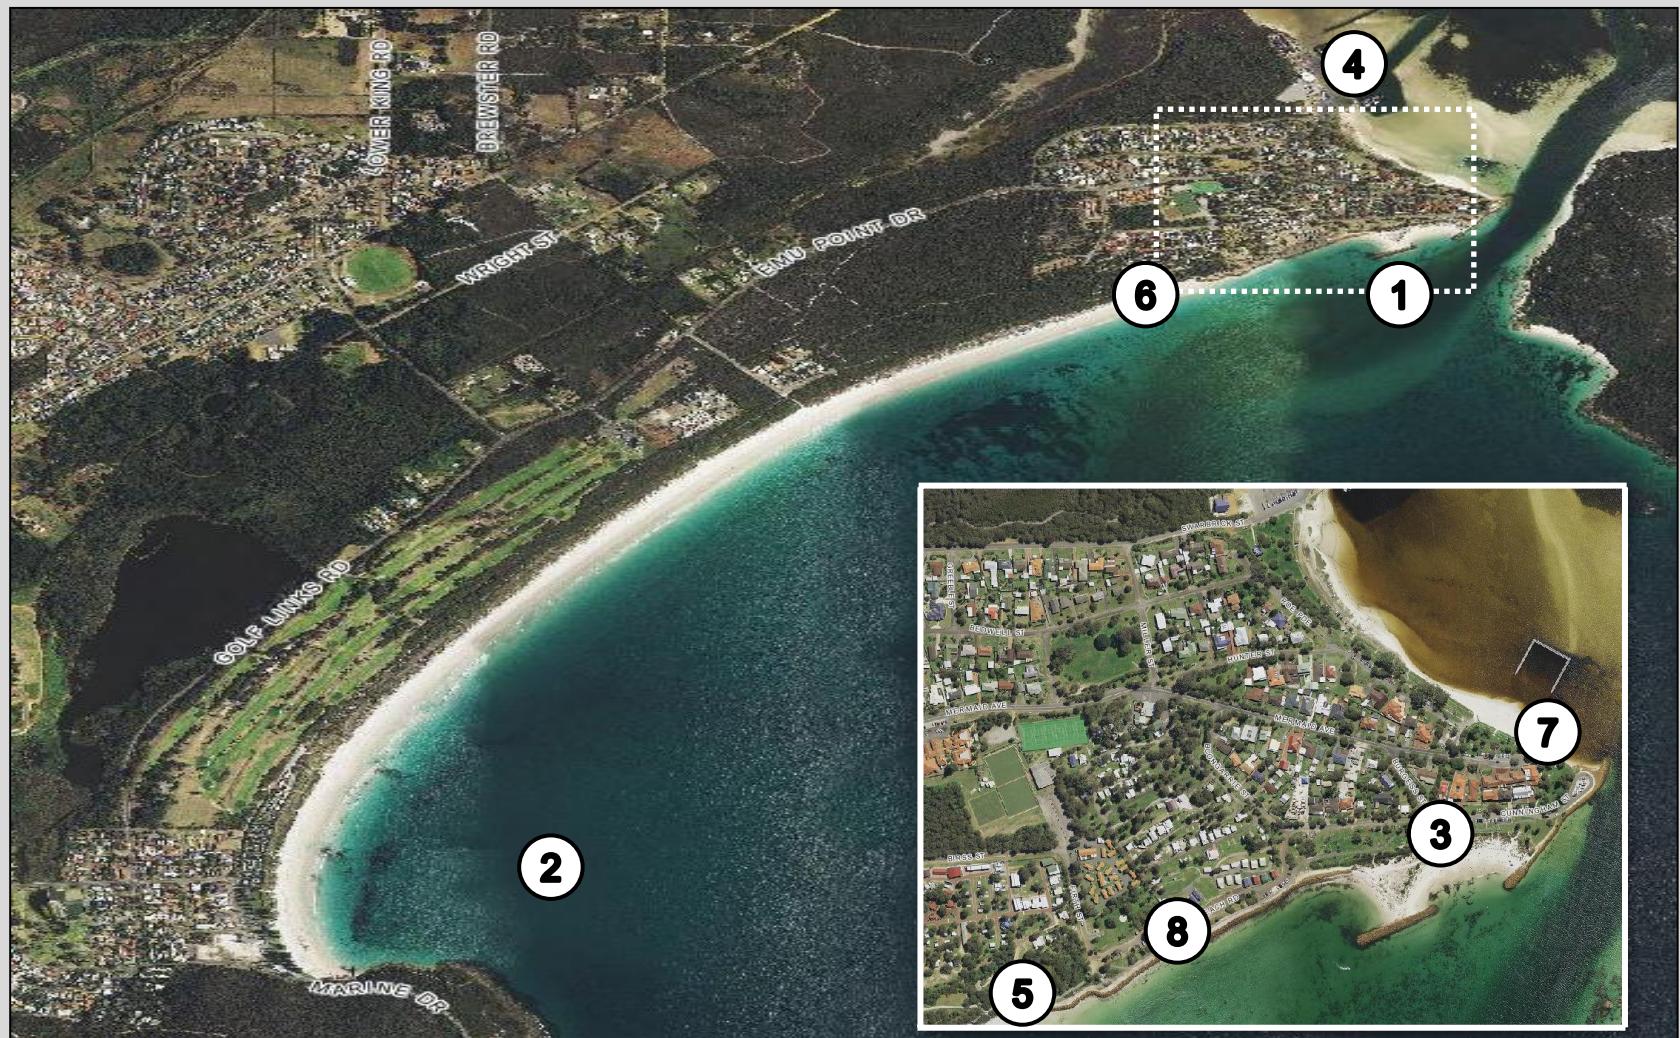
**1** AWAC

**2** AWAC

**3** Anemometer

**4** Tide Gauge

**5** Fixed Camera

**6** Trial Groynes

**7** Sand Nourishment

**8** Maintenance

**Commenced: December 2013**  
An Acoustic Water and Current Device (AWAC) was installed by **Dept of Transport (DoT)** offshore of Emu Beach. This measures wave height, period and direction, current speed and direction, water temperature and water levels. The data will be used for model calibration, which assists the design of coastal management solutions. The AWAC will be managed by **DoT**. This work is ongoing.

**Commenced: September 2015**  
In September 2015 an Acoustic Water and Current Device (AWAC) was installed by the **City of Albany** offshore of Middleton Beach. This will allow near shore data from Middleton Beach to be collected which will compliment the data being collected at Emu Point. The AWAC will be in the water for 3-6 months and managed by specialist coastal consultants **Royal Haskoning DHV**.

**Commenced: January 2014**  
Early 2014 an Anemometer was installed on the **Albany Port Authorities'** navigation beacon at Emu Beach. This instrument measures wind speed, direction and gusts and will provide localised data. Live wind data is available for viewing on the **City of Albany** website. This is managed by **Ecotech Pty Ltd**. This work is ongoing.

**Commenced: September 2014**  
In 2014 a tide gauge was installed by **Dept of Transport (DoT)** at the Emu Point Boat Pens. The aim of recording water levels in Oyster Harbour is to establish the effect of the narrow entrance on the water levels in Oyster Harbour during normal tidal conditions and also storm events. This instrument will be supplied and managed by **DoT**. This work is ongoing.

**Commenced: October 2014**  
A fixed time lapse camera was installed at the Western end of the rock revetment. This camera takes an image every half hour and these can be compiled into a time series video. This is managed by **BMT Oceanica**. This work is ongoing.

**Commenced: April 2014**  
In autumn 2014 two trial sand bag groynes were constructed at the western end of the revetment and nourished with 10000m<sup>3</sup> of sand. Early results show that local erosion in this area has stabilised. In Autumn 2016 a small amount of sand bags will be added to the groynes to maintain their structural integrity. This trial is ongoing.

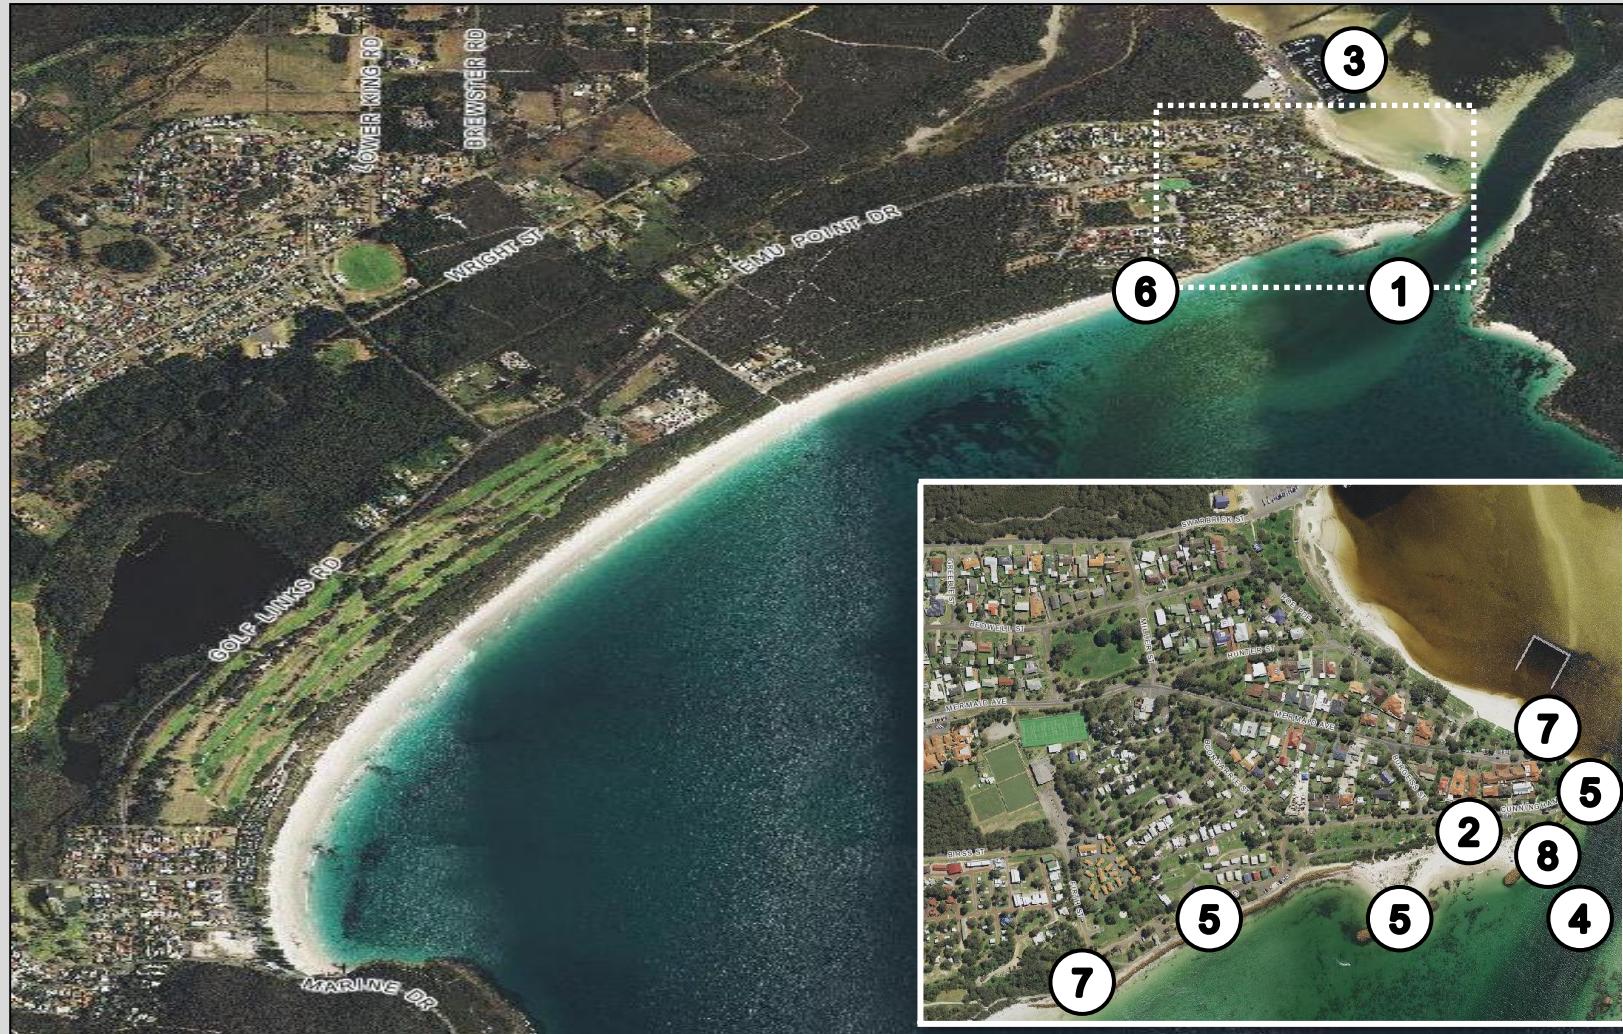
**1** AWAC

In December 2013 an AWAC (acoustic water and current device) was installed by **Dept of Transport (DoT)** offshore of Emu Beach. This measures wave height, period and direction, current speed and direction, water temperature and water levels. The data will be used for model calibration, which assists the design of new facilities and coastal management solutions. The AWAC will be in place for 1-3 years and managed by **DoT**.

**2** Anemometer

**Commenced: January 2014**  
Early 2014 an Anemometer was installed on the **Albany Port Authorities** navigation beacon at Emu Beach. This instrument measures wind speed, direction and gusts and will provide localised data. Live wind data will be available for viewing on a public website. This data will be used for model calibration. This instrument is funded by the **City of Albany, Dept of Transport** and the **Albany Port Authority**.

**3** Tide Gauge

**Commenced: September 2014**  
In 2014 a tide gauge was installed by **Dept of Transport (DoT)** at the Emu Point Boat Pens. The aim of recording water levels in Oyster Harbour is to establish the effect of the narrow entrance on the water levels in Oyster Harbour during normal tidal conditions and also storm events. This instrument will be supplied and managed by **DoT**.

**4** Current Study

**Commenced: April 2014**  
As part of a Coastwest Grant from the **Dept of Planning** a study of the Currents and Suspended Sediment in the Emu Point Channel was carried out by **University of WA (CENRM)**. The aim was to determine the speed and direction of currents through and around the Emu Point Channel and to determine the particle load of the water column during normal and unusual climatic.  
**Completed: September 2014**

**5** Structure Survey

**Commenced: October 2013**  
A Structure Condition Survey was conducted of all of the rock structures at Emu Point by coastal engineers in April 2012 and October 2013. Photos with GPS coordinates have been recorded to allow for accurate comparison. Annual monitoring of these structures will allow early identification of changes and timely maintenance to be carried out.

**6** Trial Groynes

**Commenced: April 2014**  
In autumn 2014 two trial sand bag groynes were constructed at the western end of the revetment. The expected outcome is that sand will build up to the east and erosion will occur to the west. This will allow data to be collected on the build up of sand whilst wave and current data is recorded which is important for future modelling. The expected build up may provide sand protection to the toe of the revetment.

**7** Sand Nourishment

**Commenced: March 2014**  
Sand nourishment will be carried out when necessary to Oyster Harbour and the western end of the revetment. This assists with the required scraping of Middleton Beach to provide amenity and drainage. The results of sand nourishment will be recorded with photo monitoring and beach surveys.

**8** Asset Management

**Commenced: April 2014**  
In winter 2014 a small section of the training wall was restored. This involved the addition of rock to an area where vegetation has caused slumping as well as backfilling of small rock material where over topping has occurred adjacent to the training wall.
