## Coastal Hazard Risk Management and Adaptation Plan (CHRMAP)

The City of Albany has received funding from the Western Australian Planning Commission to complete a CHRMAP for the project area. This process will take 2 years to complete. The purpose of this work is to consider a full range of planning instruments in order to plan for the short and long term management of the coast. It will be done in six stages and will involve extensive community engagement.

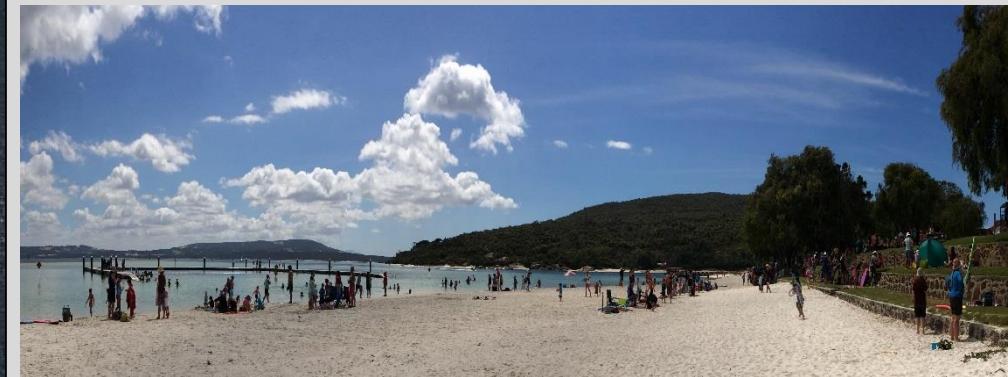
### 1 AWAC

**Start: December 2013**  
Since December 2013 Acoustic Water and Current Devices (AWAC) have been deployed to collect wave and current data. This data was used for recent modelling work for the Coastal Vulnerability and Hazard Mapping study. A data gap identified by this modelling means that an AWAC will soon be deployed off Emu Point to capture data on wind driven currents.

### 2 Trial Groynes

**Start: April 2014 - ongoing**  
In autumn 2014 two trial sand bag groynes were constructed at the western end of the revetment and nourished with 10,000m<sup>3</sup> of sand. Results show that local erosion in this area has stabilised. In autumn 2016 and 2017 a small addition of sand bags were added to the groynes to maintain their structural integrity. Sand nourishment will be carried out to this area as required.

### 3 Anemometer

**Start: January 2014-ongoing**  
In early 2014 an Anemometer was installed atop the **Albany Port Authorities'** navigation beacon at Emu Beach. This instrument measures wind speed, direction and gusts and provides localised data. Live wind data is available for viewing on the **City of Albany** website. This is managed by **Ecotech Pty Ltd.**

### 4 Tide Gauge

**Start: Sept 2014-ongoing**  
In September 2014 a tide gauge was installed by **DoT** at the Emu Point Boat Pens. The aim of recording water levels in Oyster Harbour is to establish the effect of the narrow entrance on the water levels in Oyster Harbour during normal tidal conditions and in storm events. This instrument is supplied and managed by **DoT.**

### 5 Fixed Camera

**Start: Oct 2014 - ongoing**  
In October 2014 a fixed time lapse camera was installed at the western end of the rock revetment. This camera takes an image every two hours and these images are compiled into a time series video. This is managed by **BMT Oceanica.**
