Sampling and Analysis Quality Plan (SAQP)

Woolstores Place, Mount Elphinstone, WA

66001 | 155,373 (Rev A)

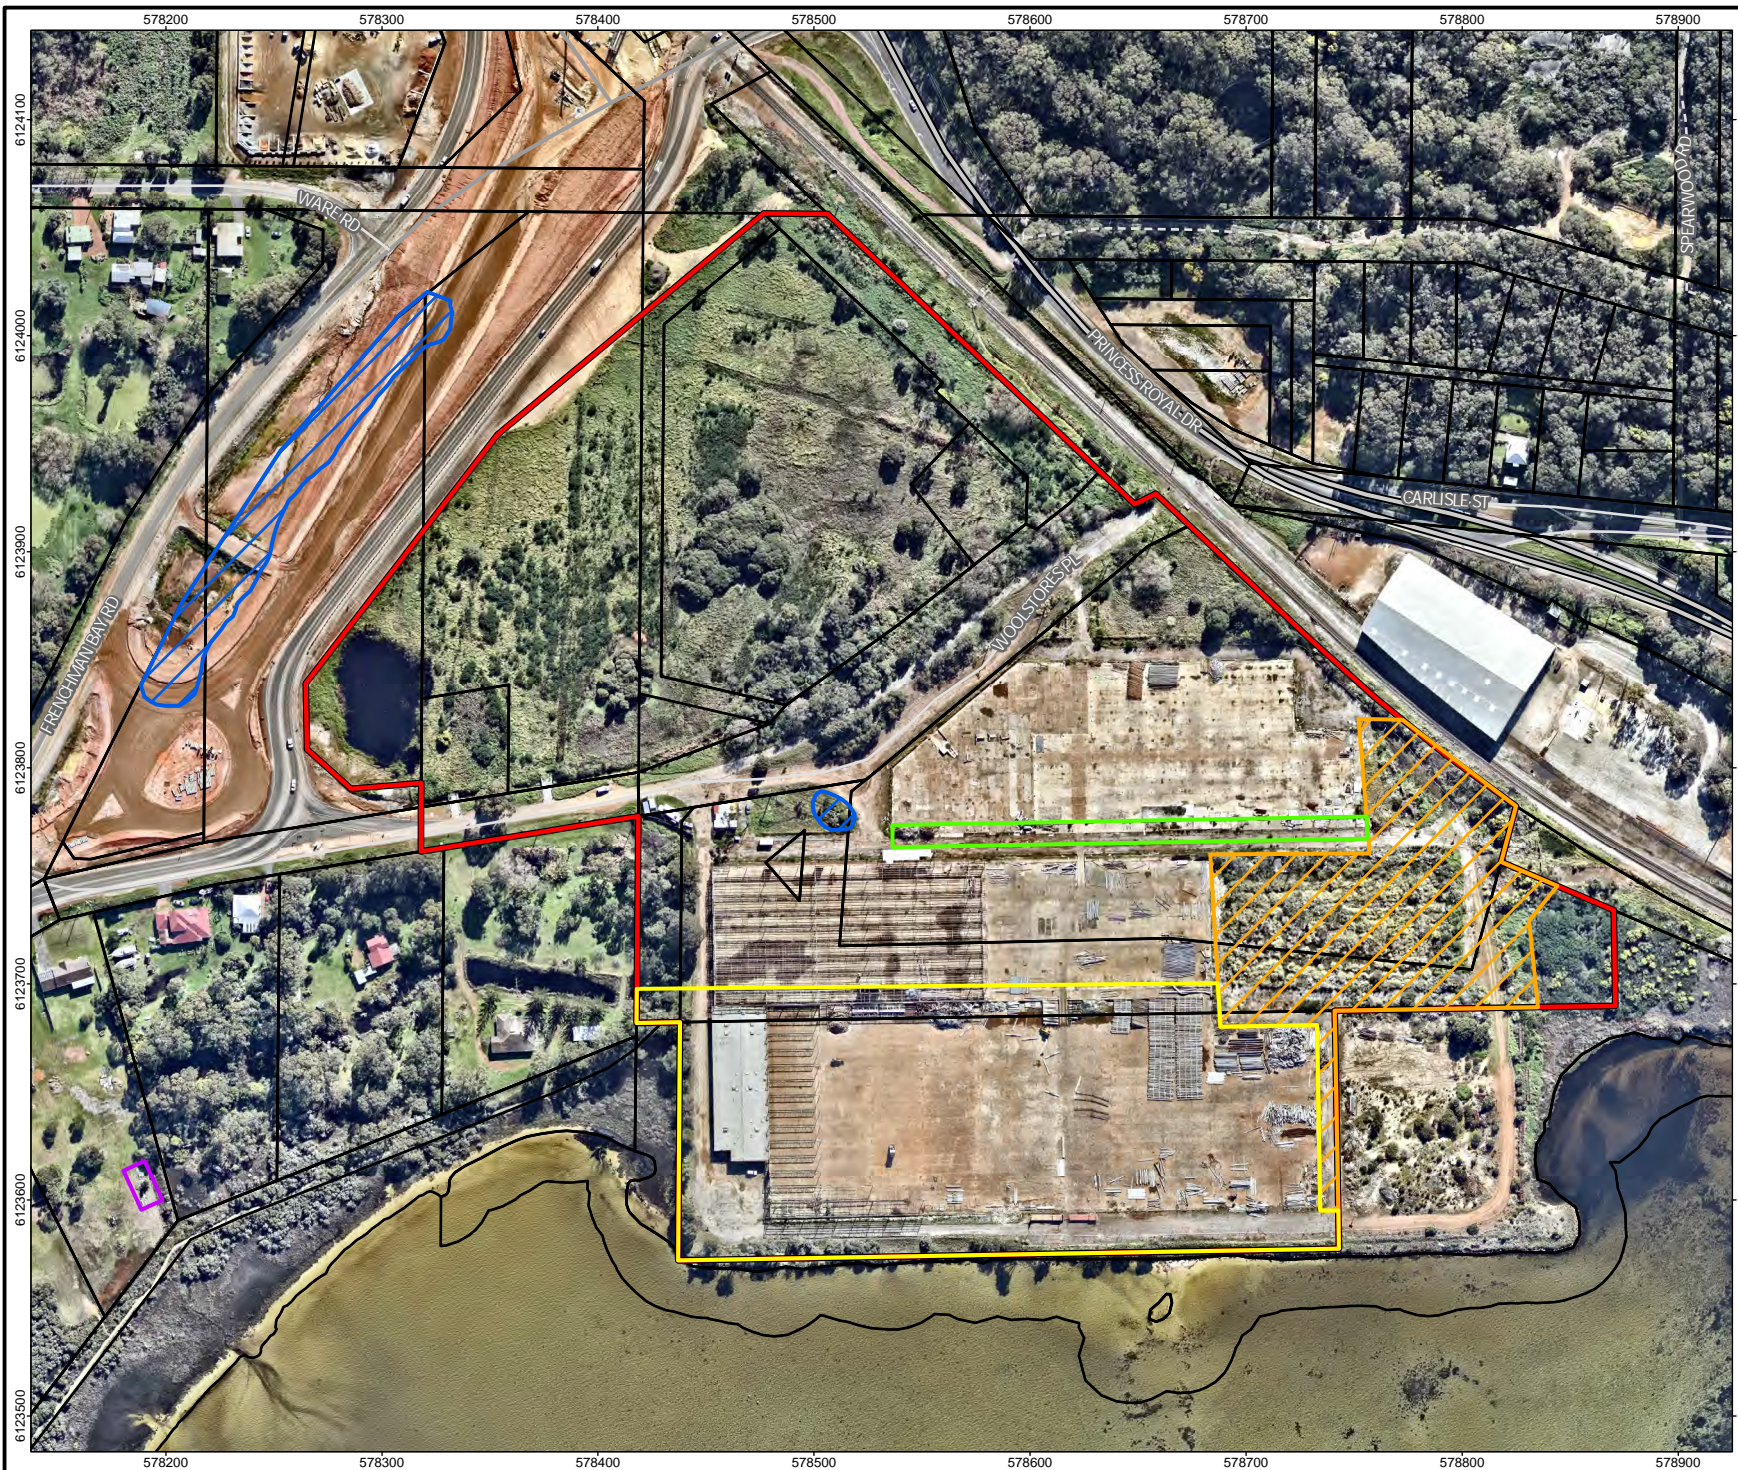
FIGURE 2

FORMER SITE LAYOUT

A review of historical aerial photographs has identified that the southern portion of the site is reclaimed land. The fill utilised to create the current site levels is of unknown origin. The relevant area is depicted in **Figure 2**. Based on the presence of uncontrolled fill, in conjunction with the description in the PSI of stockpiled soil being present throughout the site observed to contain building wastes, in accordance with Table 4 of DoH 2021, the likelihood of asbestos is considered 'suspect', and single density sampling is considered to be appropriate. Based on an area of ~3.7 ha, this would equate to 45 test pit locations. Investigation will be required to extend to below the depth of imported fill materials where virgin/natural soils are present, which is anticipated to be 1.5 m bgl to 2 m bgl. Proposed test pit locations are presented in **Figure 3**.

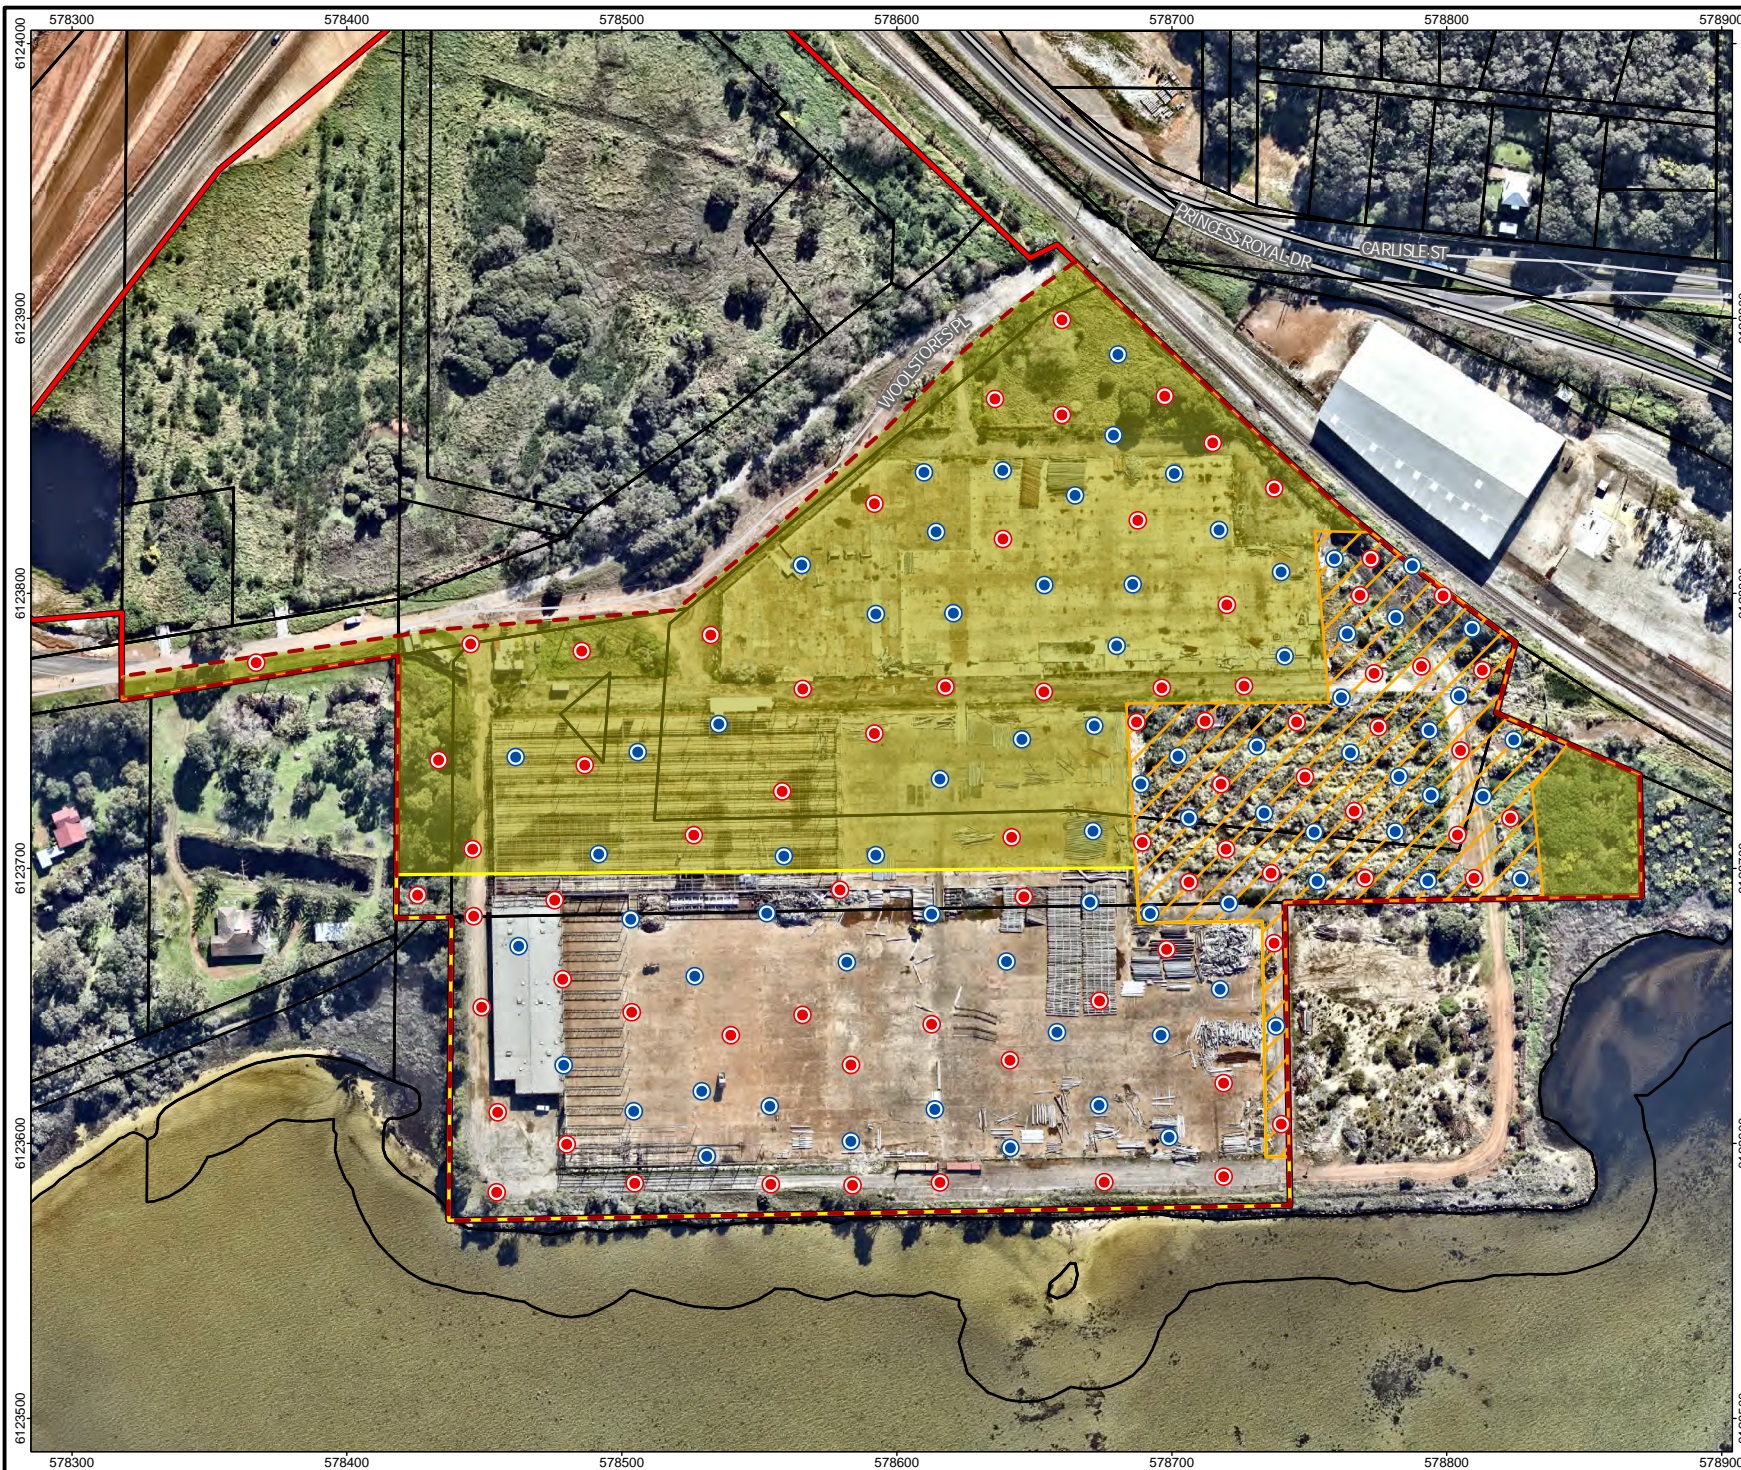
FIGURE 3

**PROPOSED TEST PIT LOCATIONS -
COMMERCIAL / INDUSTRIAL LOTS**

There is an area in the eastern portion of the site where fill material is observed to have been placed. Multiple PACM fragments were also observed across this area, and it is considered likely that these are (at least in part) associated with the inappropriate demolition of a historical building in the area. Numerous instances of fly tipping/ illegal dumping, including building wastes, were also observed in this area of the site. The relevant area is depicted in **Figure 2**. Based on the above, in accordance with Table 4 of DoH 2021, the likelihood of asbestos is considered 'likely', and double density sampling in this area is warranted. Based on an area of ~1.5 ha, this would equate to 50 test pit locations. Investigation will be required to extend to below the depth of imported fill materials where virgin/natural soils are present, which is anticipated to be 1.5 m bgl to 2 m bgl. Proposed test pit locations are presented in **Figure 3**.

The site has a long commercial/ industrial history and the presence of structures containing ACM is known. Additionally, the PSI described stockpiled soil being present throughout the commercial/ industrial lots observed to contain building wastes. It is also possible that areas of fill placement encroach on this portion of the lots. The relevant area is depicted in **Figure 2**. Based on the above, in accordance with Table 4 of DoH 2021, the likelihood of asbestos is considered 'suspect', and single density sampling is considered to be appropriate. Based on an area of ~4.5 ha, this would equate to 52 test pit locations. Investigation will be required to extend to below the depth of imported fill materials where virgin/natural soils are present, which is anticipated to be a maximum 1.5 m bgl to 2 m bgl (likely less in this area of the site). Proposed test pit locations are presented in **Figure 3**.

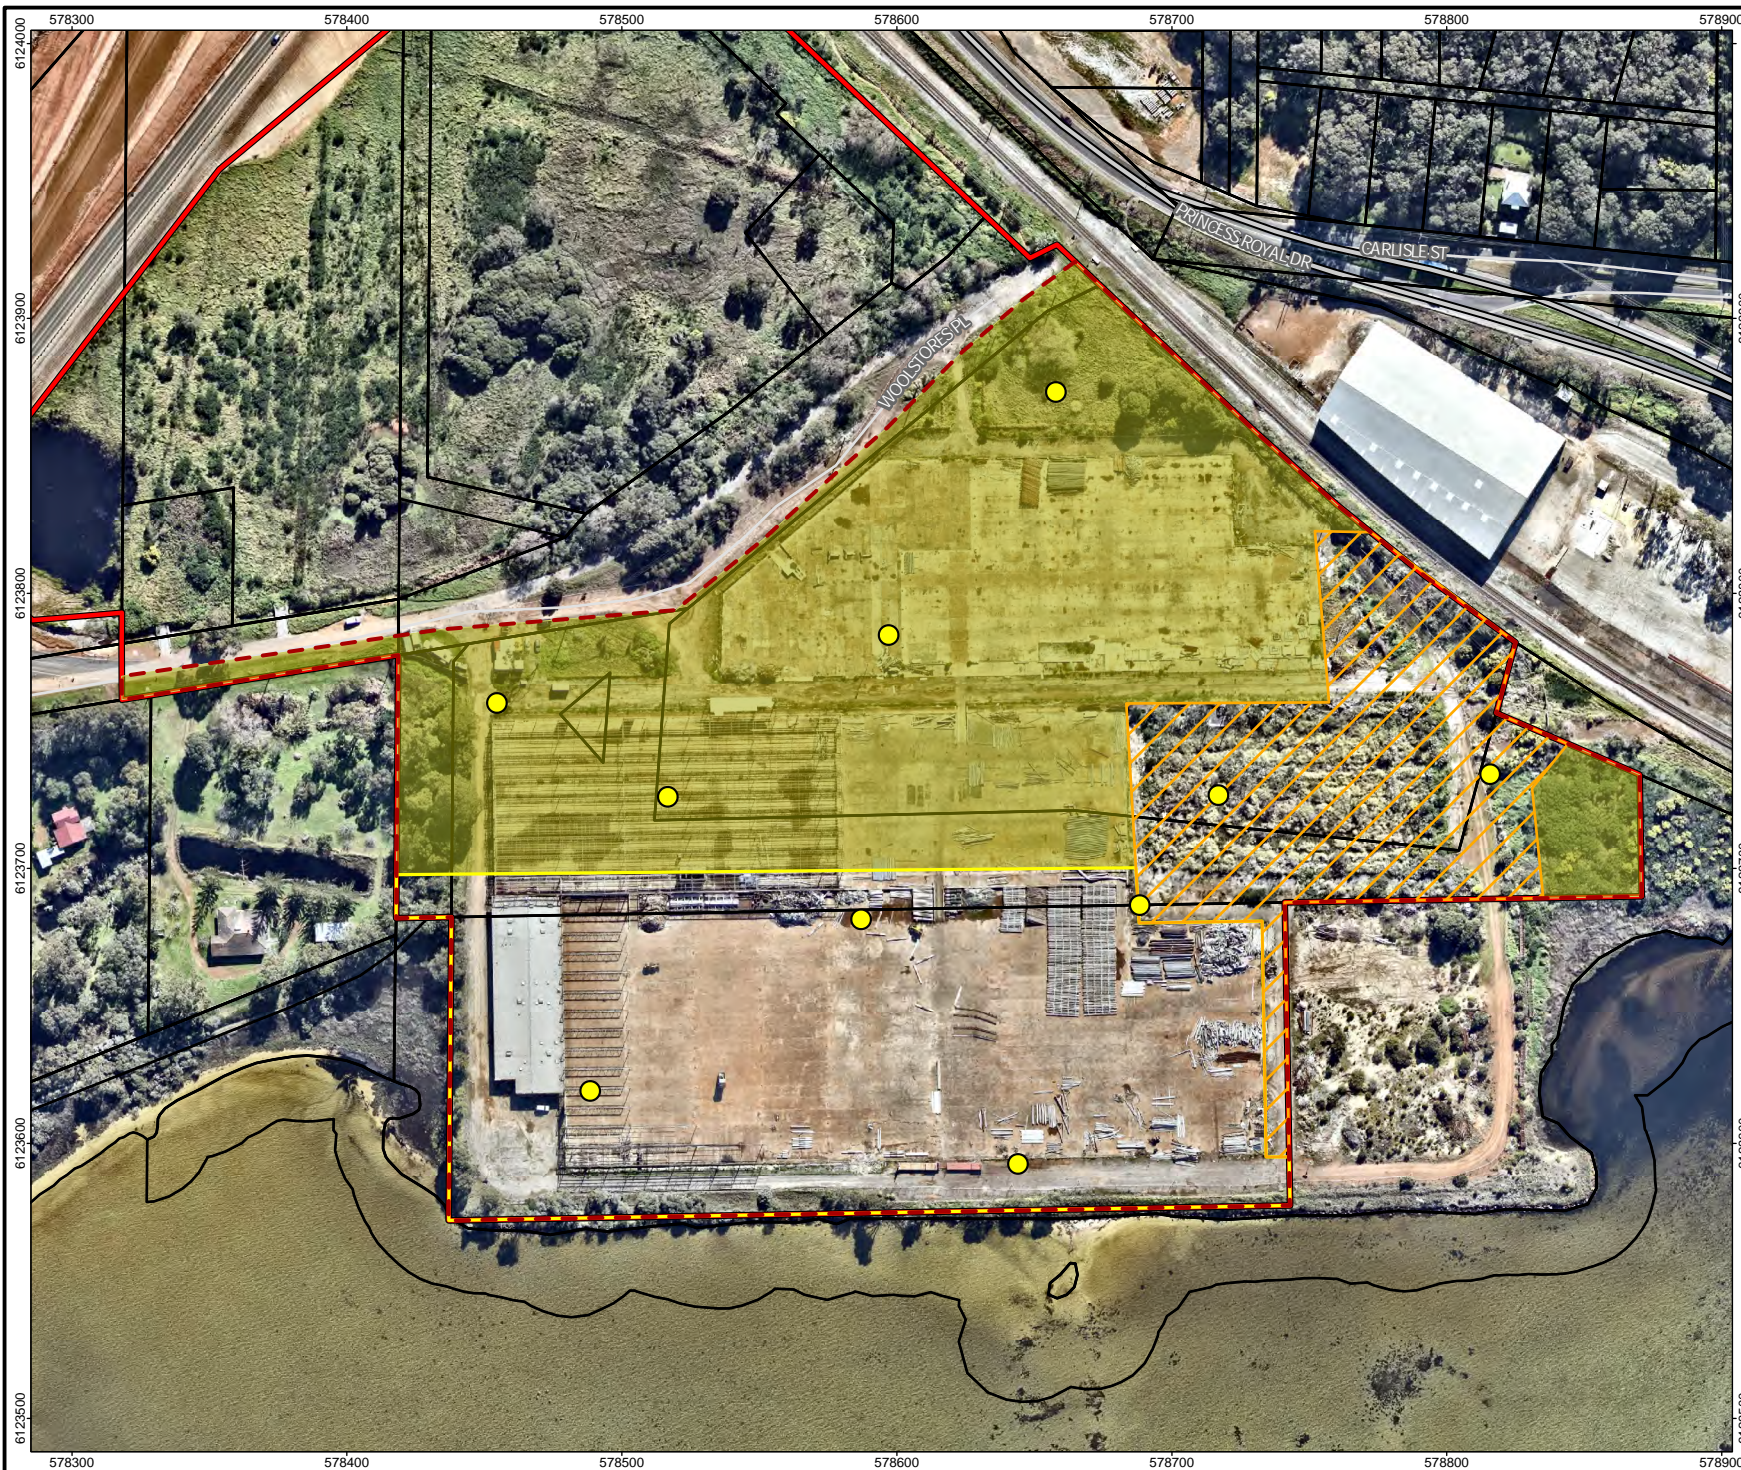
FIGURE 4a

**ASS INVESTIGATION -
COMMERCIAL / INDUSTRIAL LOTS**

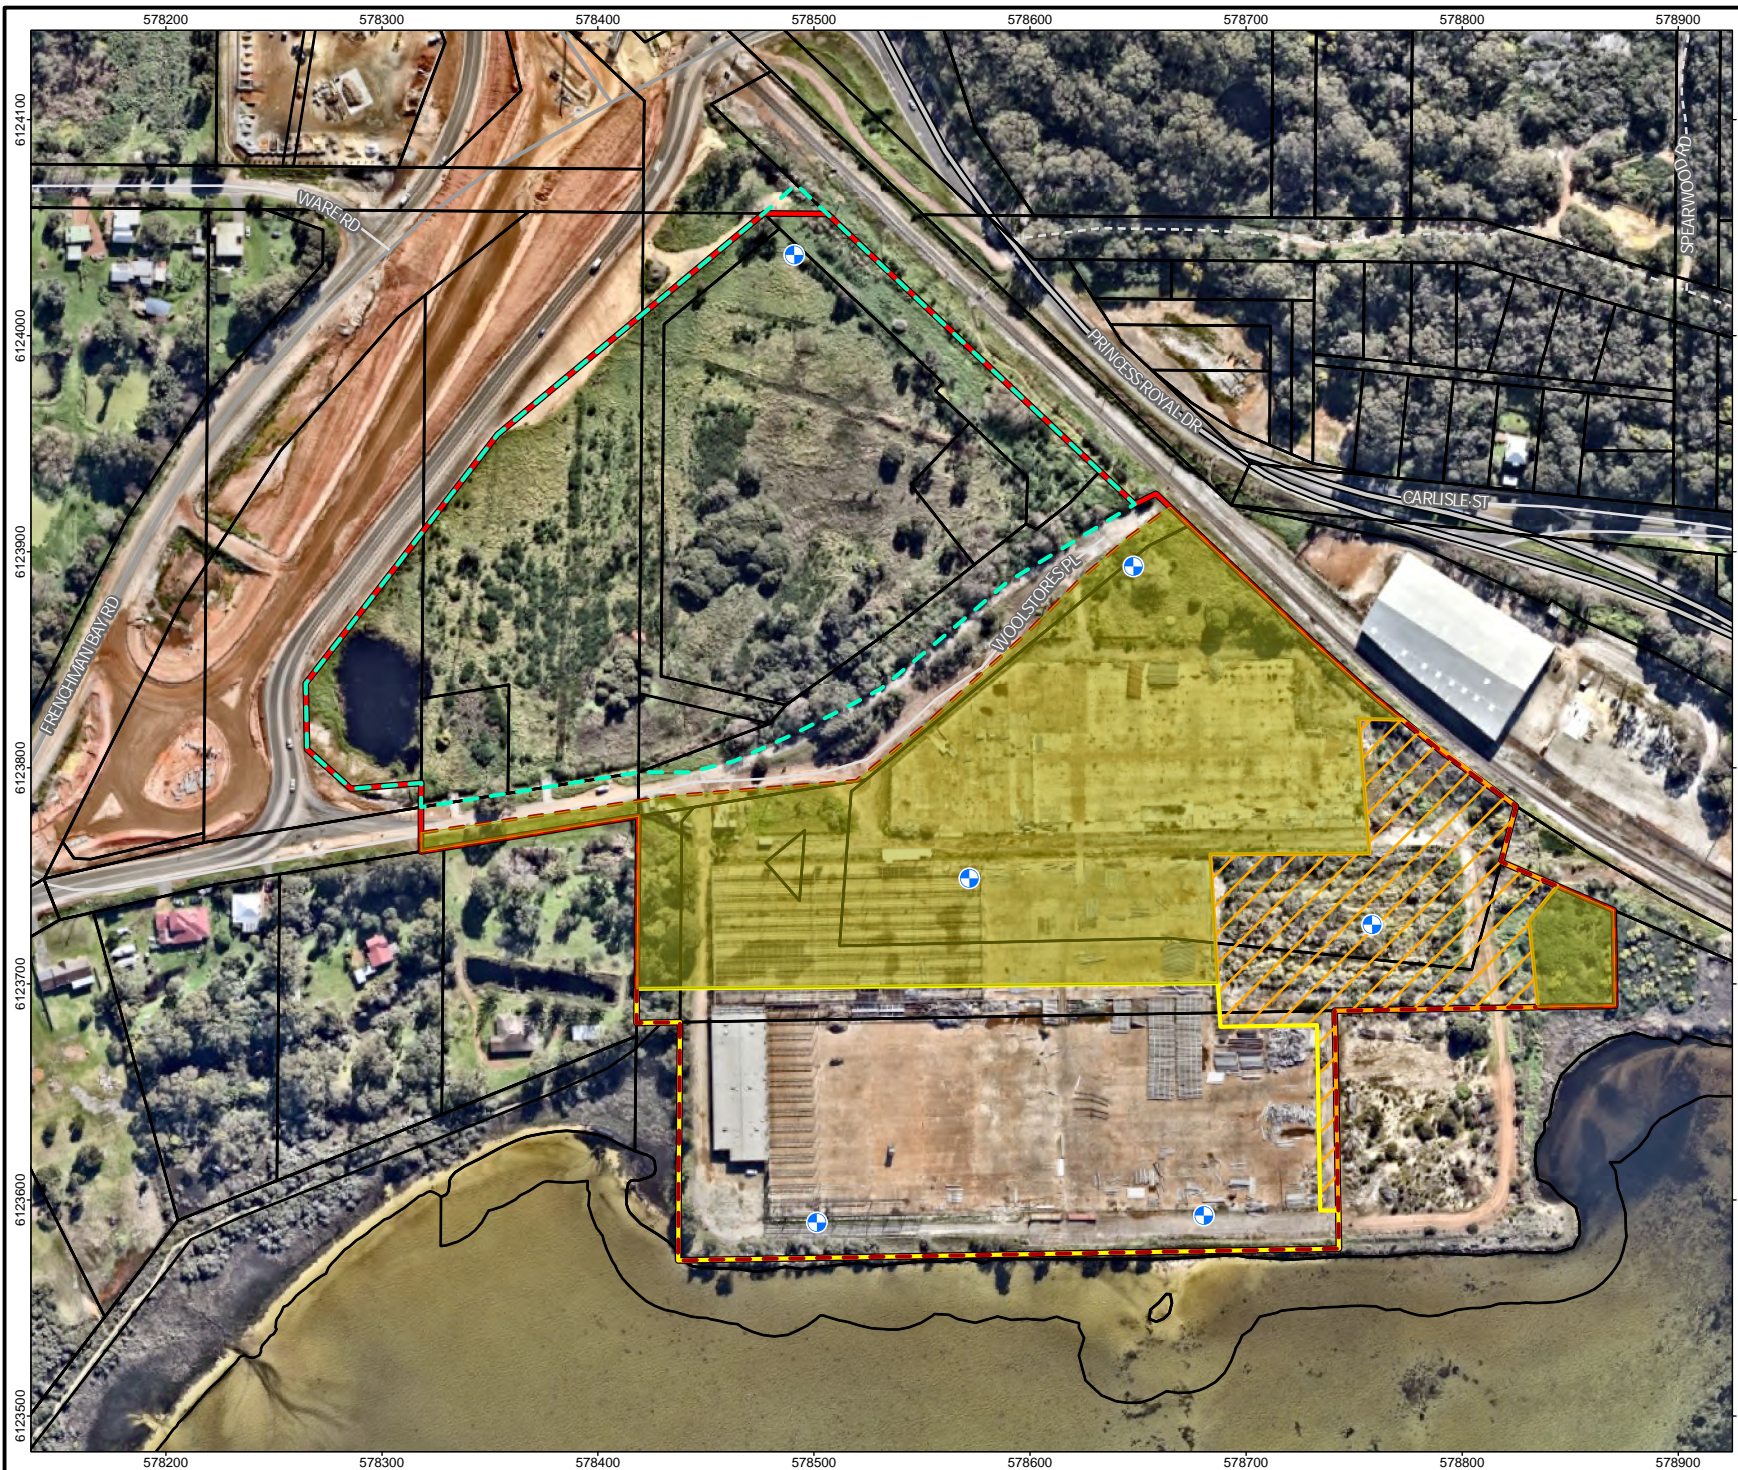
- Site boundary
- Reclaimed land
- Imported fill/fly tipping (PACM present)
- Balance of lots / Historical land uses
- Commercial / Industrial lots
- Northern rural lots
- Cadastral boundary
- Highway
- Major road
- Minor road
- Track

The Woolstores site has been built on reclaimed land. There is a potential risk associated with the unknown nature and extent of the imported material. During the preliminary site investigation, PACM fragments were observed within the fill material that was used to create site levels as they are today. The uncontrolled fill presents a potentially unacceptable health risk to future residents and construction workers, as well as an aesthetic risk.

Aspect	Observations
Visible signs of contamination	No gross contamination was observed. Fugitive PACM fragments were found around the warehouses and within the imported fill material along the southern and eastern boundary of the site.
On-site buildings and other infrastructure	Two historical warehouses associated with the historical Woolstores operations were present at the time of inspection. Both were in the process of being demolished. Roofing panels on both buildings comprised predominantly of PACM.
Aesthetic issues	No odours were detected, however, at the time of inspection the site was covered in demolition material from the warehouses.
Stockpiled material	Stockpiled material was present throughout site with construction and demolition waste, including PACM, scattered throughout the site
Presence of PACM	PACM (in the form of fibre-cement sheeting) was observed around the warehouses and within the imported fill material along the southern and eastern boundary of the site.
