PROPOSED MODIFICATIONS TO FRENCHMAN BAY LOCAL DEVELOPMENT PLAN

LOTS 1 & 2 FRENCHMAN BAY ROAD FRENCHMAN BAY

APRIL 2022

**Frenchman Bay
Coastal Hazard Assessment**

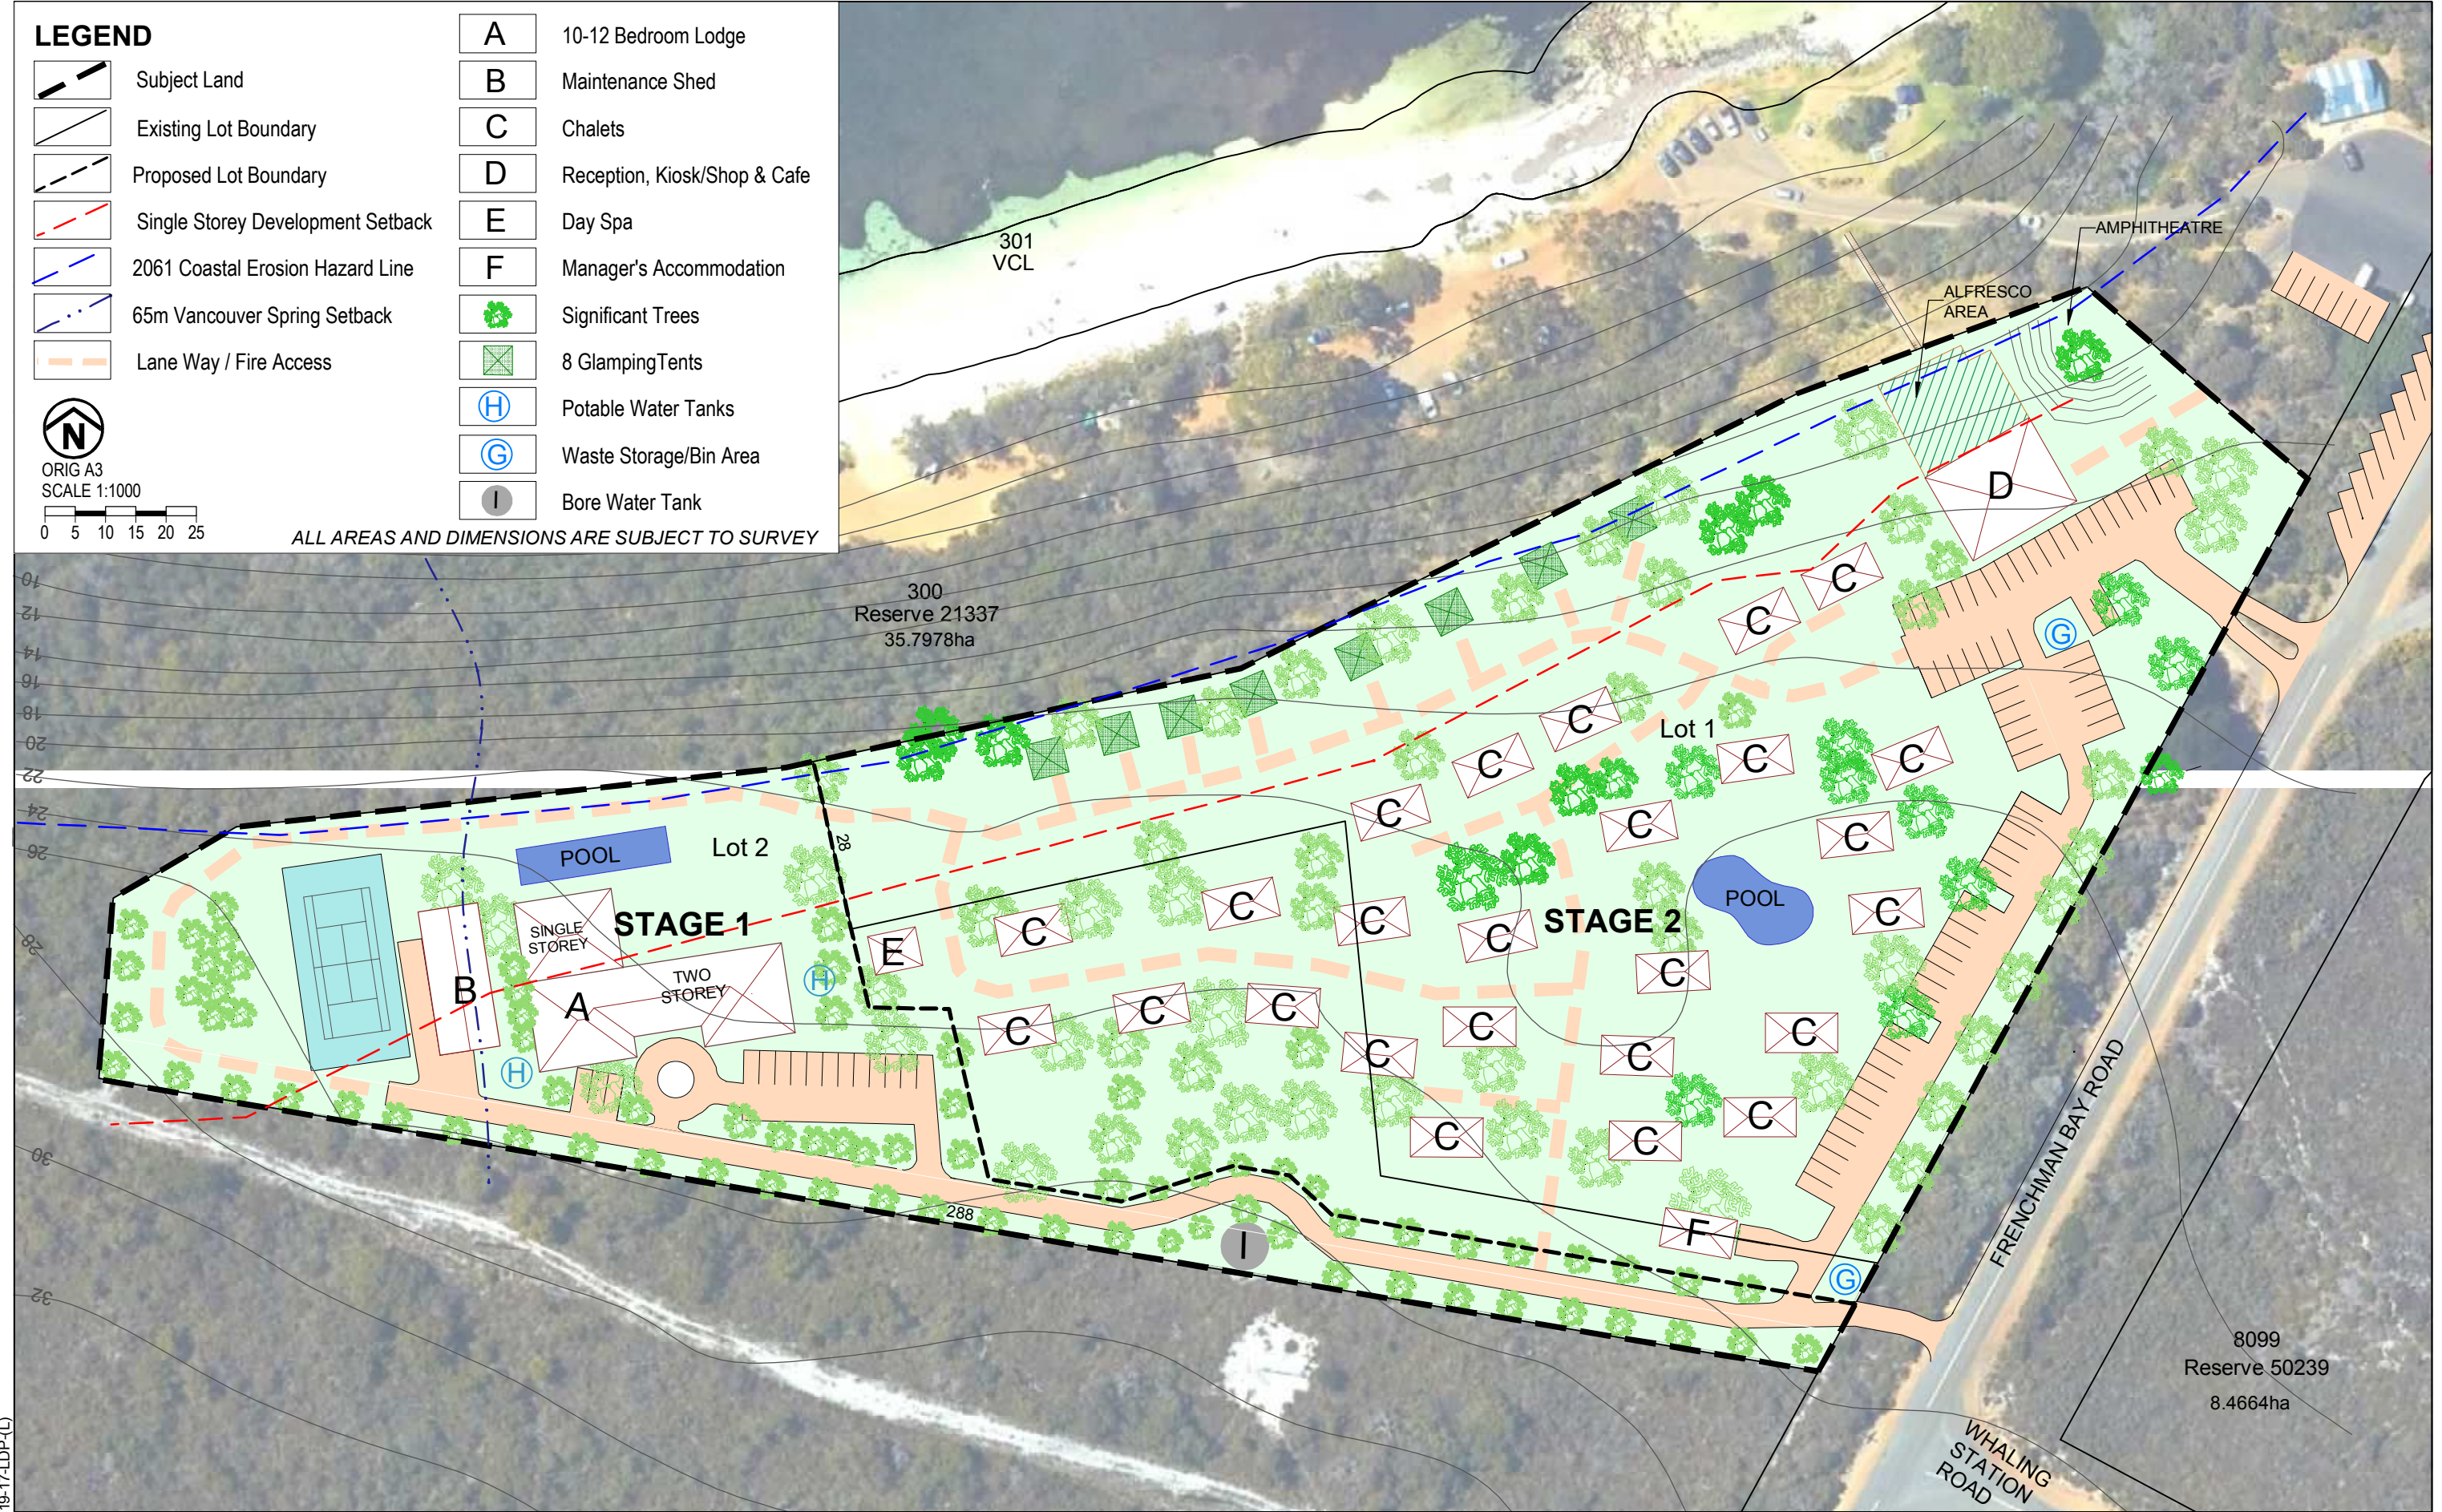
LOCAL DEVELOPMENT PLAN

Lots 1 & 2 Frenchman Bay Road
Frenchman Bay, City of Albany

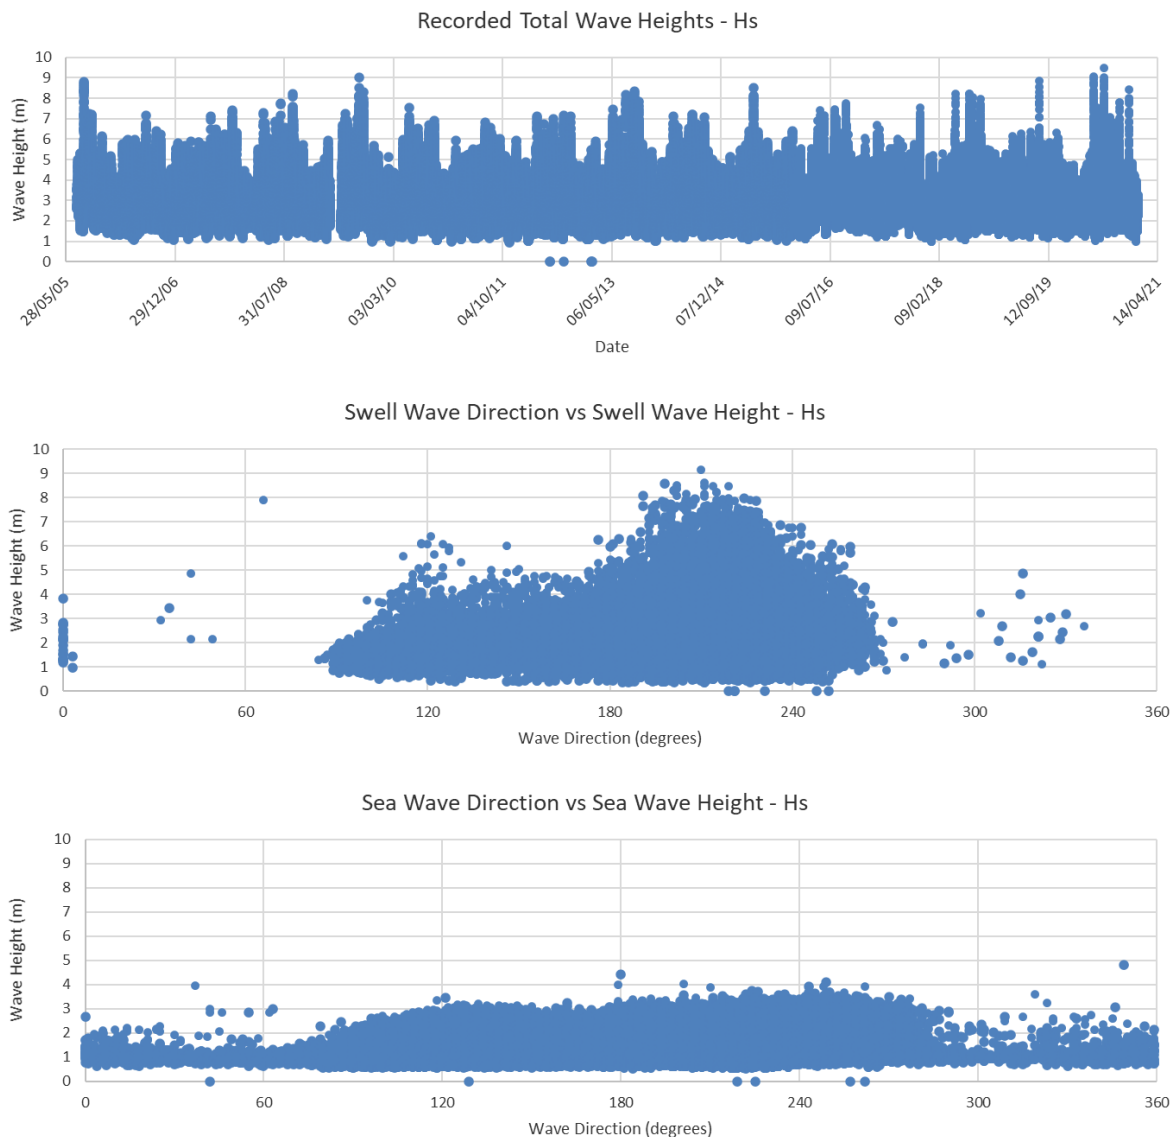
Figure 2.9 Wave Data Recorded from the Albany Waverider Buoy

Figure 2.9 shows that the most common direction for these offshore waves is from the southwest, but they also approach King George Sound from the south and occasionally the southeast. The severity of the wave heights also mirrors the persistence, with the most severe waves from the south through west. Interestingly, the plot of recorded wave heights shows that the winter of 2020 was relatively severe, with a cluster of higher wave heights than previously observed within the data record. This may explain some of the erosion pressures that have been experienced at Frenchman Bay over the past couple of years.

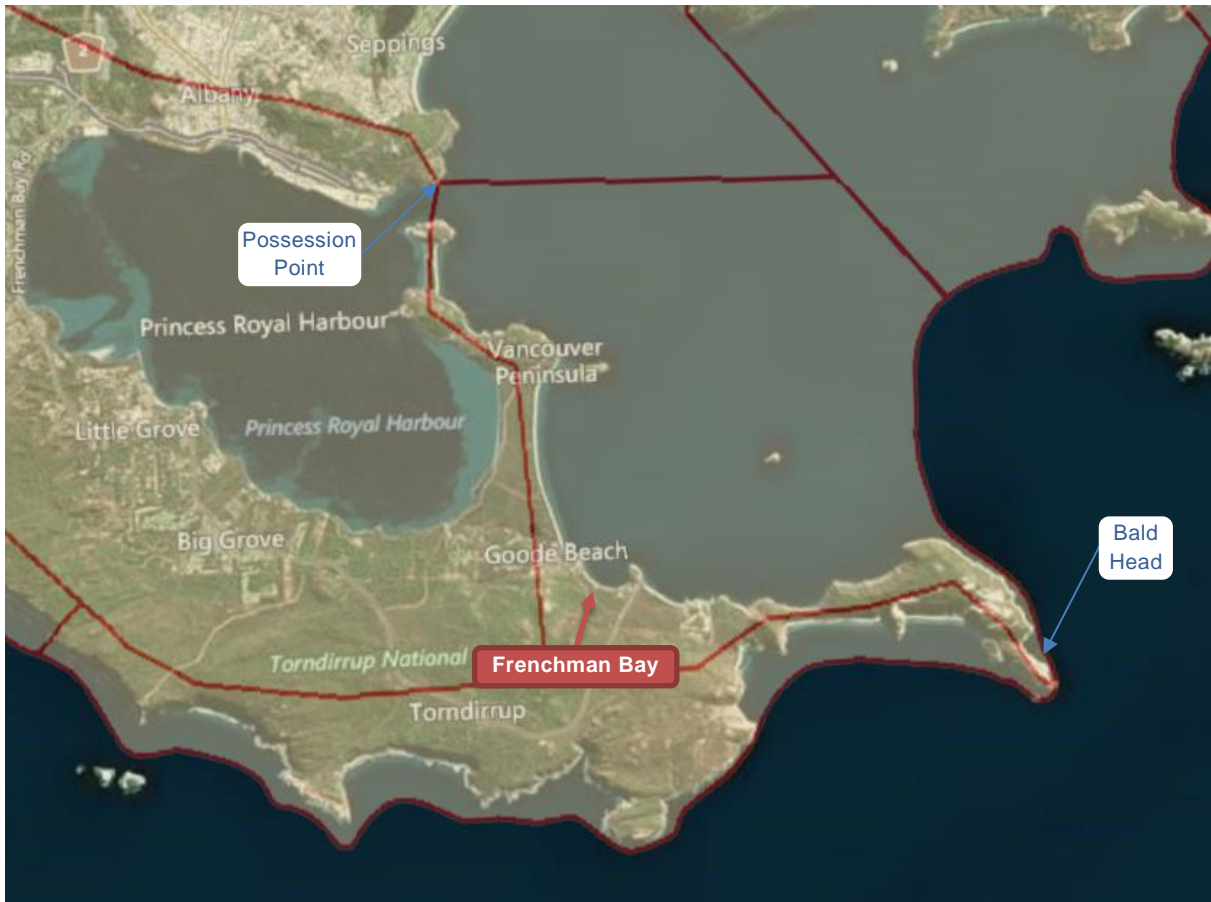
Figure 2.10 Extent of Coastal Sediment Cells

Over the planning horizons considered in this assessment (up to 100 years) Frenchman Bay can be treated as a closed sediment cell. This is due to the fact that Vancouver and Waterbay Points essentially restrict sediment transport into or out of the Bay.

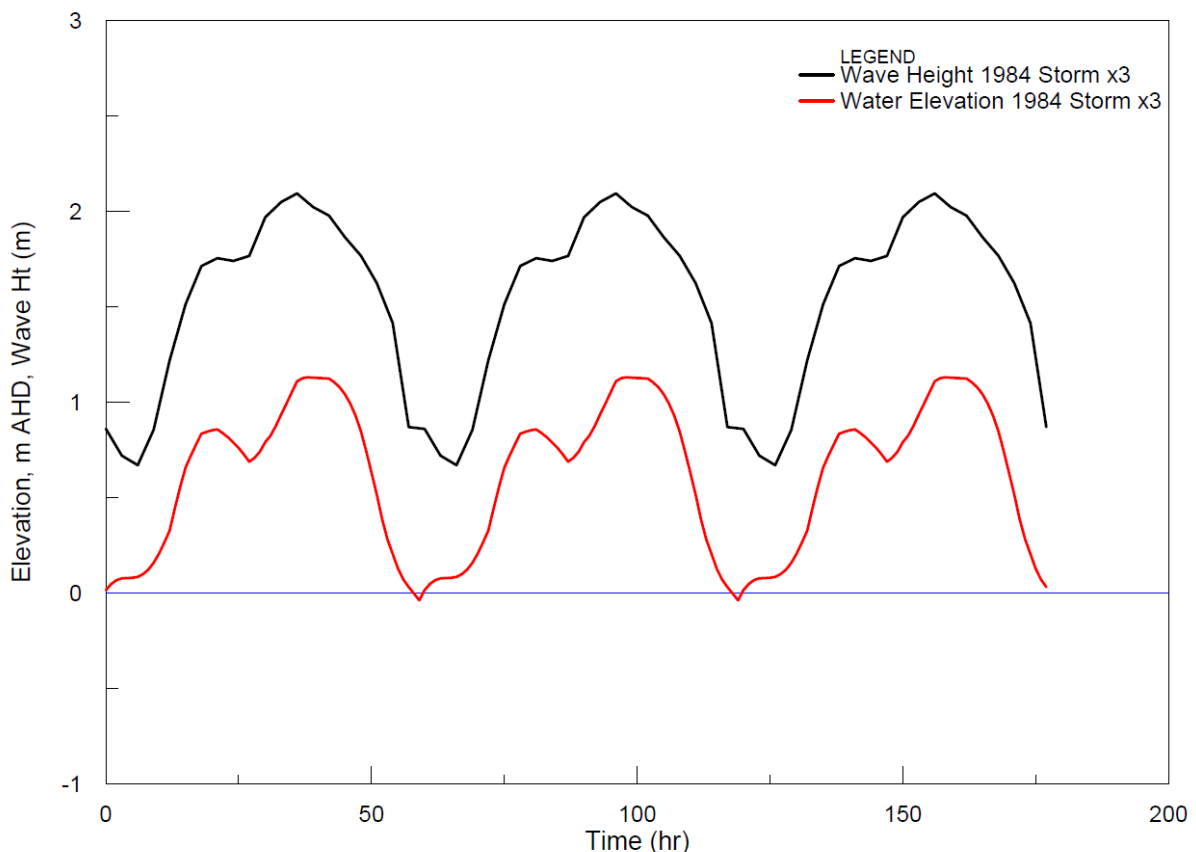
Figure 3.4 Storm Conditions for use in Storm Erosion Modelling (as determined for the area immediately offshore from the Resort site)

The August 1984 event had sustained waves from the south through east for a period of around 60 hours. The full duration of this event was therefore used for the modelling of the severe storm erosion impact. In accordance with the recommendation of SPP2.6, three repeats of this event have been used to determine the potential extent of storm erosion within Frenchman Bay. The wave heights and water level used in the modelling are presented in Figure 3.4.

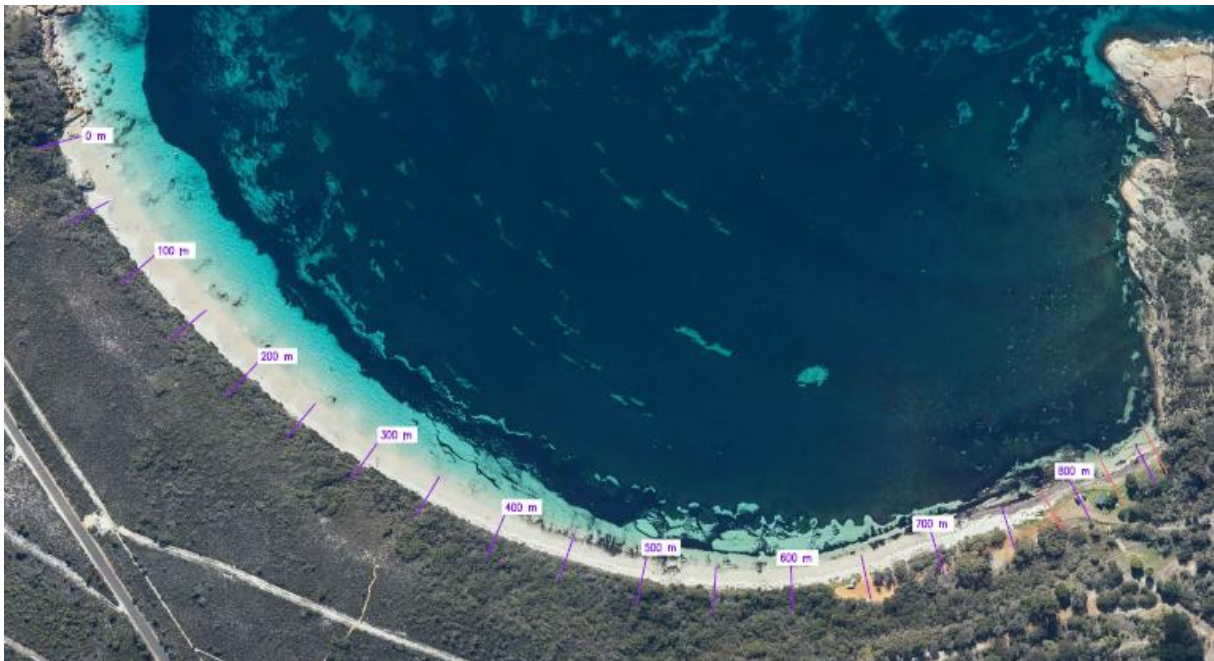
Figure 3.9 Intervals for Measurement of Shoreline Movement

Using the mapped vegetation lines, the position of the shoreline was determined at intervals of 50 m or less along Frenchman Bay. The chainage intervals for the measurement of shoreline change are shown in Figure 3.9. The position of the shoreline relative to the 1977 location was determined at each interval from the shoreline movement plan, with results presented in Figure 3.10.

MRA mapped the position of the coastal vegetation line from aerial photography captured in 1977, 1988, 1996, 2001, 2007, 2011, 2014, 2016, 2019, 2020 and 2021. Mapping of the coastal vegetation lines was completed in accordance with DoT's methodology and specification for mapping (DoT, 2009). The accuracy of the position of these vegetation lines is believed to be in the order of ± 5 m, depending on the resolution of the aerial photographs and the rectification process. A shoreline movement plan presenting the mapped vegetation lines is presented in Appendix B.

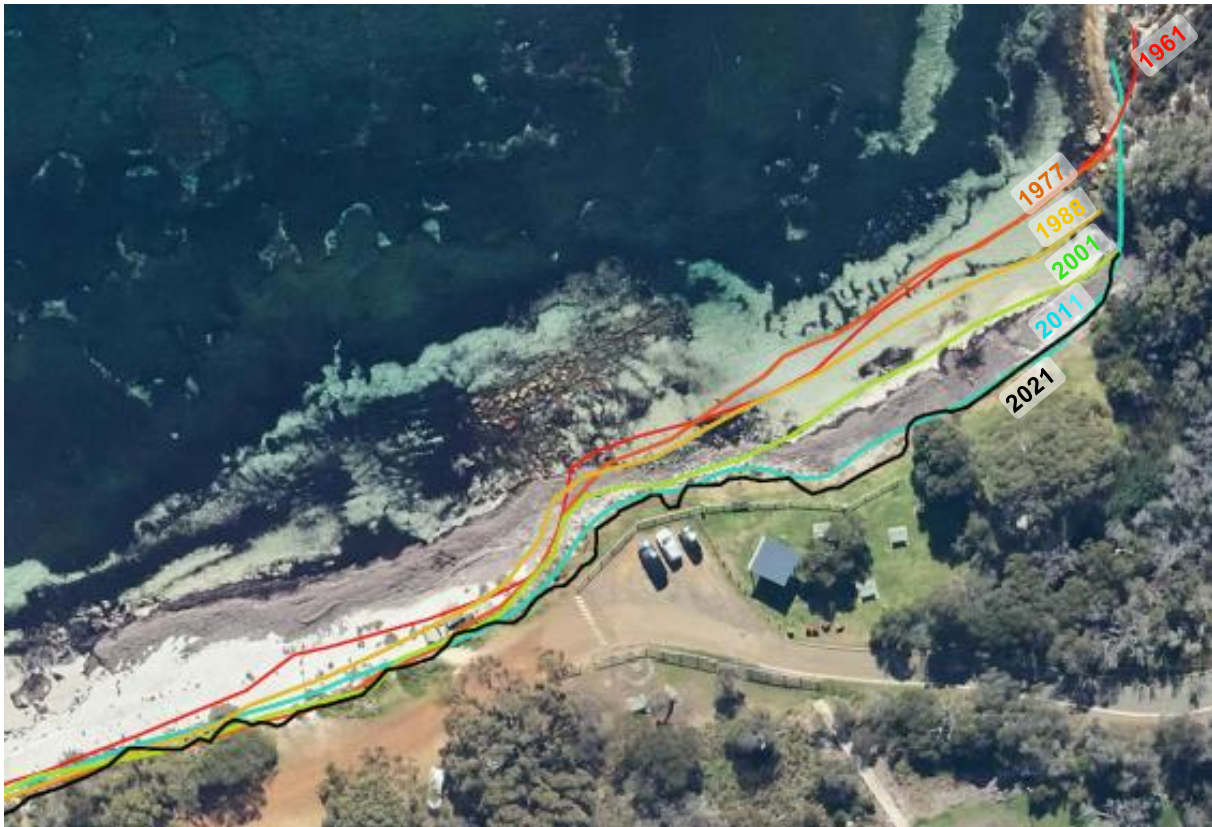
Figure 3.12 Shoreline Positions Adjacent to the Relic Seawall

Figure 3.12 shows a zoomed in view of a selection of mapped shoreline positions adjacent to the relic seawall. The figure shows an obvious disparity between the historical positions of the shoreline to the west and east of the structure. Note that this figure also includes a coastal vegetation line from 1961 which was mapped for this project but ultimately not used due to issues at the western end of Frenchman Bay.

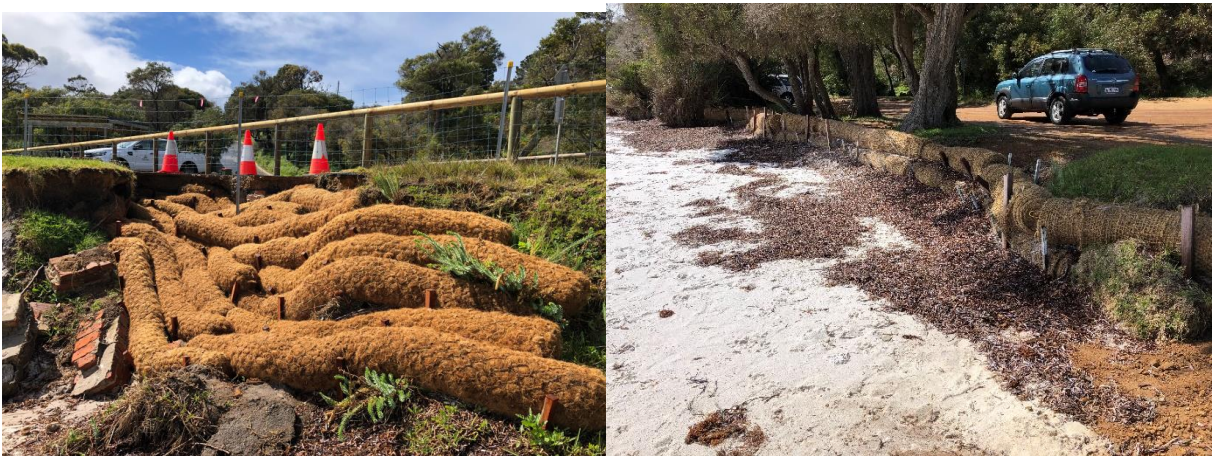
Figure 3.13 Coir Logs Installed by the City of Albany in 2021 to Combat Erosion

Regardless of the cause of the change to the seawall, and its associated level of shoreline control, it appears that the shoreline east and west of the structure are now better aligned and as a result, it is anticipated that chronic movement of the shoreline in this area would reduce in the future. Nevertheless, the fact that between 15 and 20 m of foreshore has been lost in this area means that the existing foreshore does not interface well with the adjoining beach. The absence of a dune system, or the mechanism for the natural formation of a dune system, in this area therefore further exacerbates the issue as it means that the foreshore is prone to impacts from severe storm erosion events and high water levels. This has been observed over the winter of 2021, with the City of Albany installing coir logs (refer Figure 3.13) to try and combat erosion of the foreshore area.

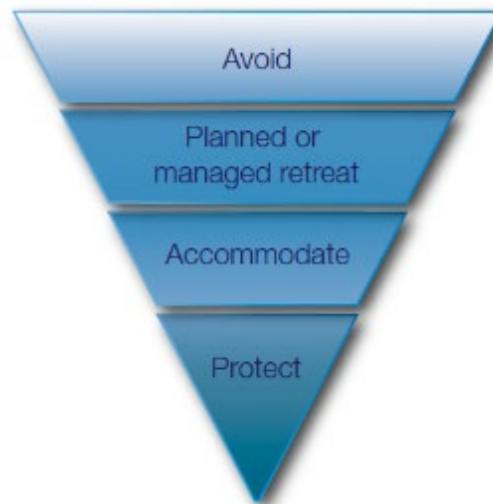
Figure 6.1 Risk Management & Adaptation Hierarchy

Risk adaptation and mitigation strategies are required for SHG to address the coastal hazard risks and asset vulnerabilities identified in Section 5. SPP2.6 outlines a hierarchy of risk adaptation and mitigation options, where options that allow for a wide range of future strategies are considered more favourably. This hierarchy of options is reproduced in Figure 6.1.

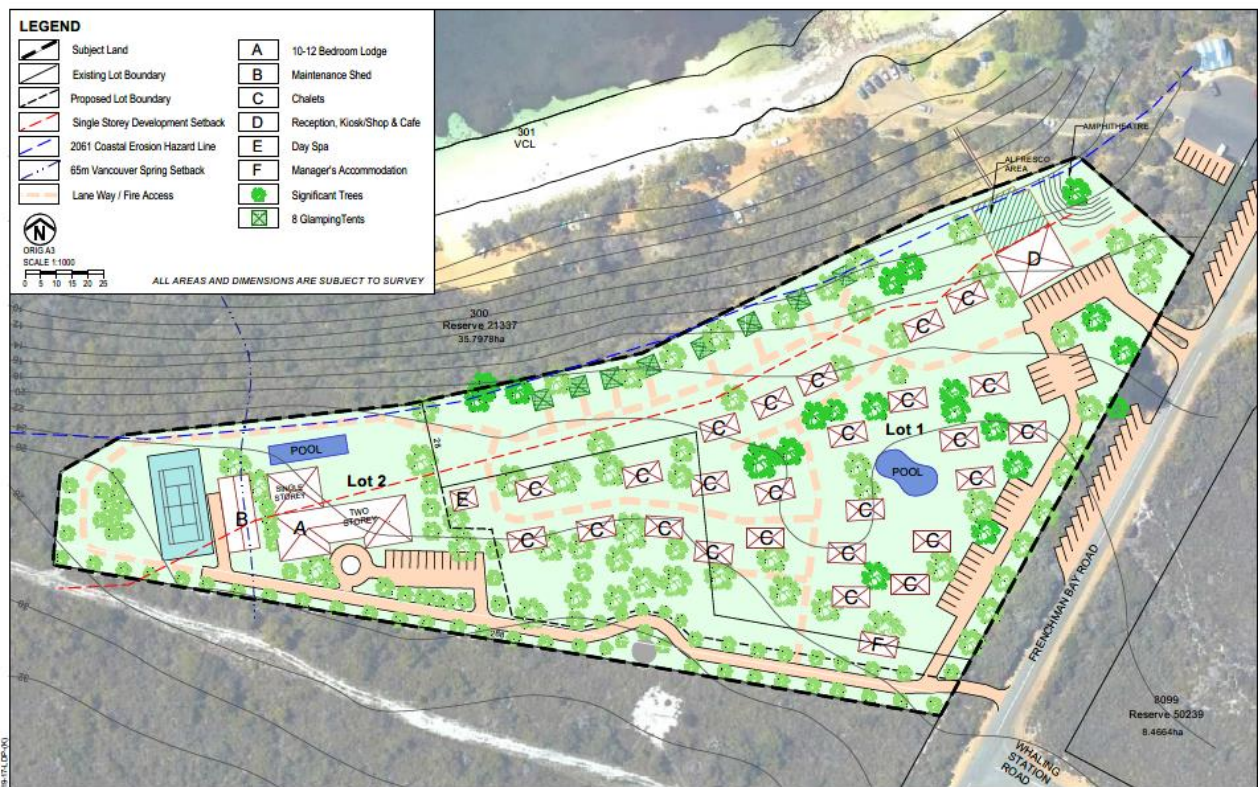
Figure 2: Proposed Local Development Plan

- A luxury holiday lodge with 10-12 bedrooms;
- Up to 25 single bedroom holiday chalets, eight glamping tents, day spa and manager’s accommodation; and
- A signature café/restaurant with associated kiosk/shop and reception office.

The proposed LDP is shown in Figure 2.

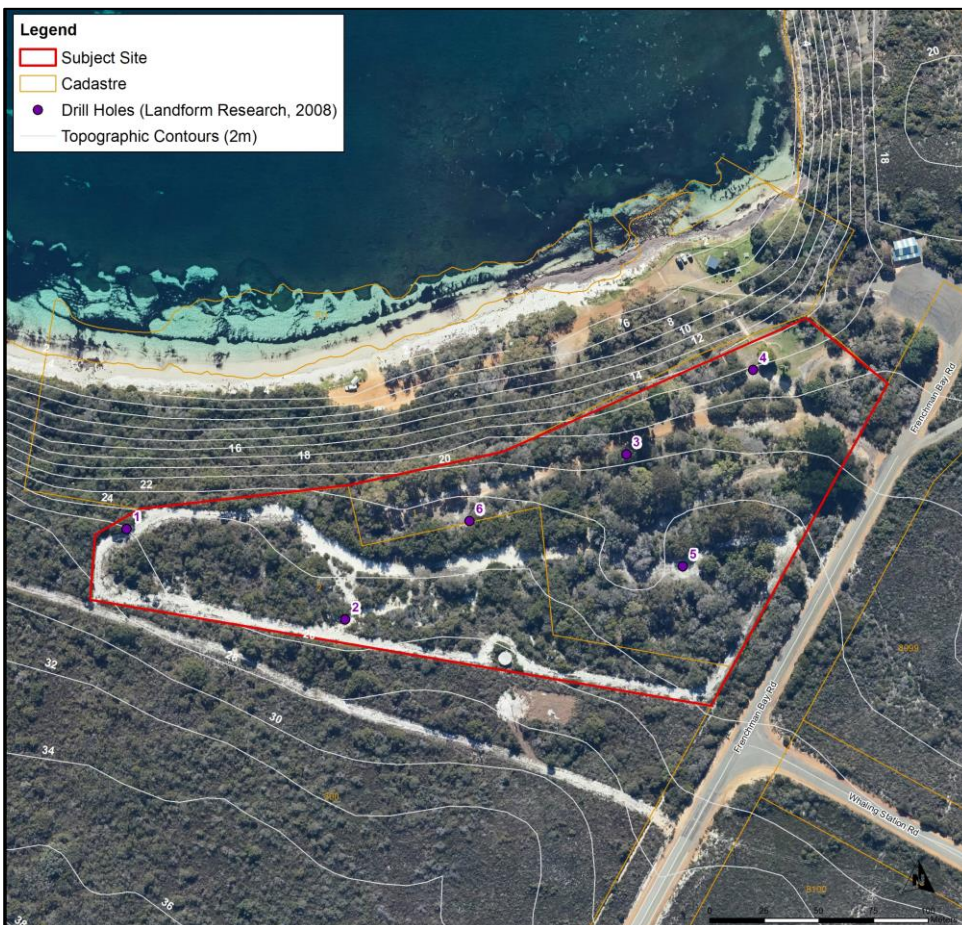
Figure 3: Topography and Geology

In 2008 Landform Research conducted a geological study of the site for a previous proposed development. In summary six air blast drill holes were constructed to varying depths from 15 – 21 m BGL, the drill holes were tested for soil type and presence of groundwater. Soil type in all six drill holes was found to be predominantly Quaternary coastal, Aeolian sands (from 0m BGL to between 6.5 and >16 m BGL). Holes 1, 2, 3 and 5 consisted of Quaternary coastal, Aeolian sands overlying possible Pallinup Siltstone, with the depth of the siltstone layer ranging from 6.5 - 16.5 m BGL in Hole 3 to 16 - >21 m BGL in Hole 1. Peats consistent with the Werillup Formation were found at Hole 3 only (from 16.5 m BGL). The location of the drill holes is shown in Figure 3.

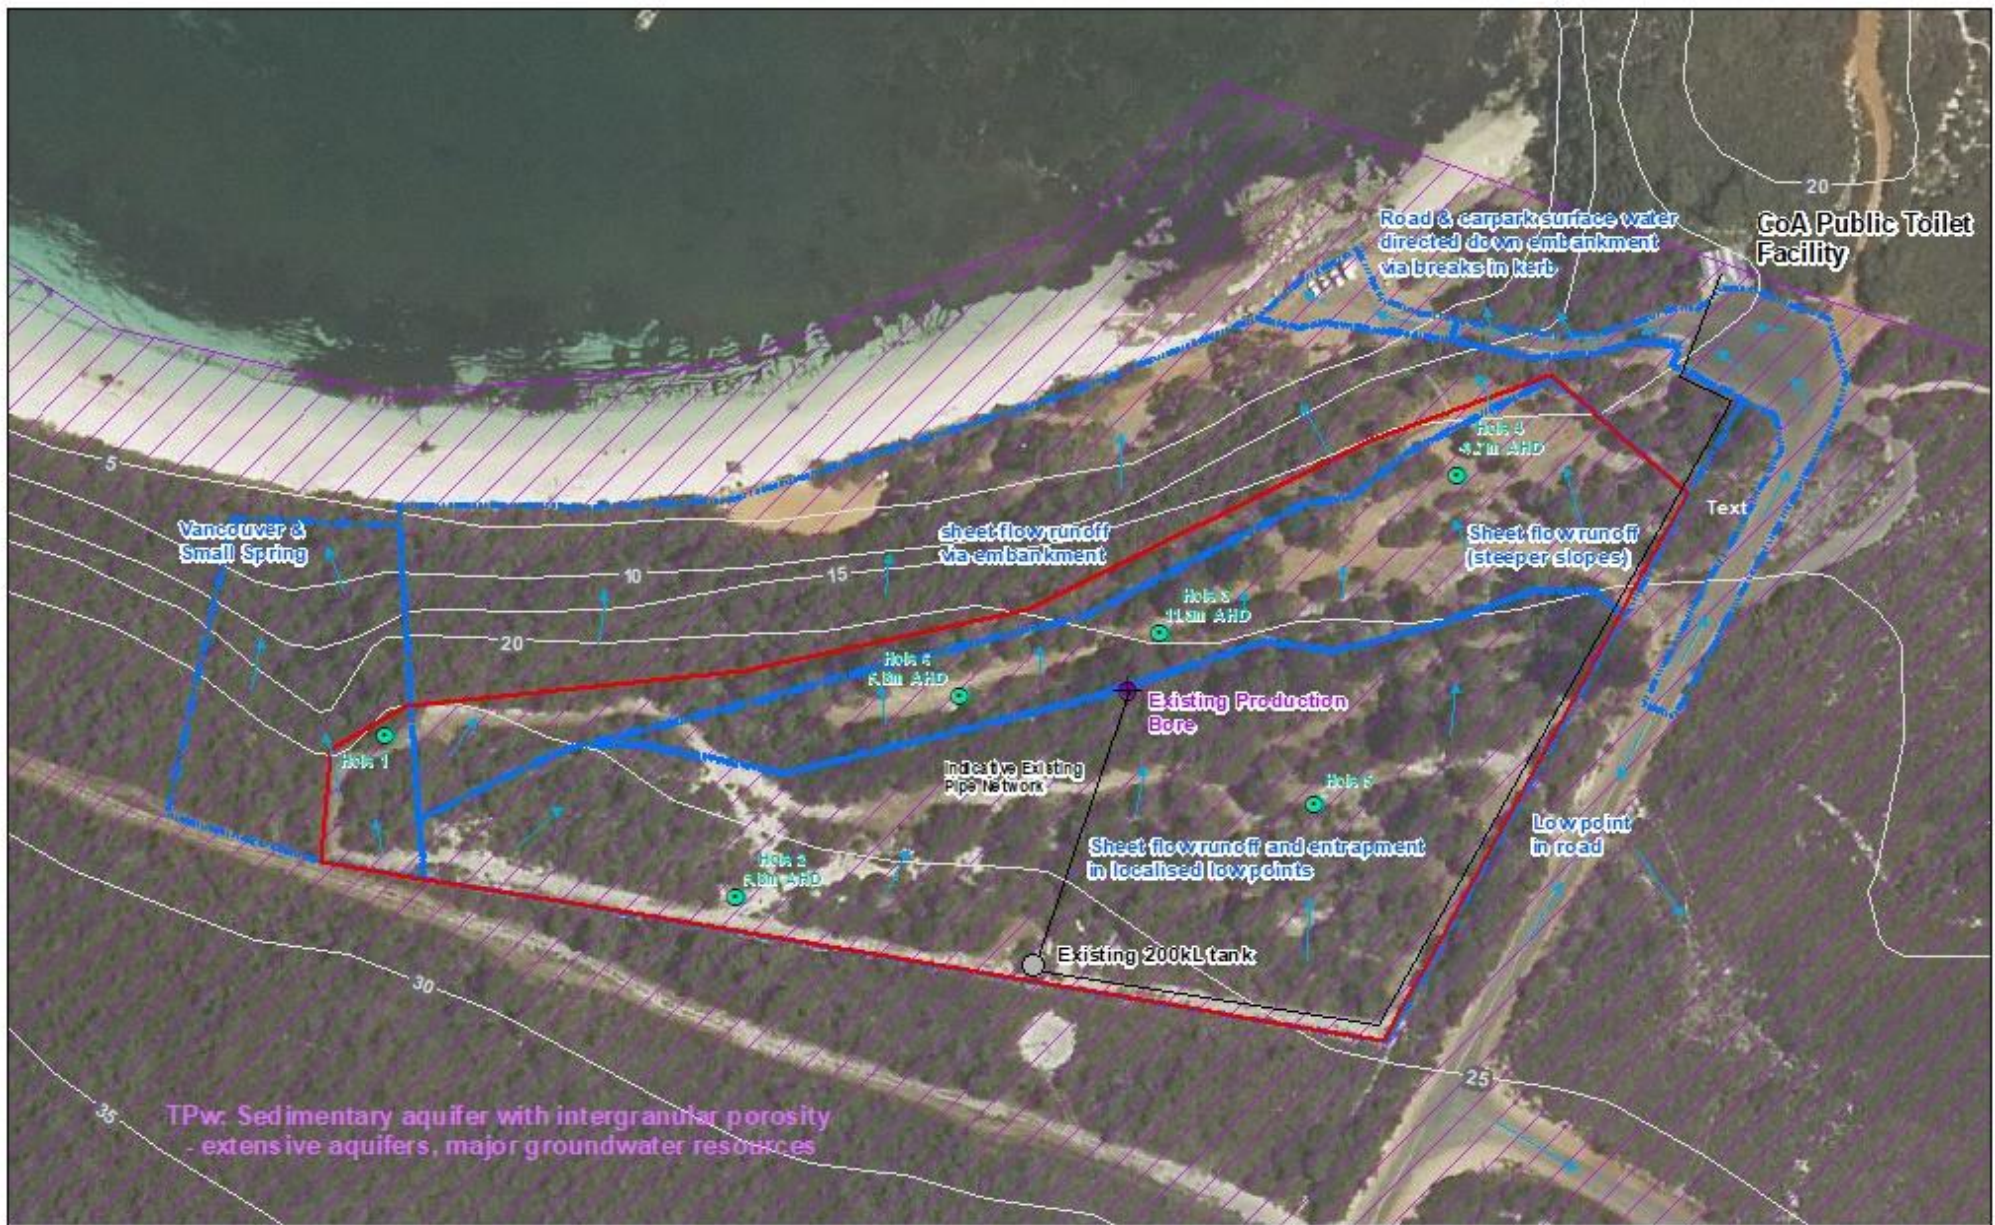
- Subject Site
- Production Bore
- Drill holes & Groundwater Level (Landform Research 2008)
- Pre-development surface water catchment
- Surface water flow direction
- 5m topographic contours (MAHD)
- TPw (250K Hydrogeological Mapping (DrWI))

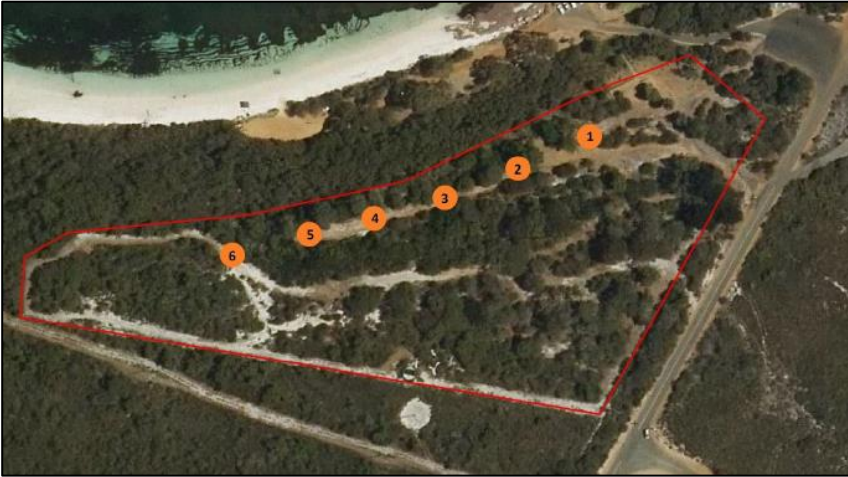
Figure 6: Soil testing hole locations

A Site Soil Investigation was conducted on the 30th September 2016 by Great Southern Geotechnics (GSG) and Bio Diverse Solutions as part of the previously proposed and approved development. The site investigation included the construction of six test holes to a depth of 2.0metres, photographing and logging of soils to the depth of the holes, and inspection and measuring of the water table if found to be present. The location of the six soil test holes is shown on Figure 6 and the Site Soil Investigation (GSG, 2016) report showing the bore hole logs is included as Appendix A.

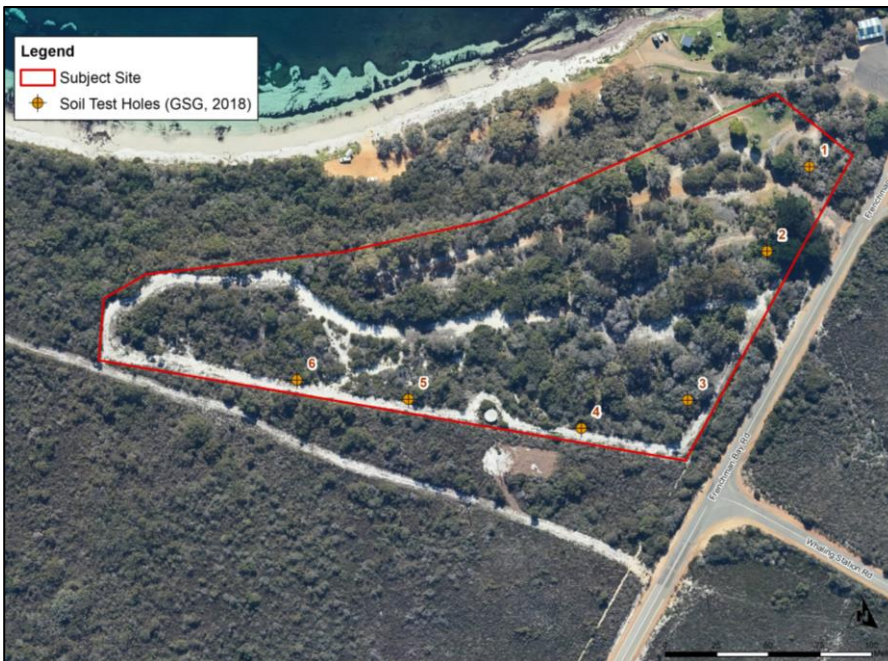
Figure 7: 2018 Soil testing hole locations

A follow up Site Soil Investigation to capture soil characteristics along the eastern and southern boundaries was conducted on the 22nd March 2018. The site investigation included the construction of a further six test holes to a depth of 2.0metres, photographing and logging of soils to the depth of the holes and inspection and measuring of the water table. The location of the additional six soil test holes is shown in Figure 7 and the Site Soil Investigation (GSG, 2018) report is included as Appendix B.

Soil test holes during both the 2016 and 2018 investigation were excavated to a depth of 2.0 metres using a Kubota KX41-3V mini excavator with a 300mm auger. The boreholes were logged and left open for a minimum of 1 hour to examine any water table or water seepage into the soil profile.

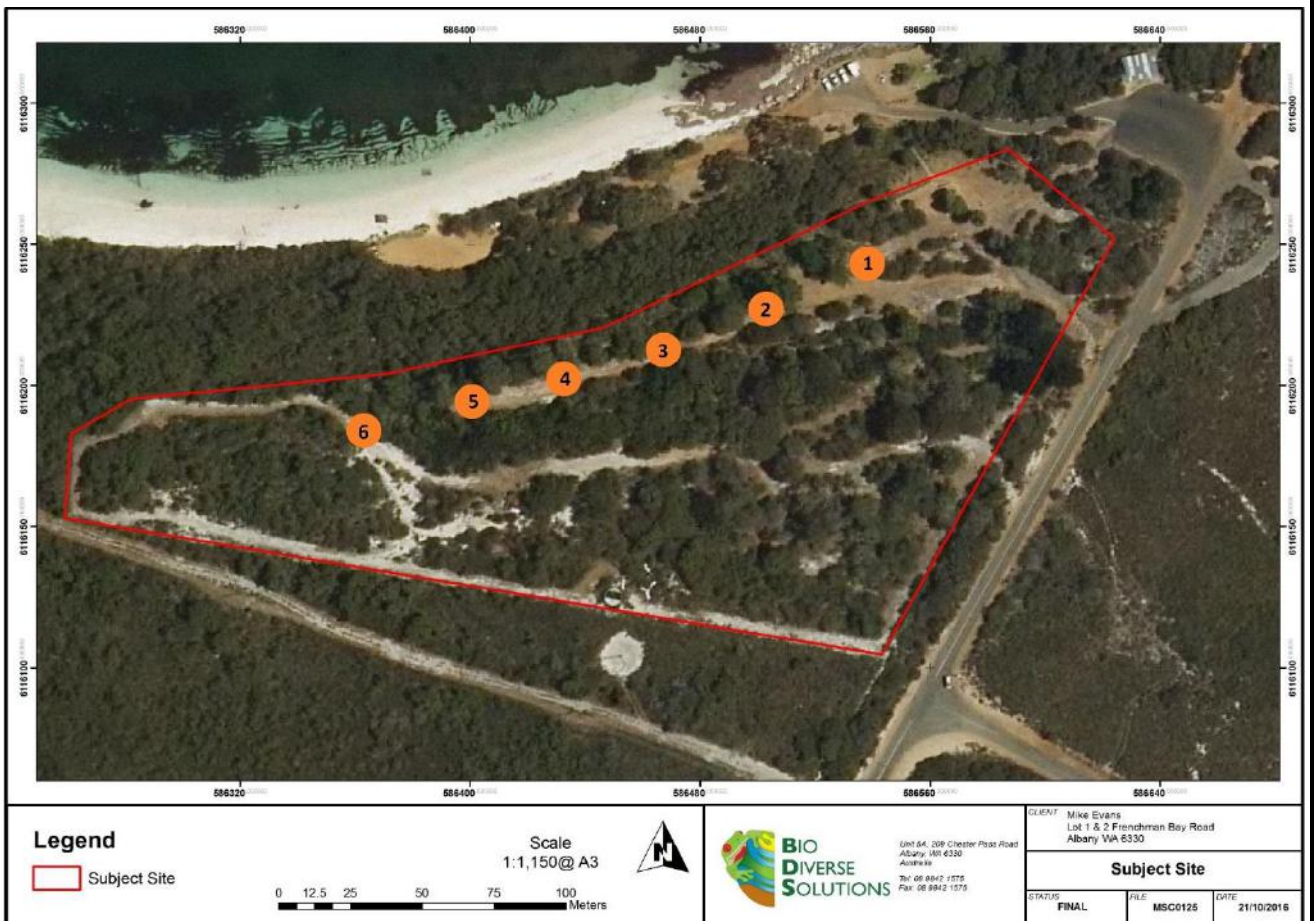
Figure 2 - Lots 1 & 2 Frenchman Bay Rd, Frenchman Bay

The fieldwork was carried out on September 30, 2016 and comprised the following:
Six (6) test pits excavated with a 301.4C Mini Hydraulic Excavator using a 300mm wide bucket to depths of 1.8 m to visually assess subsurface conditions and obtain samples for laboratory testing.
The approximate test locations are shown on **Figure 2**.

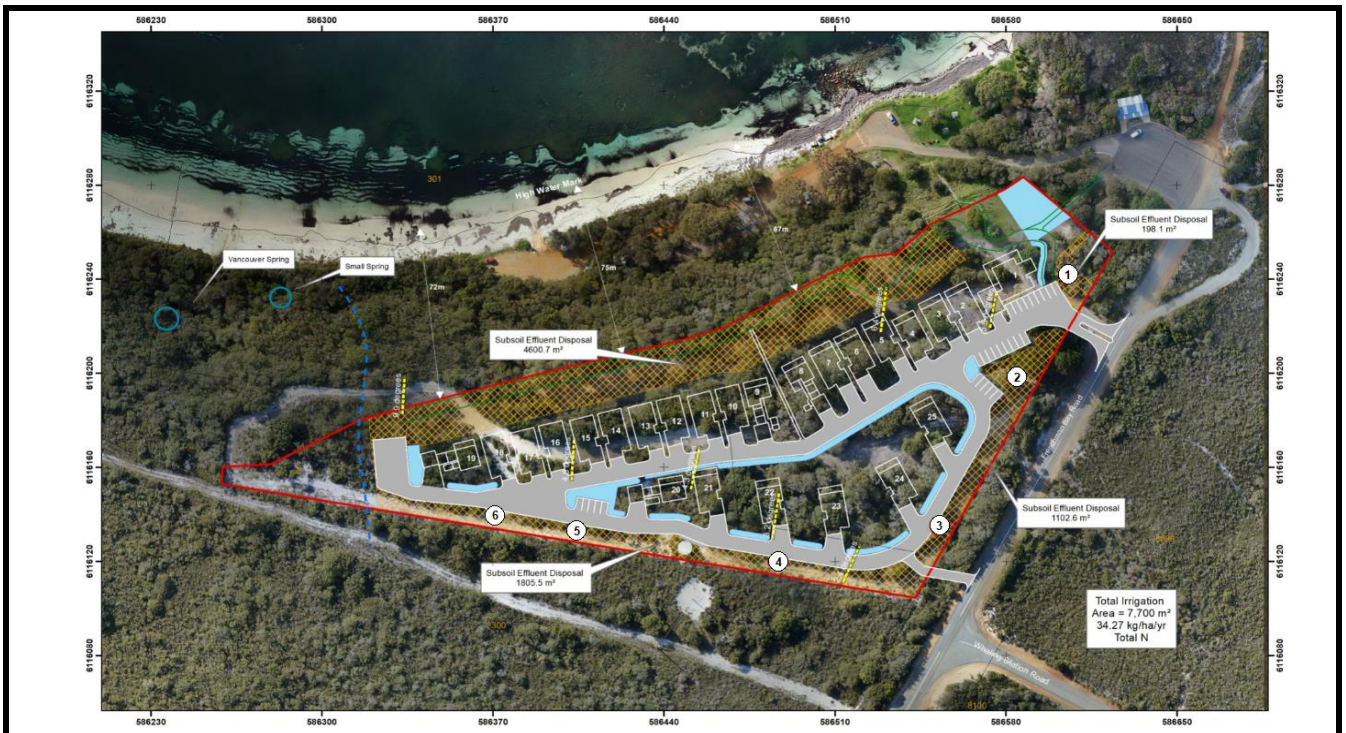
Test Pit No. 1 - Excavation

Job No 302	Report No 302/1	Sheet 1 of 6				
Client: Bio Diverse Solutions Project: Lots 1 & 2 Fenchman Bay Rd, Albany WA 6330 Project No: N/A Location: Proposed Building Envelope Test Pit No.: TP1 Sample No. 18G671			Operator/Contractor: GSG Equipment type: Kubota KX41-3V Excavation Method : 300mm Auger Position: 50 H 586602 6116250 Elevation: n/a					
Date Commenced: 22.03.2018 Date Completed: 22.03.2018		Logged By: M.Coffey Checked By: M.Coffey		Excavation Dimensions: Depth 2.0 (m) Width 0.3 (m)				
Depth Below Surface (mm)	Layer Depth (mm)	Material Description <small>SOIL TYPE, Plasticity, Colour, Particle characteristics, Secondary and other minor components</small>	Moist. Condition	Consistency / Strength	Cementation	Water Table	Classification Symbol	Sample/Test
0 - 400	400	(Topsoil) SAND with silt: Dark grey, fine to medium. Roots & root fibres.	M	L		No water table encountered.		
400 - 800	400	SAND with silt: Grey, fine to medium.	M	L

800 - 2000	1200	SAND with silt: Light grey to white, fine to medium.	M	L				
Comments			Pit Terminated at: (mm) below ground level ✓ or *		Target Depth <input checked="" type="checkbox"/> 2000 Cave In <input type="checkbox"/> Refusal <input type="checkbox"/> Near Refusal <input type="checkbox"/> Flooding <input type="checkbox"/> Lack of Reach <input type="checkbox"/>			
Materials Consistency/Strength		Rock	Cementation		Water Water first Encountered			
Cohesive VS - Very Soft S - Soft F - Firm St - Stiff VSt - Very Stiff H - Hard	Non-Cohesive VL - Very Loose L - Loose MD - Medium Dense D - Dense VD - Very Dense CO - Compact	EL - Extremely Low VL - Very Low L - Low M - Medium H - High VH - Very High EH - Extremely High	IN - Indurated PC - Poorly Cemented MC - moderately Cemented WC - Well Cemented		Moisture D - Dry M - Moist W - Wet General N/A - Not Applicable N/D - Not Determined

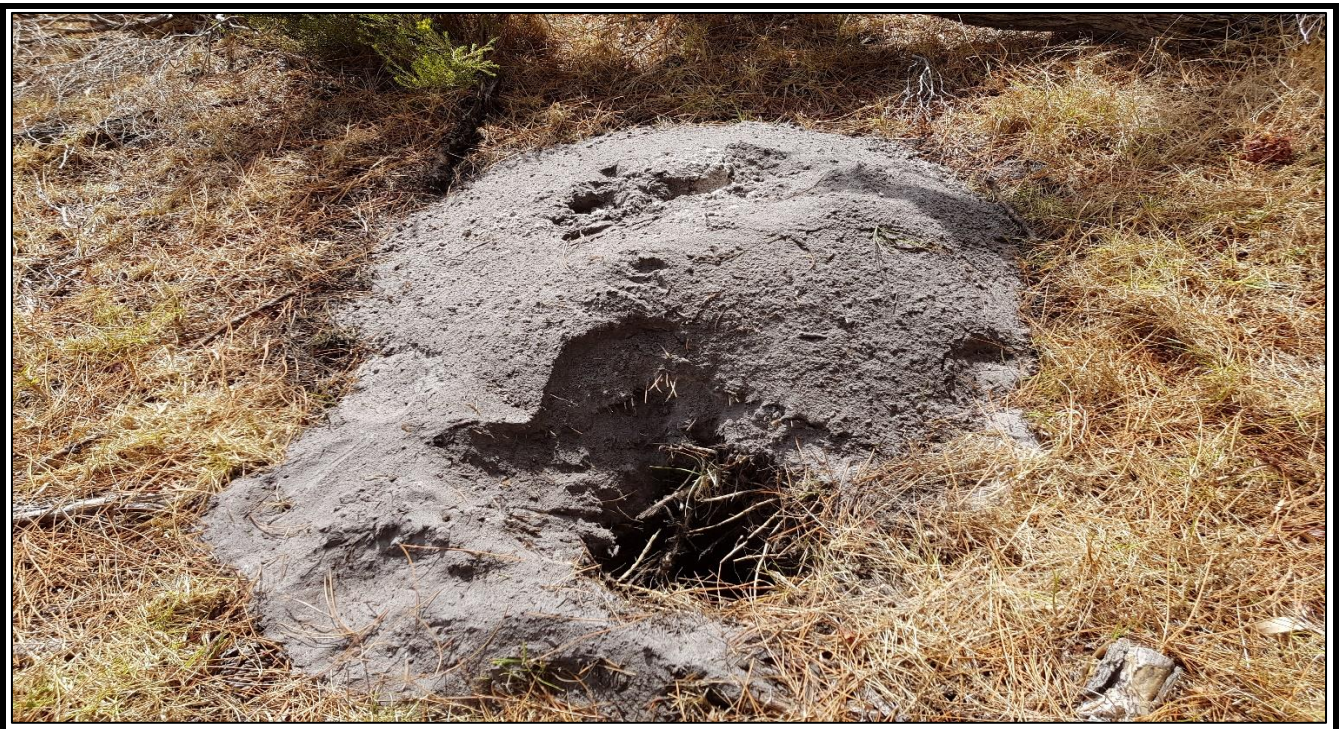
Test Pit No. 2 - Excavation

Job No 302	Report No 302/1	Sheet 2 of 6				
Client: Bio Diverse Solutions Project: Lots 1 & 2 Fenchman Bay Rd, Albany WA 6330 Project No: N/A Location: Proposed Building Envelope Test Pit No.: TP2 Sample No. 18G672			Operator/Contractor: GSG Equipment type: Kubota KX41-3V Excavation Method : 300mm Auger Position: 50 H 586582 6116174 Elevation: n/a					
Date Commenced: 22.03.2018 Date Completed: 22.03.2018		Logged By: M.Coffey Checked By: M.Coffey		Excavation Dimensions: Depth 2.0 (m) Width 0.3 (m)				
Depth Below Surface (mm)	Layer Depth (mm)	Material Description SOIL TYPE, Plasticity, Colour, Particle characteristics, Secondary and other minor components	Moist. Condition	Consistency / Strength	Cementation	Water Table	Classification Symbol	Sample/Test
0 - 1600	1600	SAND with silt: Light grey/white, fine to medium.	D-M	L		No water table encountered.		
1600 - 2000	400	SAND with silt: Light brown/grey, fine to medium.	M	L	PC

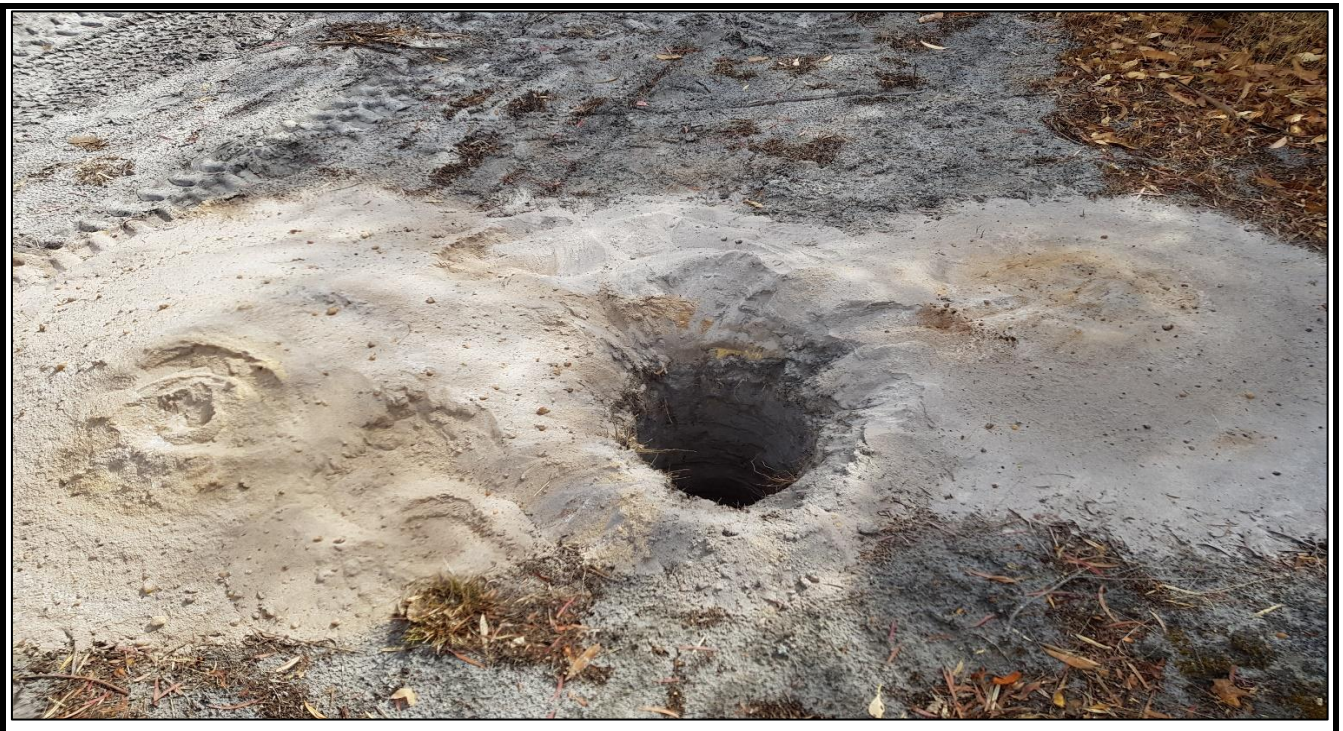
Test Pit No. 3 - Excavation

Job No 302	Report No 302/1	Sheet 3 of 6				
Client: Bio Diverse Solutions Project: Lots 1 & 2 Fenchman Bay Rd, Albany WA 6330 Project No: N/A Location: Proposed Building Envelope Test Pit No.: TP3 Sample No. 18G673			Operator/Contractor: GSG Equipment type: Kubota KX41-3V Excavation Method : 300mm Auger Position: 50 H 586542 6116110 Elevation: n/a					
Date Commenced: 22.03.2018 Date Completed: 22.03.2018		Logged By: M.Coffey Checked By: M.Coffey		Excavation Dimensions: Depth 2.0 (m) Width 0.3 (m)				
Depth Below Surface (mm)	Layer Depth (mm)	Material Description SOIL TYPE, Plasticity, Colour, Particle characteristics, Secondary and other minor components	Moist. Condition	Consistency / Strength	Cementation	Water Table	Classification Symbol	Sample/Test
0 - 400	400	(Topsoil) SAND with silt: Grey, fine to medium. Roots & root fibres.	M	L		No water table encountered.		
400 - 1000	600	SAND with silt: Light grey, fine to medium.	M	L				PERM

1000 - 2000	1000	SAND with silt: White, fine to medium.	M	L				
Comments			Pit Terminated at: (mm) below ground level ✓ or *			Target Depth <input checked="" type="checkbox"/> 2000 Cave In <input type="checkbox"/> Refusal <input type="checkbox"/> Near Refusal <input type="checkbox"/> Flooding <input type="checkbox"/> Lack of Reach <input type="checkbox"/>		
Materials Consistency/Strength		Rock	Cementation		Water Water first Encountered			
Cohesive VS - Very Soft S - Soft F - Firm St - Stiff VSt - Very Stiff H - Hard	Non-Cohesive VL - Very Loose L - Loose MD - Medium Dense D - Dense VD - Very Dense CO - Compact	EL - Extremely Low VL - Very Low L - Low M - Medium H - High VH - Very High EH - Extremely High	IN - Indurated PC - Poorly Cemented MC - moderately Cemented WC - Well Cemented		Moisture D - Dry M - Moist W - Wet General N/A - Not Applicable N/D - Not Determined
