PROPOSED MODIFICATIONS TO FRENCHMAN BAY LOCAL DEVELOPMENT PLAN

LOTS 1 & 2 FRENCHMAN BAY ROAD FRENCHMAN BAY

APRIL 2022

**Frenchman Bay
Coastal Hazard Assessment**

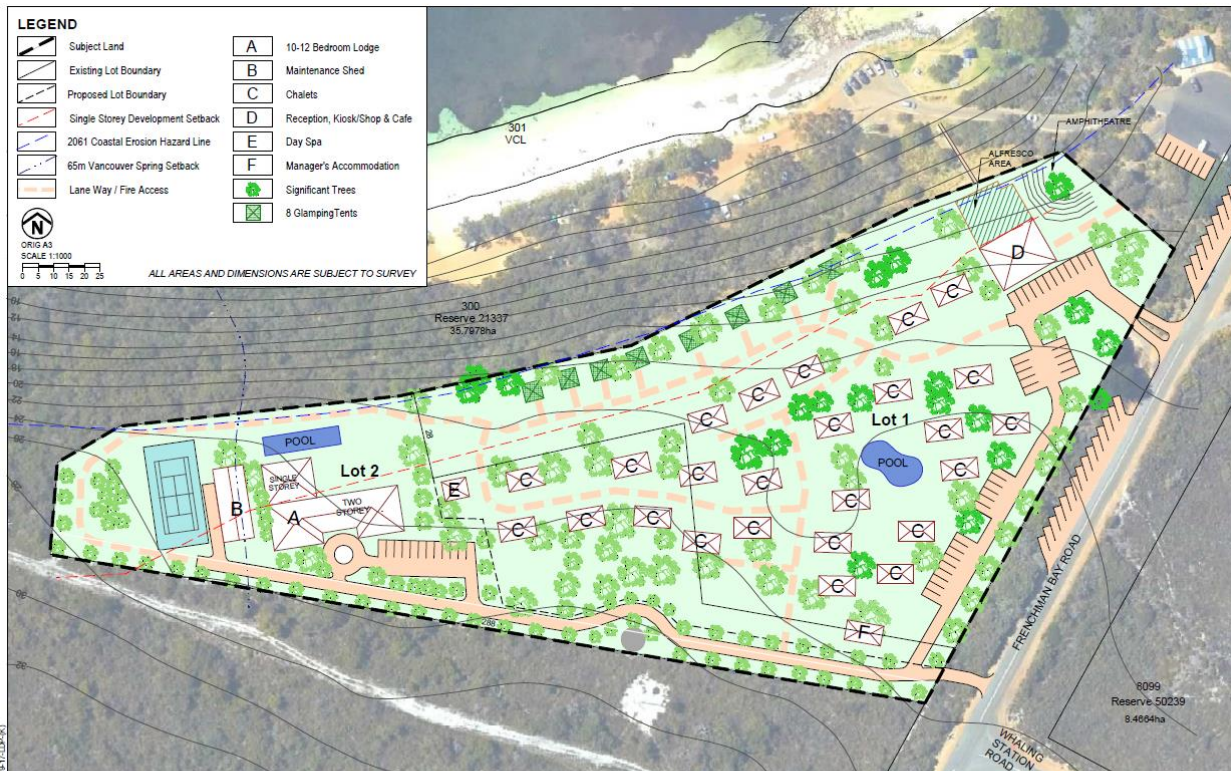
Figure 2: Local development plan

- A luxury holiday lodge with 10-12 bedrooms (occupancy approx. 24 people);
- Up to 25 single bedroom holiday chalets (occupancy approx. 50 people);
- Eight glamping tents (occupancy approx. 16 people);
- Day spa (patrons of village);
- Manager’s accommodation (occupancy approx. 2 people); and
- A signature café/restaurant with associated kiosk/shop and reception office (occupancy approx. 100 people).

- Stage 1:** Luxury holiday lodge with 10-12 bedrooms, Swimming pool and tennis court and maintenance shed; and
Stage 2: Balance of development, subject to further due diligence and design.

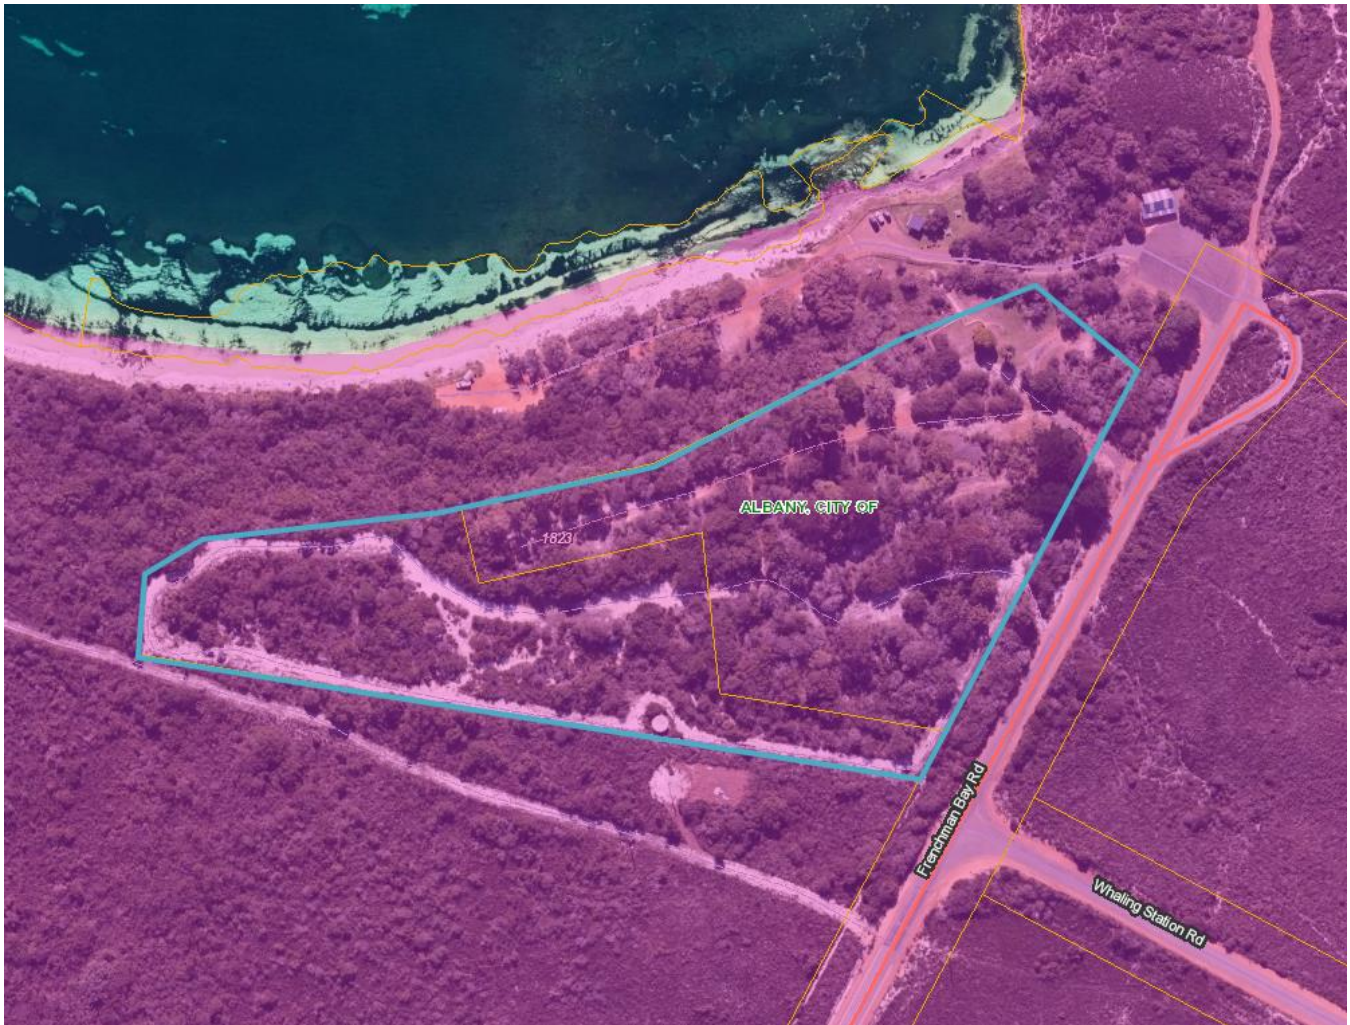
Figure 3: Map of Bushfire Prone Areas and relevance to subject site (OBRM, 2021).

It is noted that each stage will still require planning approval from the City of Albany. This BMP is to guide the LDP and subsequent development stages of the site. At this stage of planning some detail of the BMP are yet to be resolved and may require further review and consultation. The subject site is zoned as Special Residential under the City of Albany Local Planning Scheme (No. 1). The publicly released Bushfire Prone Area Mapping (OBRM, 2021) shows that the subject site is located within a Bushfire Prone Area (within 100m of >1ha of bushfire prone vegetation) and as such is subject to a planning assessment of the bushfire risks. Bushfire Prone Area Mapping (OBRM, 2019) is shown in Figure 3.

- Method 1 (AS3959-2018) Simplified procedure was used for vegetation classification and BAL Assessment process;
- The BAL Contour Plan was prepared by an Accredited Level 2 Bushfire Planning Practitioner (BPAD30794);
- The BAL Contour Map (Figure 5) has been prepared in accordance with Department of Planning (WAPC) Guidelines for Planning in Bushfire Prone Areas (Version 1.4; WAPC, 2021);
- The vegetation within the subject site has been excluded as this vegetation will be modified to a low threat state, trees >50cm DBH can remain however are managed in a fuel reduced state;
- The assumptions contained within the BAL Contour Plan is based on plan of LDP as supplied by the client (Figure 2); and
- Subject site is located in a Bushfire Prone Area, see Figure 3 (OBRM, 2019).

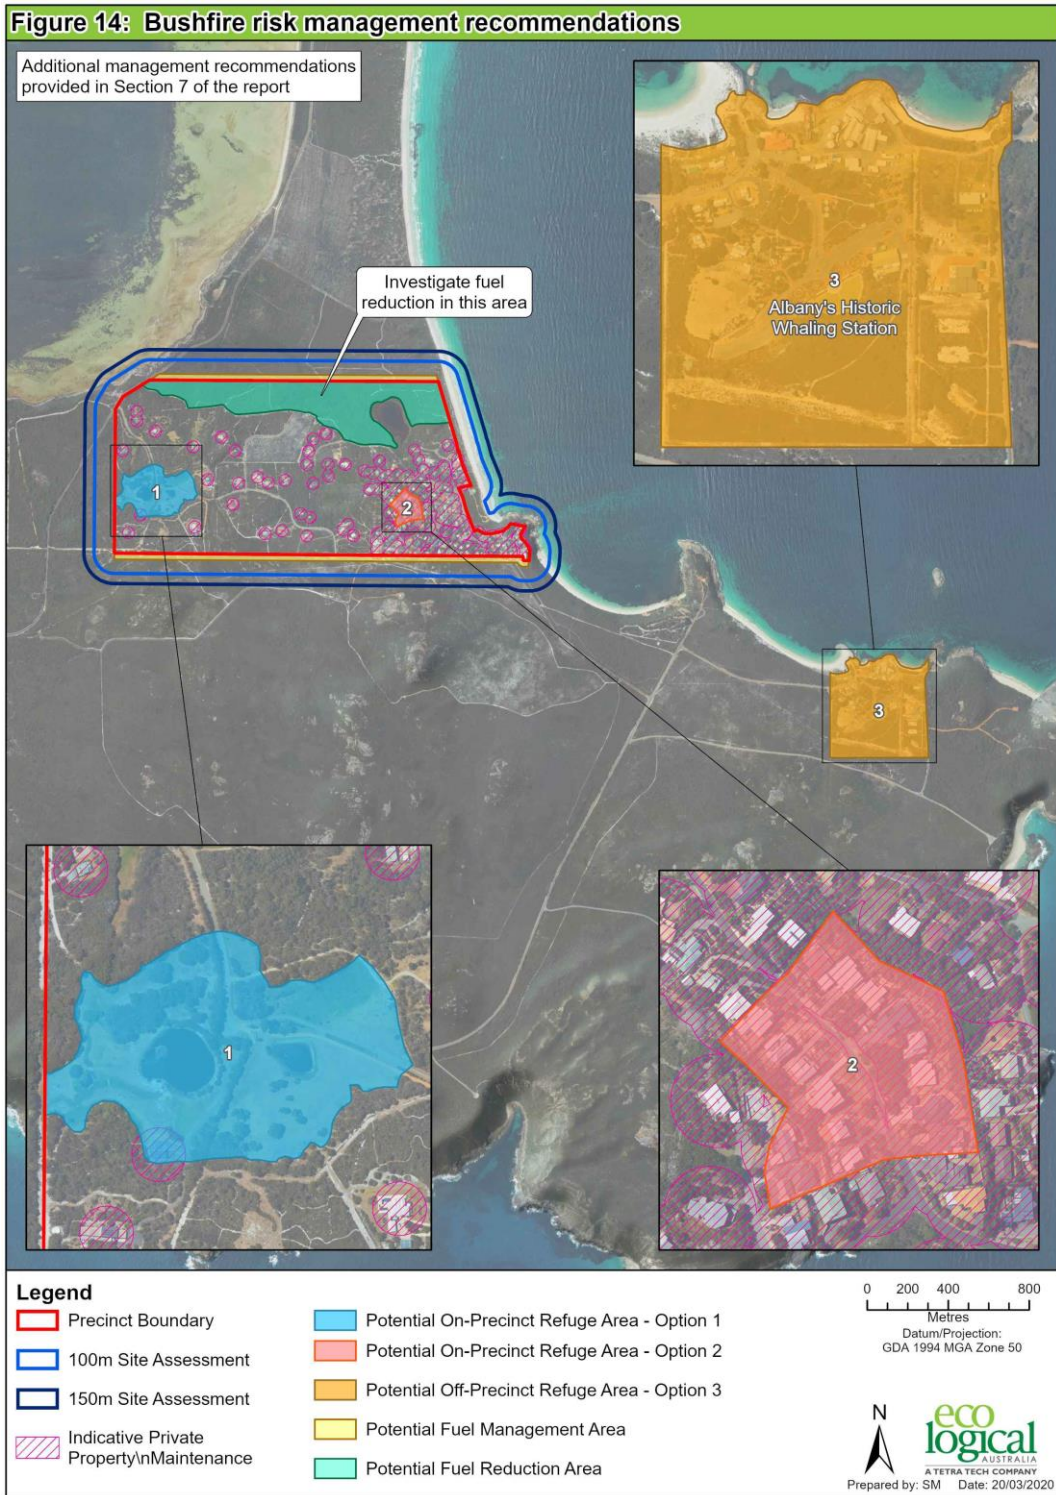
Figure 7: ELA Figure 14 Goode Beach Precinct Report (BRIGS, 2020)

The BRIGS project, delivered under the 2018-19 NDRP, found that access in/out of the Goode Beach precinct and water supply through the reticulated network, would be severely impacted from bushfire. The management of bushfire fuels, strategic water and a community refuge area/neighbourhood safer place were identified within the scope of the project. A copy of the recommendations for possible community refuge areas (three options presented) by ELA is shown in Figure 7. As the development is staged (Stage 1 is the maintenance shed and Lodge) then there would be sufficient time to investigate this refuge option further. Also refer to Section 5.2.4 of this report

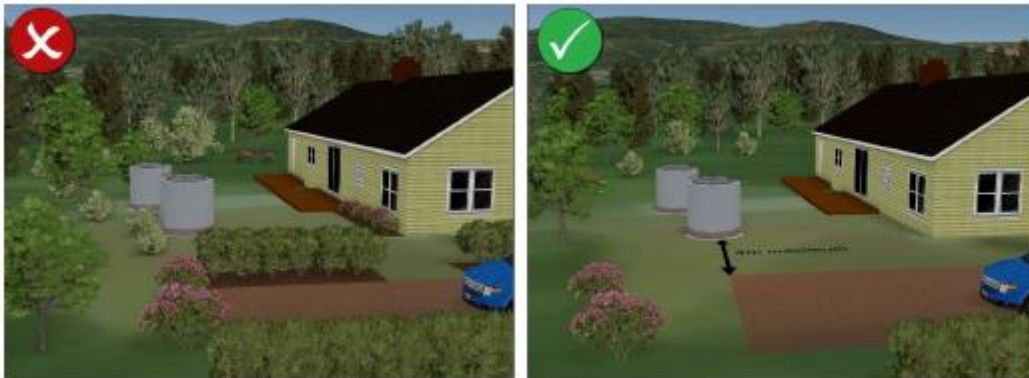
Figure 8: A good and a bad example of landscaping around a water tank and relation to hardstand areas. (WAPC, 2021)

Water tank location: Tanks are to be located with a consideration to surrounding vegetation and should avoid locations where the tanks is situated near or under vegetation or where vegetation might grow or overhand the tank. Refer to Figure 8 below.

Tank outlets: where an outlet is provided for an emergency service then an unobstructed, hardened surface is to be provided within 4m of the water supply. Refer to figure 6 below outlining the location of a tank to a hardstand area.

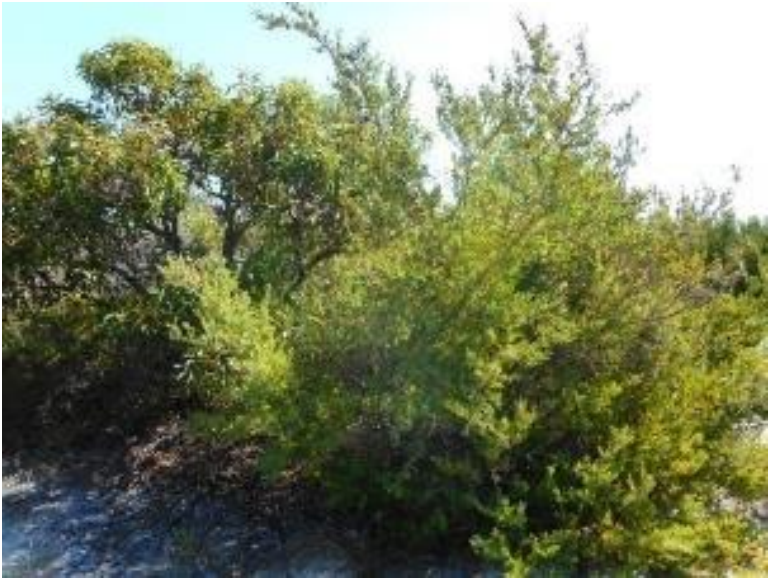
Photo Id 1: View looking at Plot 1 in a westerly direction from within the plot.

Plot	1	Classification or Exclusion Clause	Scrub Type D

<p>Location: Within the Subject Site, making up the southern portion of the site.</p> <p>Separation Distance: 0m.</p> <p>Description: Coastal scrub and some stunted Jarrah.</p> <p>Average vegetation height: 3.5m general not exceeding 4m, with isolated Jarrah reaching 5m.</p> <p>Vegetation Coverage: >30%.</p> <p>Available fuel loading: 25 t/ha.</p> <p>Effective slope: Upslope.</p>

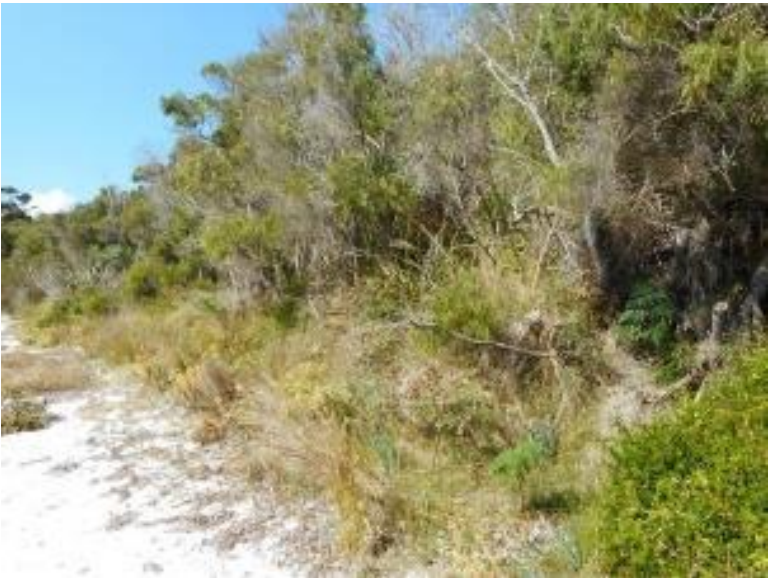
Photo Id 2: View looking along beach edge of Plot 2 in easterly direction.

Plot	2	Classification or Exclusion Clause	Scrub Type D

<p>Location: Adjacent to the north-west boundary of the site, with a small portion of the plot within the Subject Site.</p> <p>Separation Distance: 0m.</p> <p>Description: Coastal scrub.</p> <p>Average vegetation height: 3.5m with isolated trees reaching 4m.</p> <p>Vegetation Coverage: >30%.</p> <p>Available fuel loading: 25 t/ha.</p> <p>Effective slope: >0 to 5 degrees downslope.</p>

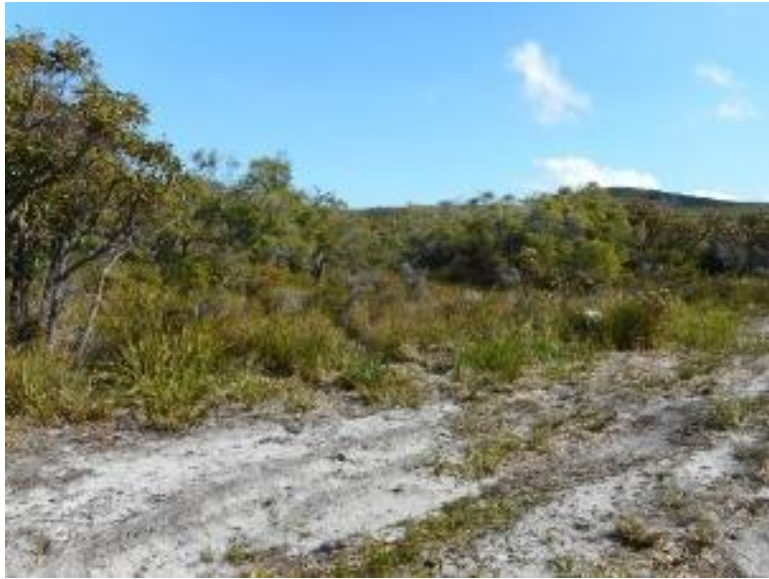
Plot	3	Classification or Exclusion Clause	Scrub Type D

<p>Location: In two locations, one to the south and west of the Subject Site and the other to the north-east.</p> <p>Description: Low coastal scrub of stunted Jarrah, banksia and Tea tree.</p> <p>Average vegetation height: 3.5m with occasional taller jarrah at 5m.</p> <p>Vegetation Coverage: >30%.</p> <p>Available fuel loading: 25 t/ha.</p> <p>Effective slope: Upslope.</p>

Photo Id 3: View looking toward the west from western boundary of the Subject Site

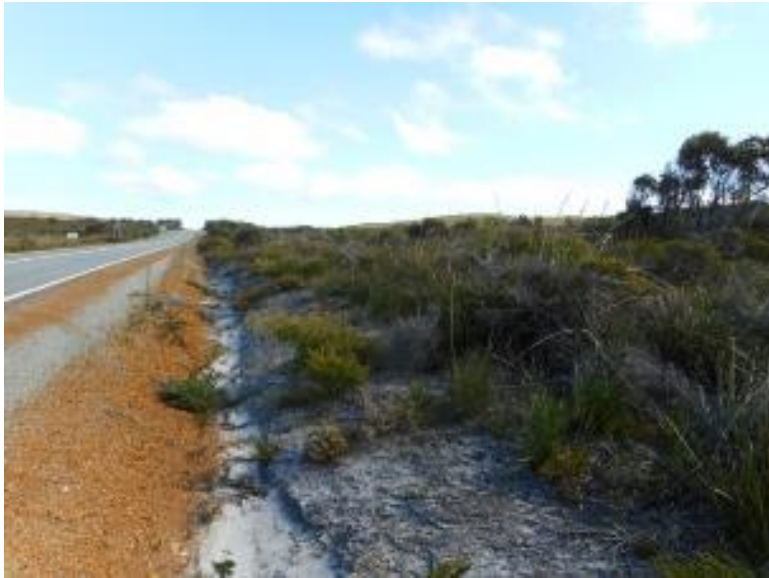
Plot	4	Classification or Exclusion Clause	Scrub Type D

<p>Location: To the south of the Subject Site adjoining Frenchman Bay Road on the northern and southern side of road.</p> <p>Separation Distance: 0 to 40m.</p> <p>Description: Low coastal shrubs and herbs. Open heathland.</p> <p>Average vegetation height: 1.2m.</p> <p>Vegetation Coverage: >30%.</p> <p>Available fuel loading: 25 t/ha.</p> <p>Effective slope: Upslope.</p>

Photo Id 4: View looking south along Frenchman Bay Road.

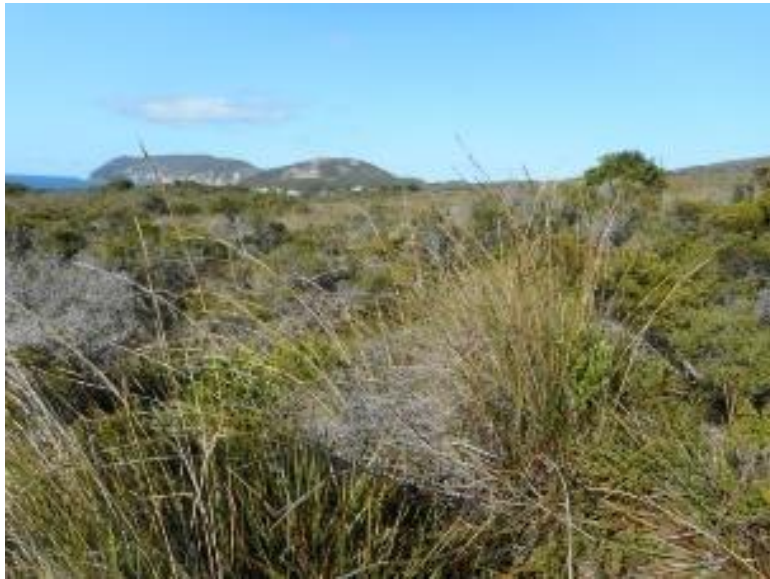
Plot	5	Classification or Exclusion Clause	Scrub Type D

<p>Location: To the east of the Subject Site on the eastern side of Frenchman Bay Rd.</p> <p>Separation Distance: 26m.</p> <p>Dominant species & description: Low coastal shrubs.</p> <p>Average vegetation height: 1.2m.</p> <p>Vegetation Coverage: >30%.</p> <p>Available fuel loading: 25 t/ha.</p> <p>Effective slope: >0 to 5 degrees downslope.</p>

Photo Id 5: View looking east across plot 5 from the eastern edge of Frenchman Bay Road.

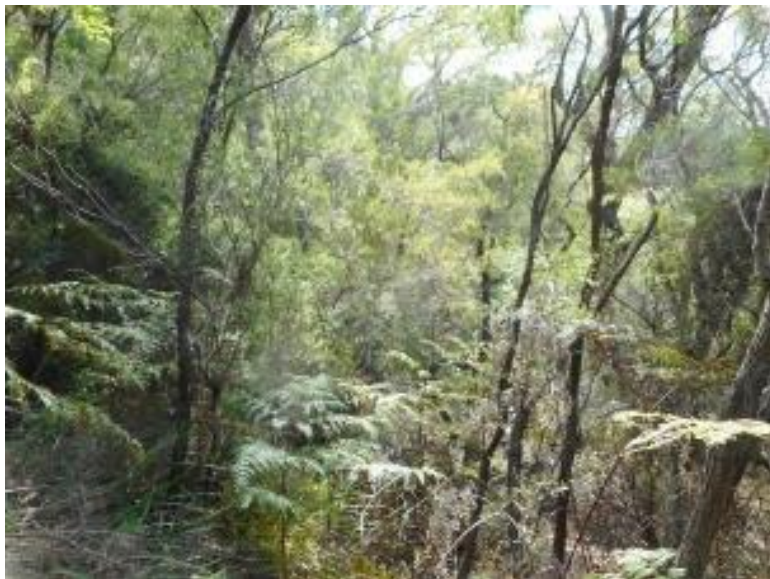
Plot	6	Classification or Exclusion Clause	Forest Type A

<p>Location: Located directly to the north-west of the Subject Site.</p> <p>Separation Distance: 24m.</p> <p>Description: Tall coastal scrub interspersed with Jarrah and Peppermint trees. Multilayered; bracken, woody scrubs mid-storey and smaller herbs and shrubs as understorey.</p> <p>Average vegetation height: 7m.</p> <p>Vegetation Coverage: >30 – 70%.</p> <p>Available fuel loading: 25 - 35t/ha.</p> <p>Effective slope: >5 to 10 degrees downslope.</p>

Photo Id 6: View looking west through Plot 6 from inside the plot.

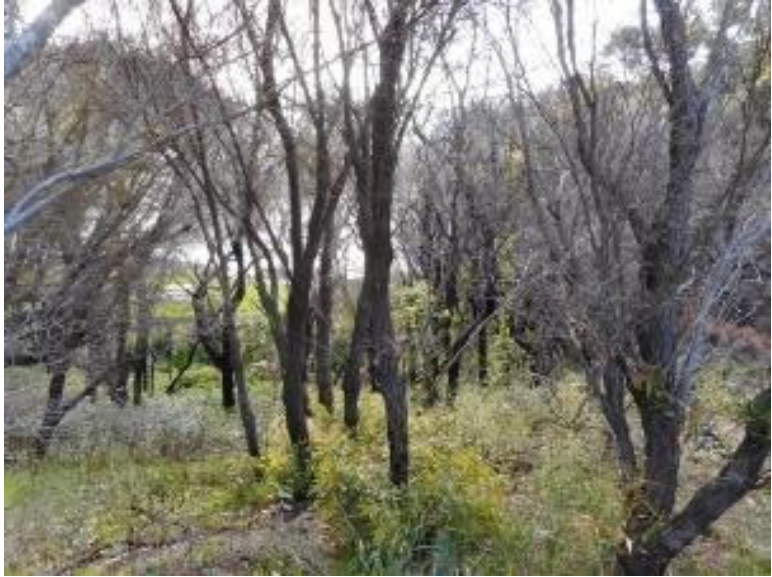
Plot	7	Classification or Exclusion Clause	Forest Type A

<p>Location: Two plots to the north of the Subject Site. Plots are separated by a beach access road.</p> <p>Separation Distance: 0 to 14m.</p> <p>Description: Jarrah and peppermint trees, eastern part of plot recently burnt. Not multilayered, grasses and bracken to 0.5m.</p> <p>Average vegetation height: 7m.</p> <p>Vegetation Coverage: >30-70% foliage cover.</p> <p>Available fuel loading: 245 - 35t/ha.</p> <p>Effective slope: >0 to 5 degrees downslope.</p> <p>Note: areas of this Plot will be fuel reduced to AS3959 Exclusion 2.2.3.2 (f)</p>	
<p><i>Photo Id 7: View north through Plot 7 to beach and picnic area.</i></p>

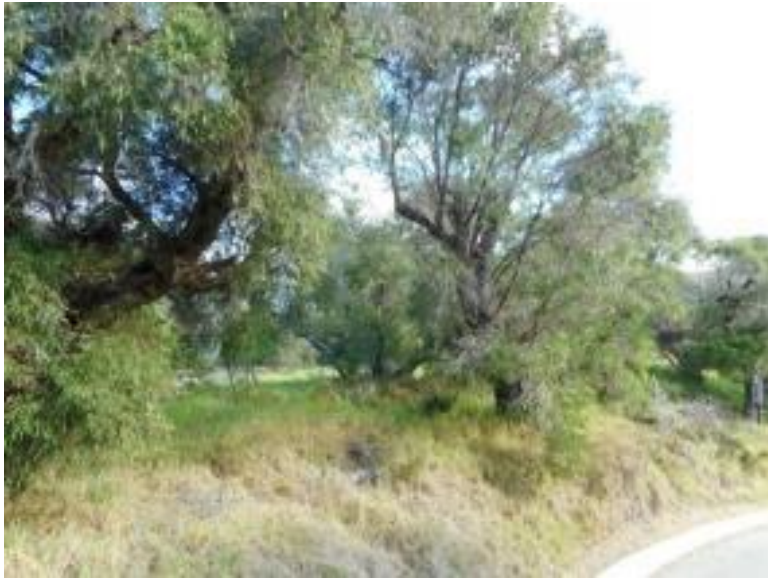
Plot	8	Classification or Exclusion Clause	Forest Type A

<p>Location: Located within the Subject Site in previous disturbed areas of the caravan park site. Also, along Frenchman Bay road reserve.</p> <p>Separation Distance: 0m.</p> <p>Description: Peppermint trees and tall coastal vegetation. Not multilayered, grasses and bracken to 0.5m understorey.</p> <p>Average vegetation height: 6m-8m</p> <p>Vegetation Coverage: <30-70% foliage cover</p> <p>Available fuel loading: 25 - 35t/ha.</p> <p>Effective slope: Upslope/flat.</p> <p>Note: areas of this Plot will be fuel reduced to AS3959 Exclusion 2.2.3.2 (f).</p>

Photo Id 8: View looking within plot from southern edge of beach access road.

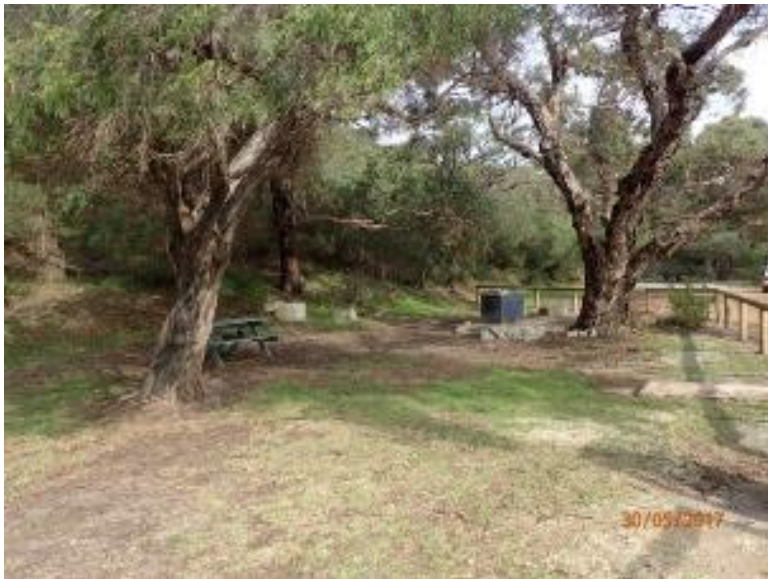
Plot	9	Classification or Exclusion Clause	Low fuel or non-vegetated areas exclusion 2.2.3.2 (f)

<p>Location: Foreshore area to the north of the Subject Site in Frenchman Bay recreation site.</p> <p>Description: Managed lawns and gardens and other low-threat vegetation. Includes maintained beach picnic area etc.</p> <p>Excluded as per AS3959 exclusion clause 2.2.3.2 (f).</p> <p>Available fuel loading: <2 t/ha.</p>

Photo Id 9: View looking towards recreation site to the north of the subject site.

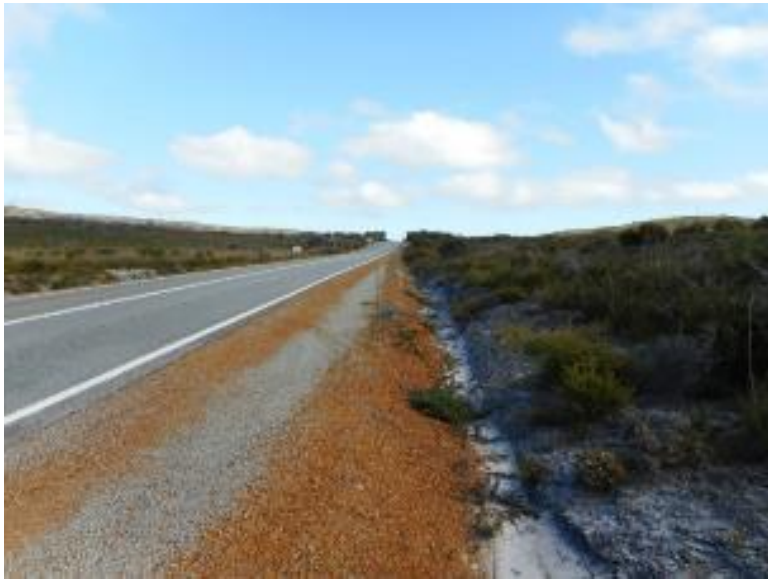
Plot	10	Classification or Exclusion Clause	Low fuel or non-vegetated areas exclusion 2.2.3.2 (e)

<p>Location: Frenchman Bay beach and the Southern Ocean to the north of the Subject Site. Adjacent roads include Frenchman Bay Road, Whaling Station Road and the firebreak track within the Subject Site.</p> <p>Description: Roads, driveways, tracks, water bodies, bare beach areas, buildings and other non-vegetated areas.</p> <p>As per exclusion clause 2.2.3.2 (e) of AS3959-2018.</p>	
<p><i>Photo Id 10: View looking south along Frenchman Bay Road.</i></p>

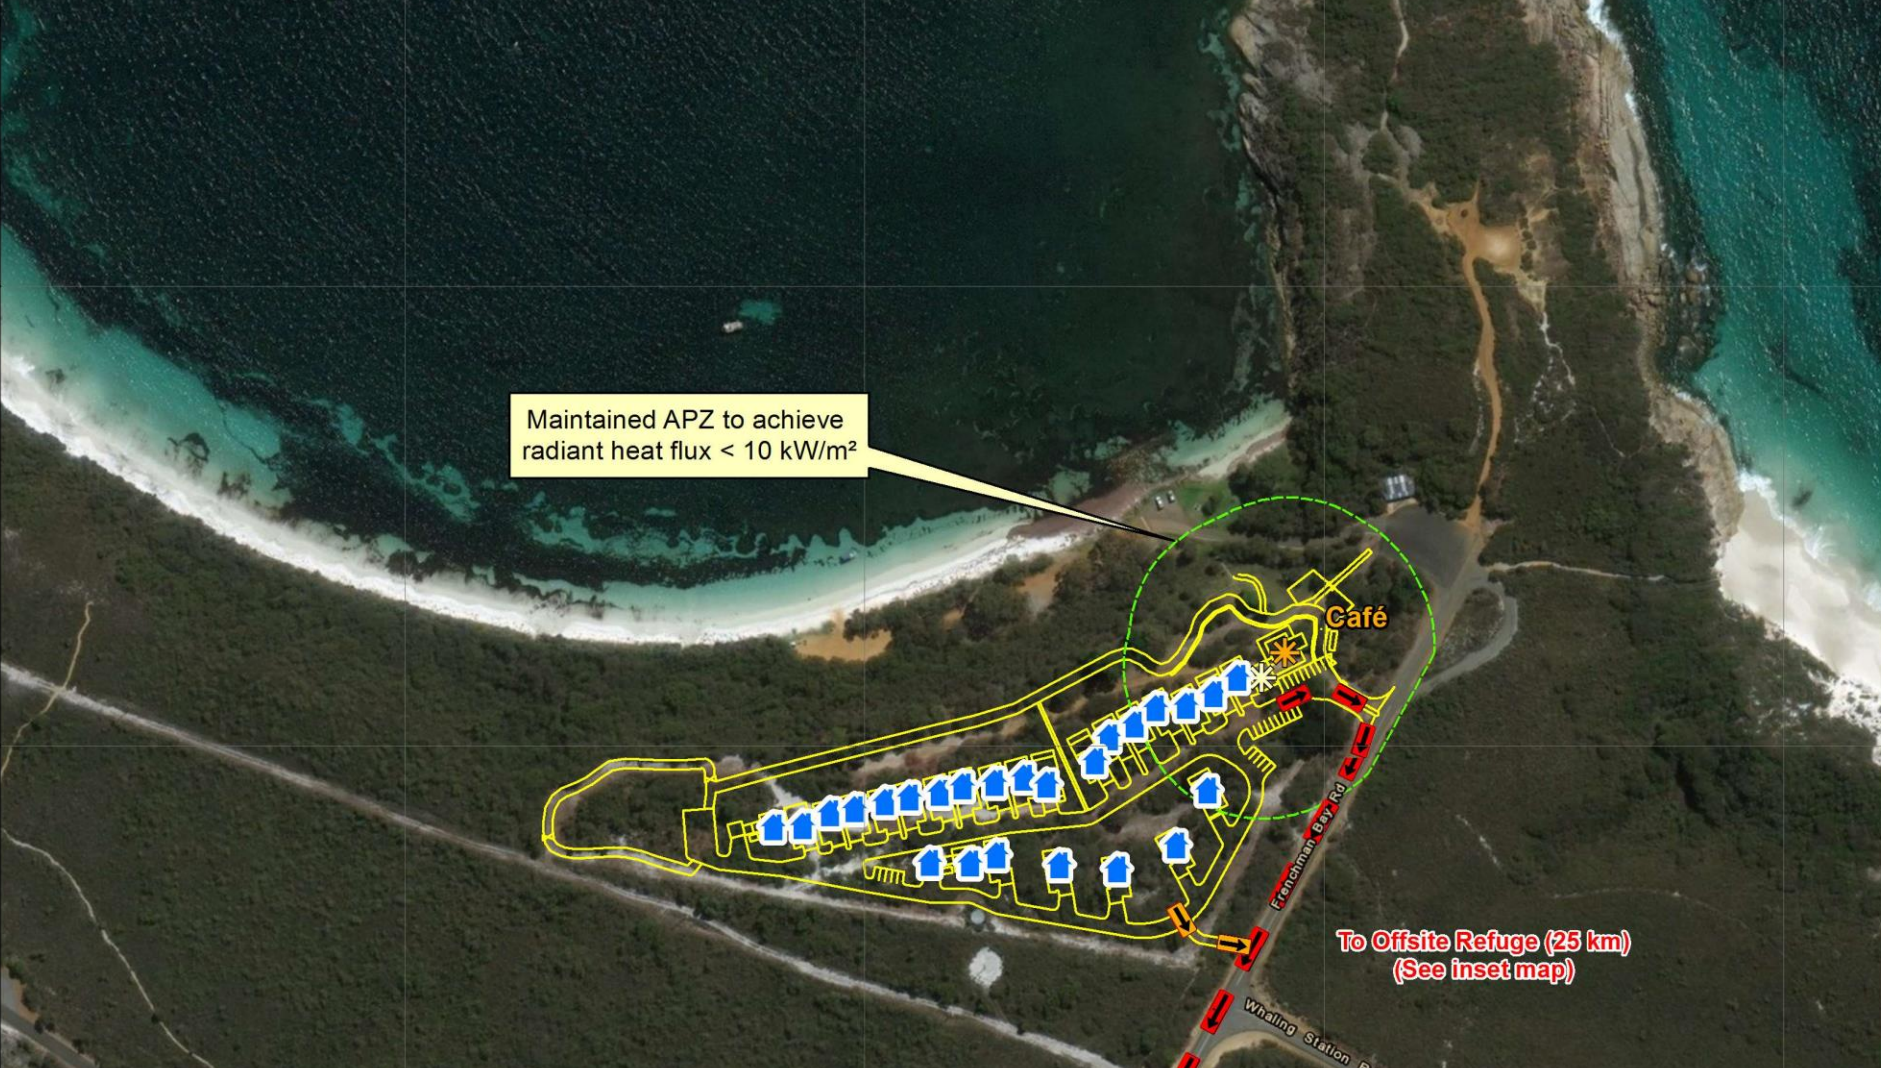
BUSHFIRE RESPONSE AND EVACUATION PLAN - Frenchman Bay Retreat: Lots 1 & 2 Frenchman Bay Road, Albany

RISK STATUS	LOW/ MOD	HIGH	VERY HIGH	SEVERE	EXTREME	CATASTROPHIC
Fire predicted to impact site or egress	Evacuate to the Albany township if safe (seek advice from DFES / Emergency Services) or if instructed to do so*3					
	Allow for at least 2-4 hours for evacuation					
Time to fire impact is <time available to evacuate*2	If safe to do so; move directly to the nominated on-site refuge*1					
Fires exist in region but no risk to site		<ul style="list-style-type: none"> Guests booked for the following 3 days alerted to possible Resort closure. Brief guests of emergency service advice and maintain regular communications with them 	<ul style="list-style-type: none"> Obtain emergency service advice on whether to close the Resort and evacuate guests off-site or shelter in place. 			<ul style="list-style-type: none"> Close Resort for forecast period
No fires	Maintain appropriate monitoring as per Bushfire Preparedness Matrix

*1 Relocate – ONLY if safe to do so e.g. flames are not visible or nearby dense smoke is not blown directly toward you. If you risk being caught on foot or in your car prior to reaching the on-site refuge, stay inside the accommodation dwelling.
 *2 NB: time to relocate is the estimated time for all occupants/guests to pack up and drive to the Albany township PLUS adding extra precautionary time based upon the FDR. Check with emergency service warnings before evacuating. Leaving at least 24 hours prior to the predicted arrival of the fire may be required.
 *3 Evacuation safety is dependent on factors such as Fire Danger Rating, wind strength and direction, and the proximity and direction of the fire. Follow advice of emergency service broadcast fire warnings or telephone them. Do not evacuate to Albany unless this can be completed many hours before the potential fire arrival. Advice from DFES or other Emergency Service should be sought before evacuating.
