CONDITION 14: ON—SITE EFFLUENT DISPOSAL – PROPOSED DEVELOPMENT OF LOTS 1 AND 2 FRENCHMAN BAY ROAD, FRENCHMAN BAY

Site Soil Evaluation

GEOTECHNICAL INVESTIGATION

HYDRAULIC SERVICES SITE PLAN (LAND APPLICATION AREA)

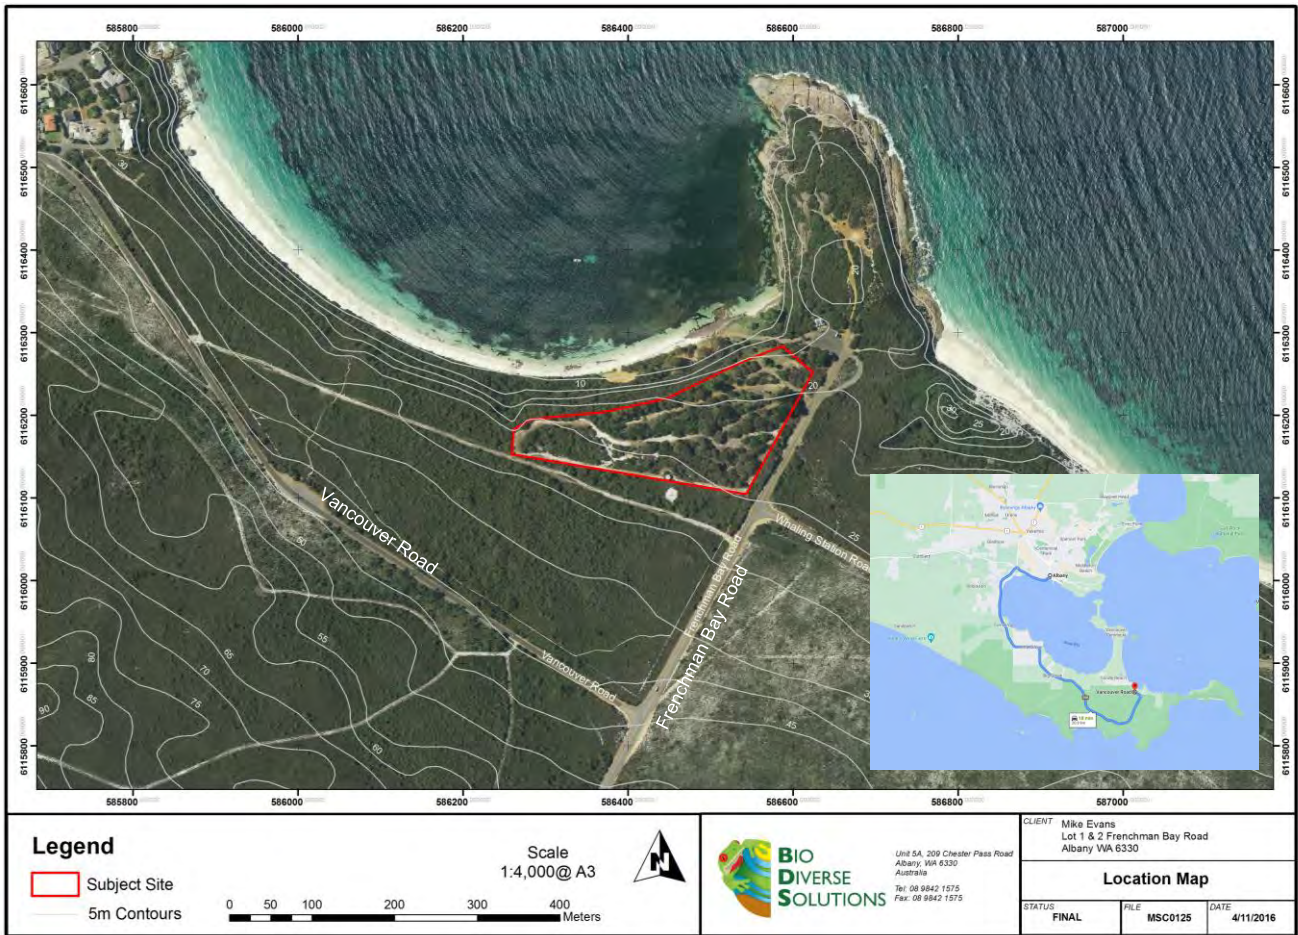
Figure 1: Location Plan

The Subject Site is defined as Lot 1 and 2 Frenchman Bay Road, Frenchman Bay WA, within the municipality of the City of Albany (CoA). It is located approximately 21km southeast of the Albany CBD. The site is bound by Frenchman Bay Road to the east, Frenchman Bay beach to the north and CoA reserve to the south and west. The location of the Subject Site is shown on Figure 1.

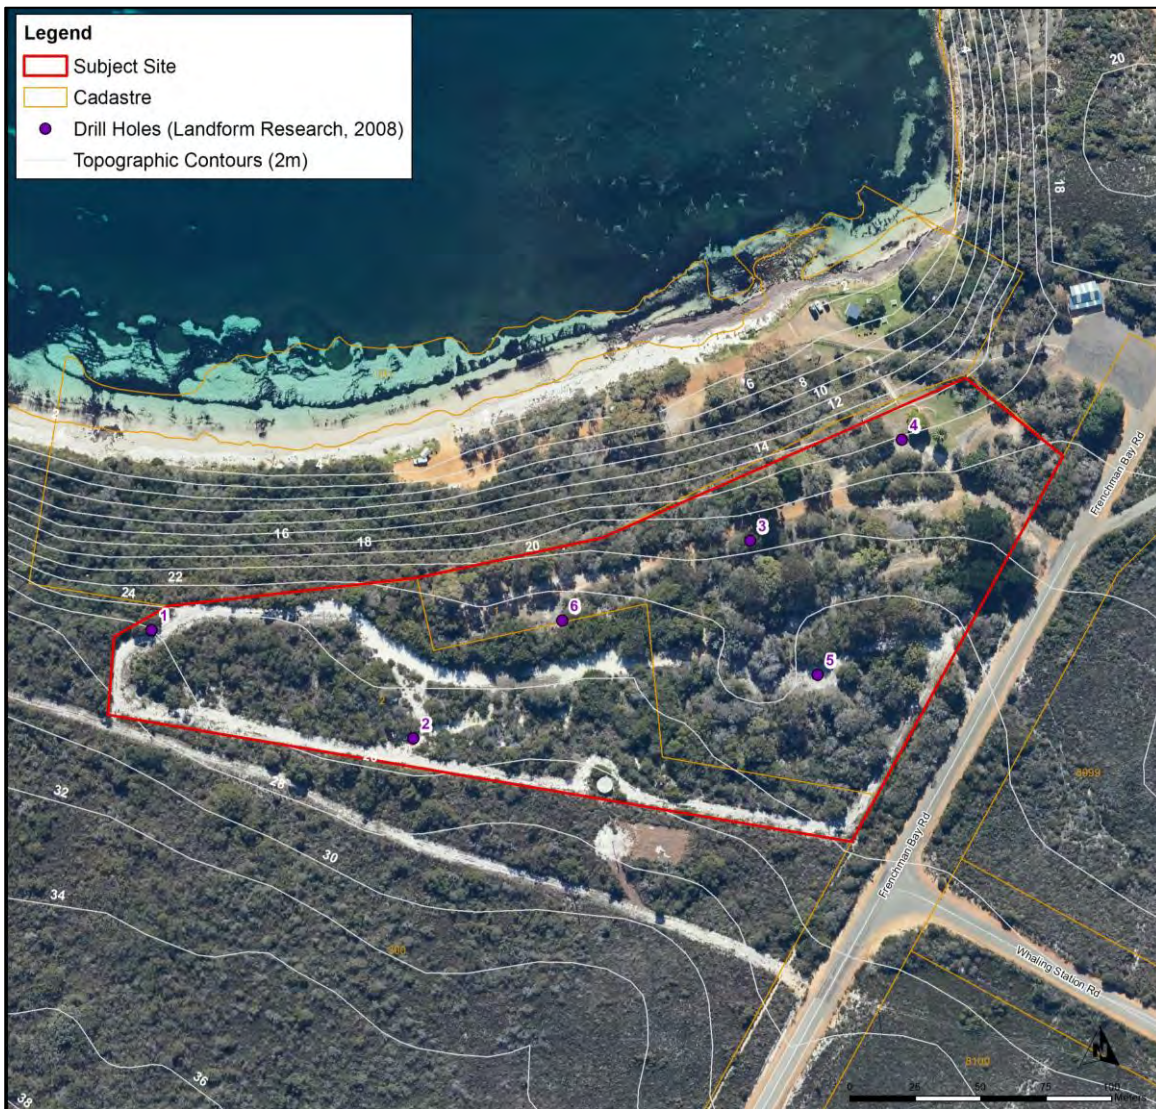
Figure 3: Topography and Geology

In 2008 Landform Research conducted a geological study of the site for a previous proposed development. In summary six air blast drill holes were constructed to varying depths from 15 – 21 m BGL (Below Ground Level), the drill holes were tested for soil type and presence of groundwater. Soil type in all six drill holes was found to be predominantly Quaternary coastal, Aeolian sands (from 0m BGL to between 6.5 and >16 m BGL). Holes 1, 2, 3 and 5 consisted of Quaternary coastal, Aeolian sands overlying possible Pallinup Siltstone, with the depth of the siltstone layer ranging from 6.5 - 16.5 m BGL in Hole 3 to 16 - >21 m BGL in Hole 1. Peats consistent with the Werillup Formation were found at Hole 3 only, from 16.5 m BGL. The location of the drill holes is shown in Figure 3.

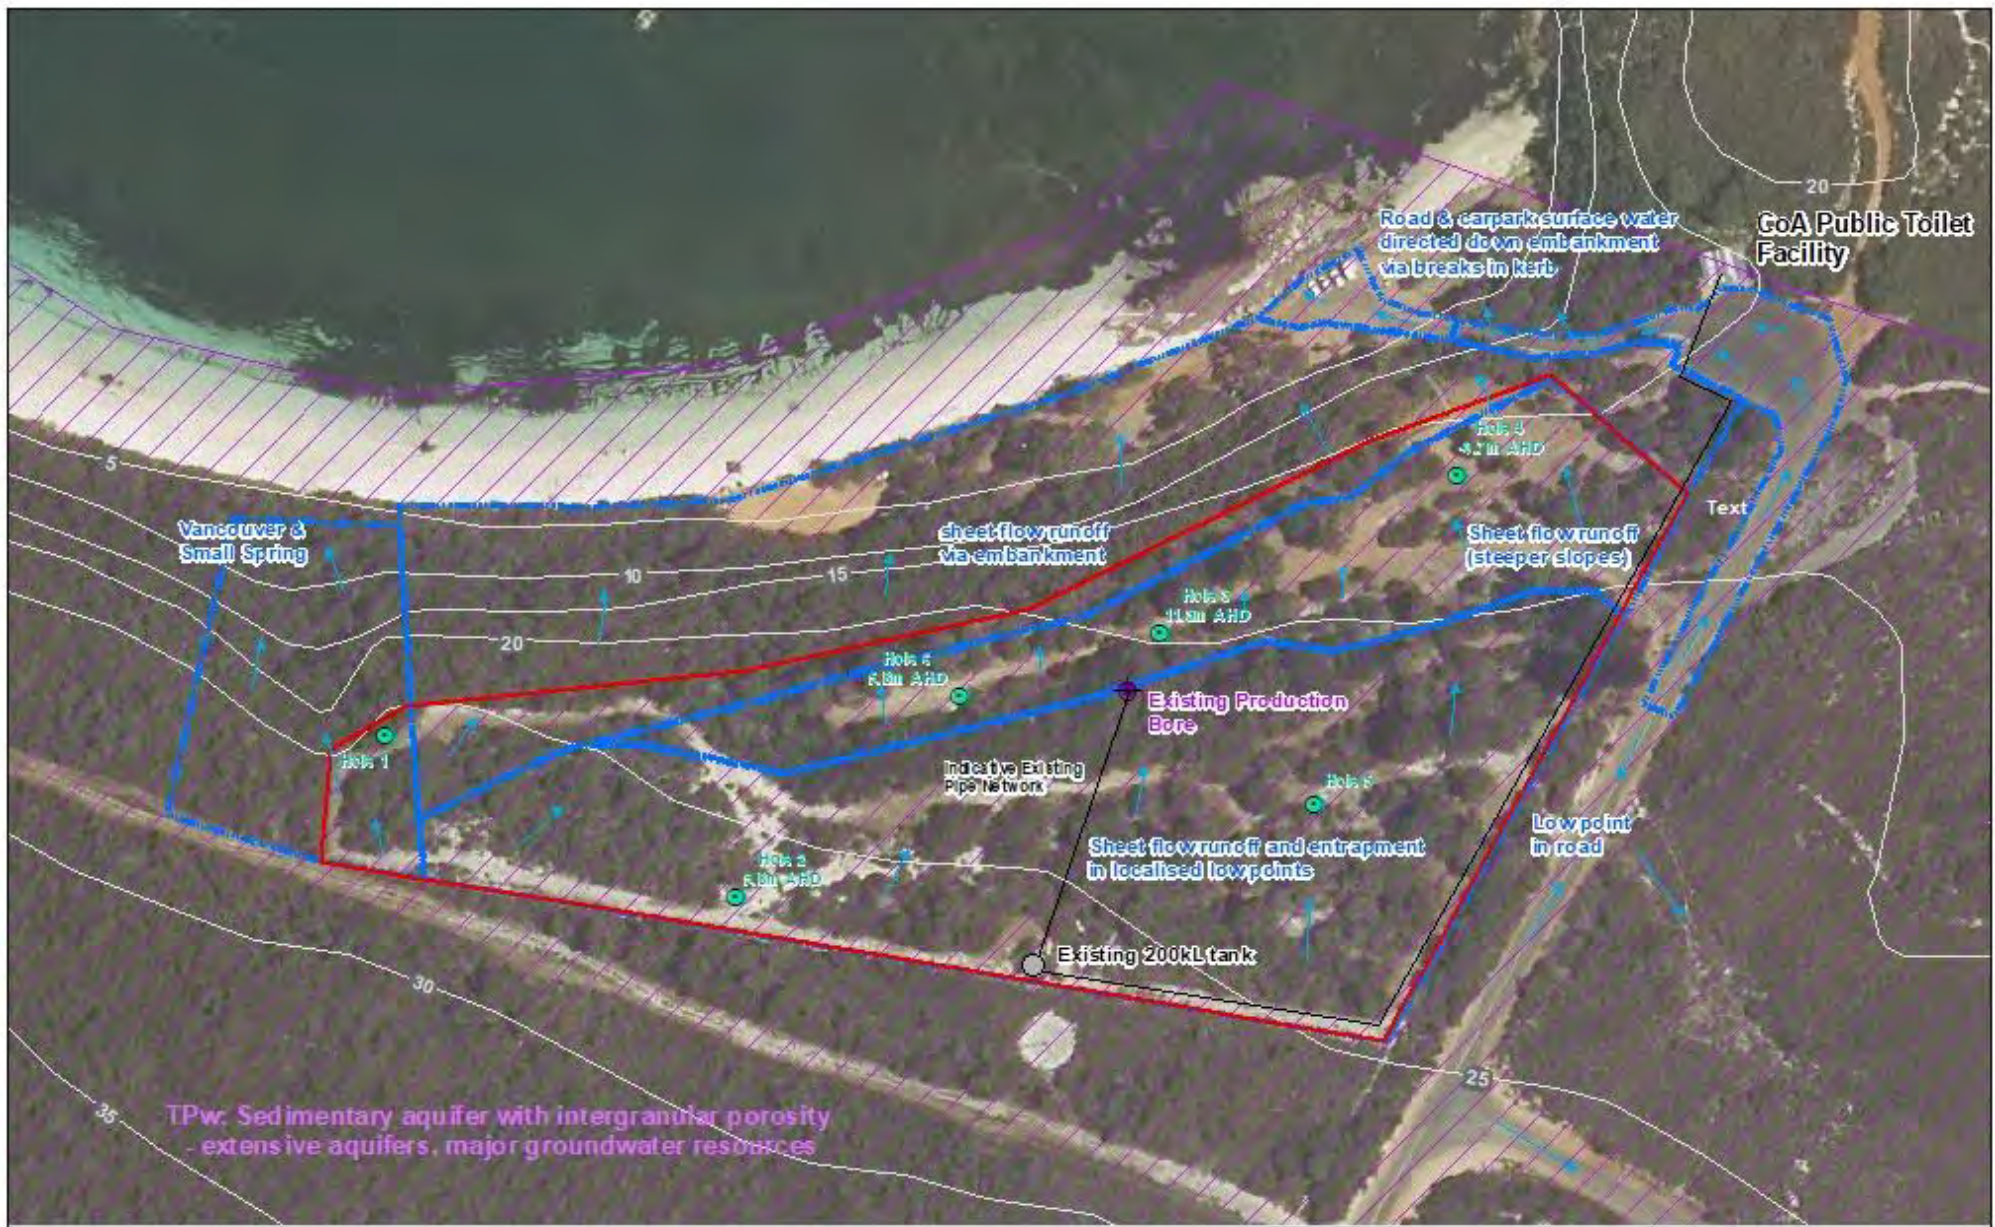
- Subject Site
- Production Bore
- Drill holes & Groundwater Level (Landform Research 2008)
- Pre-development surface water catchment
- Surface water flow direction
- 5m topographic contours (MAHD)
- TPw (250K Hydrogeological Mapping (DrWI))

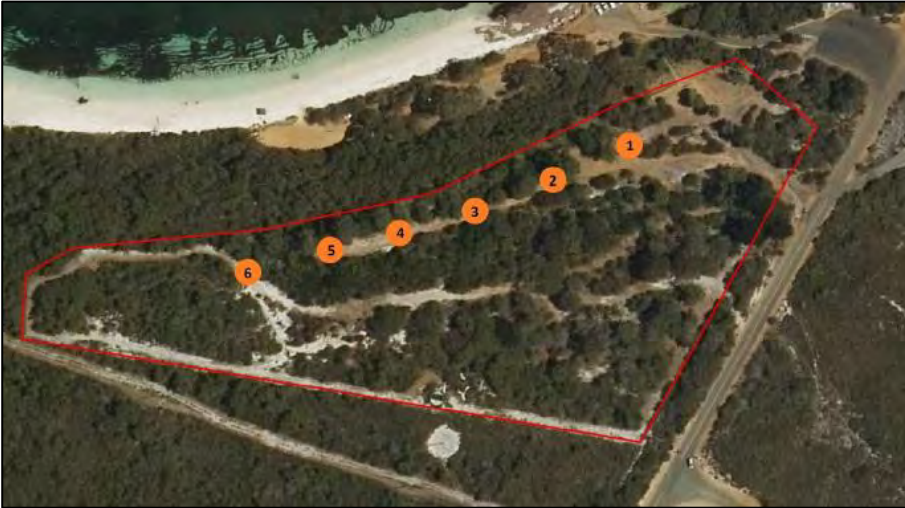
Figure 6: Soil testing hole locations

A Site Soil Investigation was conducted on the 30th September 2016 by Great Southern Geotechnics (GSG) and Bio Diverse Solutions as part of the previously proposed and approved development. The site investigation included the construction of six test holes to a depth of 2.0 metres, photographing and logging of soils to the depth of the holes, and inspection and measuring of the water table if found to be present. The location of the six soil test holes is shown in Figure 6 and the Site Soil Investigation (GSG, 2016) report showing the bore hole logs is included as Appendix A.

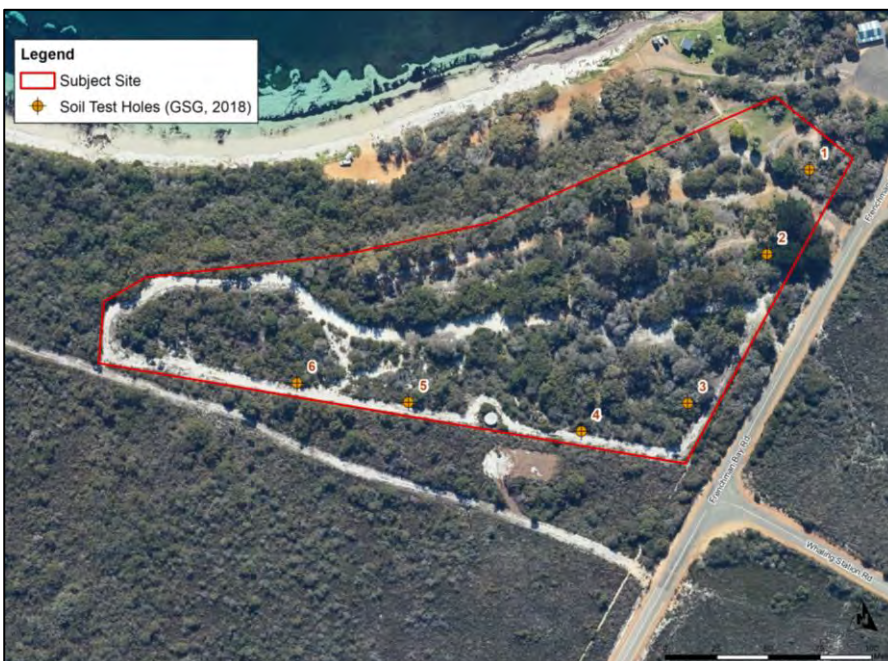
Figure 7: 2018 Soil testing hole locations

A follow up Site Soil Investigation to capture soil characteristics along the eastern and southern boundaries was conducted on the 22nd March 2018. The site investigation included the construction of a further six test holes to a depth of 2.0metres, photographing and logging of soils to the depth of the holes and inspection and measuring of the water table. The location of the additional six soil test holes is shown in Figure 7 and the Site Soil Investigation (GSG, 2018) report is included as Appendix B.

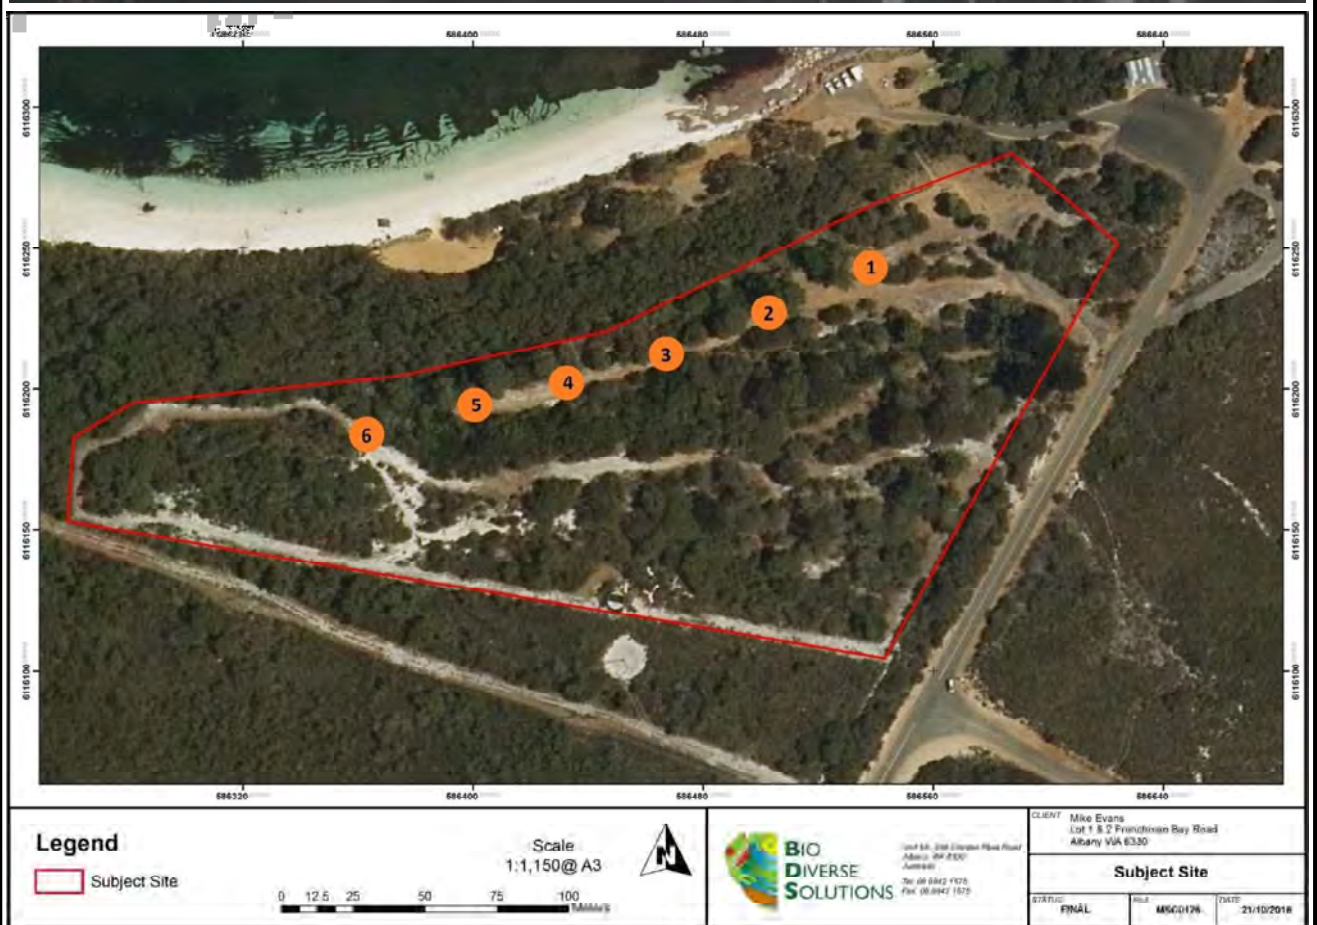
Figure 2 - Lots 1 & 2 Frenchman Bay Rd, Frenchman Bay

The fieldwork was carried out on September 30, 2016 and comprised the following:
Six (6) test pits excavated with a 301.4C Mini Hydraulic Excavator using a 300mm wide bucket to depths of 1.8 m to visually assess subsurface conditions and obtain samples for laboratory testing.
The approximate test locations are shown on **Figure 2**.

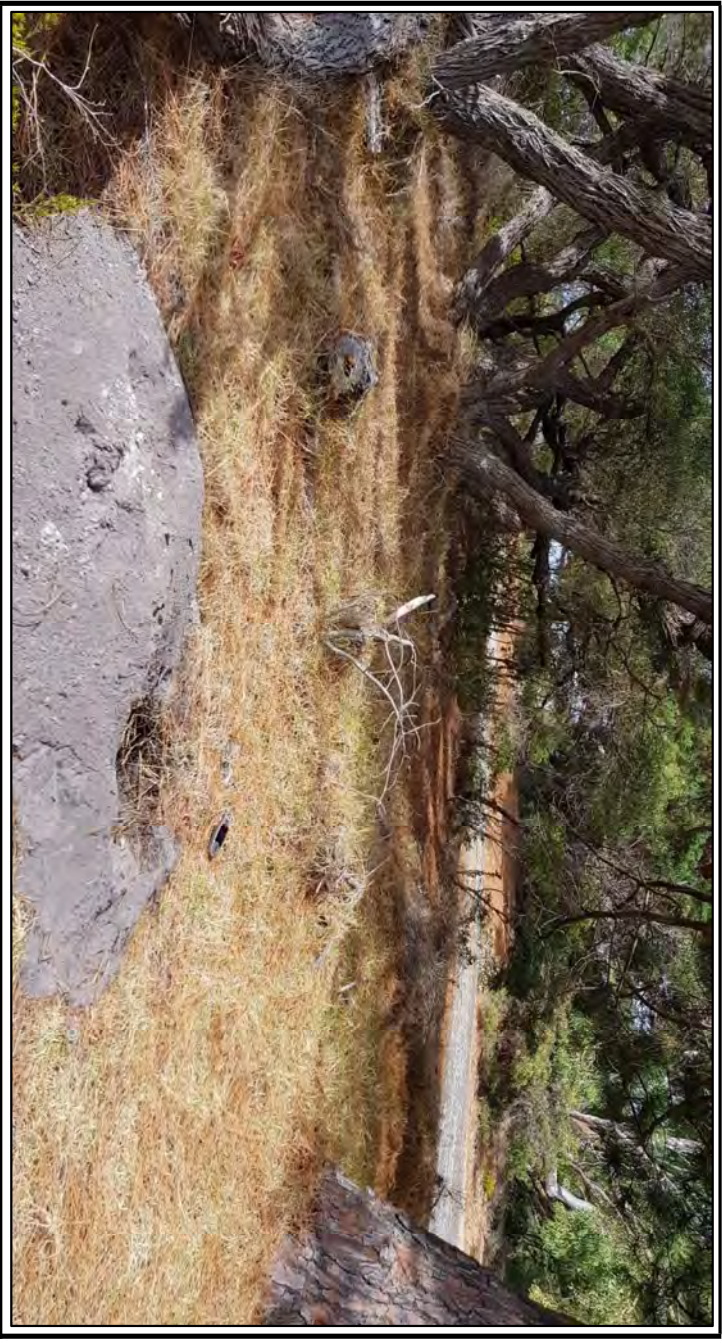
Test Pit No. 1 - Spoil

800 - 2000	1200	SAND with silt: Light grey to white, fine to medium.	M	L				
Comments			Pit Terminated at: (mm) below ground level ✓ or *					
			Target Depth <input checked="" type="checkbox"/> 2000					
			Cave In <input type="checkbox"/>					
			Refusal <input type="checkbox"/>					
			Near Refusal <input type="checkbox"/>					
			Flooding <input type="checkbox"/>					
			Lack of Reach <input type="checkbox"/>					
Materials Consistency/Strength		Rock	Cementation		Water Water first Encountered			
Cohesive VS - Very Soft S - Soft F - Firm St - Stiff VSt - Very Stiff H - Hard	Non-Cohesive VL - Very Loose L - Loose MD - Medium Dense D - Dense VD - Very Dense CO - Compact	EL - Extremely Low VL - Very Low L - Low M - Medium H - High VH - Very High EH - Extremely High	IN - Indurated PC - Poorly Cemented MC - moderately Cemented WC - Well Cemented		Moisture D - Dry M - Moist W - Wet General N/A - Not Applicable N/D - Not Determined

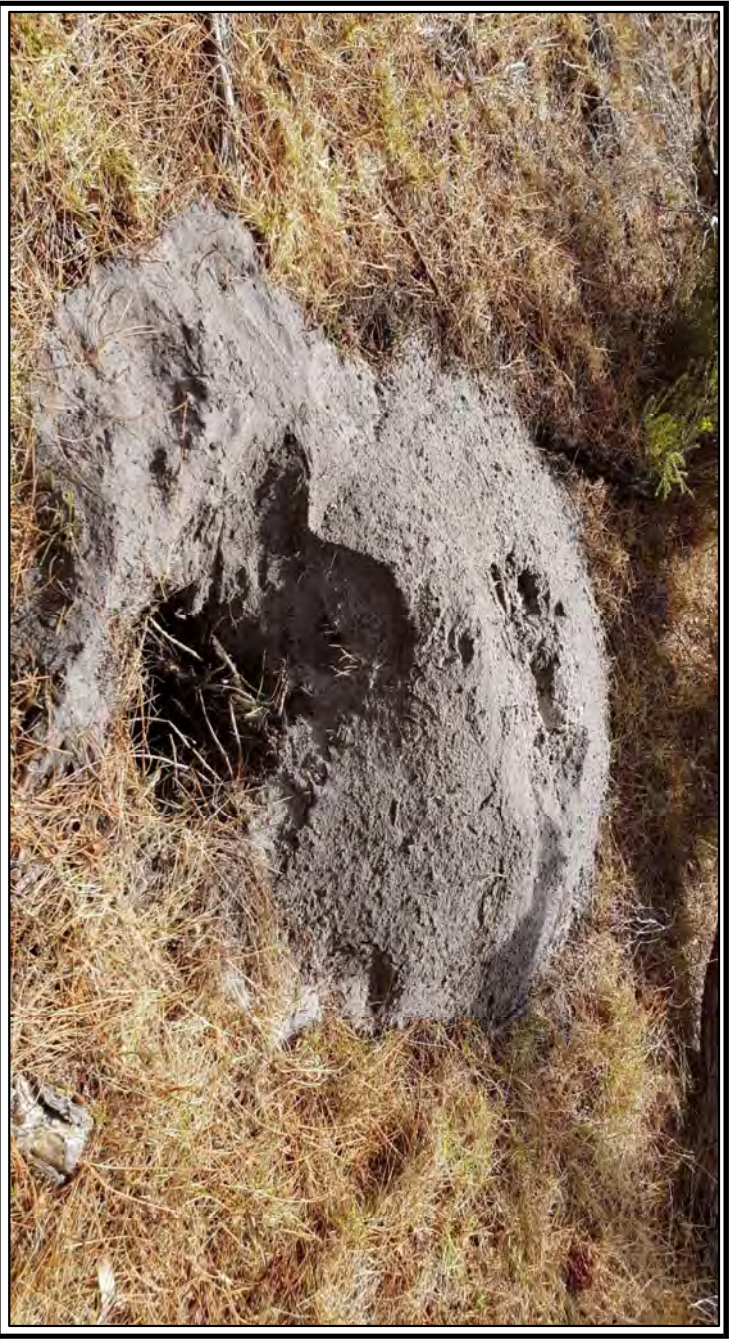
Job No 302	Report No 302/1	Sheet 2 of 6				
Client: Bio Diverse Solutions Project: Lots 1 & 2 Fenchman Bay Rd, Albany WA 6330 Project No: N/A Location: Proposed Building Envelope Test Pit No.: TP2 Sample No. 18G672			Operator/Contractor: GSG Equipment type: Kubota KX41-3V Excavation Method : 300mm Auger Position: 50 H 586582 6116174 Elevation: n/a					
Date Commenced: 22.03.2018 Date Completed: 22.03.2018		Logged By: M.Coffey Checked By: M.Coffey		Excavation Dimensions: Depth 2.0 (m) Width 0.3 (m)				
Depth Below Surface (mm)	Layer Depth (mm)	Material Description <small>SOIL TYPE, Plasticity, Colour, Particle characteristics, Secondary and other minor components</small>	Moist. Condition	Consistency / Strength	Cementation	Water Table	Classification Symbol	Sample/Test
0 - 1600	1600	SAND with silt: Light grey/white, fine to medium.	D-M	L		No water table encountered.		
1600 - 2000	400	SAND with silt: Light brown/grey, fine to medium.	M	L	PC

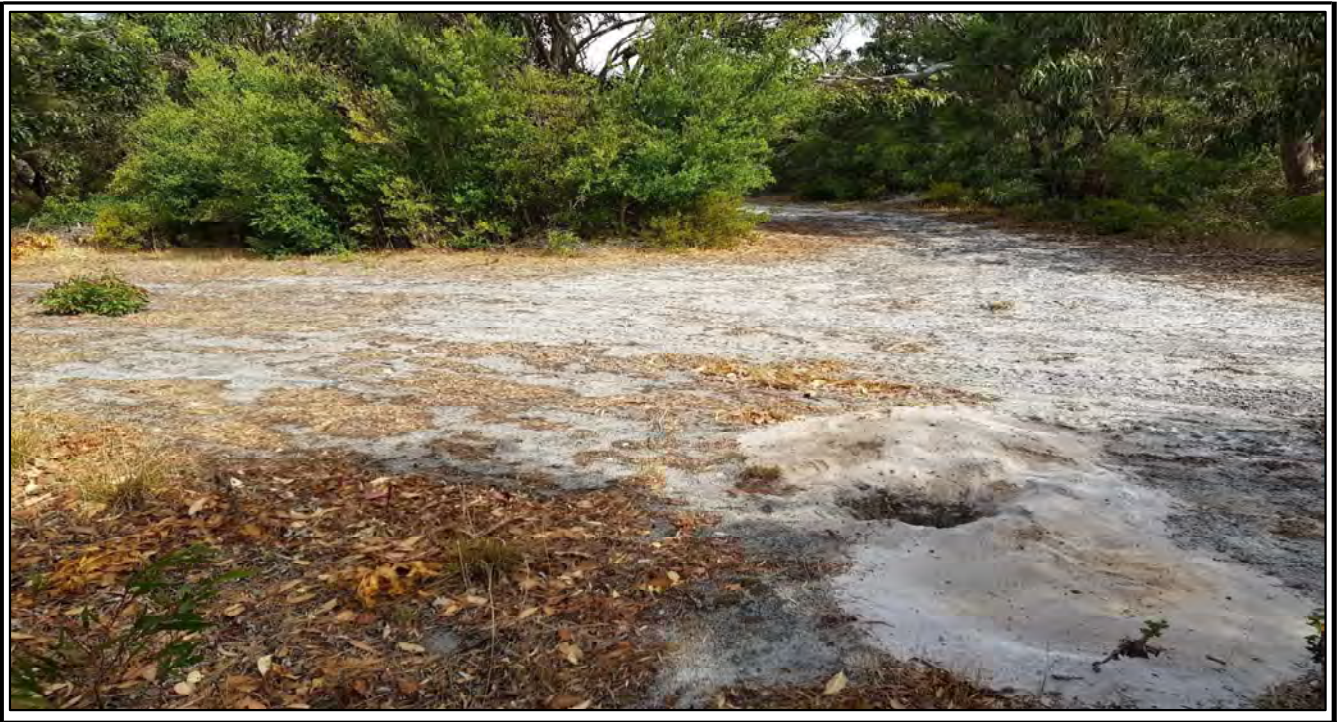
Test Pit No.2 - Spoil

Comments			Pit Terminated at: (mm) below ground level ✓ or *					
			Target Depth	✓	2000			
			Cave In					
			Refusal					
			Near Refusal					
			Flooding					
			Lack of Reach					
Materials Consistency/Strength			Rock		Cementation		Water	
Cohesive		Non-Cohesive		Water first Encountered		Moisture		
VS - Very Soft	VL - Very Loose	EL - Extremely Low	IN - Indurated	D - Dry	M - Moist	W - Wet	General	
S - Soft	L - Loose	VL - Very Low	PC - Poorly Cemented	N/A - Not Applicable		N/D - Not Determined		
F - Firm	MD - Medium Dense	L - Low	MC - moderately Cemented					
St - Stiff	D - Dense	M - Medium	WC - Well Cemented					
VSt - Very Stiff	VD - Very Dense	H - High						
H - Hard	CO - Compact	VH - Very High						
		EH - Extremely High

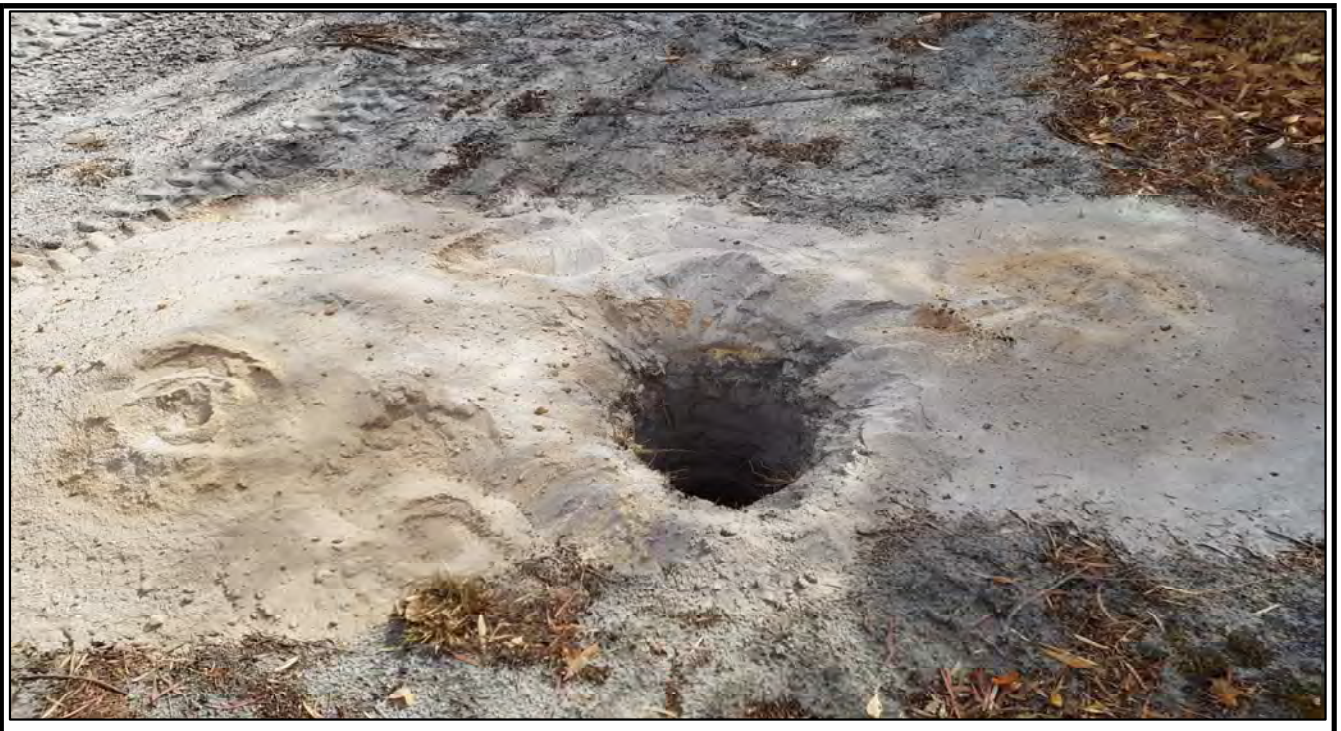
Job No 302	Report No 302/1	Sheet 3 of 6				
Client: Bio Diverse Solutions Project: Lots 1 & 2 Fenchman Bay Rd, Albany WA 6330 Project No: N/A Location: Proposed Building Envelope Test Pit No.: TP3 Sample No. 18G673			Operator/Contractor: GSG Equipment type: Kubota KX41-3V Excavation Method : 300mm Auger Position: 50 H 586542 6116110 Elevation: n/a					
Date Commenced: 22.03.2018 Date Completed: 22.03.2018		Logged By: M.Coffey Checked By: M.Coffey		Excavation Dimensions: Depth 2.0 (m) Width 0.3 (m)				
Depth Below Surface (mm)	Layer Depth (mm)	Material Description <small>SOIL TYPE, Plasticity, Colour, Particle characteristics, Secondary and other minor components</small>	Moist. Condition	Consistency / Strength	Cementation	Water Table	Classification Symbol	Sample/Test
0 - 400	400	(Topsoil) SAND with silt: Grey, fine to medium. Roots & root fibres.	M	L		No water table encountered.		
400 - 1000	600	SAND with silt: Light grey, fine to medium.	M	L				PERM

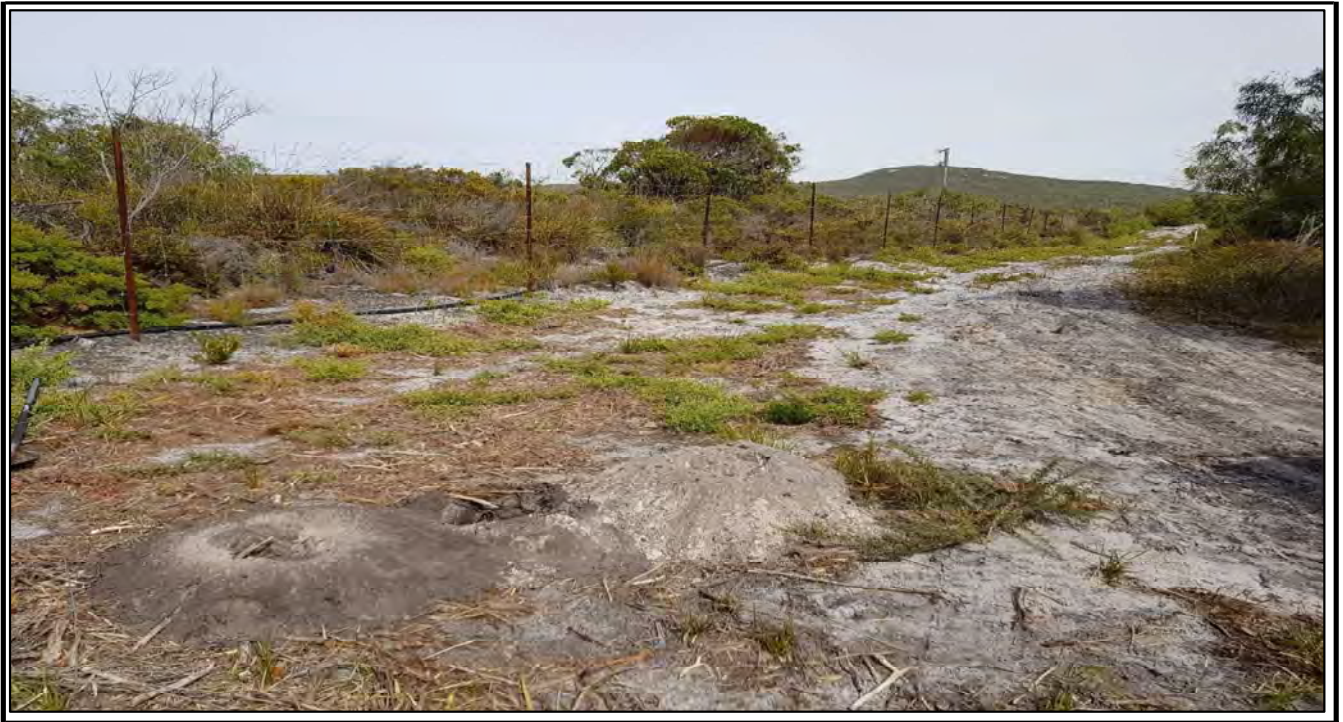
Test Pit No. 3 - Excavation

1000 - 2000	1000	SAND with silt: White, fine to medium.	M	L				
Comments			Pit Terminated at: (mm) below ground level ✓ or *					
			Target Depth <input checked="" type="checkbox"/>			2000		
			Cave In <input type="checkbox"/>					
			Refusal <input type="checkbox"/>					
			Near Refusal <input type="checkbox"/>					
			Flooding <input type="checkbox"/>					
			Lack of Reach <input type="checkbox"/>					
Materials Consistency/Strength		Rock	Cementation		Water Water first Encountered			
Cohesive VS - Very Soft S - Soft F - Firm St - Stiff VSt - Very Stiff H - Hard	Non-Cohesive VL - Very Loose L - Loose MD - Medium Dense D - Dense VD - Very Dense CO - Compact	EL - Extremely Low VL - Very Low L - Low M - Medium H - High VH - Very High EH - Extremely High	IN - Indurated PC - Poorly Cemented MC - moderately Cemented WC - Well Cemented		Moisture D - Dry M - Moist W - Wet			
					General N/A - Not Applicable N/D - Not Determined

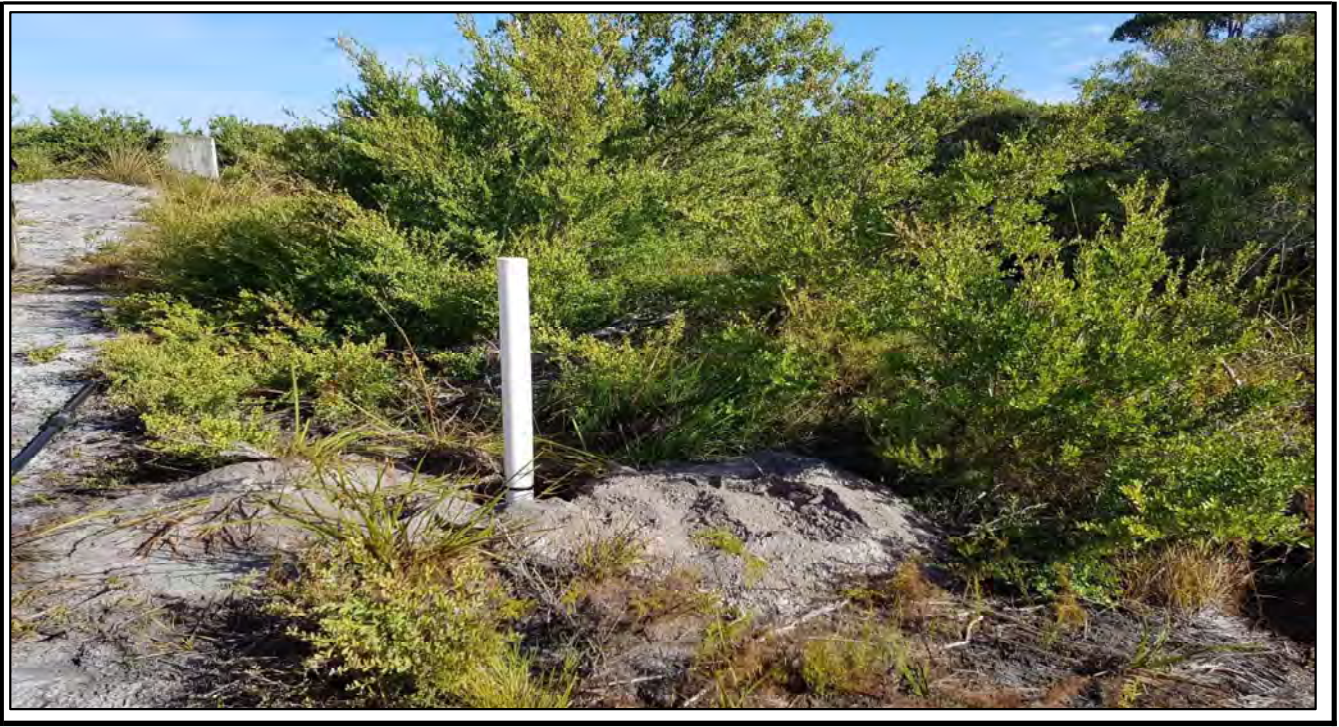
Test Pit No. 4 - Excavation

1000 - 2000	1000	SAND with silt: Light grey/white, fine to medium.	M	L				
Comments			Pit Terminated at: (mm) below ground level ✓ or *			Target Depth <input checked="" type="checkbox"/> 2000 Cave In <input type="checkbox"/> Refusal <input type="checkbox"/> Near Refusal <input type="checkbox"/> Flooding <input type="checkbox"/> Lack of Reach <input type="checkbox"/>		
Materials Consistency/Strength		Rock	Cementation		Water Water first Encountered			
Cohesive VS - Very Soft S - Soft F - Firm St - Stiff VSt - Very Stiff H - Hard	Non-Cohesive VL - Very Loose L - Loose MD - Medium Dense D - Dense VD - Very Dense CO - Compact	EL - Extremely Low VL - Very Low L - Low M - Medium H - High VH - Very High EH - Extremely High	IN - Indurated PC - Poorly Cemented MC - moderately Cemented WC - Well Cemented		Moisture D - Dry M - Moist W - Wet General N/A - Not Applicable N/D - Not Determined

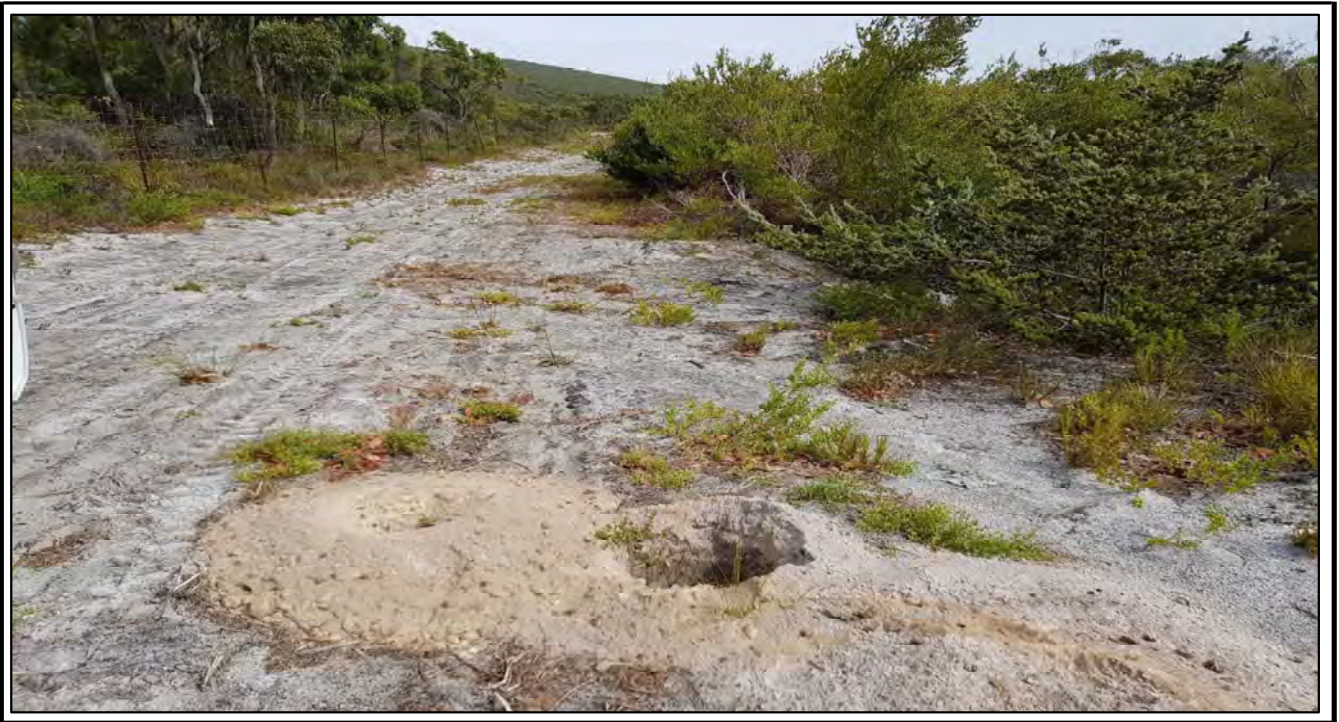
Test Pit No. 5 - Excavation

800 - 2000	1200	SAND with silt: Light grey/yellow, fine to medium.	M	L	PC			PERM	
Comments			Pit Terminated at: (mm) below ground level ✓ or *			Target Depth <input checked="" type="checkbox"/> 2000 Cave In <input type="checkbox"/> Refusal <input type="checkbox"/> Near Refusal <input type="checkbox"/> Flooding <input type="checkbox"/> Lack of Reach <input type="checkbox"/>			
Materials Consistency/Strength		Rock	Cementation		Water				
Cohesive VS - Very Soft S - Soft F - Firm St - Stiff VSt - Very Stiff H - Hard	Non-Cohesive VL - Very Loose L - Loose MD - Medium Dense D - Dense VD - Very Dense CO - Compact	EL - Extremely Low VL - Very Low L - Low M - Medium H - High VH - Very High EH - Extremely High	IN - Indurated PC - Poorly Cemented MC - moderately Cemented WC - Well Cemented		Water first Encountered Moisture D - Dry M - Moist W - Wet General N/A - Not Applicable N/D - Not Determined

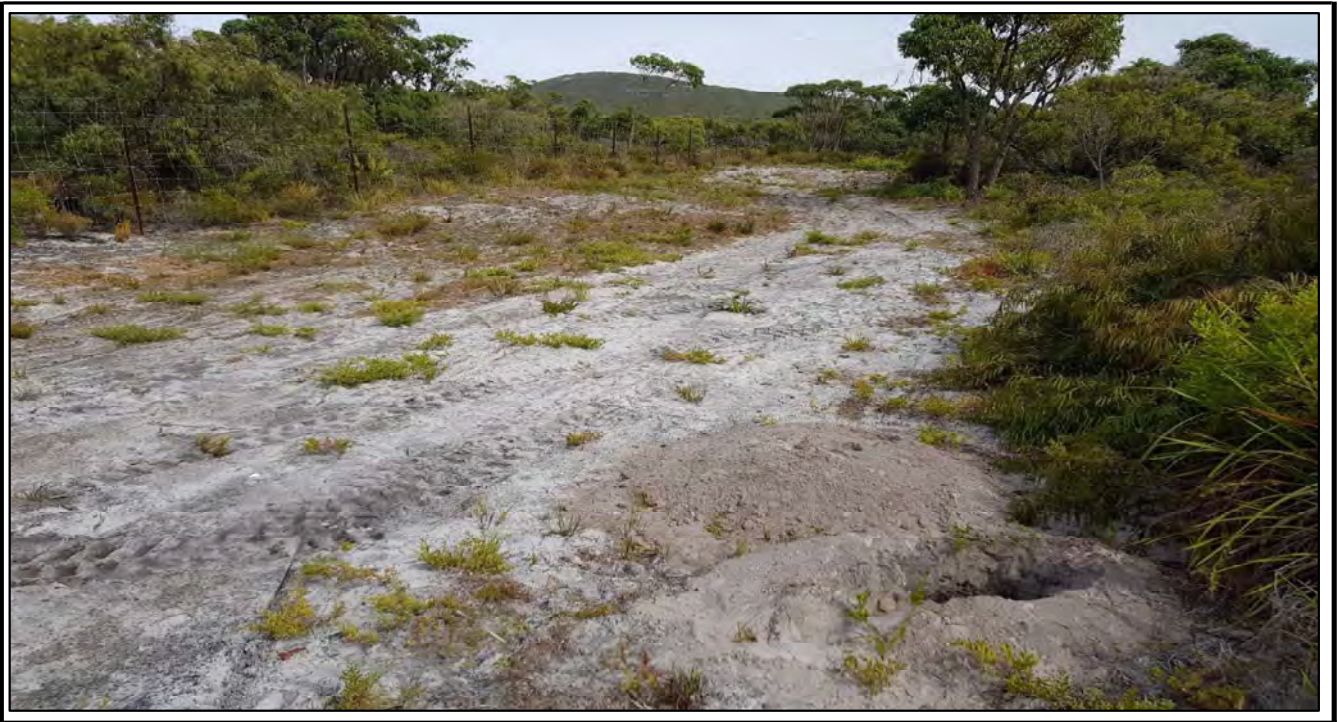
Test Pit No. 6 - Excavation

1700 - 2000	300	SAND with silt: Brown/grey, fine to medium.	M	L-MD	PC			
Comments			Pit Terminated at: (mm) below ground level ✓ or *			Target Depth <input checked="" type="checkbox"/> 2000 Cave In <input type="checkbox"/> Refusal <input type="checkbox"/> Near Refusal <input type="checkbox"/> Flooding <input type="checkbox"/> Lack of Reach <input type="checkbox"/>		
Materials Consistency/Strength		Rock	Cementation		Water Water first Encountered			
Cohesive VS - Very Soft S - Soft F - Firm St - Stiff VSt - Very Stiff H - Hard	Non-Cohesive VL - Very Loose L - Loose MD - Medium Dense D - Dense VD - Very Dense CO - Compact	EL - Extremely Low VL - Very Low L - Low M - Medium H - High VH - Very High EH - Extremely High	IN - Indurated PC - Poorly Cemented MC - moderately Cemented WC - Well Cemented		Moisture D - Dry M - Moist W - Wet General N/A - Not Applicable N/D - Not Determined
