FORESHORE MANAGEMENT PLAN

Emu Beach

EEL19265.001
Rev 0
04 June 2021

REPORT

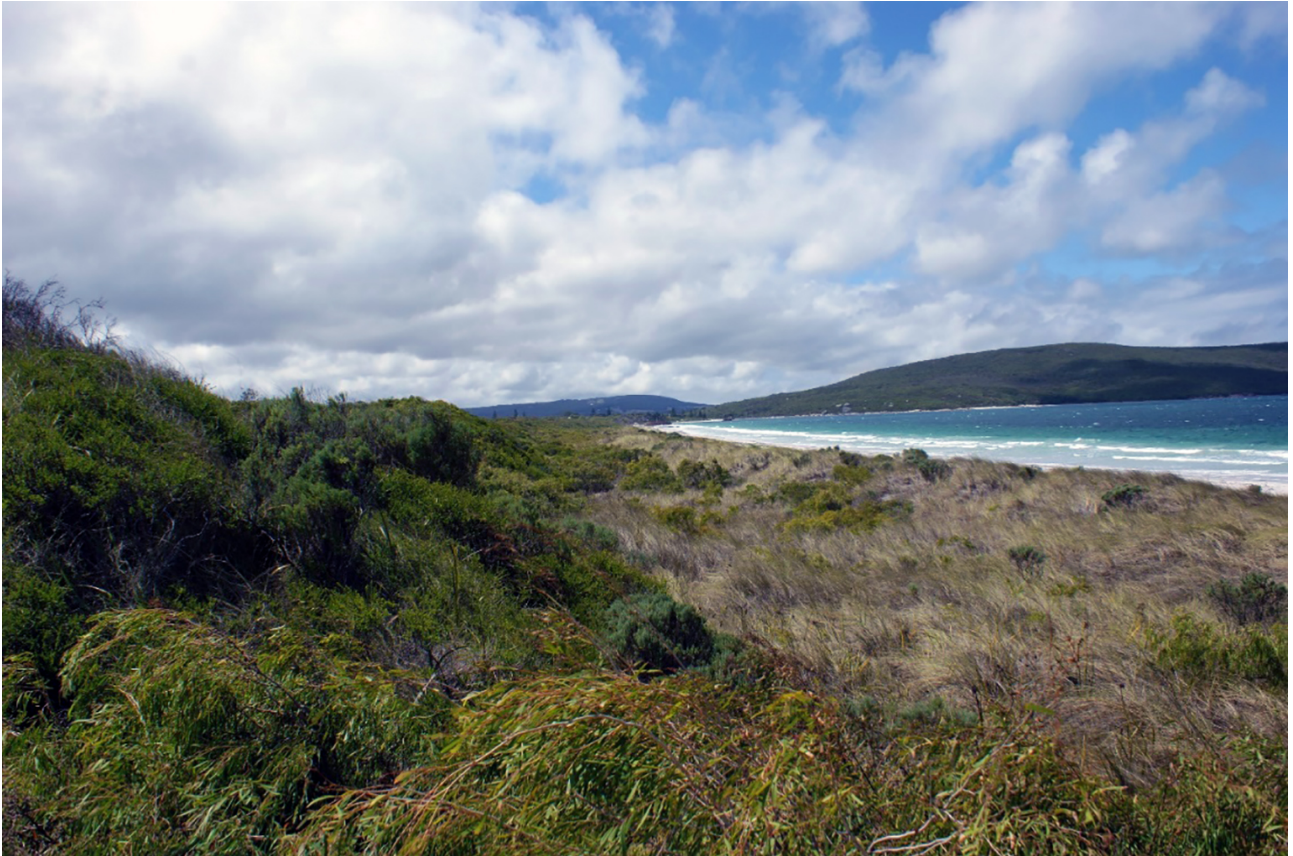
Plate 2: Peppermint Thicket and Littoral zone vegetation associations in the south of the FMP area

The site walk over confirmed the findings of Strategen (2007), and ATA Environmental (2006), that the peppermint thicket vegetation extends to the southern border of the FMP area (Plate 2) and to the north of the Hickman (2005) survey area to Firth Street (Figure H). The Littoral zone vegetation was also found to extend to the southern border of the FMP area (Plate 2) and approximately 150 m to the north of the Hickman (2005) survey area (Figure H).

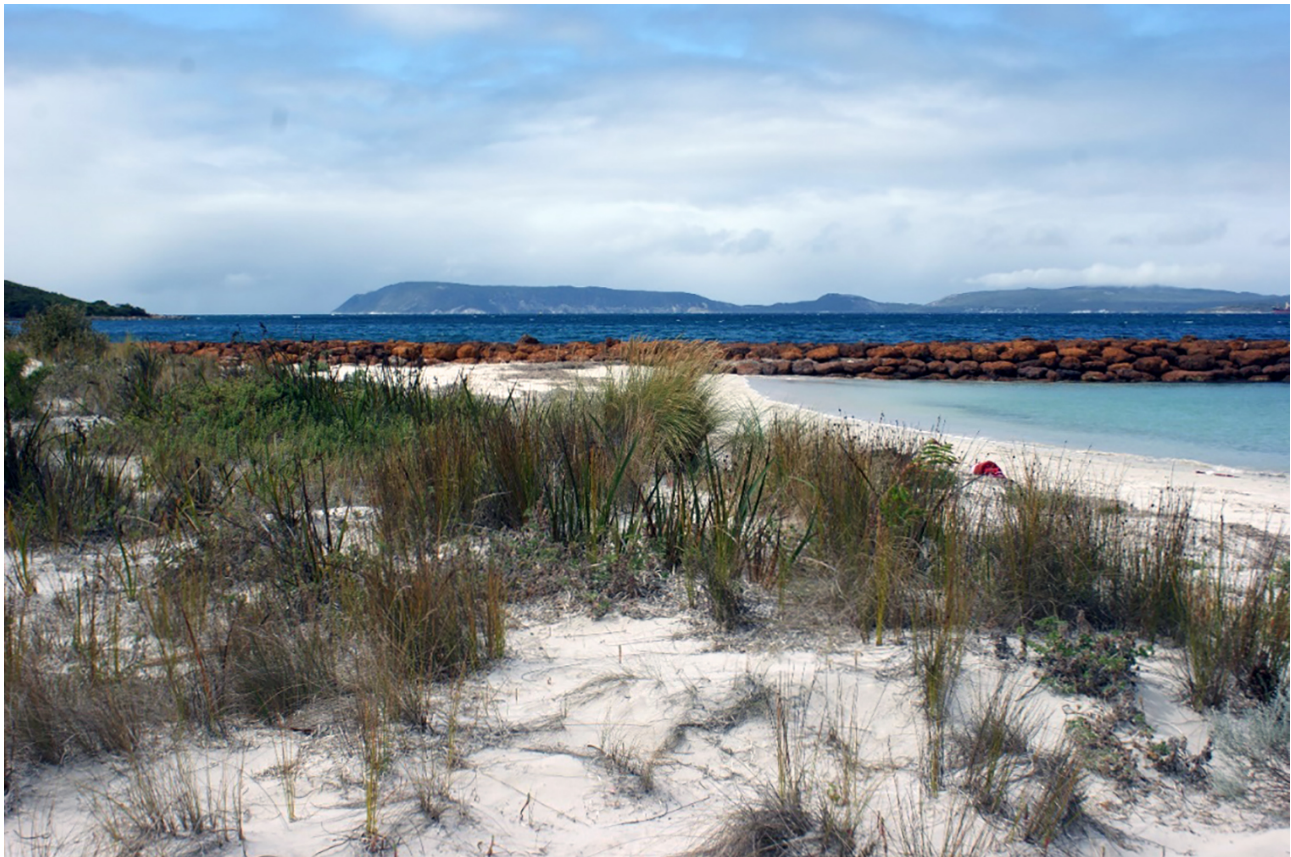
Plate 3: Rehabilitation of Littoral zone vegetation association at Emu Point beach

The Littoral Zone vegetation at Emu Point Beach and the fringing peppermint trees to the north of the beach have been subject to rehabilitation efforts (Plate 3; Figure H). Ongoing weed management is required to control introduced species, including sea spurge (**Euphorbia paralias*), within the rehabilitation areas. Section 7 identifies the approach to be implemented in rehabilitating Emu Point Beach foreshore environment.

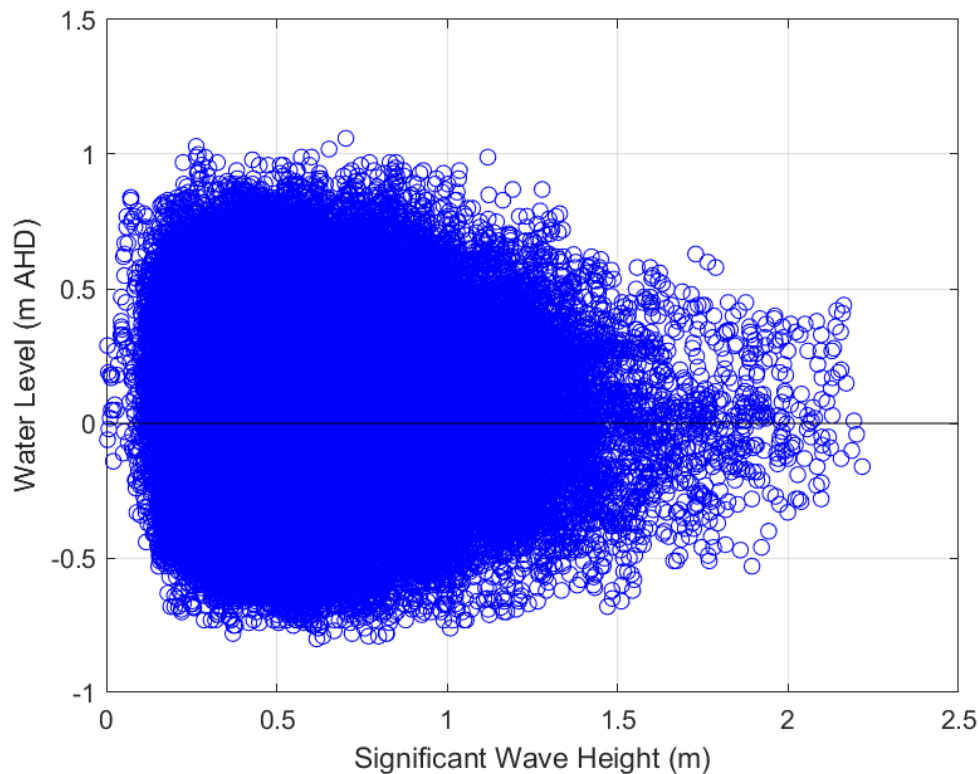
Figure 13: Joint occurrence of significant wave heights at the central model extraction point (P2) from the hindcast wave model and water levels recorded at Port of Albany since 1987 (33-year record).

observed wave heights and water levels, i.e. larger wave heights often coincide with higher water levels.

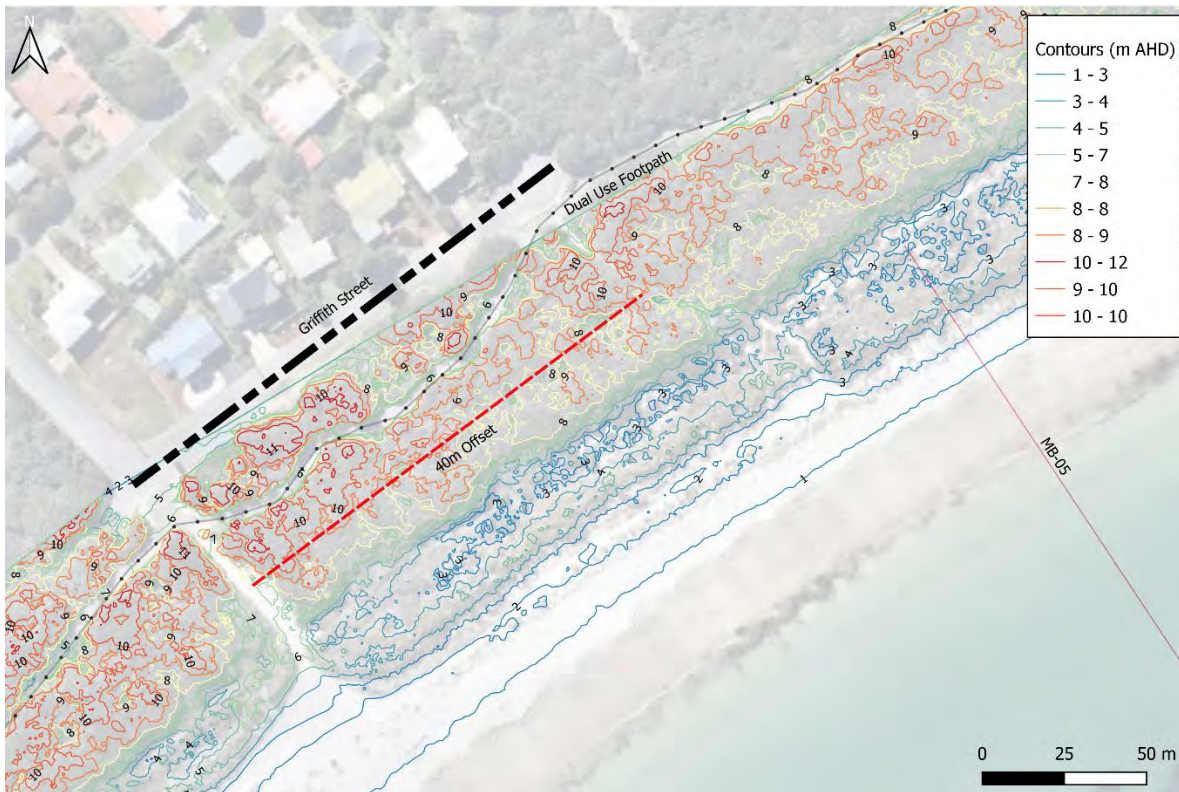
Figure 19: Contour map of the Griffiths Street foreshore from March 2019 showing the 40m seaward offset Coastal Adaptation Trigger Point and long-term beach transect MB-05

Note: MB-05 is the closest long term measured transect to Griffiths St

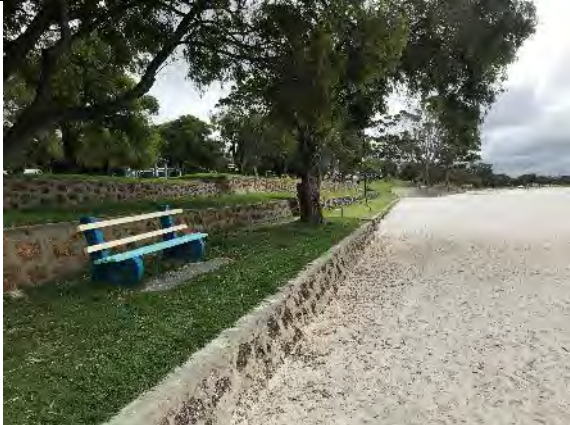
Moderate	Some defects in older portion of structure – grouting missing in places, cracking, evidence of piping of fill material through holes in structure face
Emu Point - north groyne	Rock groyne connected to training wall that stabilises western side of Emu Point channel and protects foreshore area from erosion

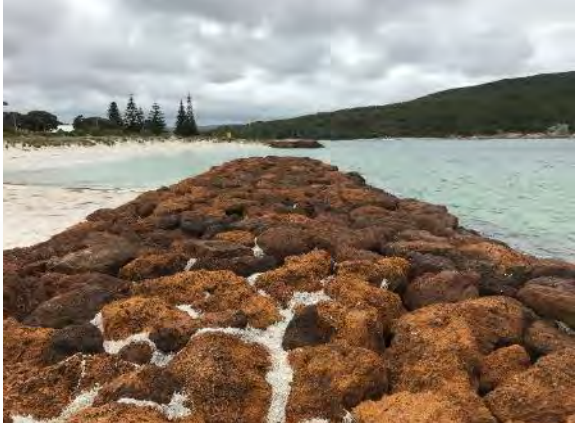
Very good	No significant defects
Emu Point - rock revetment	Sloping rock seawall that protects foreshore area from erosion

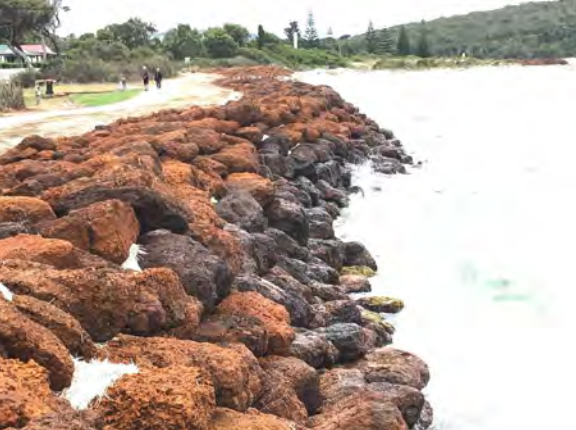
Poor	Some significant defects – significant slope steepening in some sections, likely due to settlement of toe, causing loss of interlocking between armour rocks and filter exposure; crest washout holes, likely due to overtopping

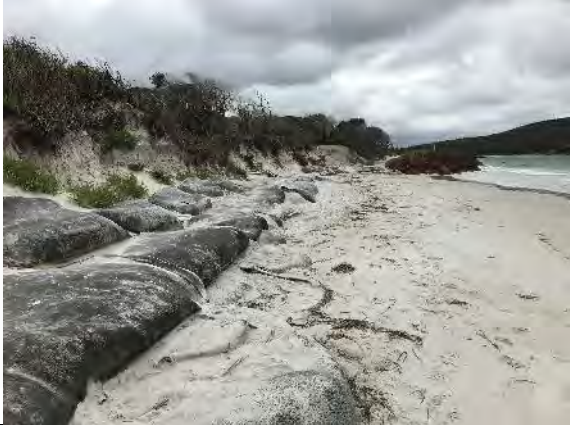
Very poor	Structure has failed – bags have split open and washed away; significant reduction in crest height; overtopping has eroded foreshore behind structure
Sandbag groyne 1 (east)	Trial sandbag beach groyne which helps to stabilise beach and limit impact of erosion scour at end of seawall structures

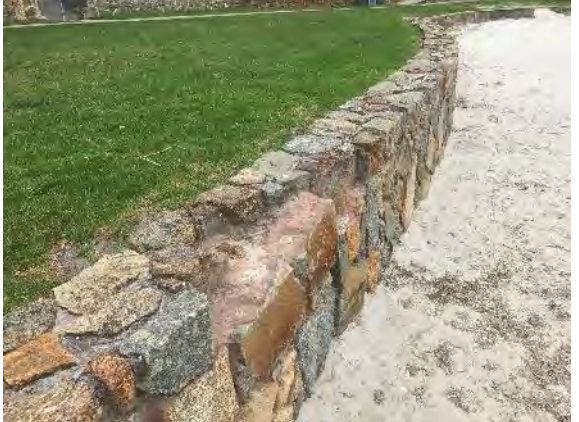
Moderate	Some defects – grouting missing in places; rocks missing from crest of structure; some concrete panels tilting
Frenchman Bay Road revetment	Sloping rock seawall that protects foreshore area and path and road from erosion

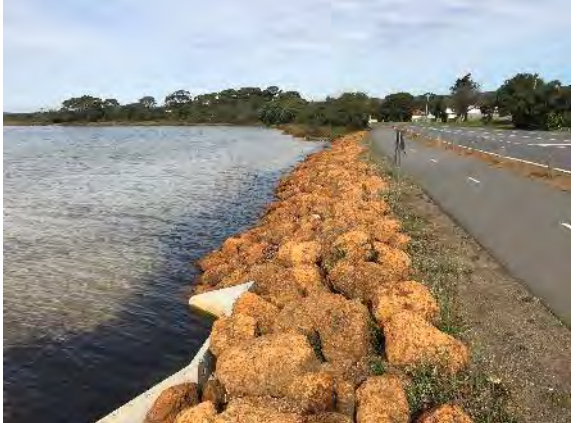
Good	Minor defects include some slumping, armour range too wide and some small/core rock placed on top of armour

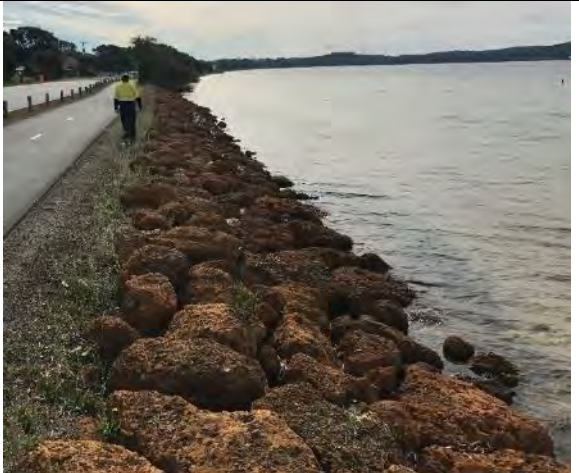
Moderate	Some defects - loss of interlocking at top of slope, likely due to settlement of toe; slope steepening; some washout at crest; large armour size range

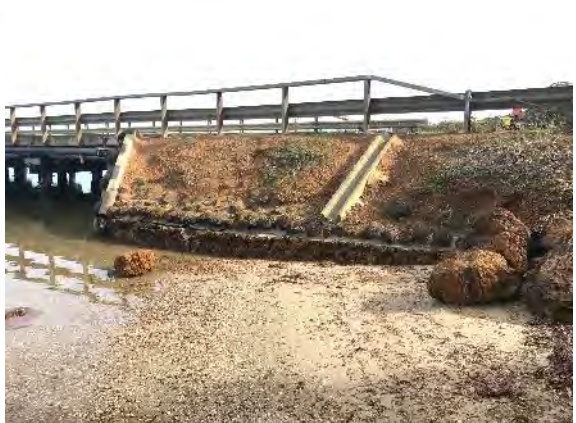
Moderate	Some defects - grouted section of structure has slumped ~50mm; slope steepening; displaced toe rocks; exposure of core and fill
