Albany Motorsport Park – Development Application

Site and Soil Evaluation for Onsite Wastewater Management

City of Albany 19 August 2021

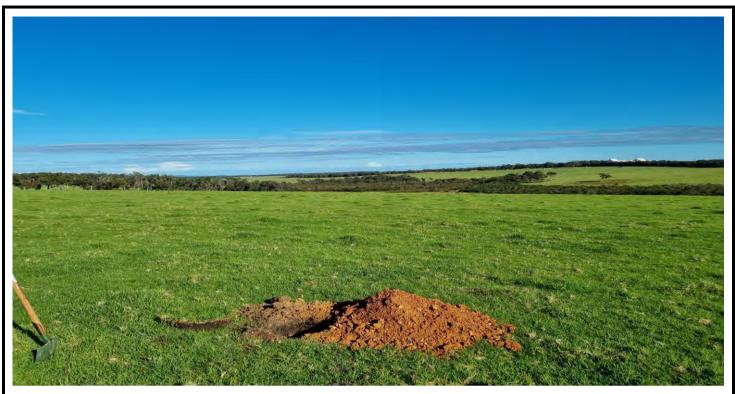
B Image: Signed Sector Se	GREA GEO COMSTRUC	AT SOUT DTECHI	THERN NICS	Job No 4626	Test Pit N 1	1o.	Sample No. 4626G1		Sheet	1	of	12	
Image: Control of the set of the	Project: Alb Project No. QU	bany Motors U-0498		·	25/06/202 Logged B	21 3y	Equipment type: Excavation Method	Kubota KX41-3V d : 300mm Auger					
Image: Normal Standard State State Image: Normal State	Depth Below Surface (mm)	Layer Depth (mm)	Ρε	SOIL TY	PE, Plasticity, Colo		nponents	Moist. Condition	Classification Symbol	Sample/Test			
Image: Normal state	0 - 180	180	(Topsoi	I) SAND with silt: Dark	grey, fine to mediu	m. Roots	and root fibres.	M L-MD					
Image: Normal state	400 400	24.0	0				ude en ander						
Contains approximately 10% Cobbles & Boulders in excess of 250mm diameter. Image: Contains approximately 10% Cobbles & Boulders in excess of 250mm diameter. Image: Contains approximately 10% Cobbles & Boulders in excess of 250mm diameter. Image: Contains approximately 10% Cobbles & Boulders in excess of 250mm diameter. Image: Contains approximately 10% Cobbles & Boulders in excess of 250mm diameter. Image: Contains approximately 10% Cobbles & Boulders in excess of 250mm diameter. Image: Contains approximately 10% Cobbles & Boulders in excess of 250mm diameter. Image: Contains approximately 10% Cobbles & Boulders in excess of 250mm diameter. Image: Contains approximately 10% Cobbles & Boulders in excess of 250mm diameter. Image: Contains approximately 10% Cobbles & Boulders in excess of 250mm diameter. Image: Contains approximately 10% Cobbles & Boulders in excess of 250mm diameter. Image: Contains approximately 10% Cobbles & Boulders in excess of 250mm diameter. Image: Contains approximately 10% Cobbles & Boulders in excess of 250mm diameter. Image: Contains approximately 10% Cobbles & Boulders in excess of 250mm diameter. Image: Contains approximately 10% Cobbles & Boulders in excess of 250mm diameter. Image: Contains approximately 10% Cobbles & Boulders in excess of 250mm diameter. Image: Contains approximately 10% Cobbles & Boulders in excess of 250mm diameter. Image: Contains approximately 10% Cobbles & Boulders in excess of 250mm diameter. Image: Contains approximately 10% Cobbles & Boulders in excess of 250mm diameter. Image: Contains approximately 10% Cobbles & Boulders in excess of 250mm diameter. Image: Contains approximately 10% Cobbles & Boulde	180 - 490	310	Sand	-									#

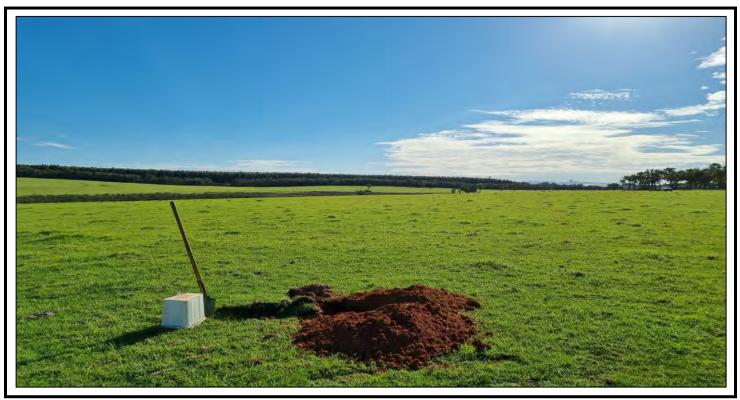
GR GR GR GR GR	EAT SOU EOTECH	THERN INICS RIALS TESTING	Job No 4626	Test Pit No 2	о.	Sample No. 4626G2		Sheet	3	of	12		
Client: Project: Project No. Location:	QU-0498	orsport Park De S 117°44'50.2"		Date Commen 25/06/2021 Logged By M.Coffey	1 y	Operator/Contractor Equipment type: Excavation Method Position:							
Depth Below Surface (mm)	Layer Depth (mm)	F		rial Description PE, Plasticity, Colou condary and other n		nponents	Moist. Condition Consistency / Strength Cementation Vater Table						
0 - 140	140	(Topso	oil) SAND with silt: Dark	grey, fine to medium	n. Roots	and root fibres.	fibres. M L-MD						
140 400	000	<u> </u>		. to oppose - 1	م م م	uh angular							
140 - 400	260	Sar	dy GRAVEL: Brown, fine (F:20% / M:20% / C:15				M VD MC						
		Contains	approximately 10% Cobb		-								
		Contains											
400 - 1400	1000		Sandy CLAY: Low to	medium plasticity,	Light bro	wn.	M _ F

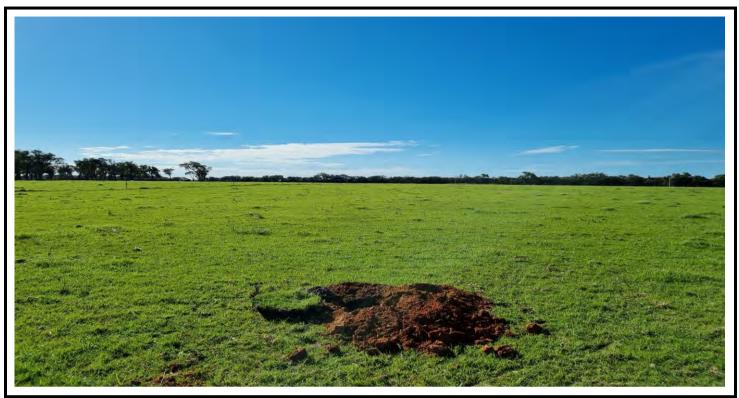
UCTION MATERIA	NICS	Job No 4626	Test Pit N 3	lo.	Sample No. 4626G3		Sheet	5	of	12		
Project: A Project No. Q	U-0498	sport Park De 117°44'56.4"E		Date Commer 25/06/202 Logged B M.Coffey	1 y	Operator/Contractor Equipment type: Excavation Method Position:	Kubota KX41-3V						
Depth Below Surface (mm)	Layer Depth (mm)	Ρ		erial Description (PE, Plasticity, Colo econdary and other i		iponents	Moist. Condition Consistency / Strength Cementation Water Table						
0 - 250	250	(Topsoil) S	SAND with silt: Dark gre	ey to grey, fine to me	edium. Ro	ots and root fibres.	fibres. M L-MD						
050 000	500												
250 - 830	580	San	dy GRAVEL: Brown, fine	e to medium, sub-rol . Fine to medium gra		v .	M MD-D						
		Contains	approximately 10% Cob	-			-+++++						
		Contains				dameter.							
830 - 1600	770		Sandy CLAY: Low to	o medium plasticity.	Liaht bro	wn.	MF					#

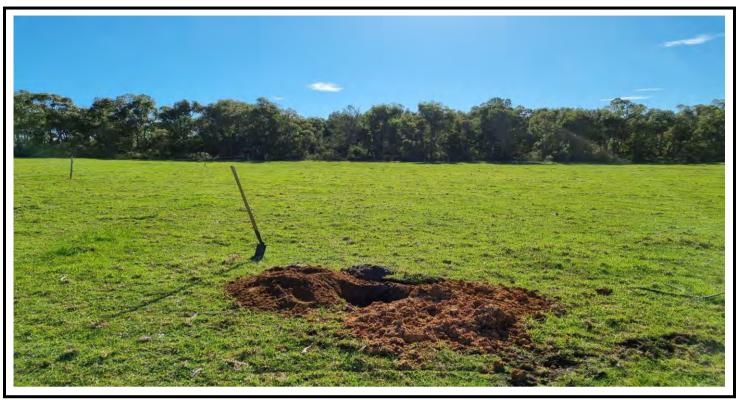
G GF G	REAT SOU EOTEC	UTHERN HNICS ERIALS TESTING	Job No 4626	Test Pit No 4	o.	Sample No. 4626G4		Sheet	7	of	12	
Client: Project: Project No. Location:	QU-0498	torsport Park De "S 117°44'17.6"l		Date Commen 25/06/2021 Logged By M.Coffey	1 y	Operator/Contractor Equipment type: Excavation Methoo Position:	Kubota KX41-3V					
Depth Below Surface (mm)	Layer Depth (mm)	Р		erial Description PE, Plasticity, Colou econdary and other n		iponents	Moist. Condition	Classification Symbol	Sample/Test			
0 - 220	220	(Topso	bil) SAND with silt : Dark	grey, fine to medium	n. Roots a	and root fibres.	М	L-MD				
000 4050	4000											
220 - 1250	1030	Sar	dy GRAVEL: Brown, fine (F:25% / M:20% / C:10			-	M D					
		Contains	approximately 10% Cobb	•	-							
		Contains				oomin diameter.	+ $+$ $+$ $+$ $+$					
1250 - 1750	500		Sandy CLAY: Low to me	dium plasticity. Ligh	ht brown/o	orange.	M F					#

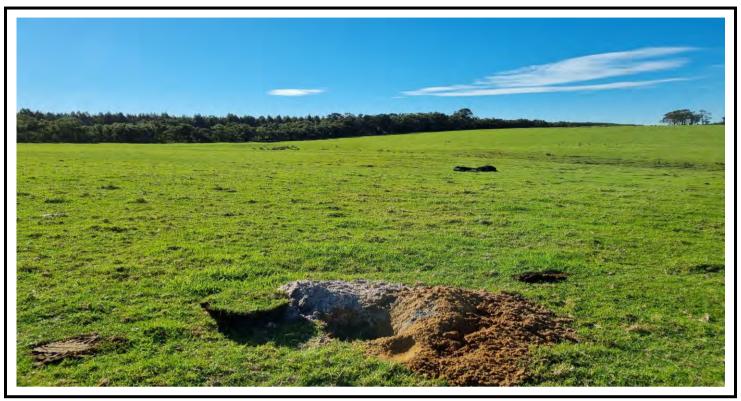
GR GE CONST	EAT SOU OTECH	THERN INICS HALS TESTING	Job No 4626	Test Pit N 5	No.	Sample No. 4626G5		Sheet	9	of	12	
Project: Project No.	QU-0498	orsport Park De S 117°44'17.5"		Date Comme 25/06/202 Logged E M.Coffey	21 3y	Operator/Contractor Equipment type: Excavation Methoo Position:		Kubota KX41-3V				
Depth Below Surface (mm)	Layer Depth (mm)	F		erial Description (PE, Plasticity, Colo econdary and other		nponents	Moist. Condition	Classification Symbol	Sample/Test			
0 - 230	230	(Topso	bil) SAND with silt : Dark	grey, fine to mediu	ım. Roots	and root fibres.	M L-MD					
230 - 880	650		SAND with s	silt: Grey, fine to me	edium.		M MD					#
880 - 2500	1620			a ta agarag ayık ya	unded to .	uh angular	M MD-D					
880 - 2500	1620	Sar	ndy GRAVEL: Brown, fin (F:15% / M:30% / C:10									#
		Contains	approximately 10% Cob		-

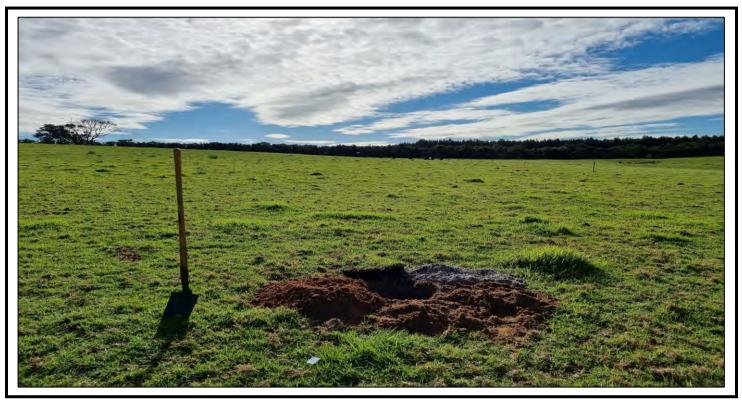
GR GR GR	REAT SOU EOTECI STRUCTION MATE	UTHERN HNICS ERIALS TESTING	Job No 4626	Test Pit N 6	lo.	Sample No. 4626G6		Sheet	11	of	12	1
Client: Project: Project No. Location:	QU-0498	torsport Park De "S 117°44'17.4"		Date Comme 25/06/202 Logged B M.Coffey	1 9 y	Operator/Contractor Equipment type: Excavation Methoor Position:		Kubota KX41-3V				
Depth Below Surface (mm)	Layer Depth (mm)	F		erial Description /PE, Plasticity, Colo econdary and other		nponents	Moist. Condition	Classification Symbol	Sample/Test			
0 - 350	350	(Topso	bil) SAND with silt: Dark	grey, fine to mediu	m. Roots	and root fibres.	M L-MD					
		_										
350 - 1200	850	Sar	ndy GRAVEL: Brown, fin				M D-VD					#
		Oantaina	(F:20% / M:20% / C:10		-							
		Contains	approximately 10% Cobl	bies & Boulders in e	excess of	400mm diameter.						
1200 - 1800	600	Sandy	GRAVEL: Light brown,	fine to coarse sub-	rounded	o sub-angular	M D					#

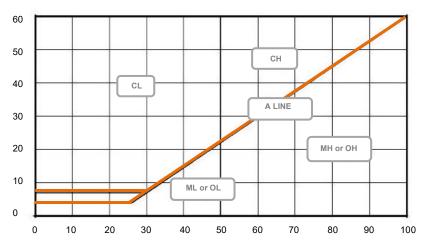
PLASTICITY CHART

For laboratory classification of fine grained soils
