# Development Application

**Proposed Warehouse, Workshop and Office**

Lots 1-2 on Diagram 22830, 29 on Diagram  
23804 and 174-175 on Plan 9216, Chester Pass  
Road, Milpara

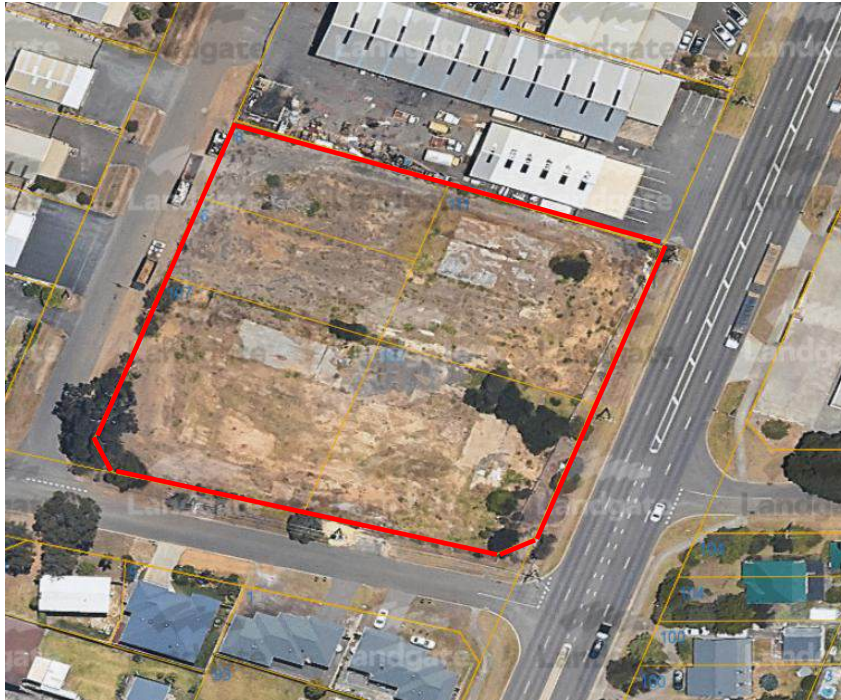
**FIGURE 2: AERIAL IMAGE**

The subject land is 7,636m<sup>2</sup> in area and is located within the City of Albany. The subject land is located approximately 3.3km northwest of the Albany city centre. The subject land is bounded by Chester Pass Road to the east, Richard Street to the south and Lance Street to the west. A location plan is shown in **Figure 1** below, with an aerial image of the site shown at **Figure 2**, that outlines the extent of the development area.

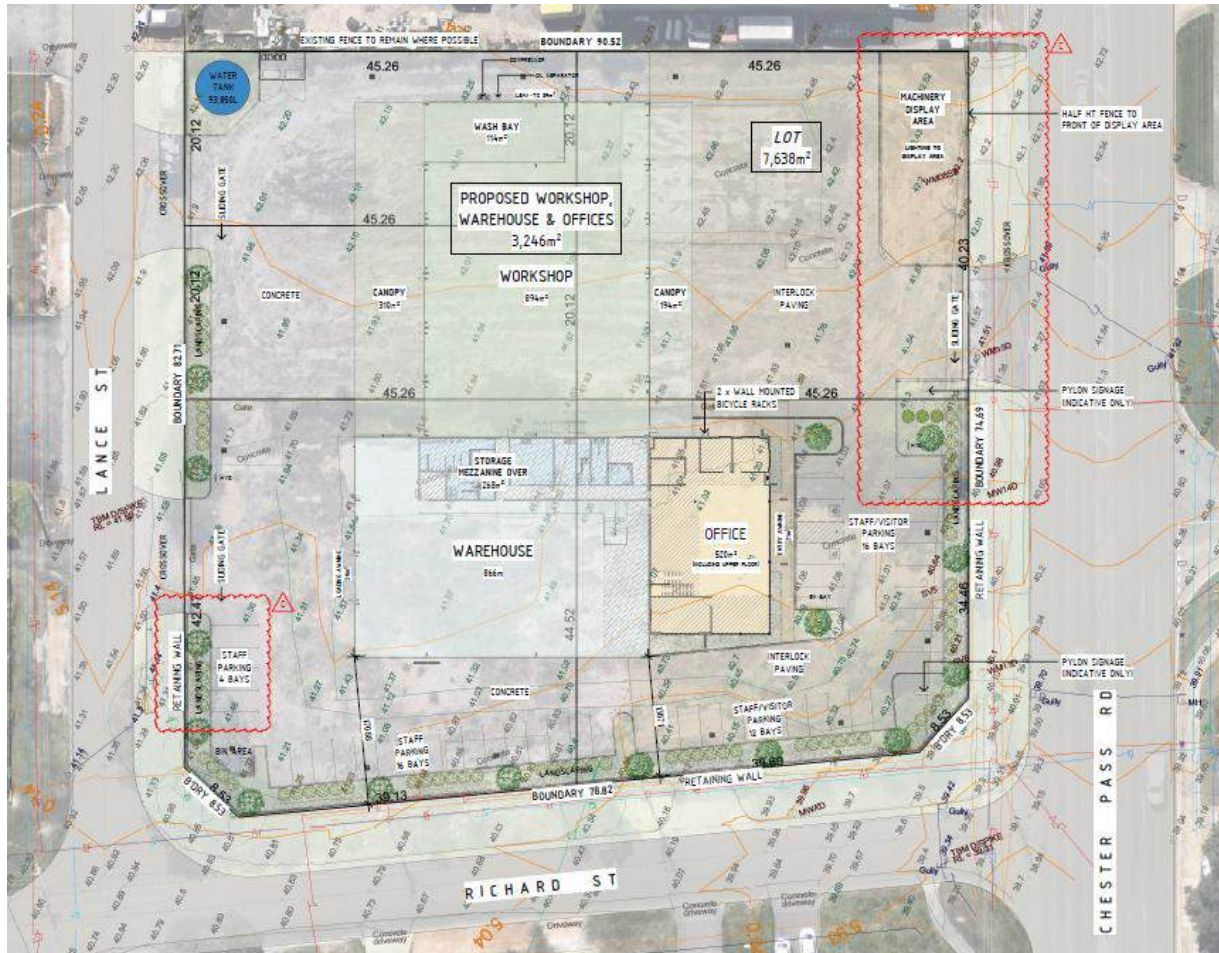
**FIGURE 4: SITE LAYOUT**

This application proposes the development of a warehouse, workshop and two-storey office. An excerpt of the site layout has been shown in **Figure 4**, while the development plans, including floor plans and elevations have been included at **Appendix A**.

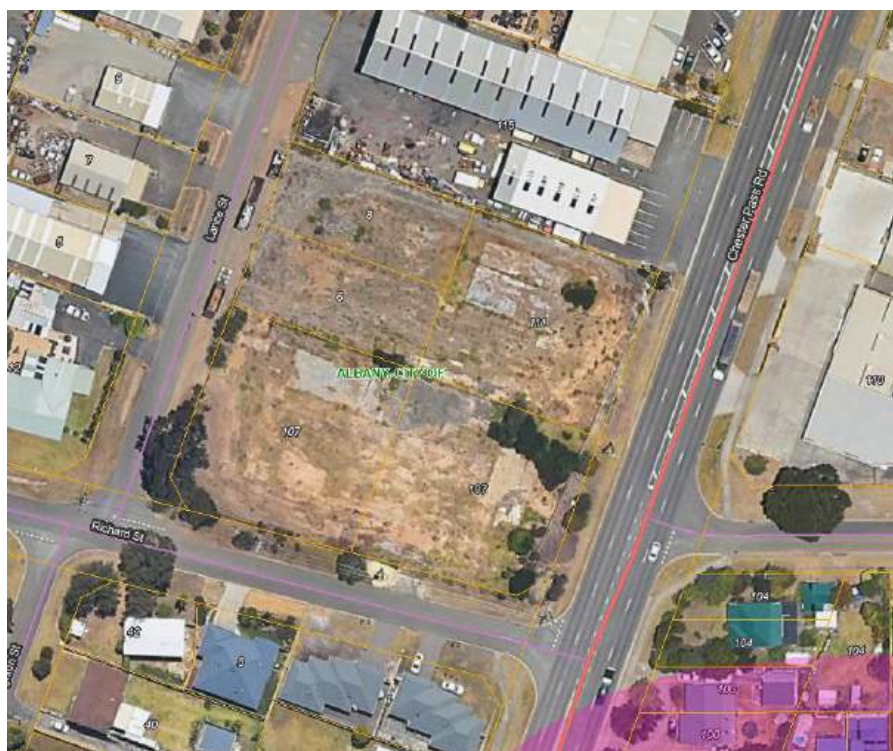
**FIGURE 5: BUSHFIRE PRONE MAPPING**

**Figure 5** demonstrates that the subject land is not located within a bushfire prone area, as designated by the Department of Fire and Emergency Commissioner and as such, the development is considered exempt of bushfire reporting under the Guidelines for Planning in Bushfire Prone Areas Ver 1.4, and no detailed fire assessment is required.

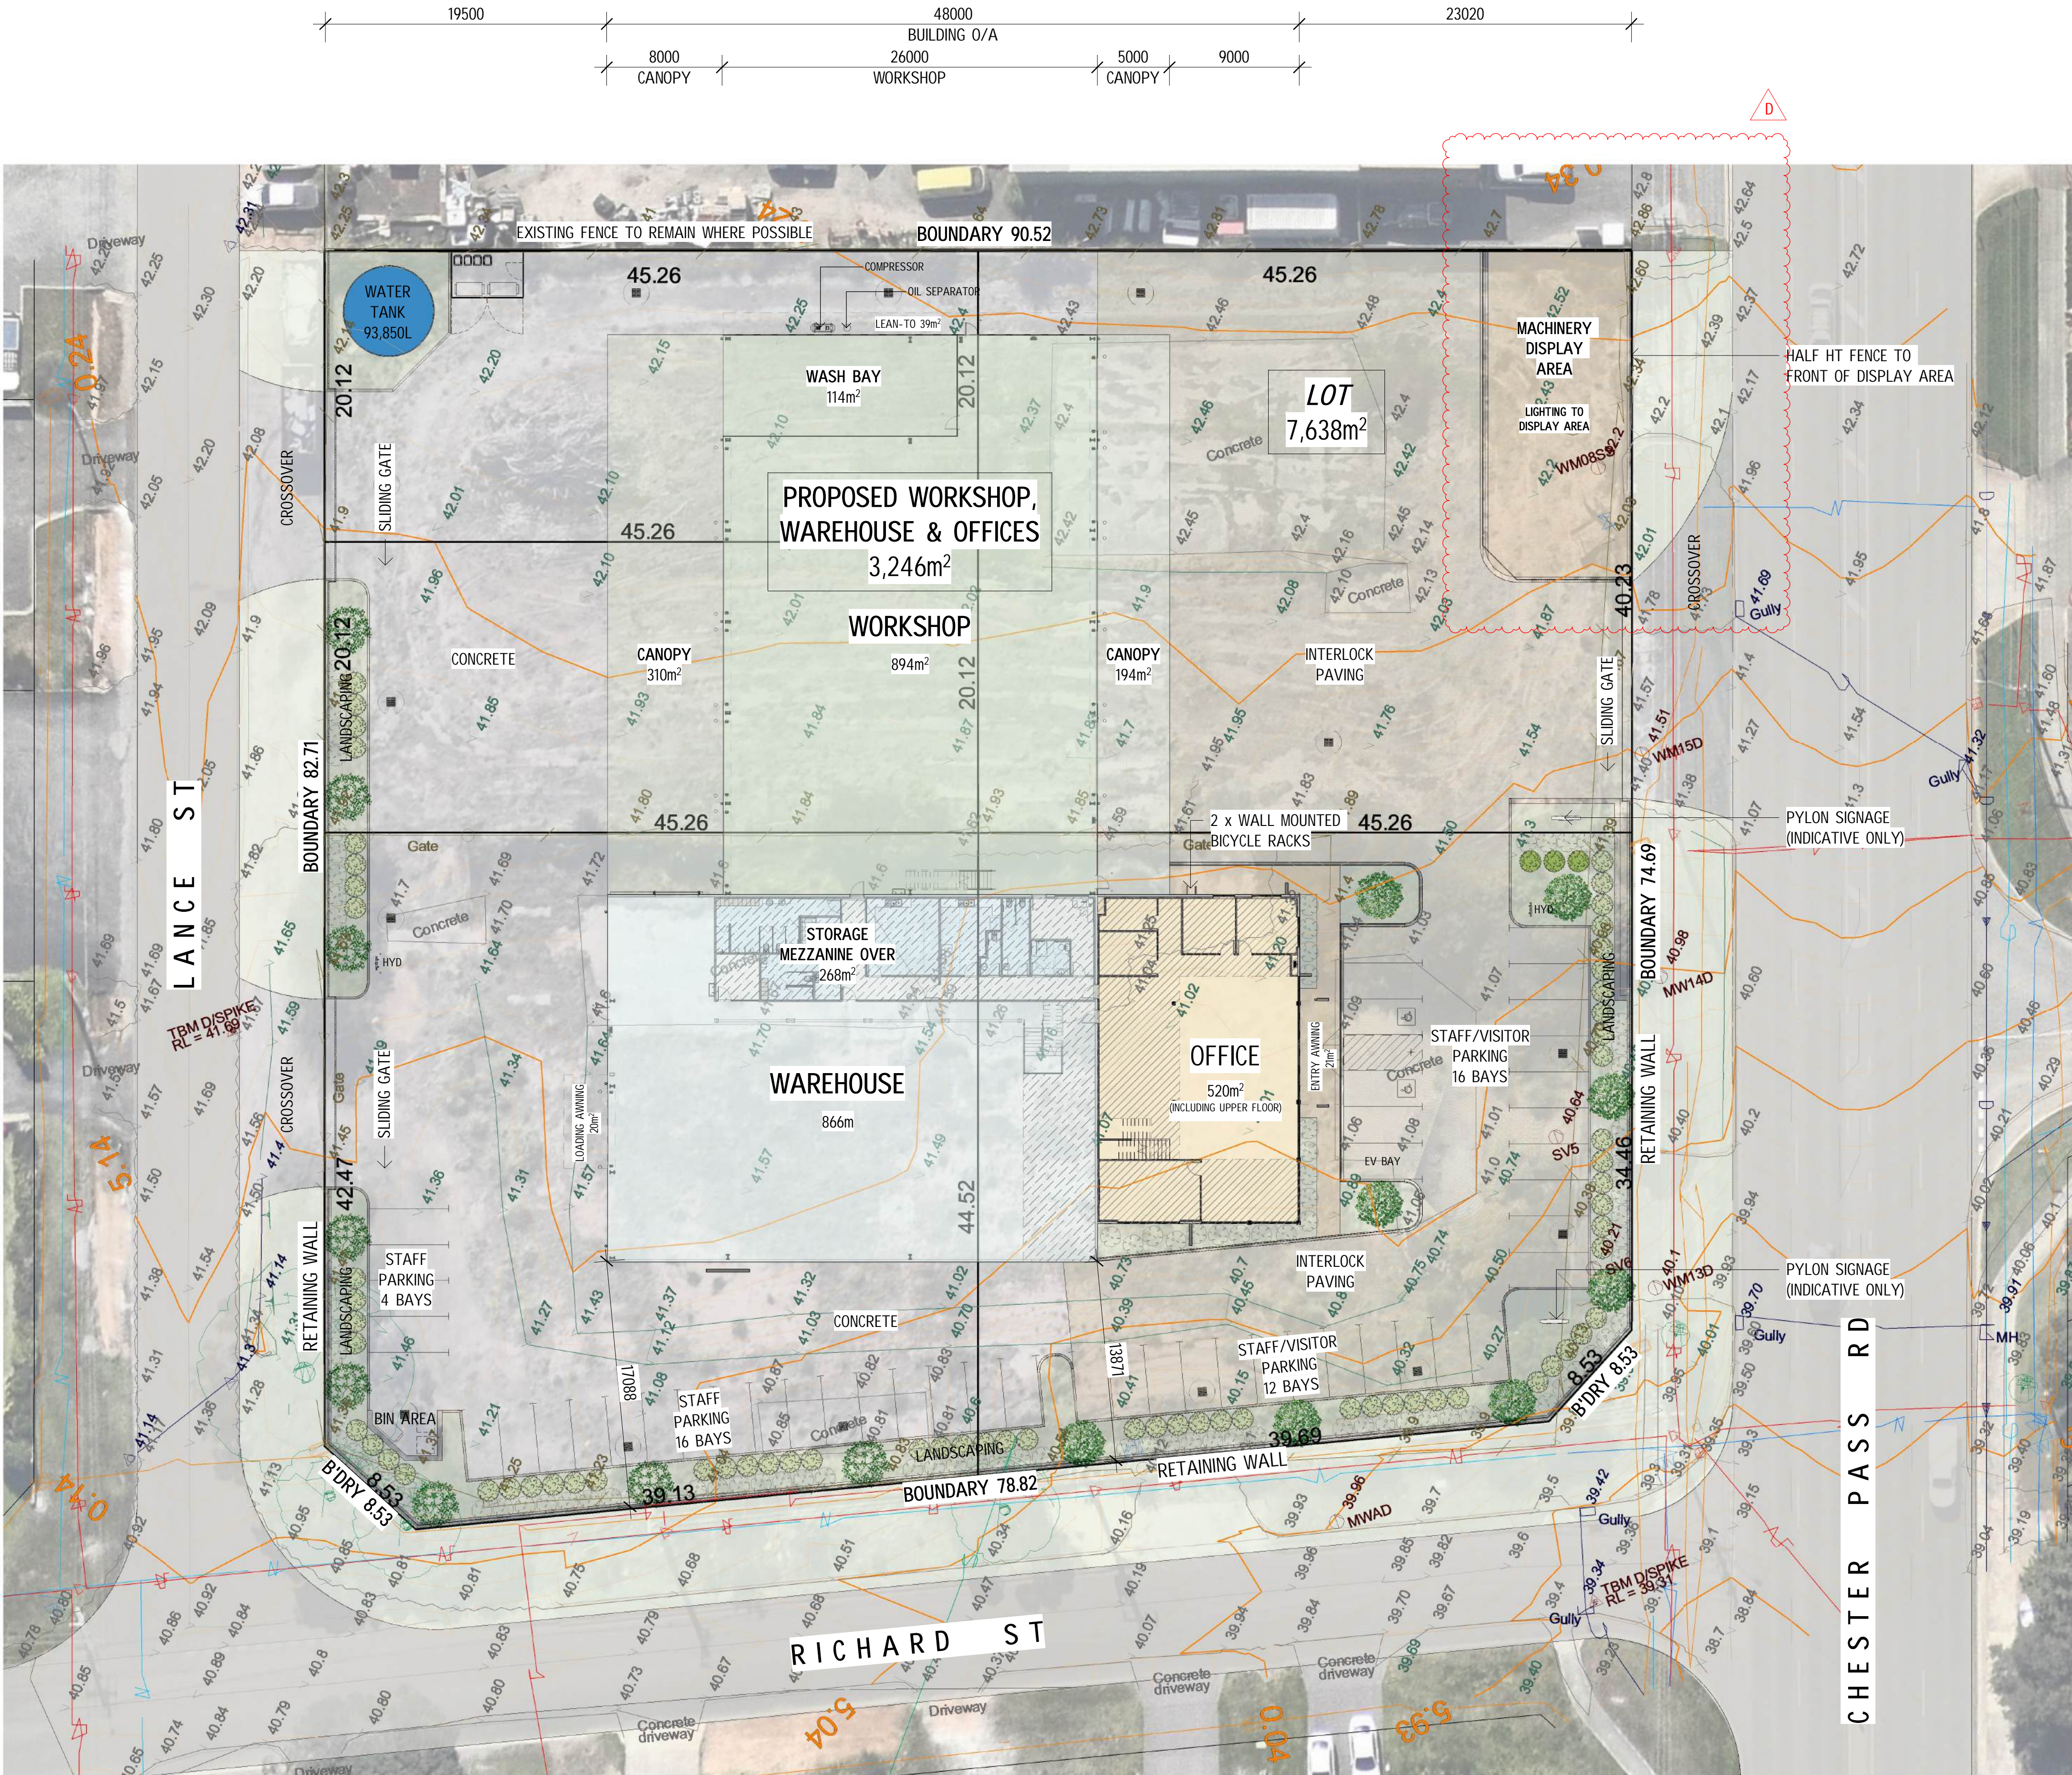
SITE PLAN  
1 : 250

SETBACKS  
PRIMARY STREET 7.5m  
REAR & SIDE NIL

DATE	REV	AMENDMENT	BY
21/02/2025	D	CHESTER PASS RD CROSSOVER MODIFIED TO SUIT VEHICLE TURNING REQUIREMENTS	ER
22/01/2025	C	CHESTER PASS RD CROSSOVER RELOCATED TO SUIT EXISTING. MACHINERY DISPLAY AREA EXPANDED.	ER
20/12/2024	B	SOAKWELL RELOCATED TO SUIT UPDATED CONSULTANT STORMWATER DESIGN. SURVEY ADDED FOR CLARITY	ER
05/12/2024	A	ISSUED FOR DA	ER

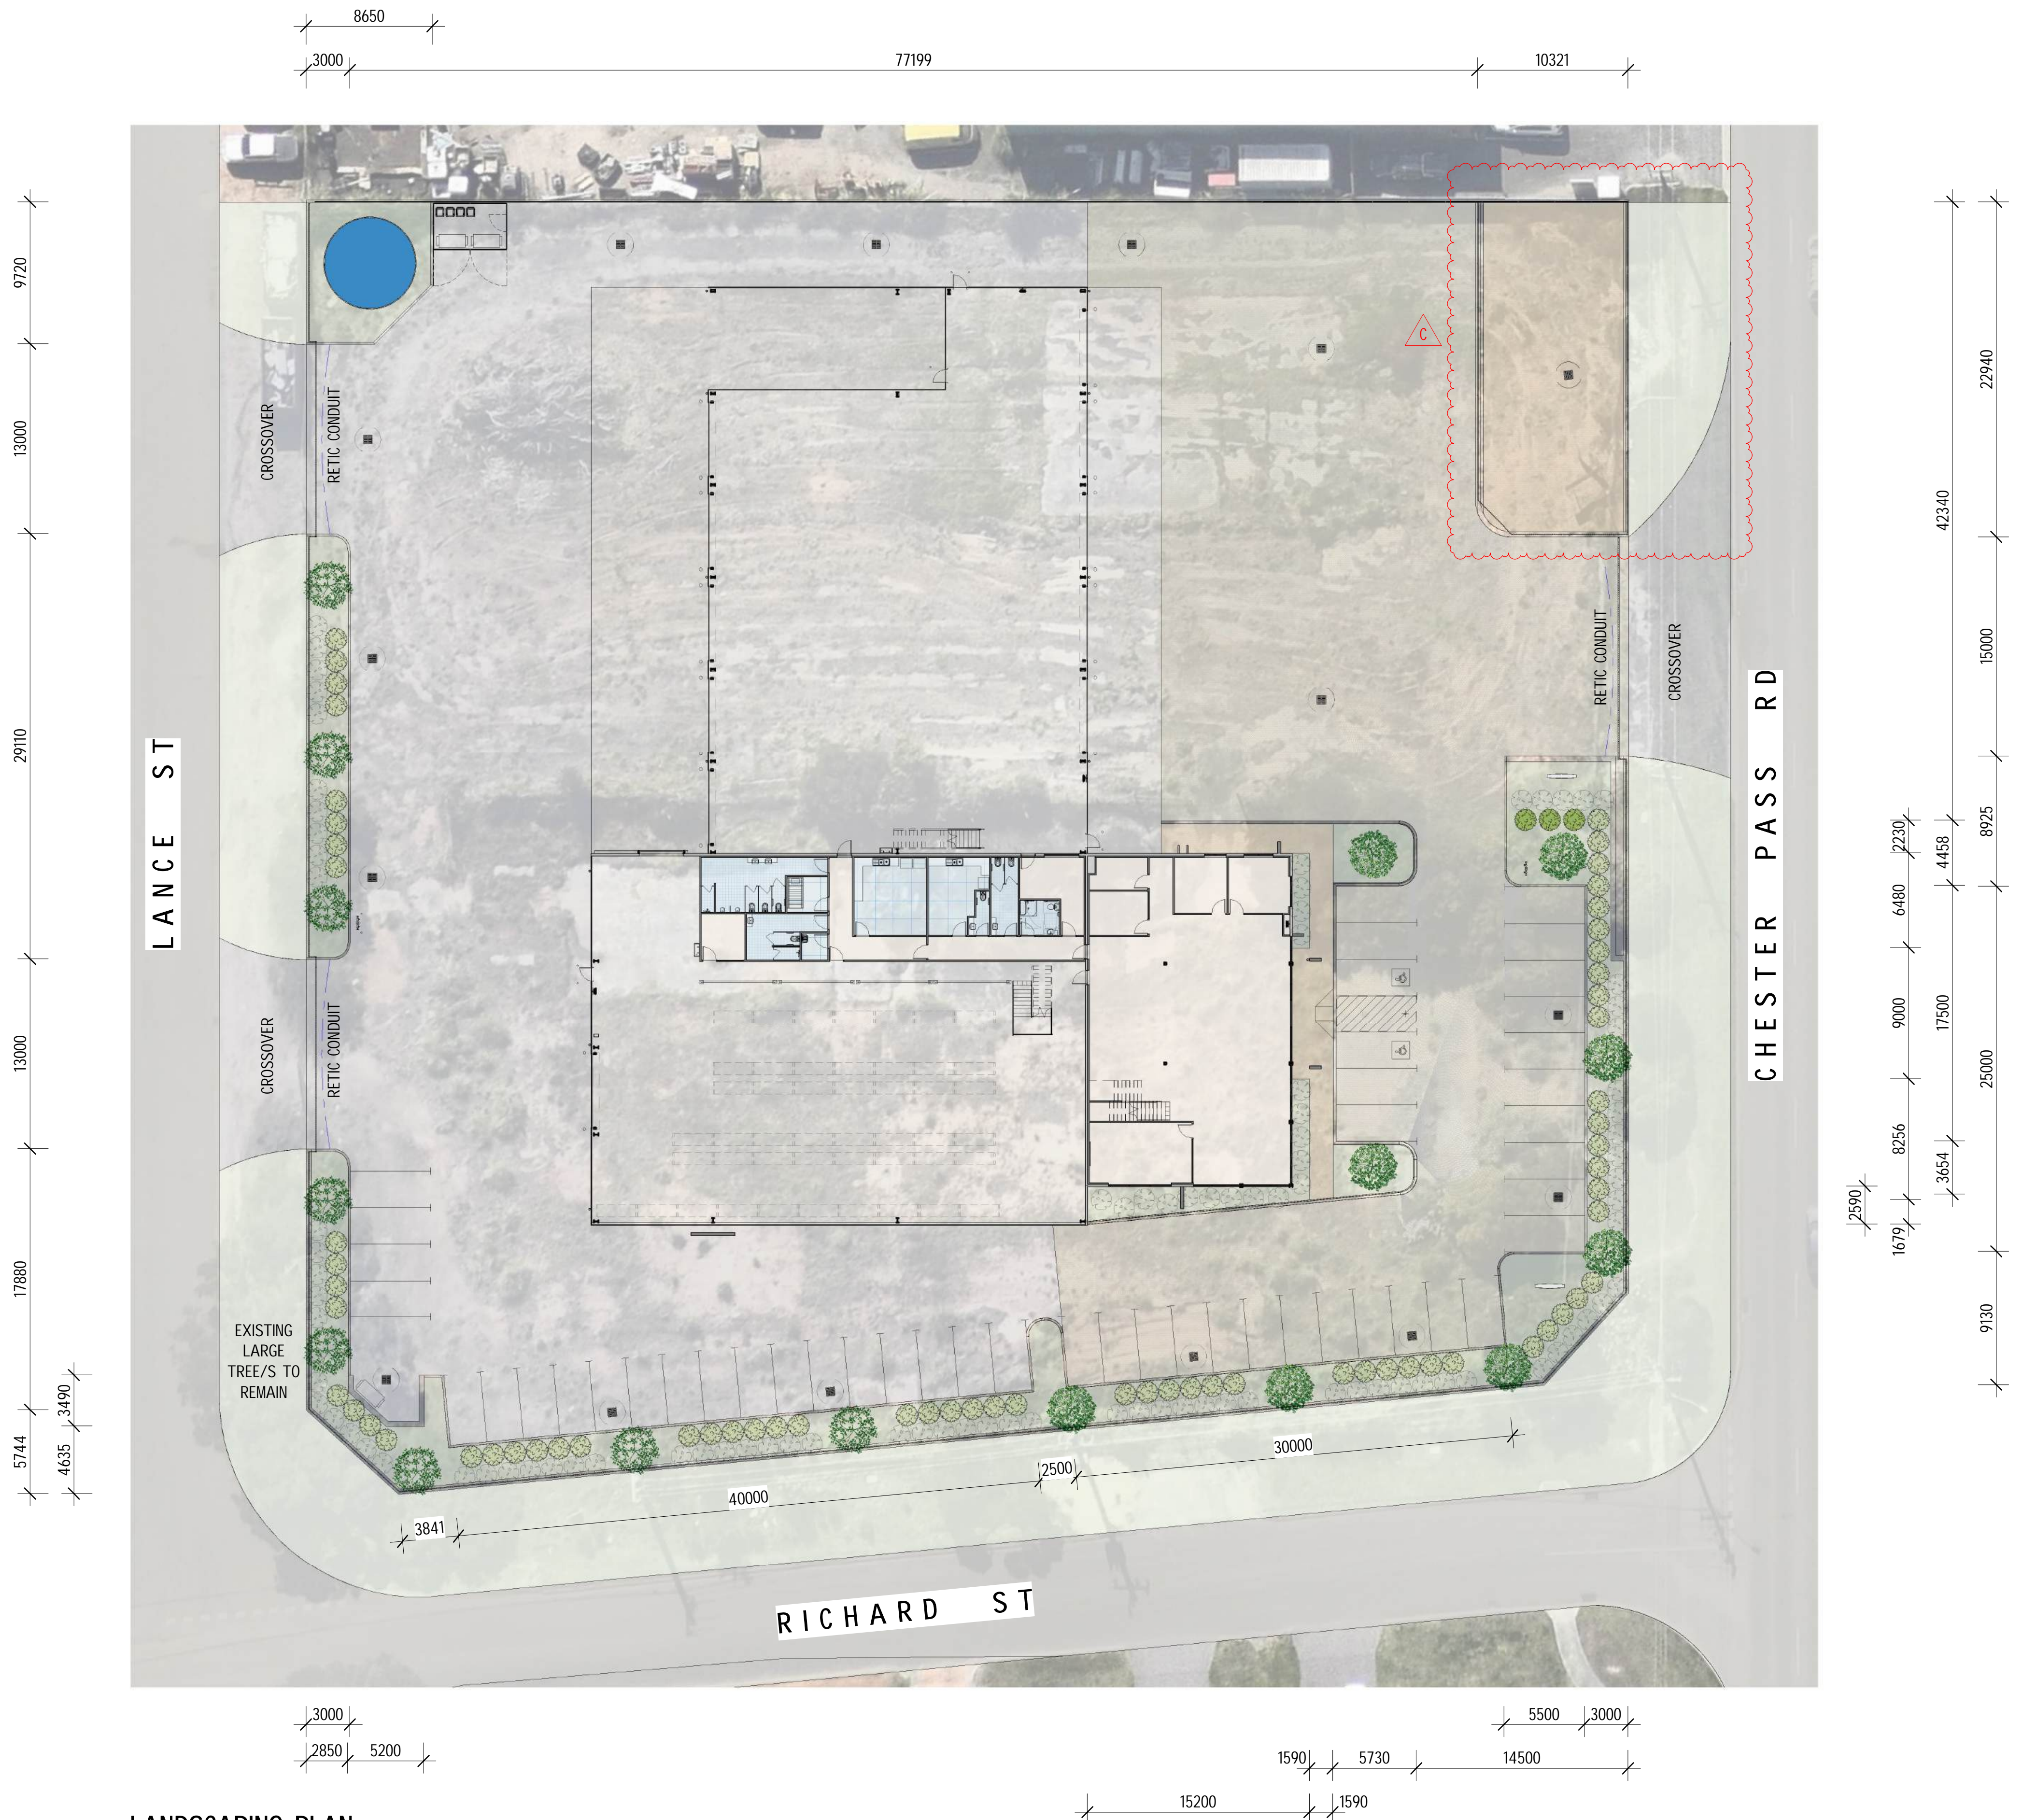
# LANDSCAPING PLAN

ADENANTHOS SERICEUS	WOOLLY BUSH	1 PLANT PER sqm

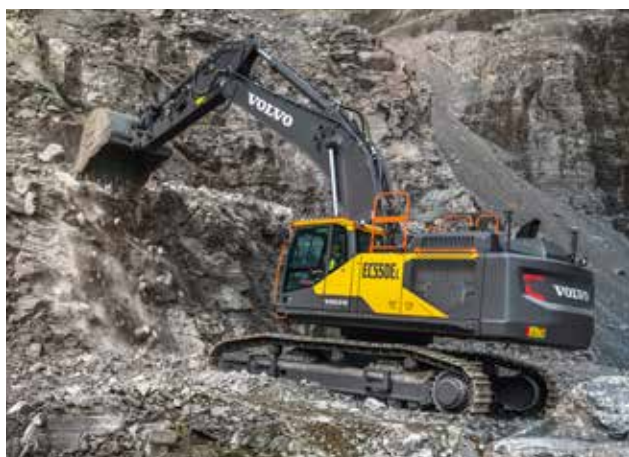
## The undercarriage for the job

The perfect choice for the toughest applications, the robust EC550E undercarriage features a longer and wider lower frame compared to the EC530E, providing enhanced stability when handling heavier loads.

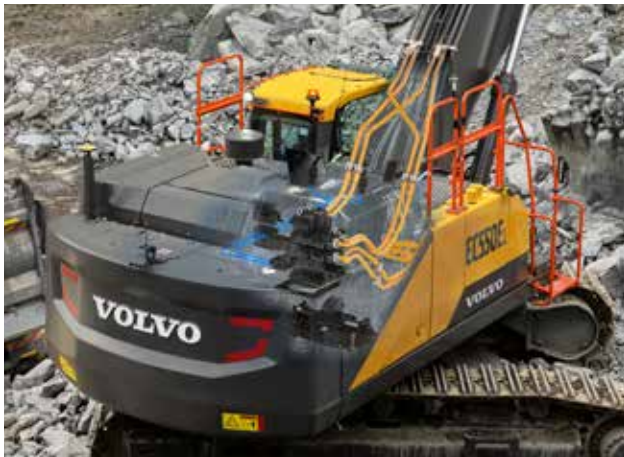
## The right tool for the job

Take on a variety of tasks with our range of factory-delivered attachments, including quick couplers and buckets. Perfectly matched to your machine, Volvo attachments are designed to create a single solid and reliable unit, delivering faster and more fuel-efficient cycle times. What's more, the machine is prepared with the necessary auxiliary piping to power hydraulic attachments such as breakers, thumbs, shears, grapples and more.

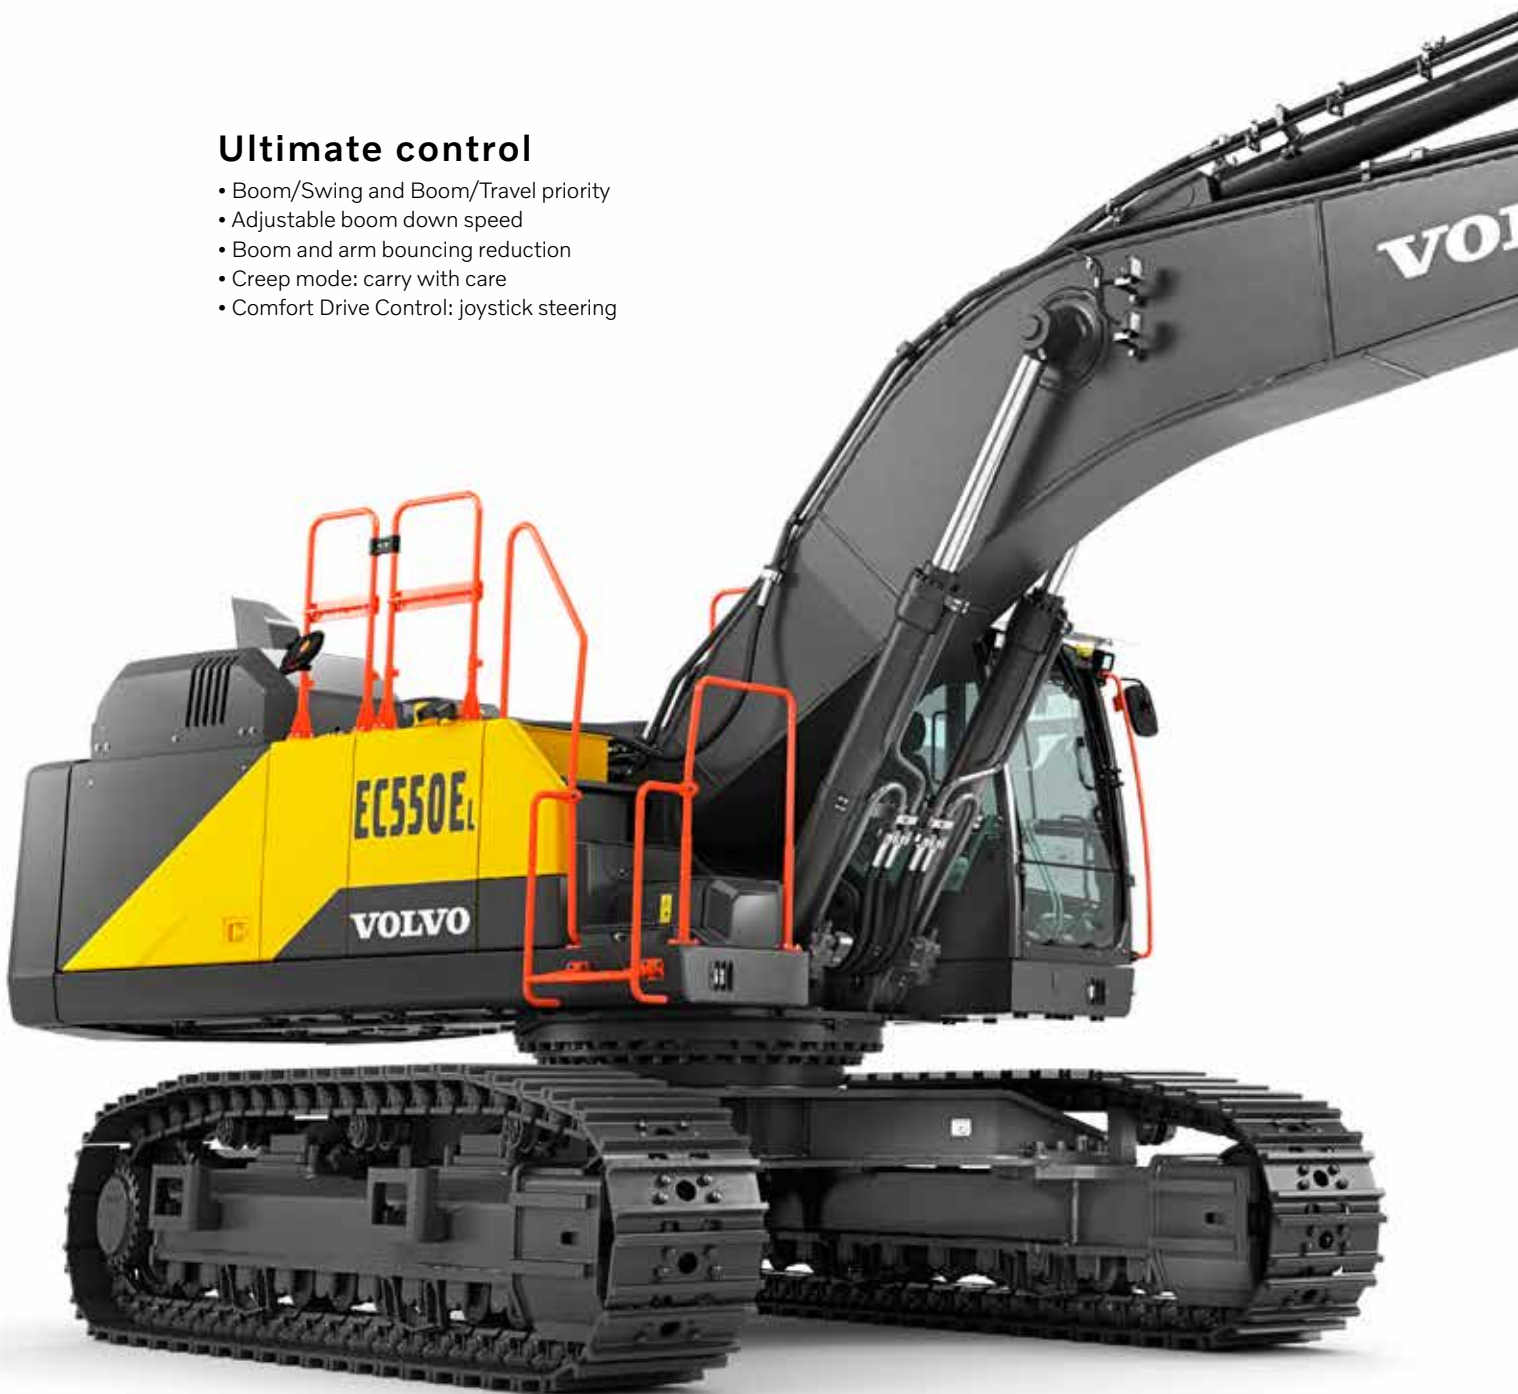
## Ultimate control

- Boom/Swing and Boom/Travel priority
- Adjustable boom down speed
- Boom and arm bouncing reduction
- Creep mode: carry with care
- Comfort Drive Control: joystick steering

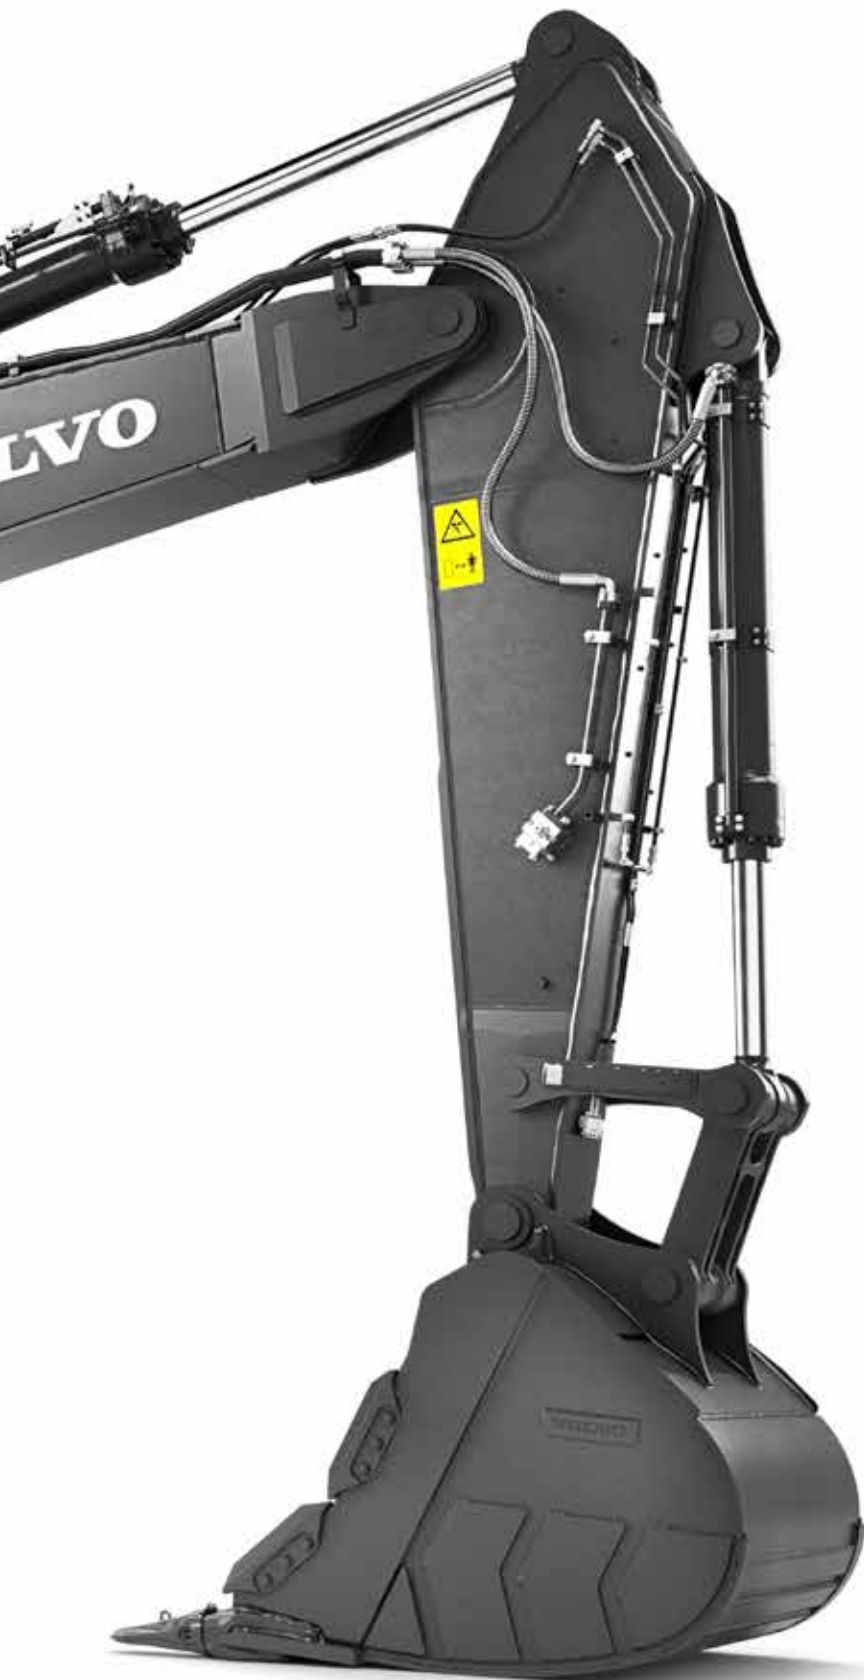
## True 50-tonne performance

- Big buckets, 20% more productivity
- Highest engine power of its class
- Superior swing torque and tractive force
- Digging forces/lifting capacity commonly found in a 60-tonne machine
- Handle heavier loads with the longer/wider EC550E undercarriage
- Perfect match to 30-40t Volvo Articulated Haulers

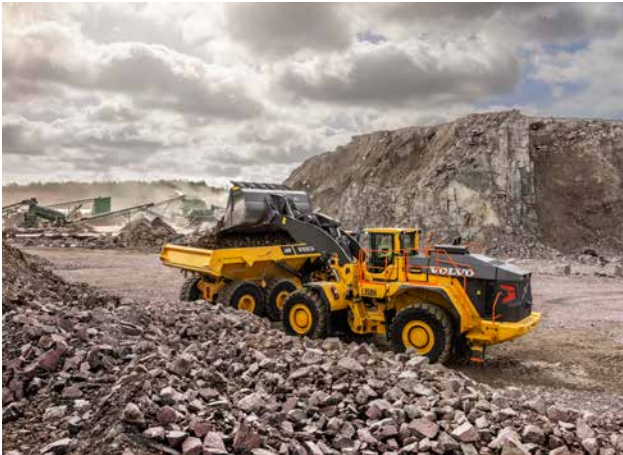
## Rock loader

The L350H is prepared for tire chains and is the perfect match with a 65t truck due to the long boom configuration. With a long floor and optimized radius, the Volvo Rock Bucket makes for easy filling, and a Side Dump variant is available for tunneling applications.

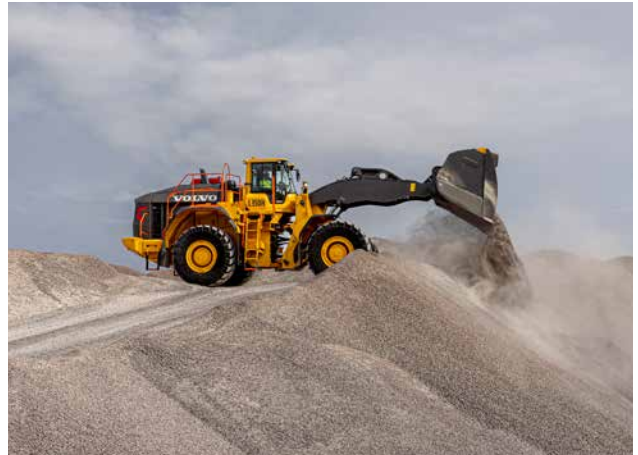
## Rehandler

With an impressive 10.7m<sup>3</sup> capacity, the Volvo Rehandling Bucket is easy to fill and minimizes spillage. Choose the Boom Suspension System, which automatically engages depending on the prevailing gear and speed, to enhance productivity and absorb shocks.

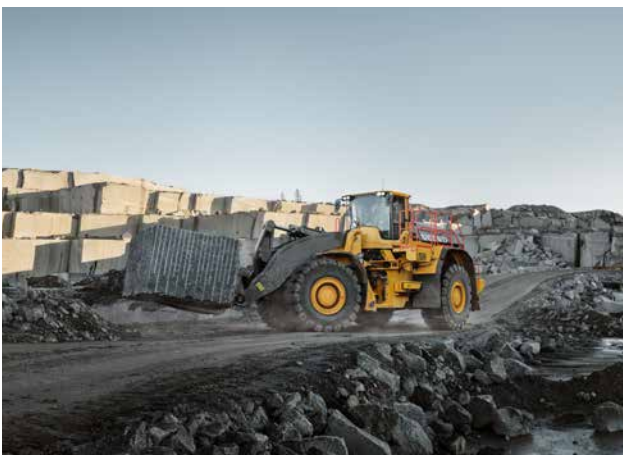
## Block handler

For high lifting force and maximum stability in block handling applications, choose from the standard or heavy-duty kit variants and a range of robust Volvo Attachments, including block forks, breaker tine and clearing rakes. The optional Volvo Engine Brake provides a smoother operation when travelling downhill with heavy marble blocks.

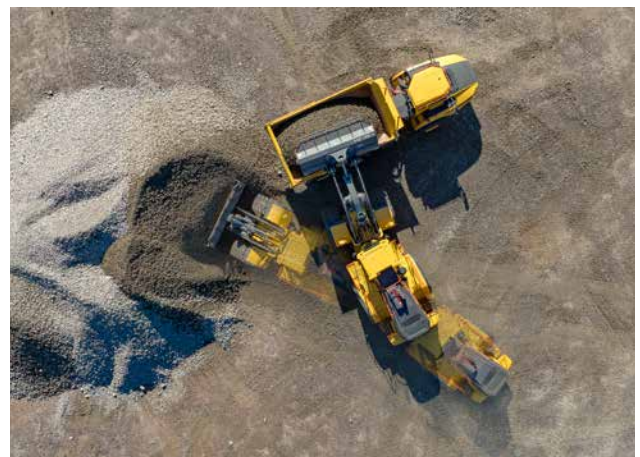
## Faster cycle times

Benefit from faster cycle times and more productivity thanks to the new hydraulic system with increased hydraulic pressure and new lift/tilt cylinders, combined with new driveline.

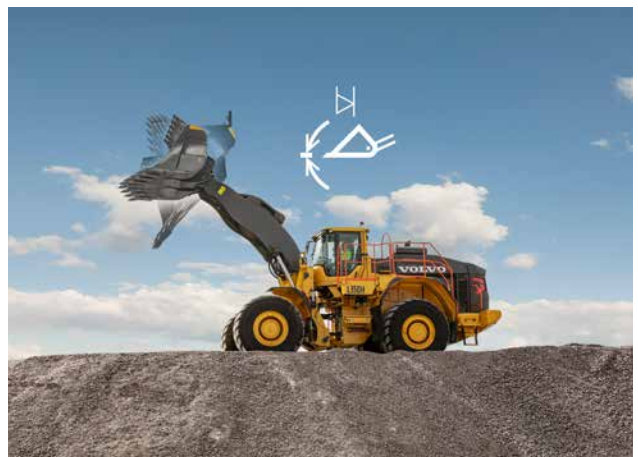
## Bucket leveling function

The bucket leveling function automatically returns the bucket to level, from both dump and curl positions, helping to reduce operator fatigue.

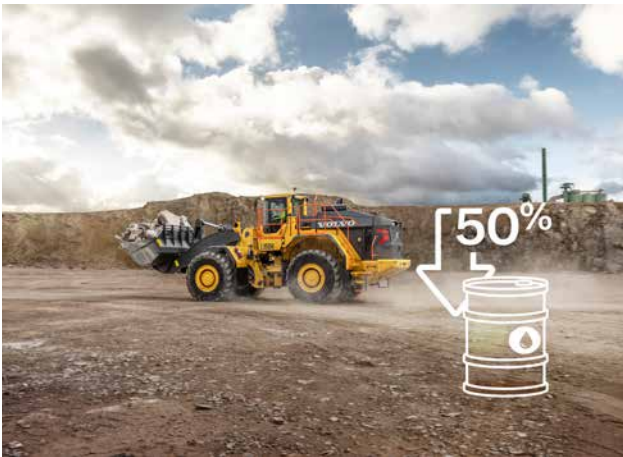
## Extended service intervals

Maintenance is kept to a minimum with a 4 000-hour axle oil change interval – made possible by the external axle oil cooler with filtration. The subsequent 50% reduction in related service time ensures your machine stays on site, working and earning, for longer – while also reducing oil and filters requirements.

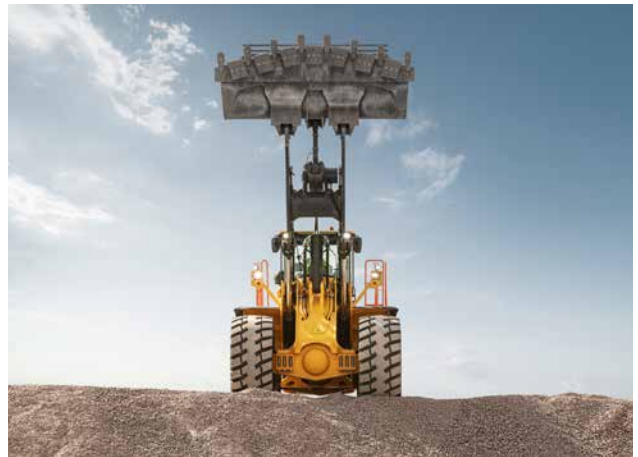
## Built to last

Minimize machine downtime and increase component life with features including heavy-duty axles with fully floating shafts, planetary hub reduction and maintenance-free rear axle trunnion bearings. Breather filters further help to increase component life and the reinforced upper bearing of the center hinge boasts a heavy-duty design to accommodate the new transmission and axles.

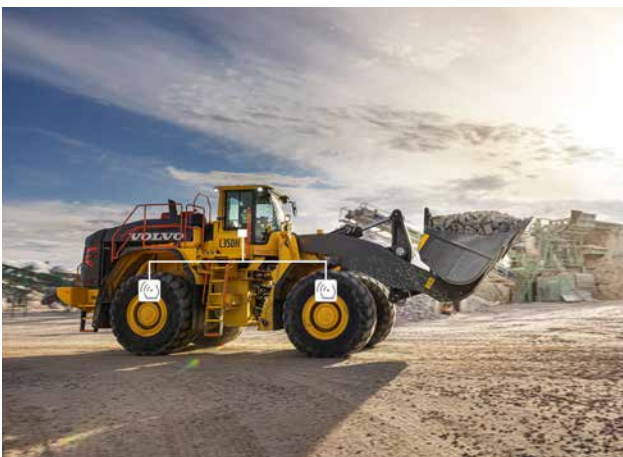
## Tire Pressure Monitoring System

Extend tire life and save fuel with the support of the Tire Pressure Monitoring System, part of the Load Assist suite of apps accessed from the Volvo Co-Pilot display. The system enables the pressure and temperature of tires to be monitored from the comfort of the cab.

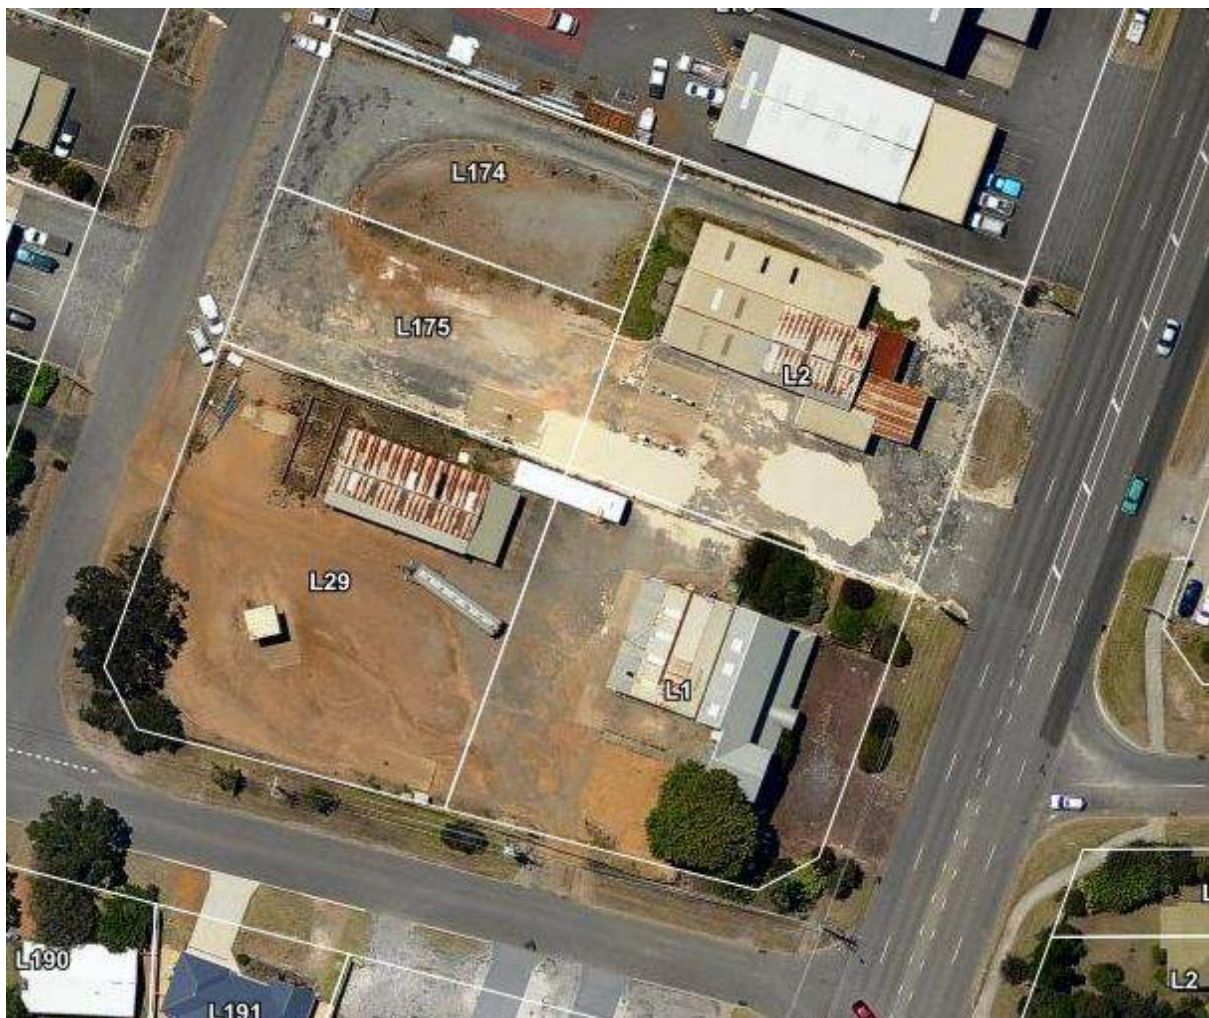
During further discussions between Brooke and Russell, it was noted that aerial imagery from December 2013 (shown below) identifies three existing crossovers from the site to Chester Pass Road: one from Lot 1 and two from Lot 2. These crossovers are also depicted on the Survey Drawing included in the architectural set. We propose upgrading the middle crossover (the southernmost crossover on Lot 2) to meet current City engineering standards and replacing the asphalt with concrete to enhance durability and longevity.

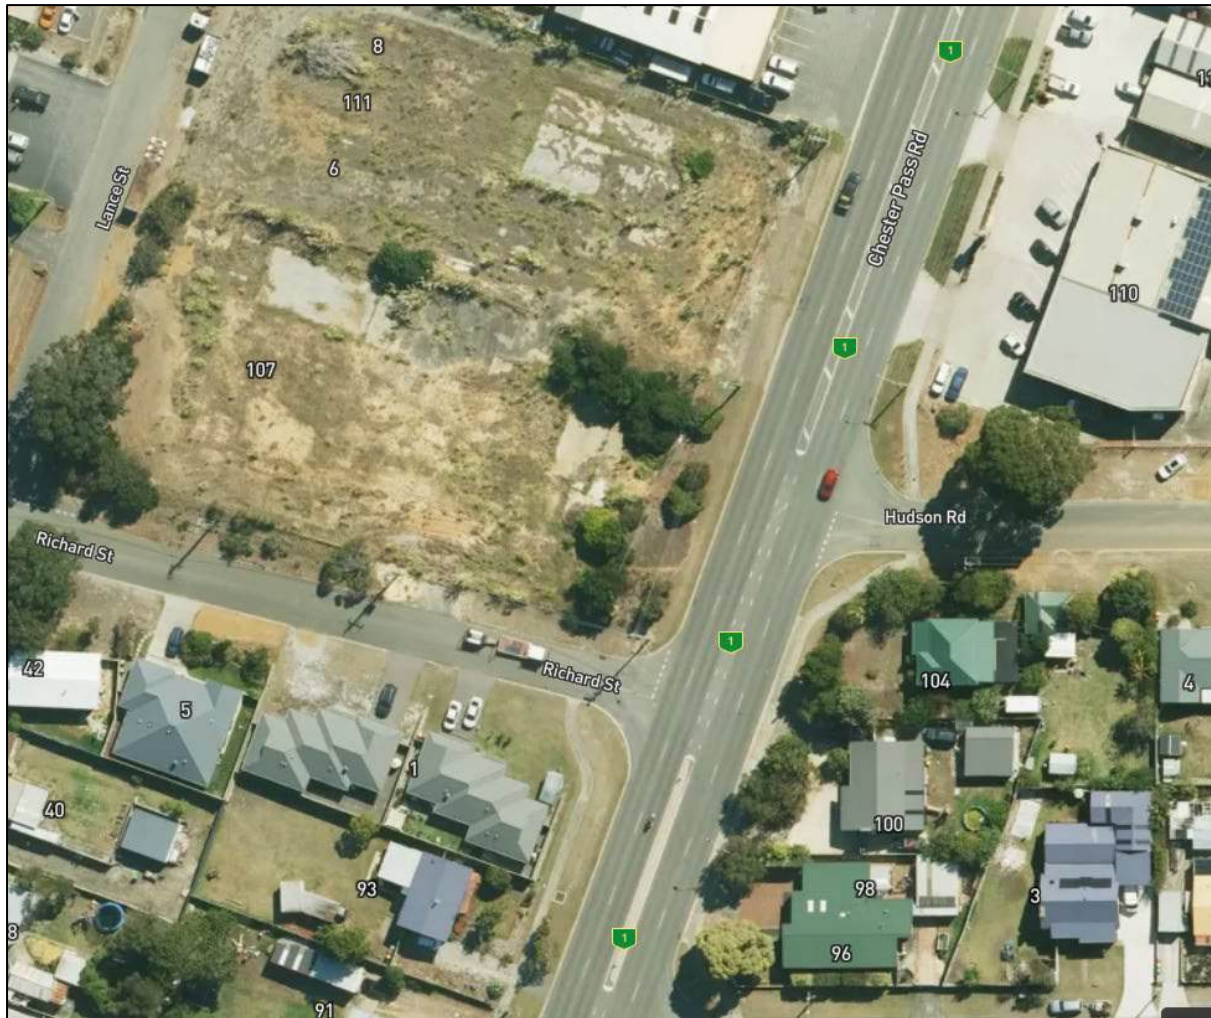
*Figure 11 Existing Pedestrian Paths along Chester Pass Road*

As shown in **Figure 11**, there are pedestrian paths on the eastern side of Chester Pass Road, as well as one the western side, south of Richard Street.

There are no dedicated cycling facilities.

Currently, there is a lack of official pedestrian/cycle network in the area surrounding the Site as shown in **Figure 11**. As a result, connectivity to bus stops and public transportation in general is considered poor. However, there is 1.5m – 2m wide pedestrian path along the eastern side of Chester Pass Road that can be used to access bus stops 72871 and 74306.
