# Development Application

**Proposed Warehouse, Workshop and Office**

Lots 1-2 on Diagram 22830, 29 on Diagram  
23804 and 174-175 on Plan 9216, Chester Pass  
Road, Milpara

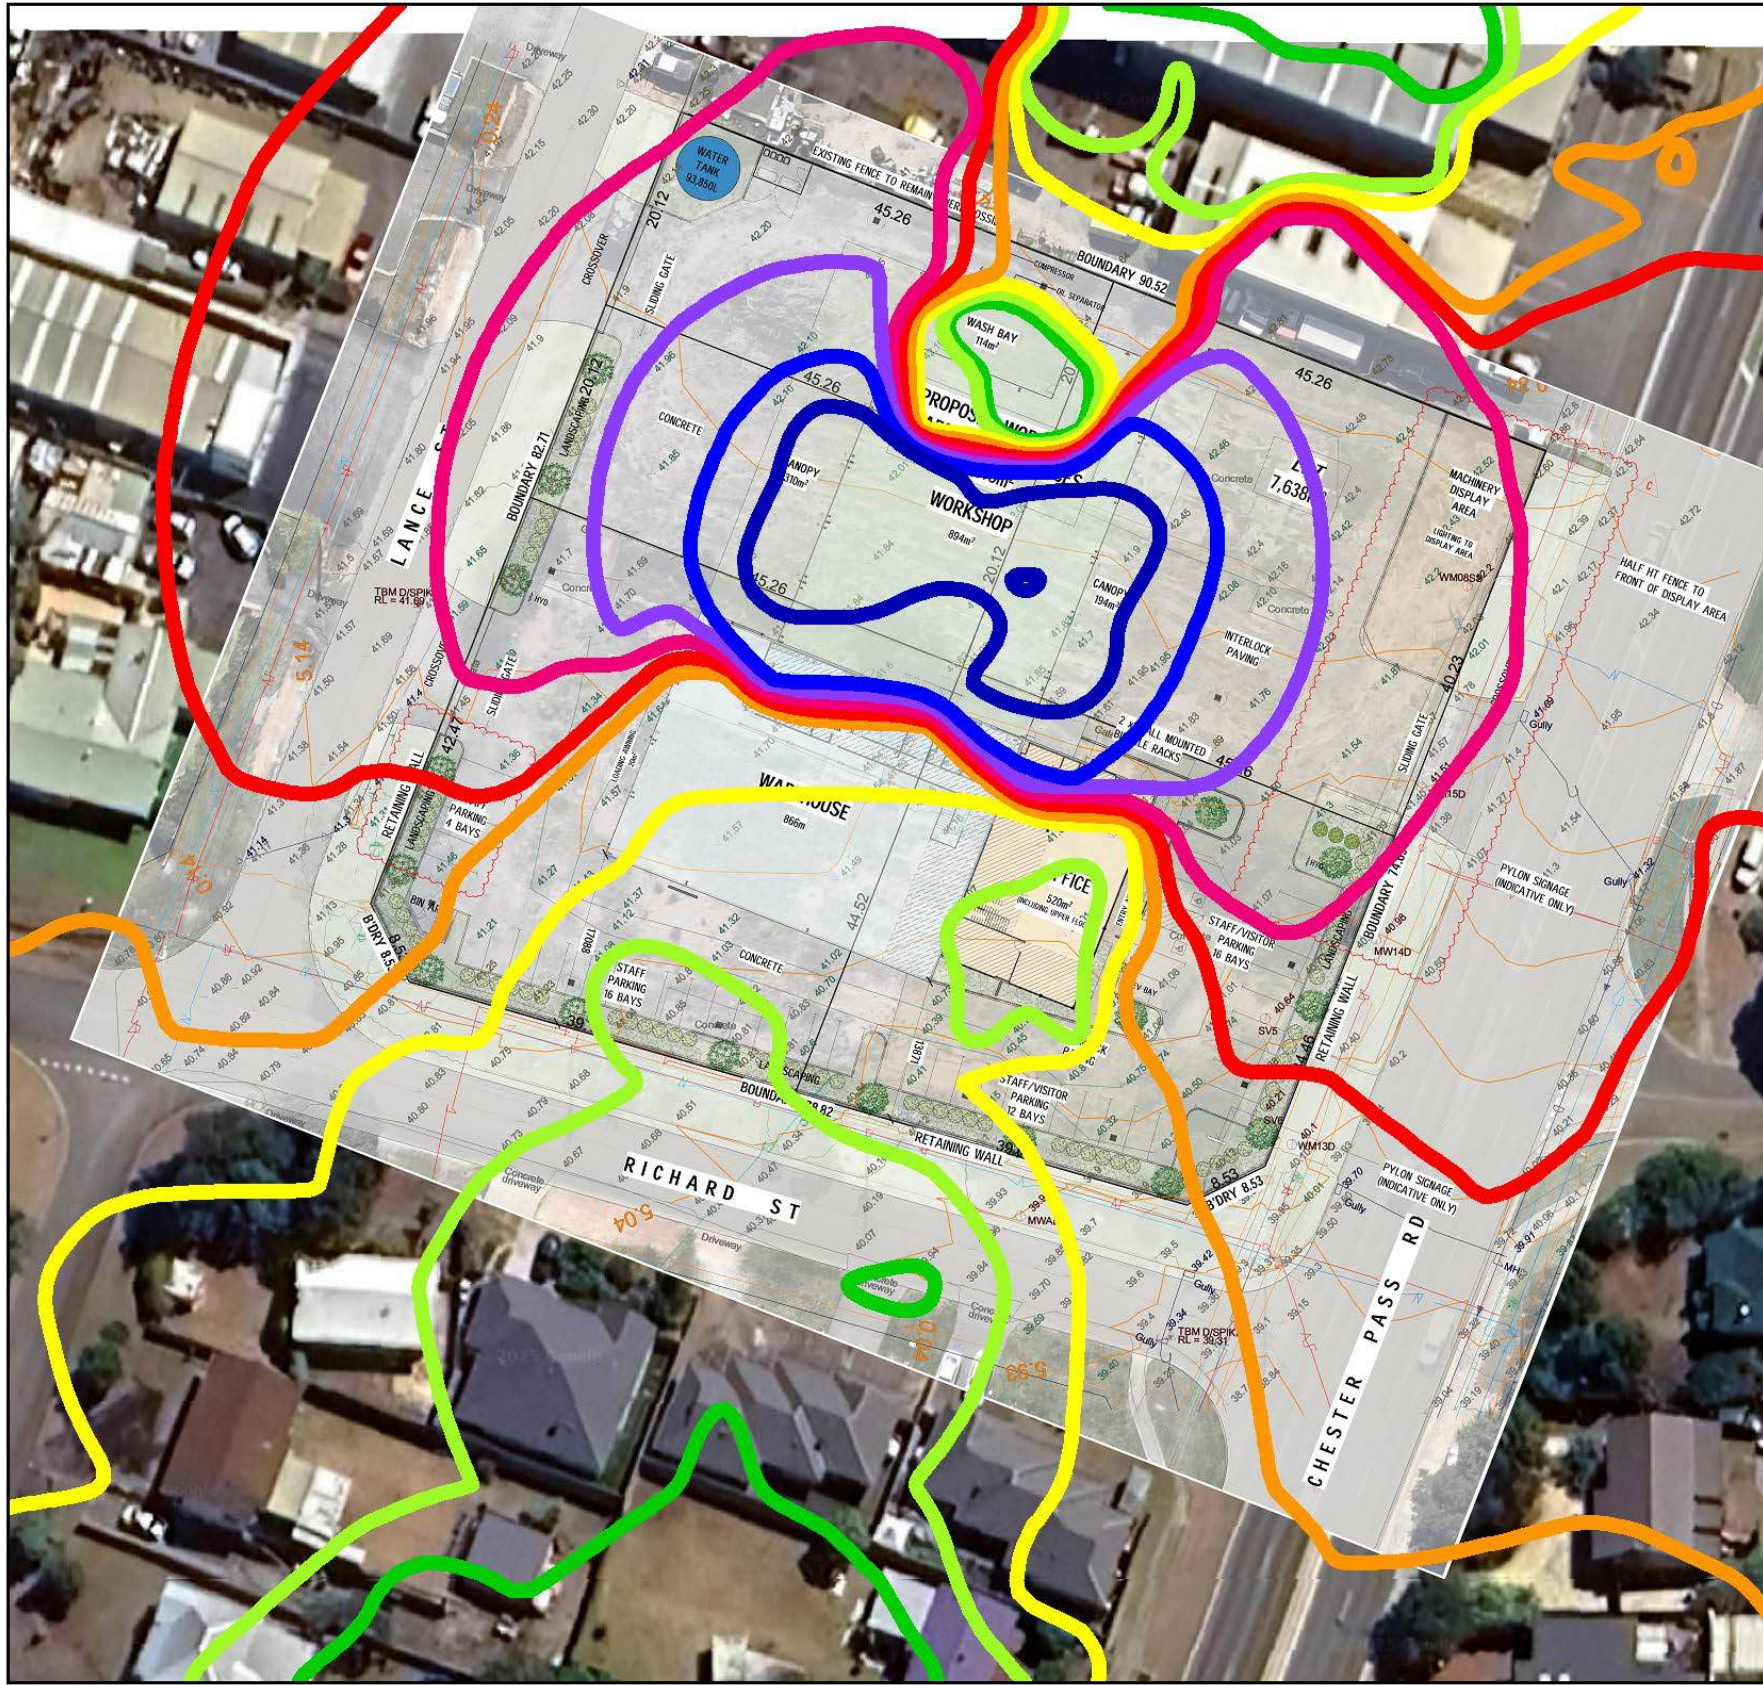
### **NOISE CONTOUR PLOTS**

The report noted that noise emissions associated with the proposed development have been found to be compliant with the relevant Assigned Noise Levels at all times with the exception of the night period. Hence, if the workshop is restricted to the day/evening (and Sunday day/ public holiday) time periods, the proposed development is compliant with the Assigned Noise Levels stipulated by the Environmental Protection (Noise) Regulations 1997.
