LOCAL WATER MANAGEMENT STRATEGY

Lot 124 & 125 South Coast Hwy
Marbelup, WA 6330

01/05/2024

Title: Local Water Management Strategy – Lot 124 & 125 South Coast Hwy, Marbelup WA

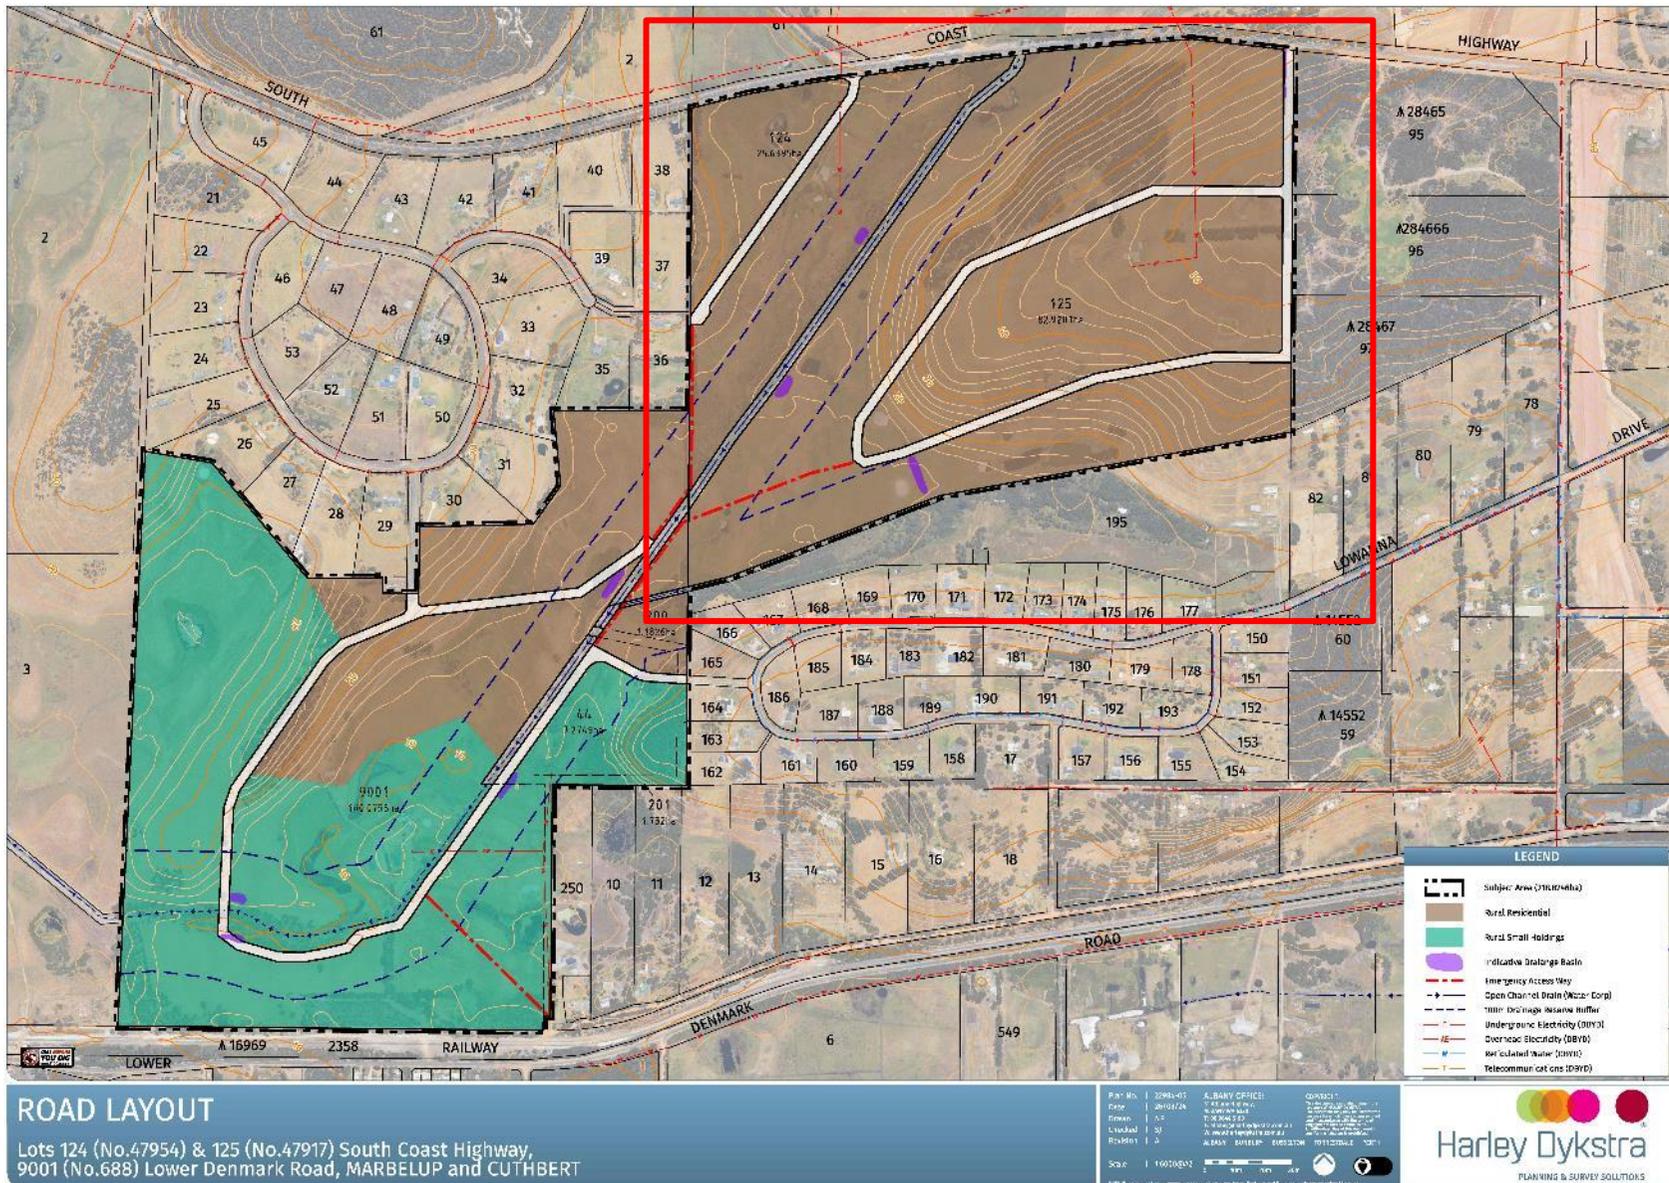
Figure 2: Scheme Amendment Plan. Subject Site is defined by red square.

The Subject Site is zoned as *'General Agriculture'* under the City of Albany's Local Planning Scheme No. 1 (DPLH, 2014). It is proposed the Subject Site be rezoned to *'Rural Residential'* and *'Rural smallholdings'*, and forms part of a larger plan area that includes Lot 9001 Lower Denmark Road to the southwest of the Subject Site. The Scheme Amendment plan for the site is shown in Figure 2.

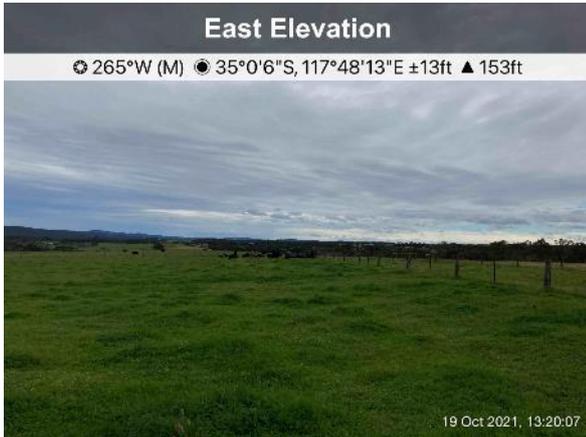
Photo 1: East elevation of agricultural land within the Subject Site.

The site currently consists of agricultural land used for mixed cropping and livestock (Photo 1 and 2). There are two residential dwellings on the Subject Site, one to the west of Five Mile Creek, on Lot 124 (Photo 3 and 4) and one to the east on Lot 125. The land immediately south and west of the Subject Site is currently utilised for rural residential living.

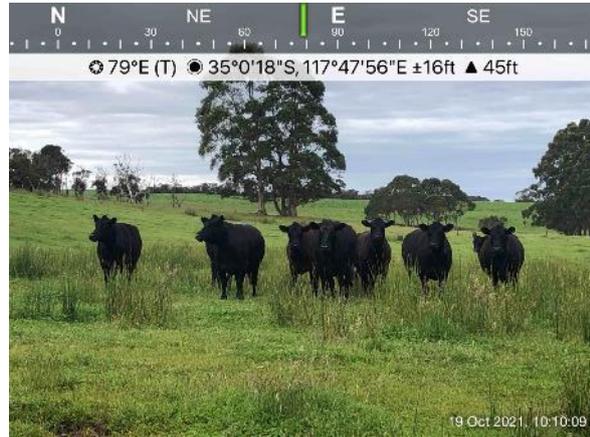
Photo 2: View to the east of cattle within the Subject Site.

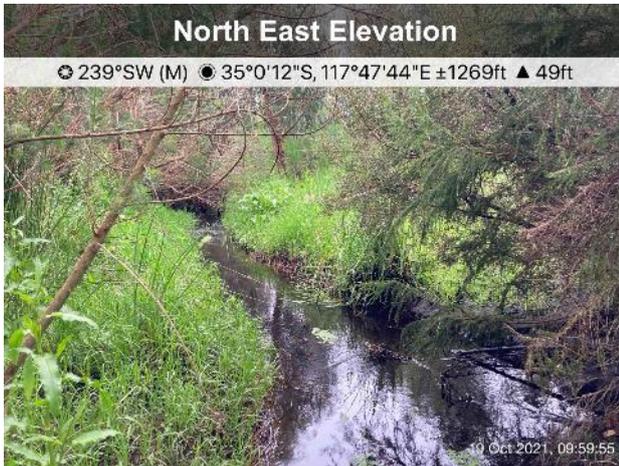
Photo 5: A northeast elevation of Five Mile Creek, centrally located within the Subject Site. This is a general view of Five Mile creek within the Subject Site.

A site investigation of the hydrological features of the site was conducted on the 19th of October 2021 to confirm the surface water hydrology and to assist the development of the stormwater management plan. Rainfall in the Albany area (BoM Station No. 009500) prior to the site investigation, was significantly higher than for the same time in an average year. The increased rainfall resulted in increased surface water expressions in the area compared to an average late winter period providing an adequate depiction of the ‘worst case scenario’ in terms of seasonal inundation. Photographs 5 to 8 show the hydrological features of the site during the site investigation.

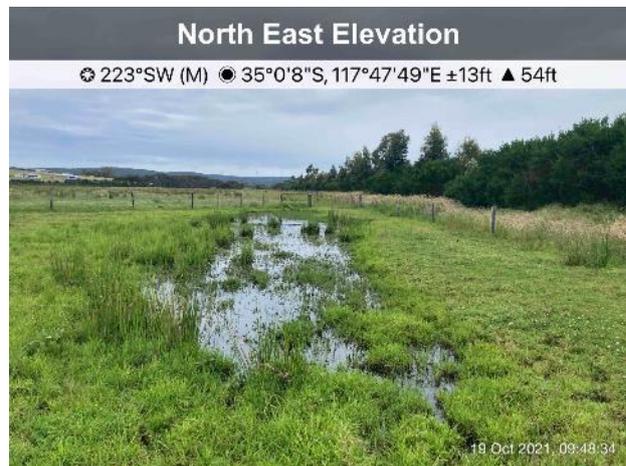
Photo 6: A northeast elevation of a seasonally inundated area adjacent to Five Mile Creek.

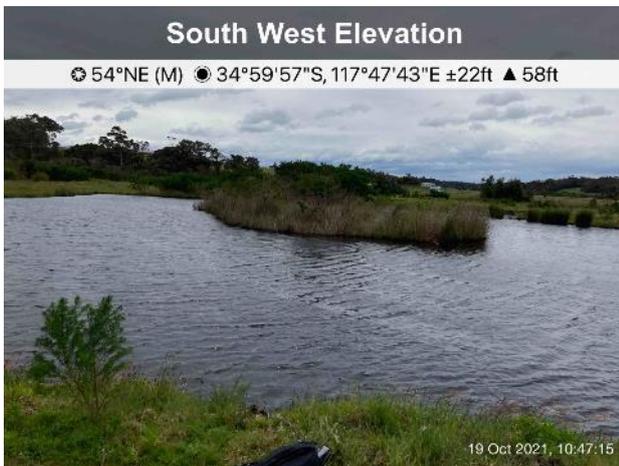
Photo 7: A southwest elevation of a farm dam in the northwest of the Subject Site.

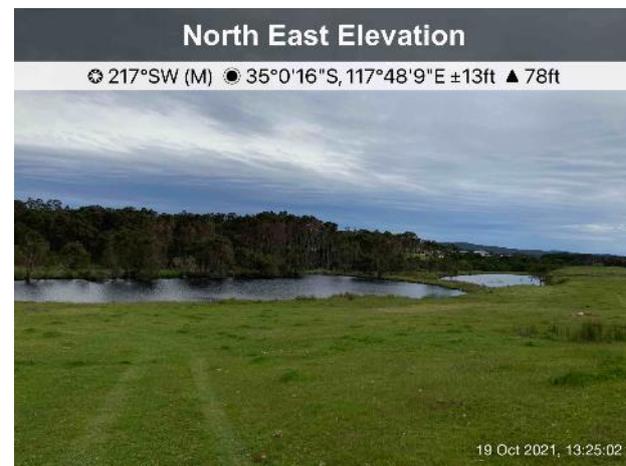
Photo 8: A northeast elevation of farm dams along the southern boundary of the Subject Site.

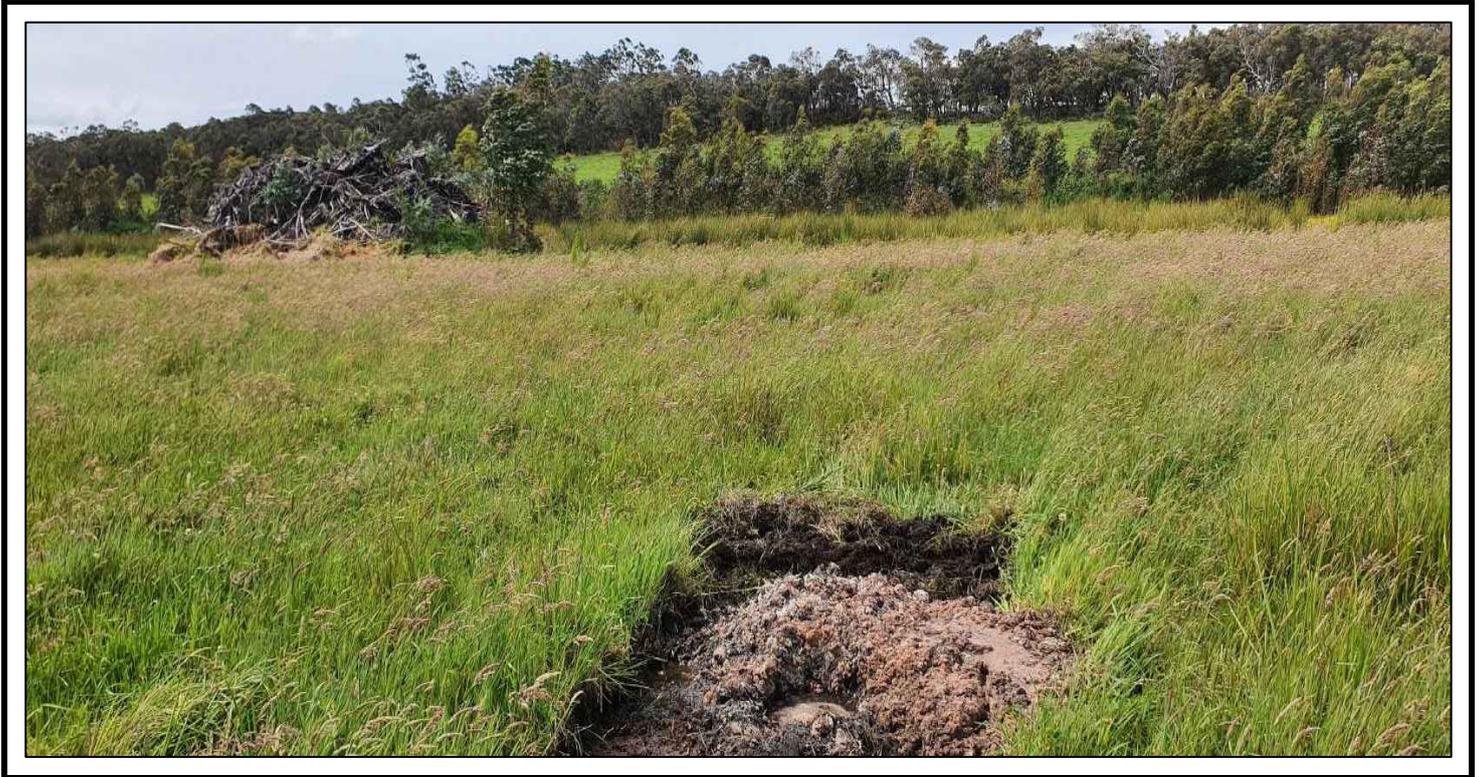
Test Pit No.1

Depth Below Surface (mm)	Layer Depth (mm)	Material Description SOIL TYPE, Plasticity, Colour, Particle characteristics, Secondary and other minor components	Moist. Condition	Consistency / Strength	Cementation	Water Table	Classification Symbol	Sample/Test
0 - 400	400	(Topsoil) SAND with silt: Grey/brown, fine to medium. Contains roots and root fibres.	W	L-M		Water table encountered @ ground level.		
400 - 1500	1100	SAND with silt: Grey to light grey, fine to medium.	W	L-MD				
1500 - 2000	500	SAND with silt: Light brown, fine to medium.	W	L-MD

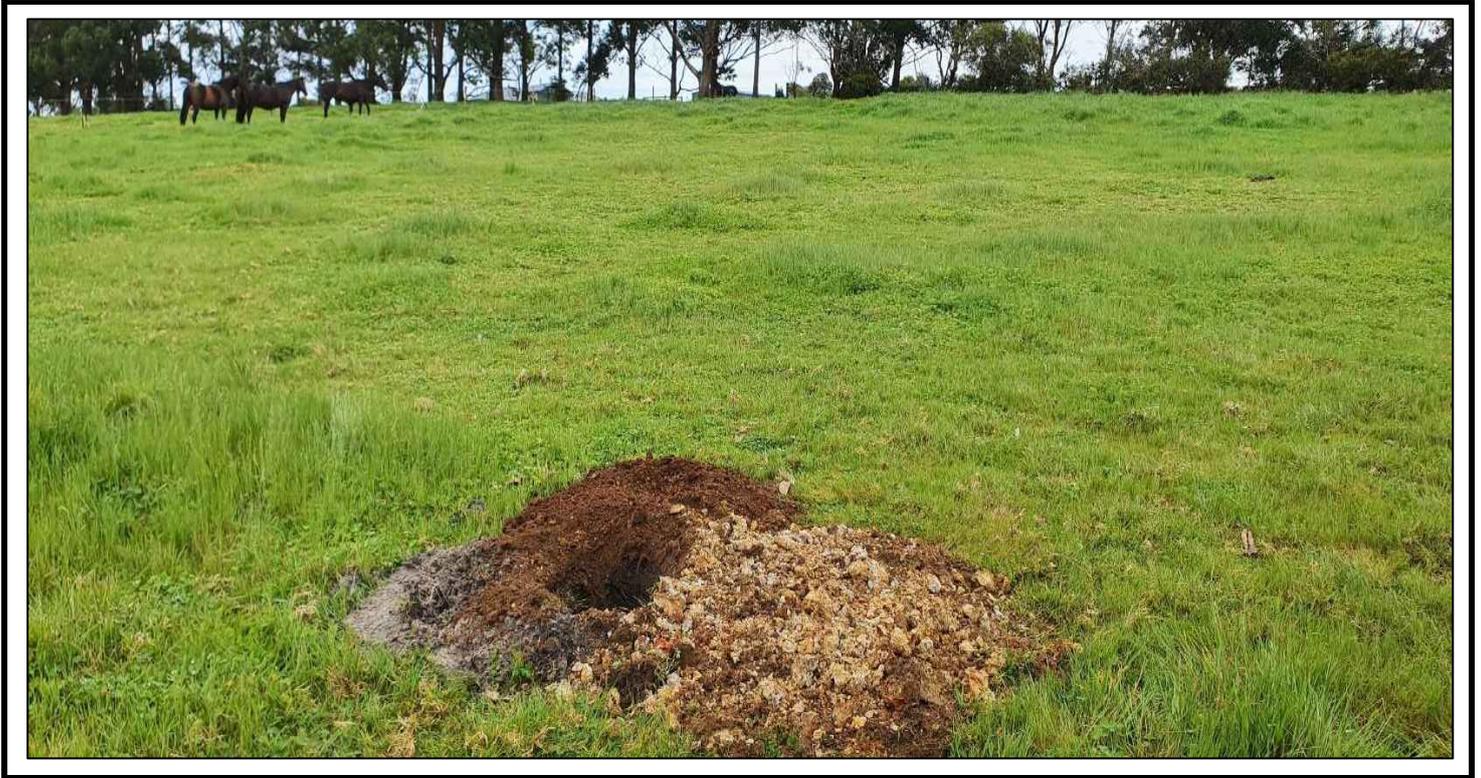
Test Pit No.3

Depth Below Surface (mm)	Layer Depth (mm)	Material Description SOIL TYPE, Plasticity, Colour, Particle characteristics, Secondary and other minor components	Moist. Condition	Consistency / Strength	Cementation	Water Table	Classification Symbol	Sample/Test
0 - 120	120	(Topsoil) SAND with silt: Dark grey, fine to medium. Contains roots and root fibres.	W	L-MD		Water table encountered @ 1020mm below existing ground level.		
120 - 500	380	SAND with silt: Grey to light grey, fine to medium.	M	L-MD				
500 - 1200	700	Sandy GRAVEL: Dark/light brown, fine to coarse, sub-rounded to sub-angular. Fine to medium grained sand. (*Refer to comments)	M	D-VD				
1200 - 2000	800	SANDY CLAY: Low to medium plasticity, light brown/grey with red and orange mottle. Fine to medium grained sand.	M	F-St

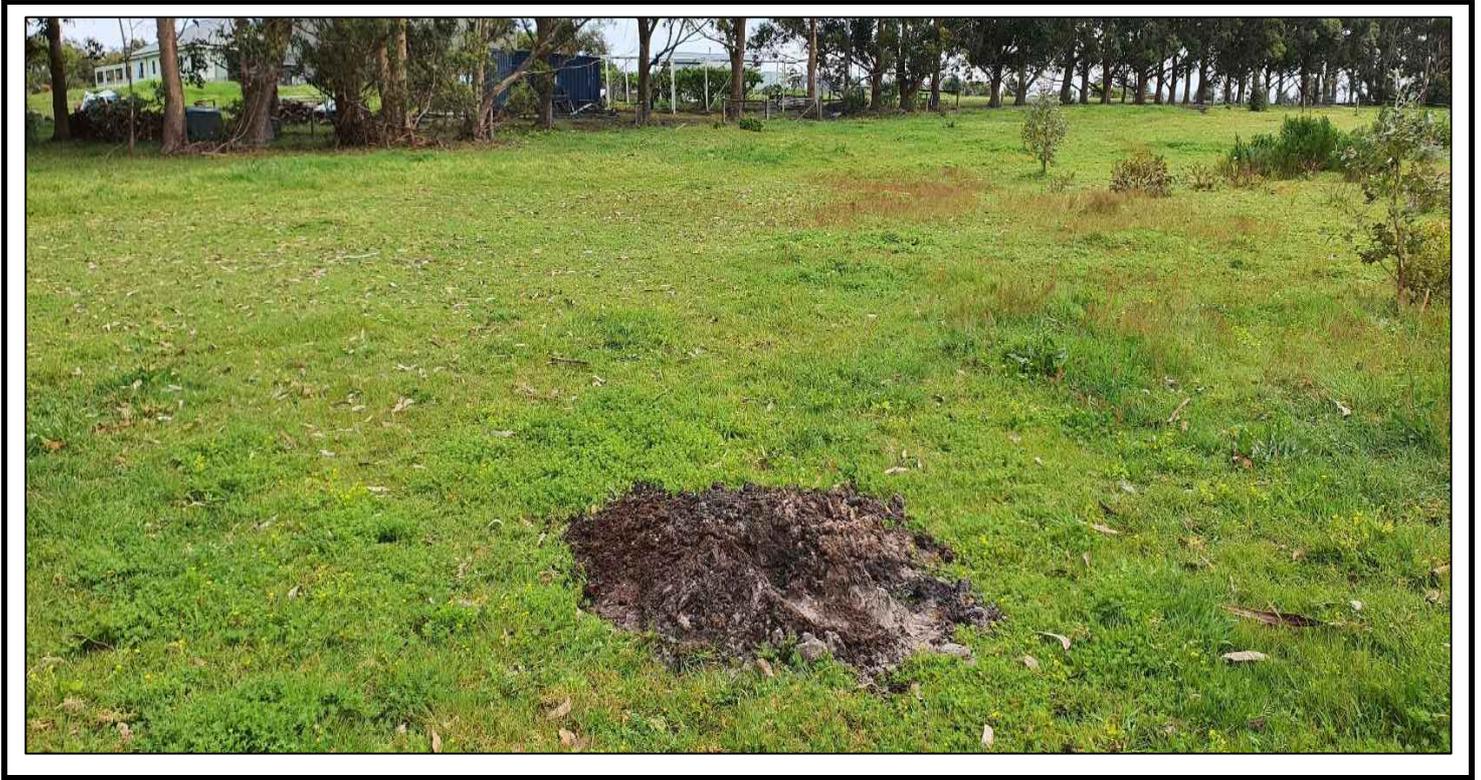
Test Pit No.4

Depth Below Surface (mm)	Layer Depth (mm)	Material Description SOIL TYPE, Plasticity, Colour, Particle characteristics, Secondary and other minor components	Moist. Condition	Consistency / Strength	Cementation	Water Table	Classification Symbol	Sample/Test
0 - 160	160	(Topsoil) SAND with silt: Dark grey, fine to medium. Contains roots and root fibres.	W	L-MD		Water table encountered @ 350mm below existing ground level.		
160 - 1050	890	SAND with silt: Grey to light grey, fine to medium.	M	W				
1050 - 1680	630	Sandy GRAVEL: Dark/light brown, fine to coarse, sub-rounded to sub-angular. Fine to medium grained sand.	M	MD	PC			
1680 - 2000	320	SAND: Light brown/grey, fine to medium.	W	L-MD

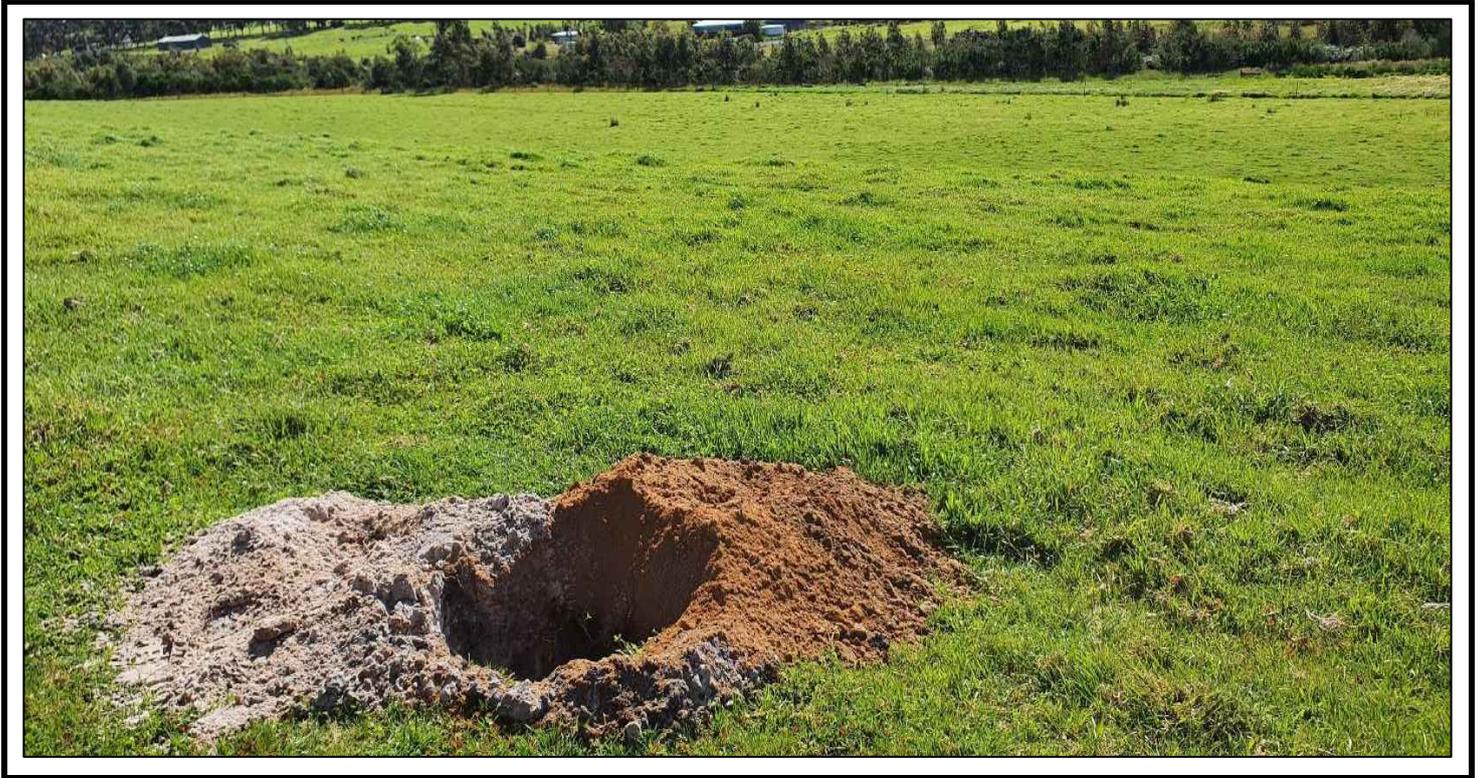
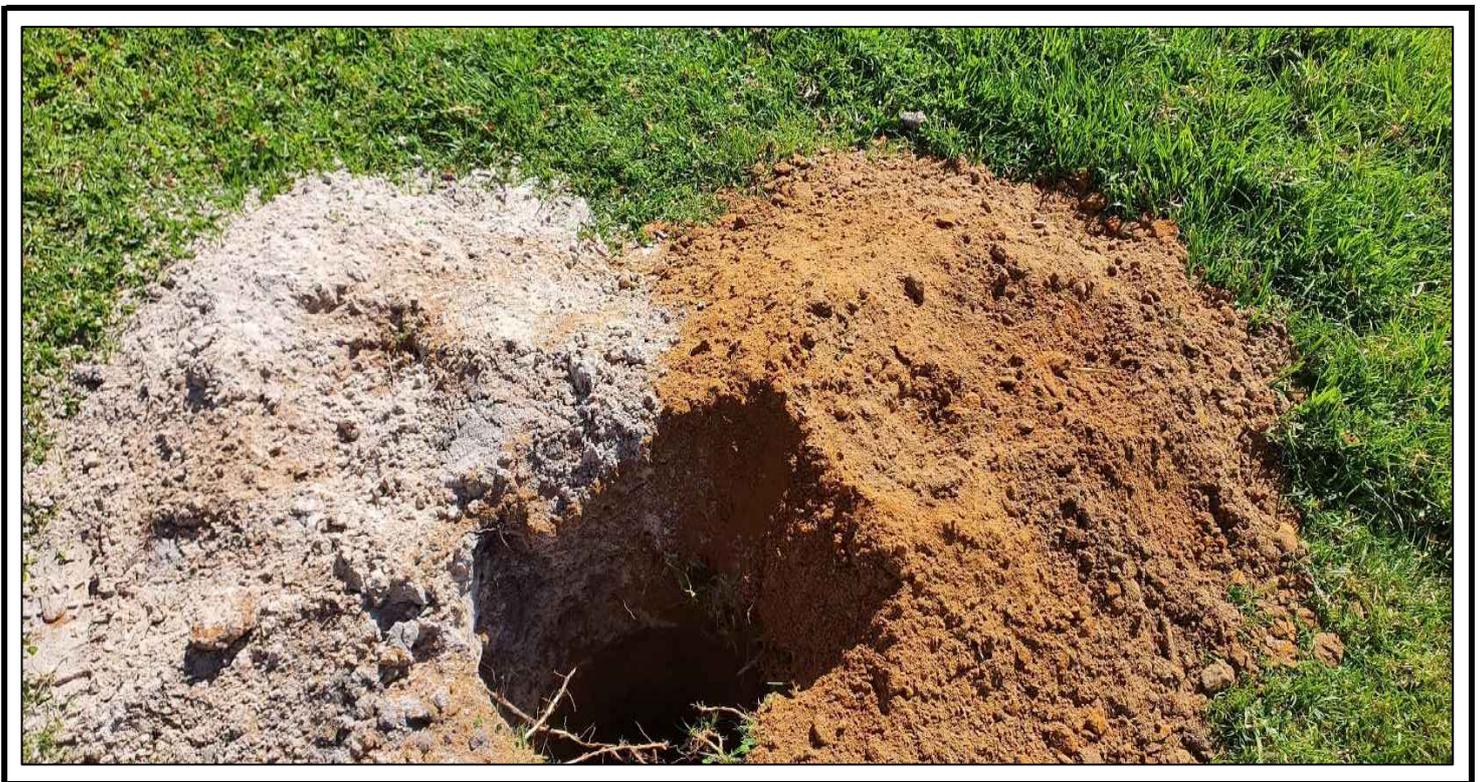
Test Pit No.17

Depth Below Surface (mm)	Layer Depth (mm)	Material Description SOIL TYPE, Plasticity, Colour, Particle characteristics, Secondary and other minor components	Moist. Condition	Consistency / Strength	Cementation	Water Table	Classification Symbol	Sample/Test	
0 - 130	130	(Topsoil) SAND with silt: Grey, fine to medium.	M	L-MD		No water table encountered.			
130 - 920	790	Sandy GRAVEL: Light brown, fine to coarse, sub-rounded to sub-angular. Fine to medium grained sand.	M	D	MC				
920 - 2000	1080	Silty sandy CLAY: Low to medium plasticity, light brown with grey mottle. Fine to medium grained sand.	M	F

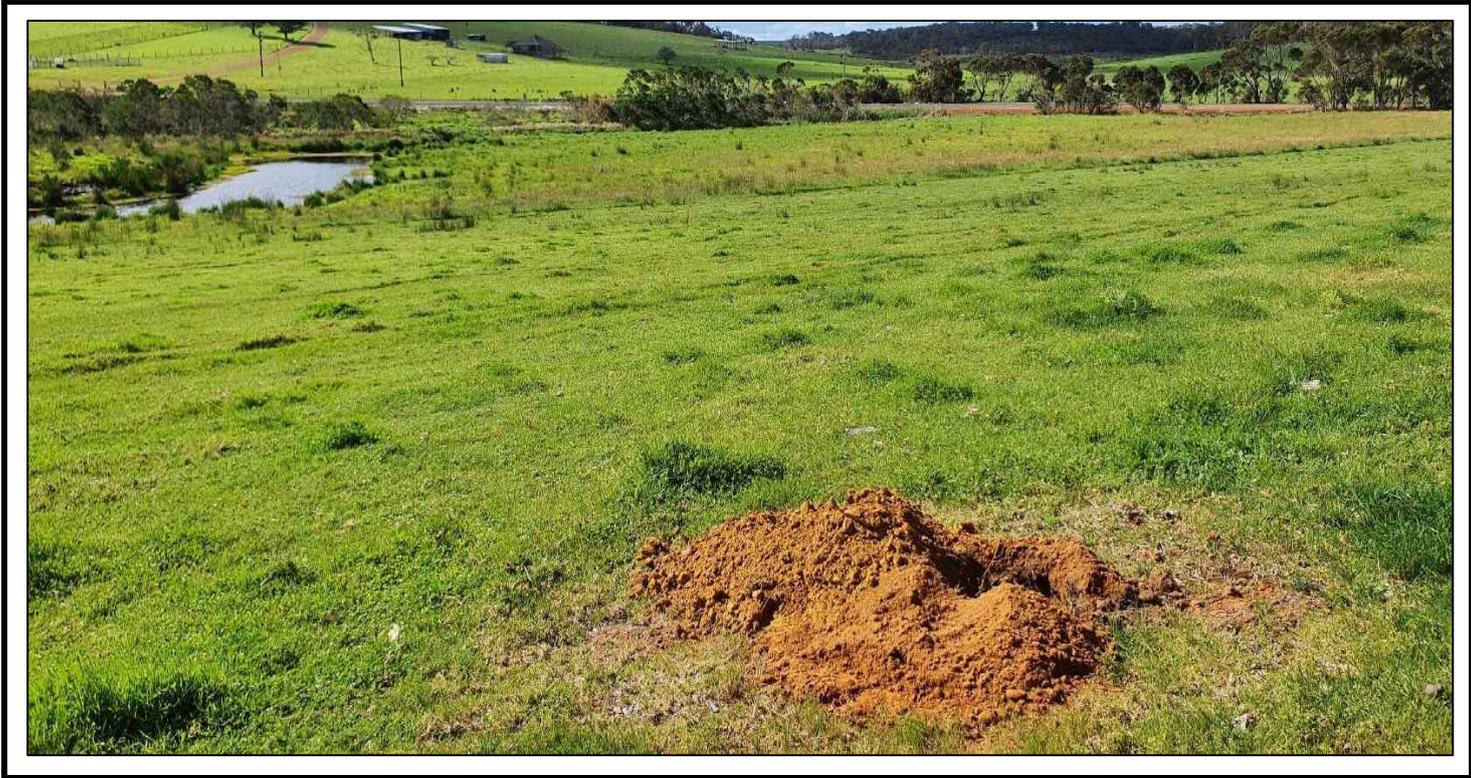
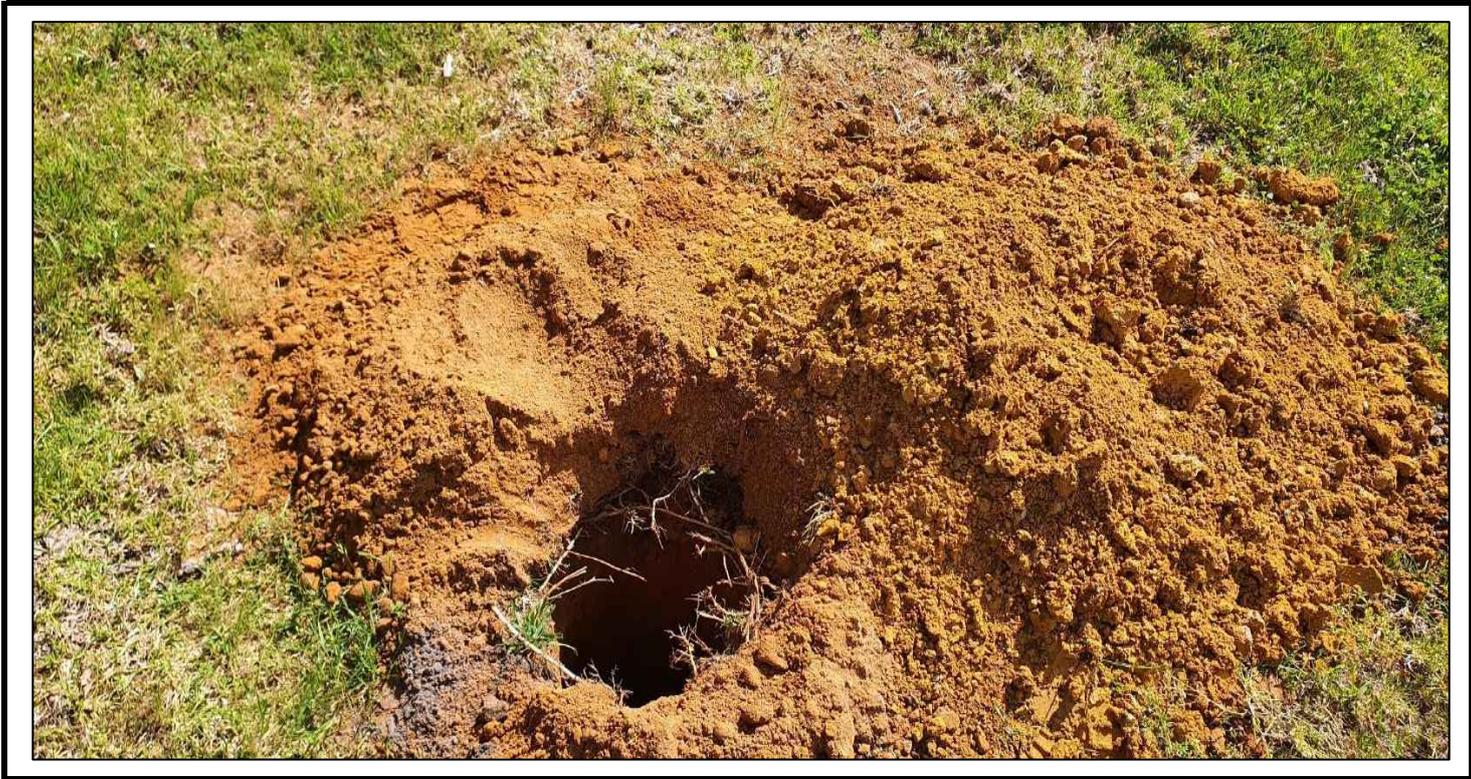
Test Pit No.18

Depth Below Surface (mm)	Layer Depth (mm)	Material Description SOIL TYPE, Plasticity, Colour, Particle characteristics, Secondary and other minor components	Moist. Condition	Consistency / Strength	Cementation	Water Table	Classification Symbol	Sample/Test
0 - 250	250	(Topsoil) SAND with silt: Grey, fine to medium.	M	L-MD		No water table encountered.		
250 - 740	490	Sandy GRAVEL: Brown, fine to coarse, sub-rounded to sub-angular. Fine to medium grained sand. (*Refer to comments)	M	MD-D				
740 - 2000	1260	Silty sandy CLAY: Low to medium plasticity, light brown with red and white mottle. Fine to medium grained sand.	M	F

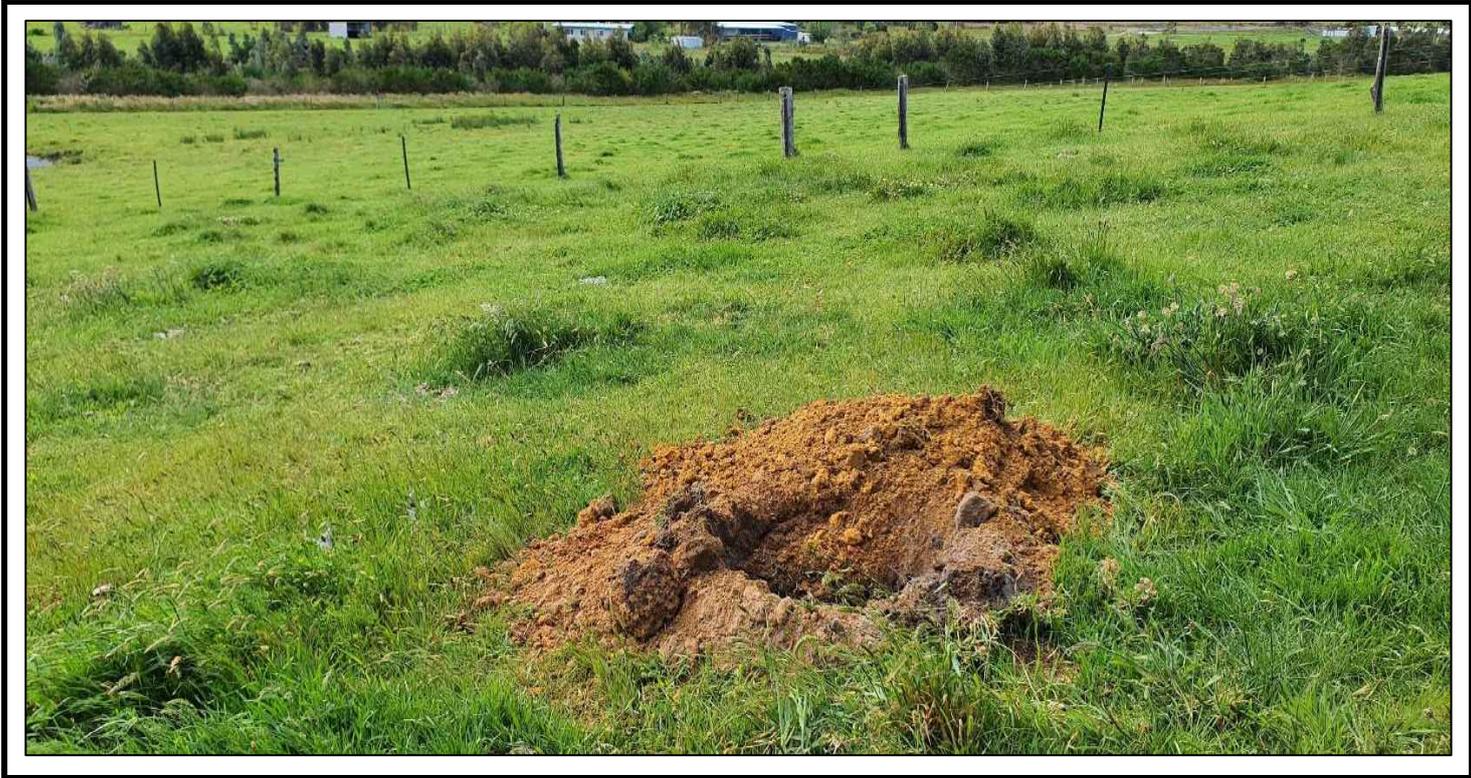
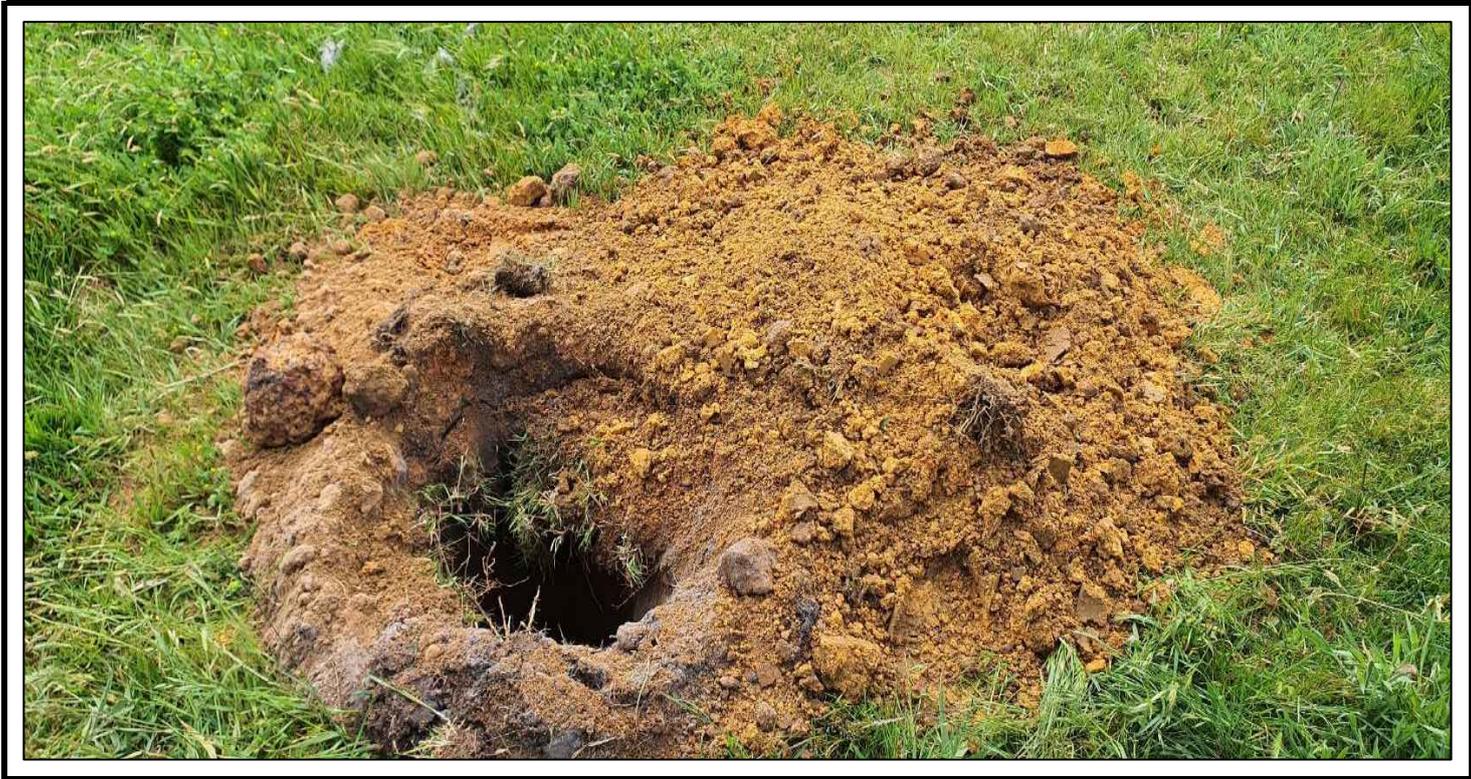
Test Pit No.19

Depth Below Surface (mm)	Layer Depth (mm)	Material Description SOIL TYPE, Plasticity, Colour, Particle characteristics, Secondary and other minor components	Moist. Condition	Consistency / Strength	Cementation	Water Table	Classification Symbol	Sample/Test
0 - 200	200	(Topsoil) SAND with silt: Dark grey, fine to medium. Contains roots and root fibres.	W	L-MD		Water table encountered @ 150mm below existing ground level.		
200 - 1100	900	SAND with silt: Light grey, fine to medium.	M-W	L-MD				
1100 - 1200	100	SAND with silt: Dark brown, fine to medium.	M	MD	MC			
1200 - 2000	800	SAND with silt: Light brown, fine to medium.	W	L-MD

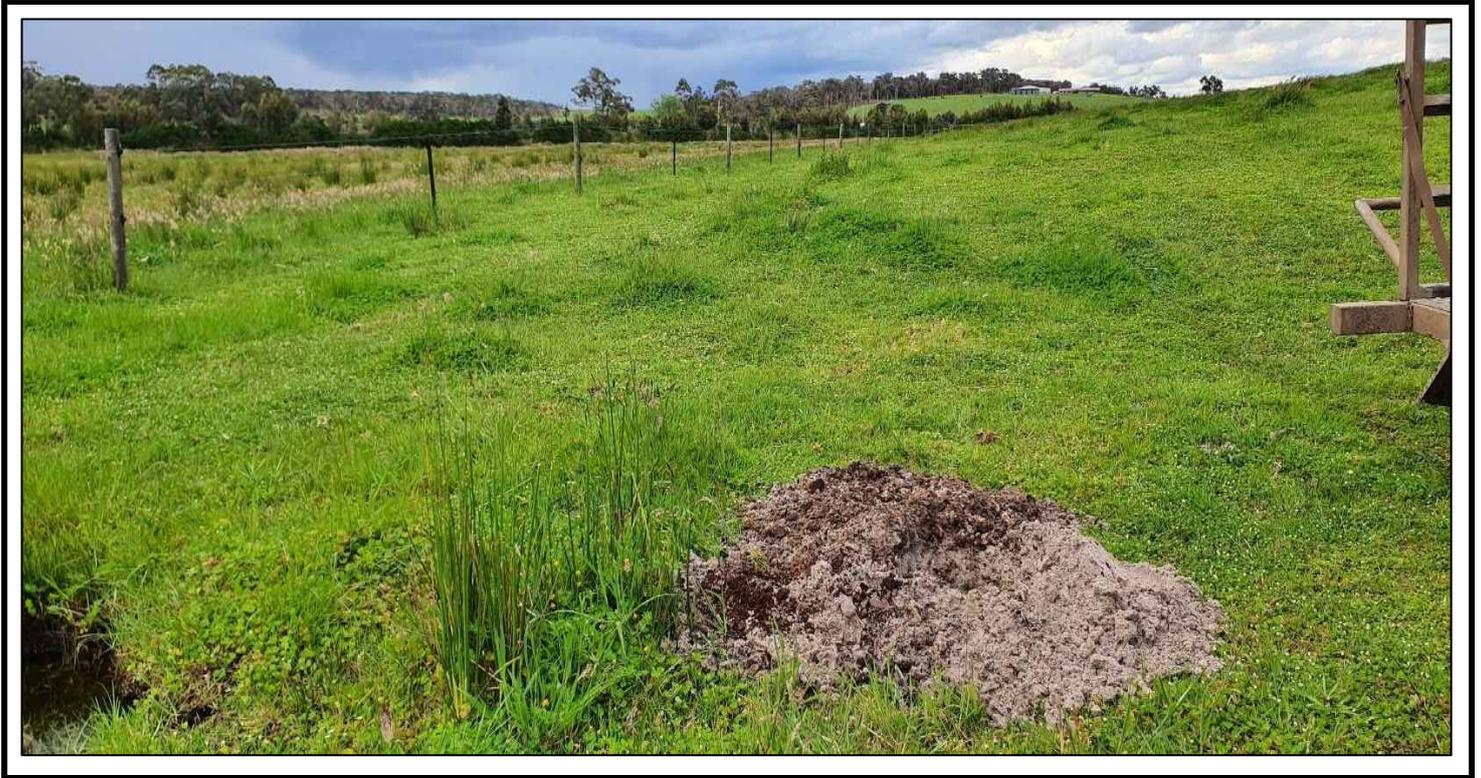
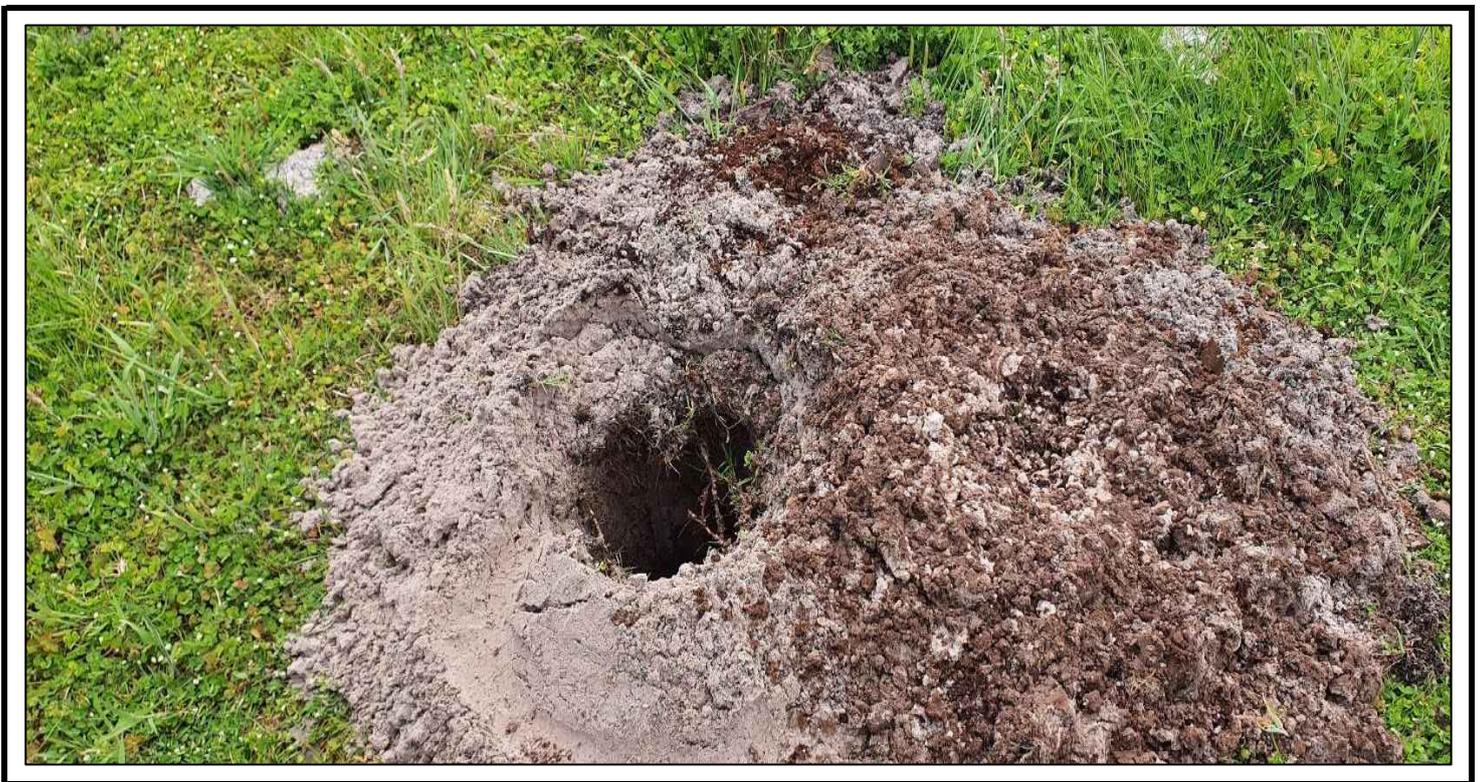
Test Pit No.20

Depth Below Surface (mm)	Layer Depth (mm)	Material Description SOIL TYPE, Plasticity, Colour, Particle characteristics, Secondary and other minor components	Moist. Condition	Consistency / Strength	Cementation	Water Table	Classification Symbol	Sample/Test
0 - 300	300	(Topsoil) SAND with silt: Dark grey, fine to medium. Contains roots and root fibres.	W	L-MD		Water table encountered @ ground level.		
300 - 900	600	SAND with silt: Dark grey/grey, fine to medium.	W	L-MD				
900 - 1600	700	SAND with silt: Light grey, fine to medium.	W	L-MD				
1600 - 2000	400	SAND with silt: Brown, fine to medium.	W	L-MD

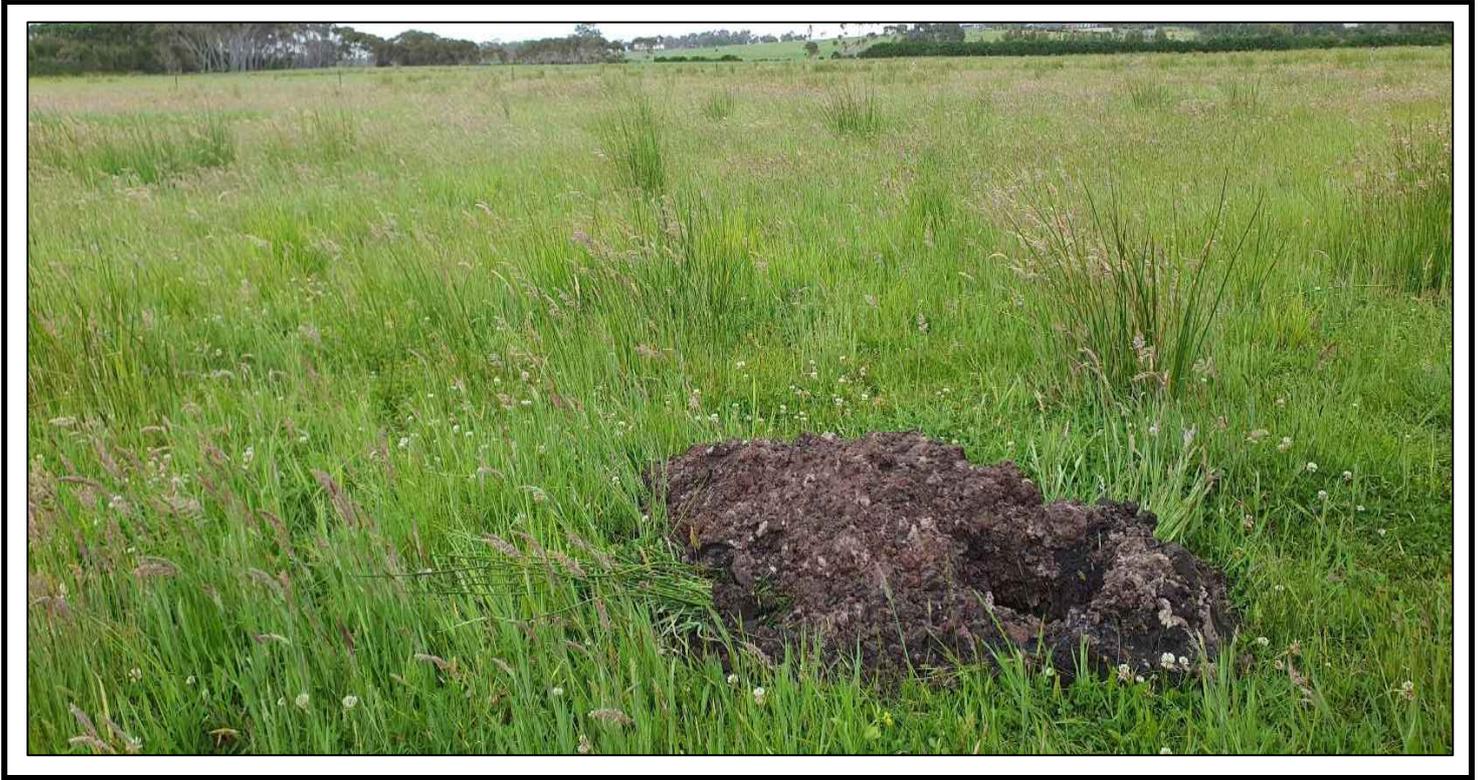
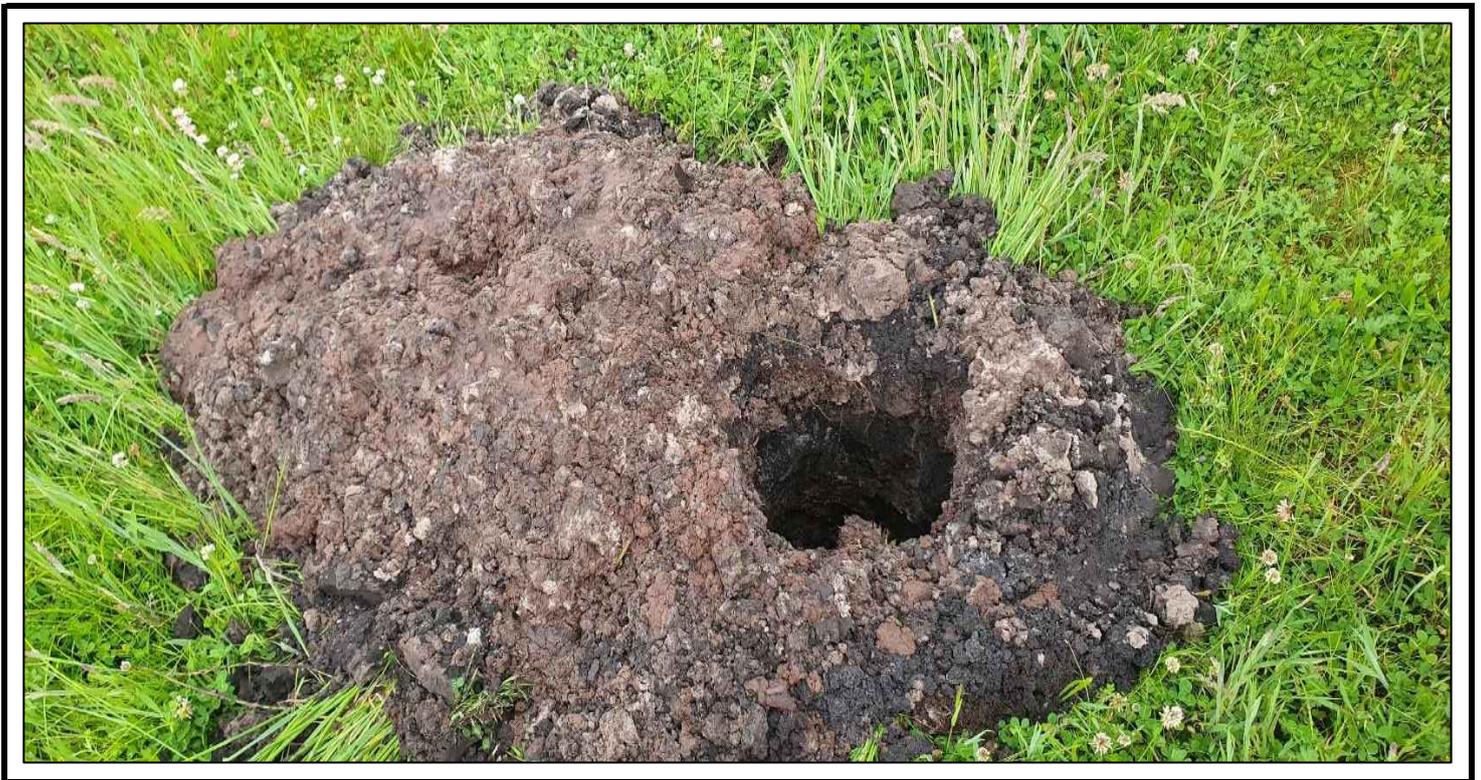
Test Pit No.21

Depth Below Surface (mm)	Layer Depth (mm)	Material Description SOIL TYPE, Plasticity, Colour, Particle characteristics, Secondary and other minor components	Moist. Condition	Consistency / Strength	Cementation	Water Table	Classification Symbol	Sample/Test
0 - 300	300	(Topsoil) SAND with silt: Dark grey, fine to medium. Contains roots and root fibres.	W	L-MD		Water table encountered @ 550mm below existing ground level.		
300 - 1600	1300	SAND with silt: Grey , fine to medium.	W	L-MD				
1600 - 2000	400	SAND with silt: Dark grey/ black , fine to medium.	W	L-MD	PC

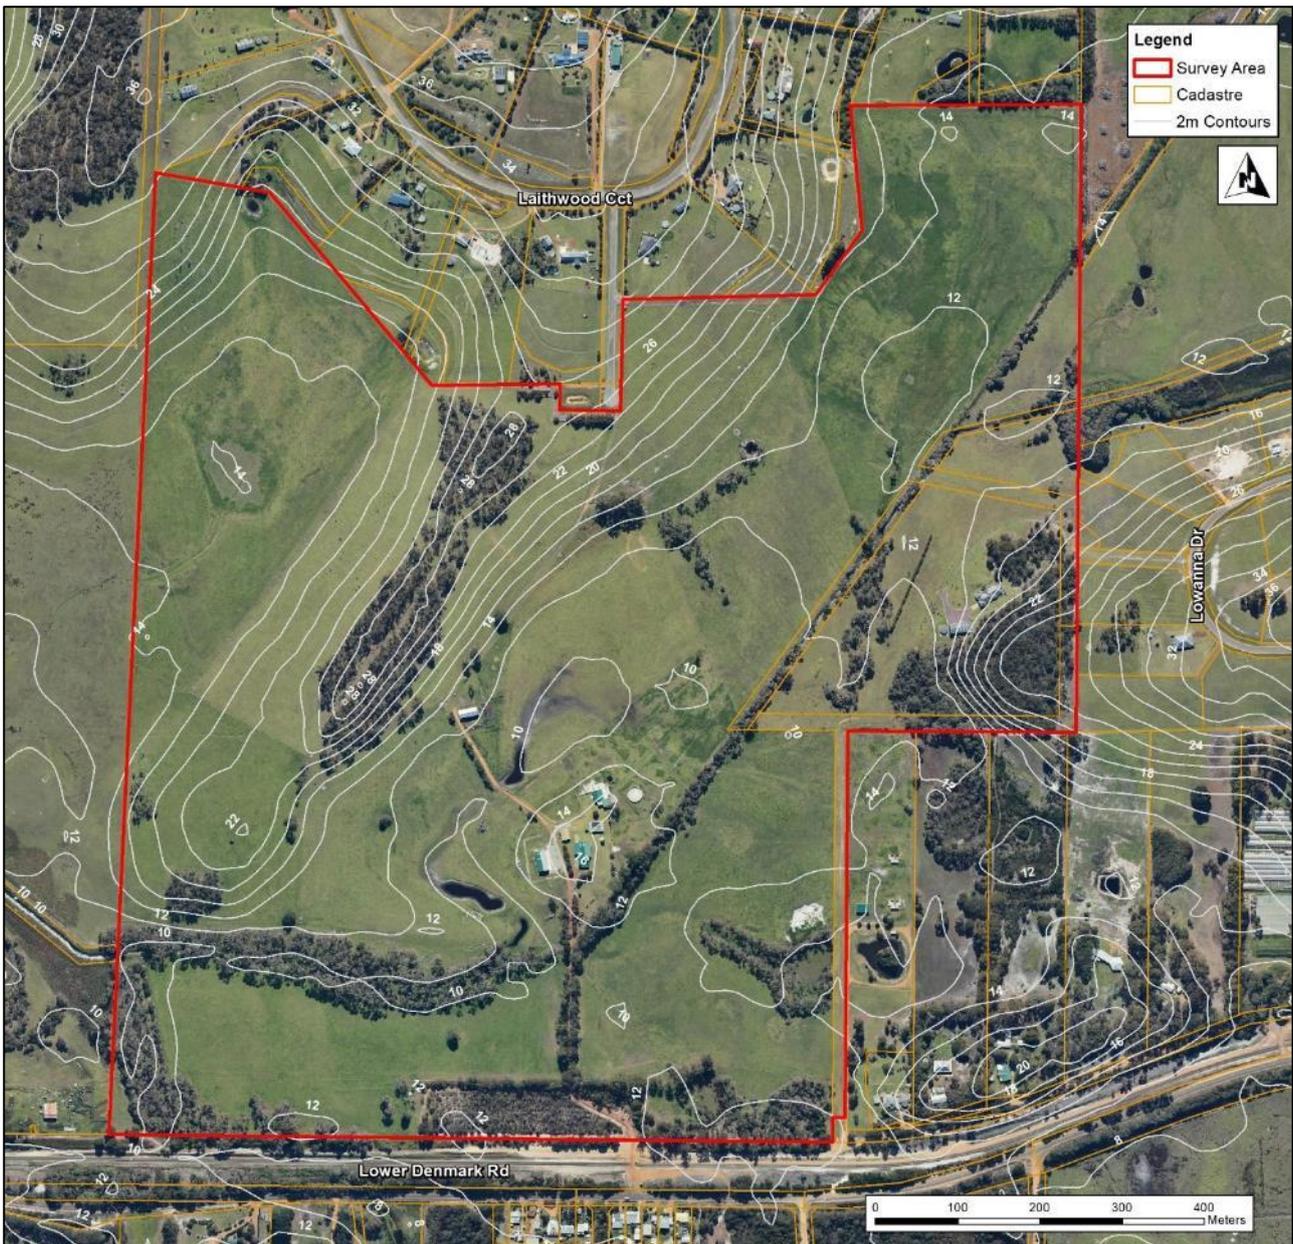
Figure 3: Topography

The Subject Site is generally low lying and flat, with an elevated ridgeline running from northeast to southwest in the central west of the site. The northwest corner and the central eastern edge of the Subject Site are also elevated. Elevation ranges from a high point of 32 mAHD in the northwest of the Subject Site to a low point of 10 mAHD in the central and southern portions of the site. Topographic contours are shown in Figure 3.
