LOCAL WATER MANAGEMENT STRATEGY

Lot 124 & 125 South Coast Hwy
Marbelup, WA 6330

01/05/2024

Title: Local Water Management Strategy – Lot 124 & 125 South Coast Hwy, Marbelup WA

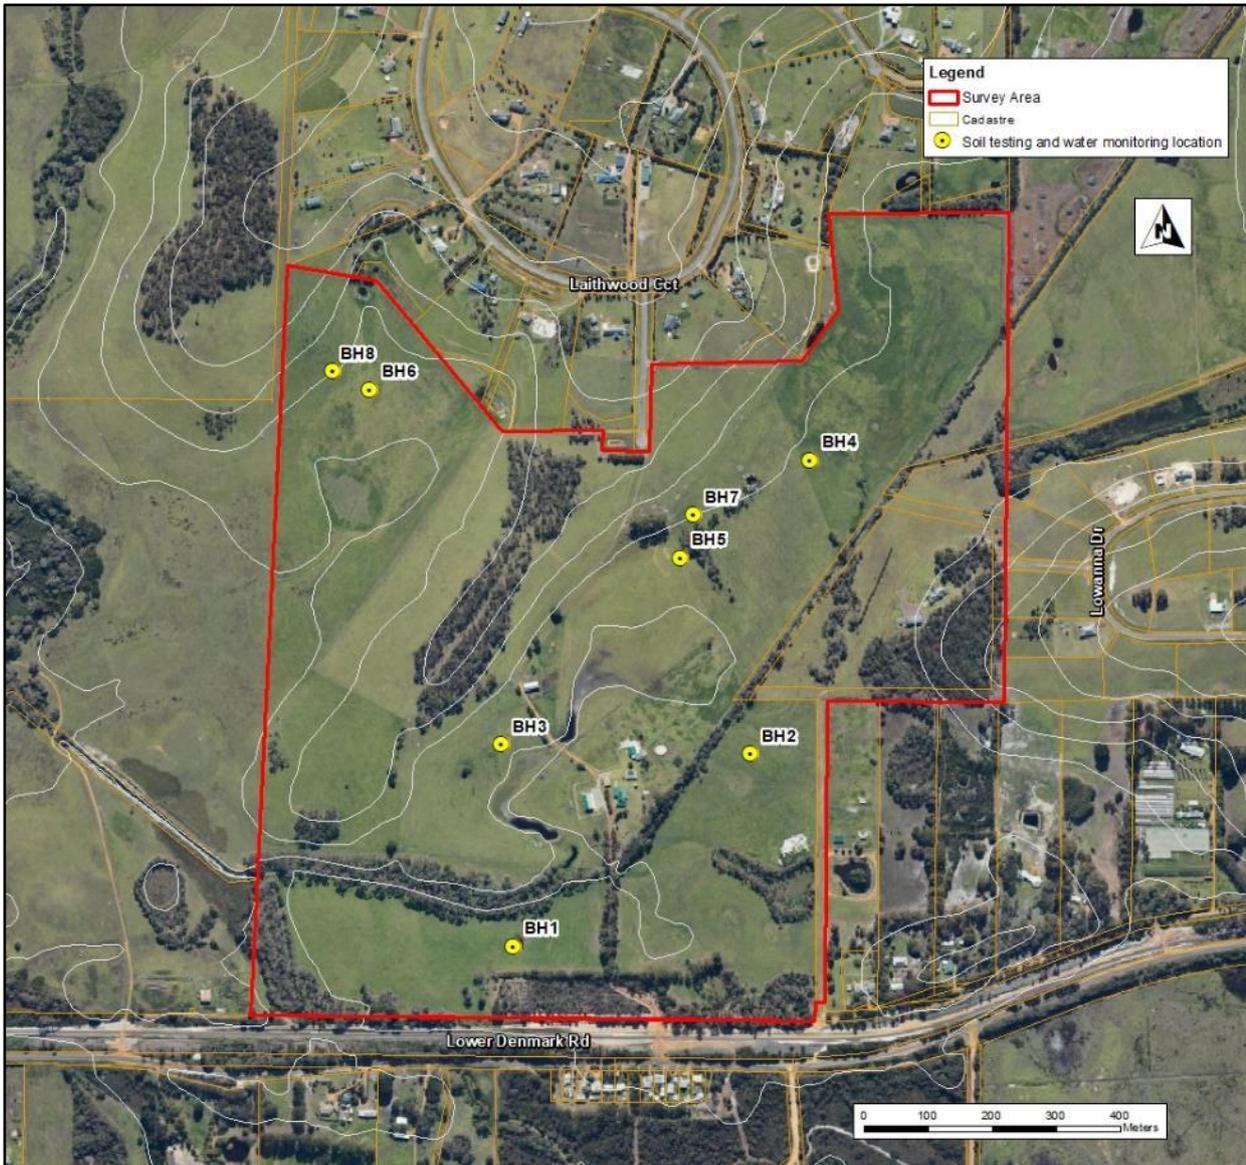
Figure 7: BDS (2013) soil testing and bore locations

Site soil testing was conducted on the 1st August 2013 by Bio Diverse Solutions under late winter conditions. Testing involved site soil analysis, photographic recording, logging of soil types and measuring of water table. In total, eight test/bore holes were constructed to a minimum depth of 2 metres and left open for a minimum of 1 hour to identify any water table present. The soil test hole (bore hole) locations are shown in Figure 7.

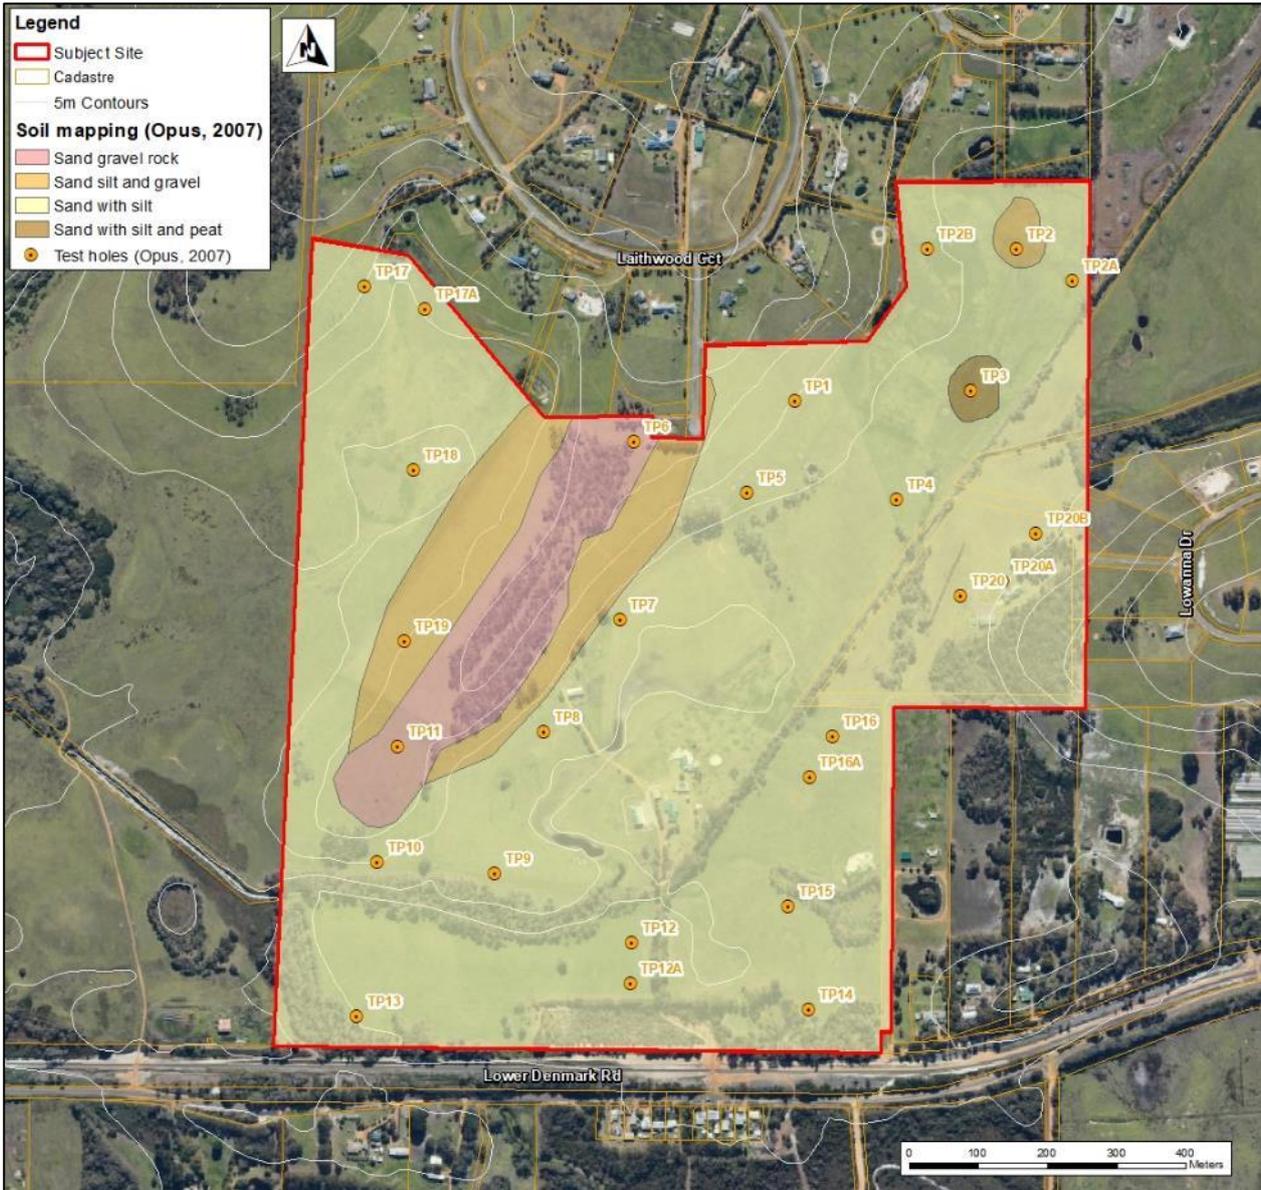
Figure 8: Soil mapping and test hole locations (Opus, 2007)

Four soil types were identified across the Subject Site from the soil testing results. Soil types identified by Opus (2007) include; sand with silt, sand with silt over gravel, sand over gravel over rock and sand with silt and peat, as shown in Figure 8. The majority of the Subject Site is mapped as sand with silt. More detailed descriptions of soil types found at the Subject Site are presented in Appendix A.

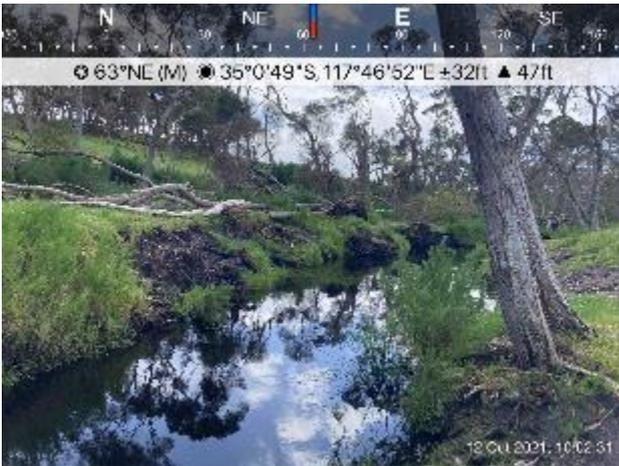
Photo 5: A general view to the east northeast of Five Mile Creek in the south of the Subject Site.

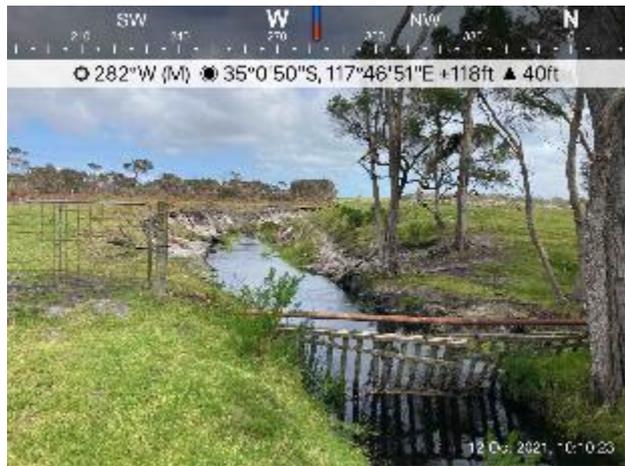
Photo 6: View to the west of Five Mile Creek at the western boundary of the Subject Site.

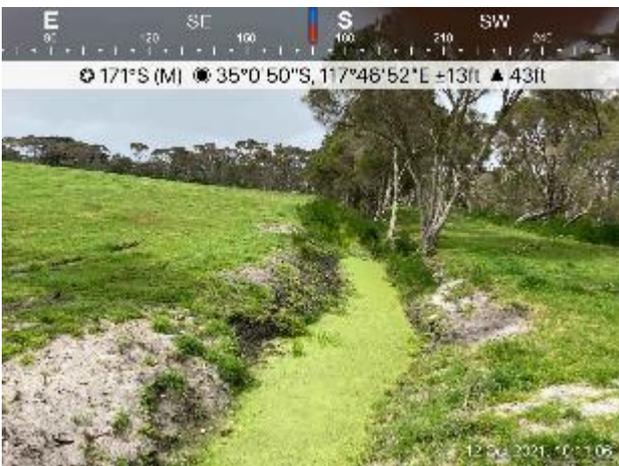
Photo 7: View to the south of constructed drain discharging to Five Mile Creek in the southwest of the Subject Site.

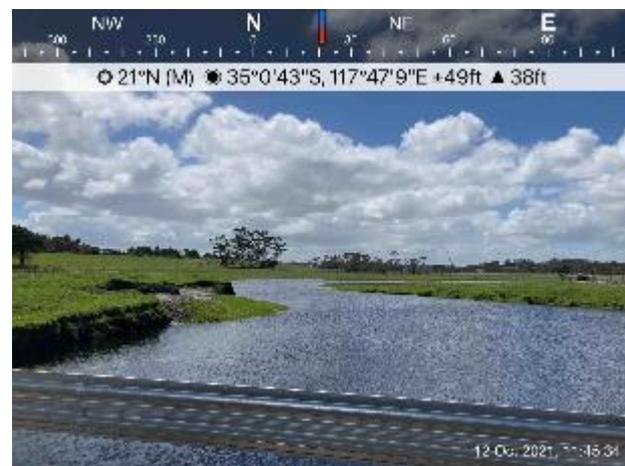
Photo 8: View to the north northeast of seasonally inundated area in the low-lying central portion of the Subject Site.

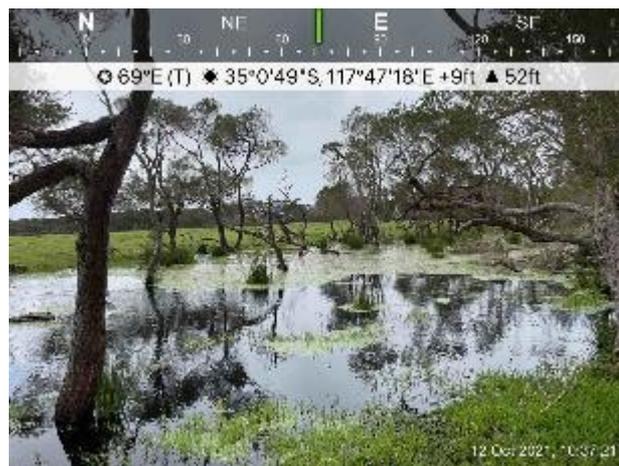
Photo 9: View to the east northeast of seasonally inundated area (wetland) in the south of the Subject Site.

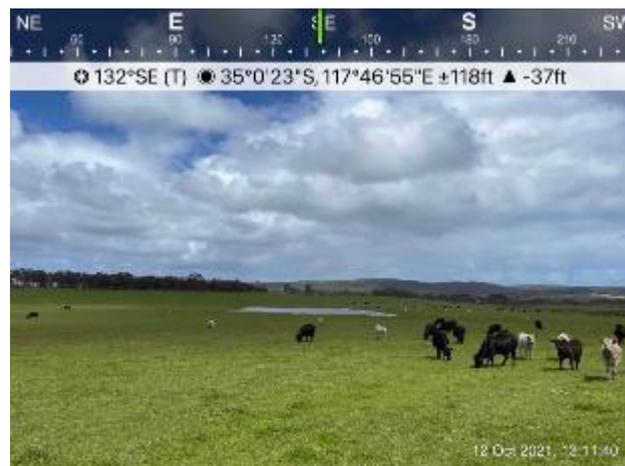
Photo 10: View to the southeast of seasonally inundated area in the northwest of Subject Site.

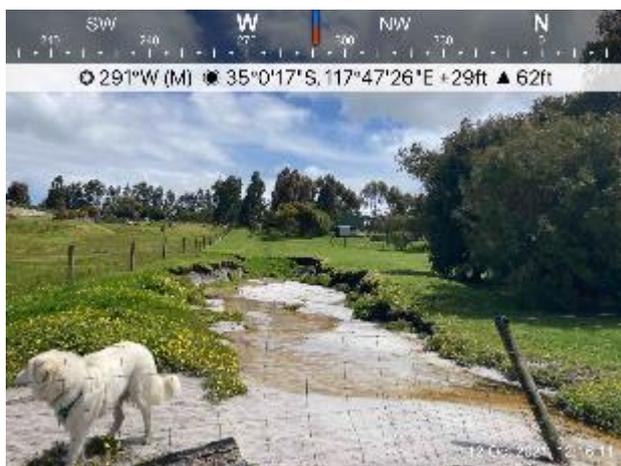
Photo 11: View to the west northwest of eroded drainage easement to the west of eastern corner of Subject Site. Easement discharging runoff and sediment into the Subject Site.

During the hydrological investigation, two drainage easements discharging into the Subject Site in the north were identified as having significant erosion and deposition of sediment in to the Subject Site. Photos of the two eroded drainage easements upstream of the Subject Site are shown in Photos 11 and 12. The location of the drainage easements discharging into the Subject Site are shown in Figure 10 (Seasonal Drainage lines).

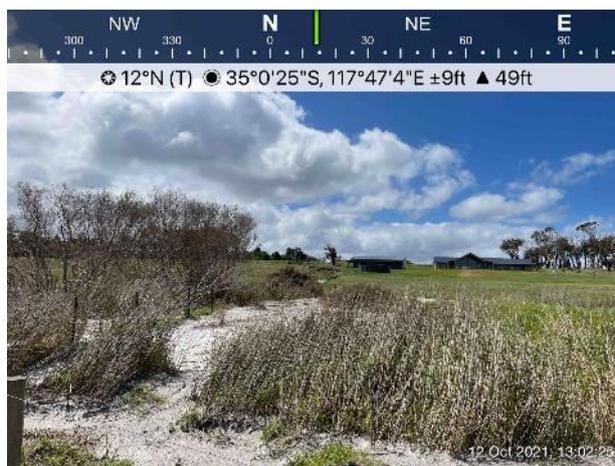
Photo 12: View to the north of eroded drainage easement to the north of Subject Site. Easement discharging runoff and sediment into the Subject Site.

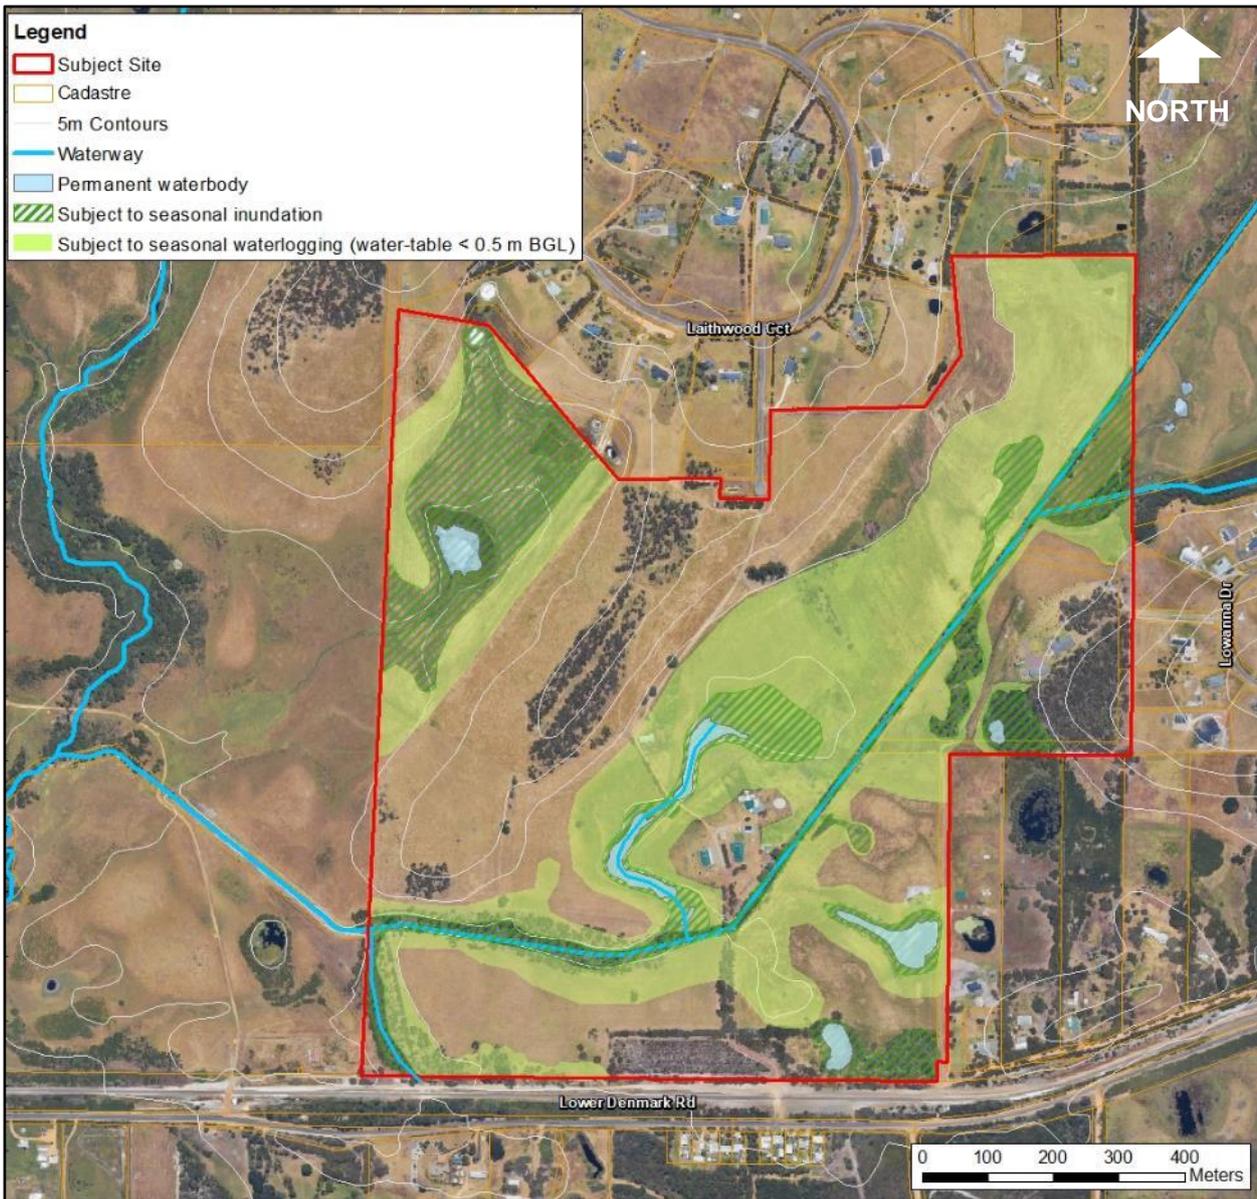
Figure 11: Waterlogged and seasonally inundated areas

The areas subject to seasonal waterlogging and seasonal inundation were mapped by Opus (2007) as part of the LCA. Areas subject to seasonal waterlogging (groundwater \leq 0.5 m BGL) and seasonal inundation (water sitting on the surface for extended periods of time) were confirmed during the site assessment on the 12th October 2021 and using historical imagery of the site. Approximate areas found to be subject to seasonal waterlogging and seasonal inundation are shown in Figure 11.

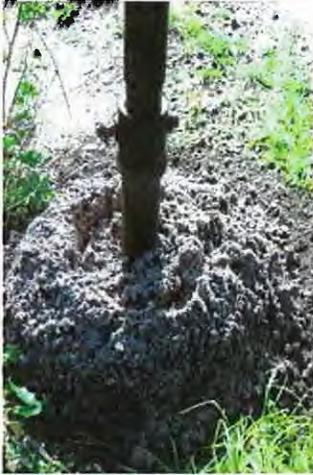
The top layer of the soil profile consisted of moist sand with silt which was light grey to dark grey in colour. The sand with silt layer extended from the surface to 2000 below the surface. The majority of the test pits across the site recorded this soil type on or below the 15m contour. Please see photographs below.

Photo One – Sand with Silt

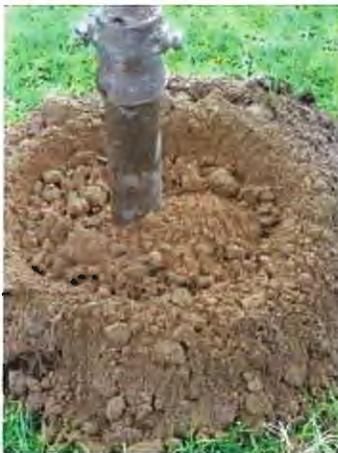
Test pit 2 and 19 recorded black sand to dark grey sand with silt over brown sand with gravel. These soils were found mid slope along the ridge, with the gravel layer varying from 100mm below surface level to 900mm. Test pit 19 had some silty clayey sand below the gravel layer. The presence of gravel soils indicates that there is the capacity of the soil to absorb phosphorous and nitrogen. Test pit 2 in the north west corner was the only test pit with gravel which encountered water table (in June 2007 sampling).

Photo 4: Sand over gravel
Test pit 19

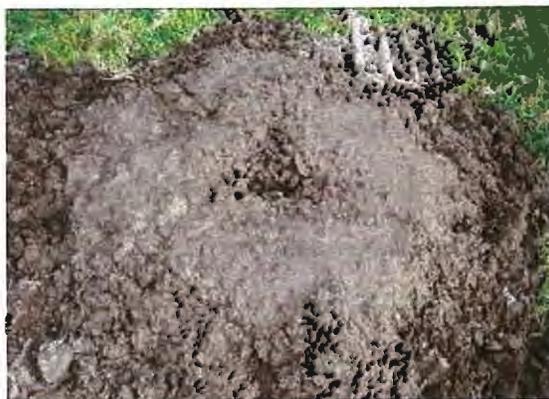
Photo Four: Test pit 2 sand over gravel, water table at 1.1m in June, and water table at ground level in August.

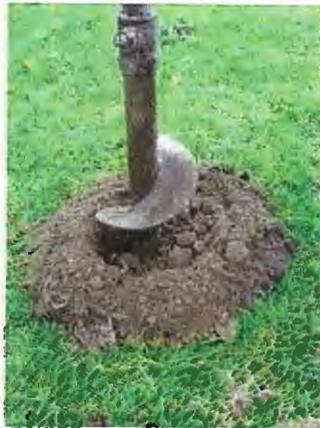
Test pits 6 and 111 recorded shallow layers (0-100mm) of dark grey sand with silt over brown sandy gravel ranging from 100mm to 600mm below ground level. See Photo five below. The test pits were terminated due to the auger unable to penetrate past the rock layer. The locations are on the highest points of the subject site.

Photo Five: Sand over rock

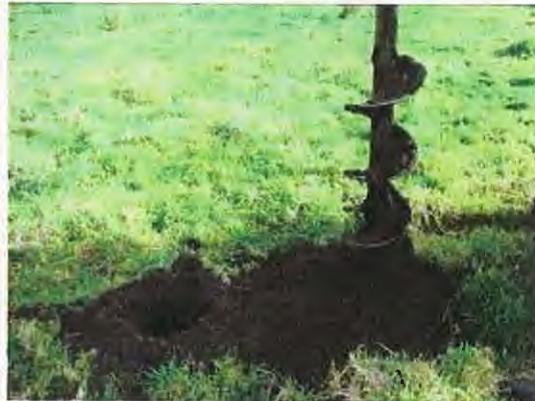
Photo Six: Sand with silt and peat

Test pit 3 was the only test pit within this sample regime which had black peaty sand with silt extending to 700mm over dark brown sand with silt. Please see photograph 6 above. This test pit reached the water table at 1.1m, sampled under late winter conditions water table was reached at ground level. Test pits 16 and 18 are low in the contour (<5m contour) and recorded high organic content in the topsoil, however were predominantly sandy silt in profile. These test pits recorded high water table under late winter conditions.

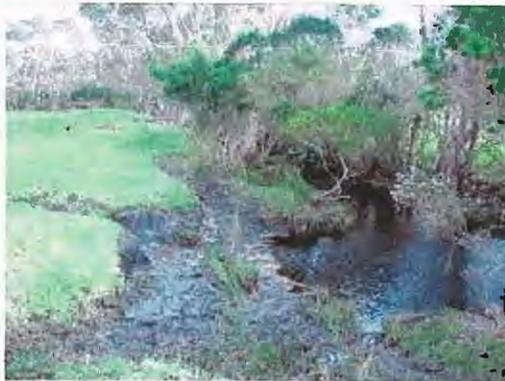
Stock (cattle) currently grazed on the property have access to all creek and wetland systems on the property. This is causing erosion to the creek lines and loss of vegetation to these areas. Please refer to photographs Nine and Ten below.

Photo Nine: Erosion to the banks of Five Mile Creek from cattle.

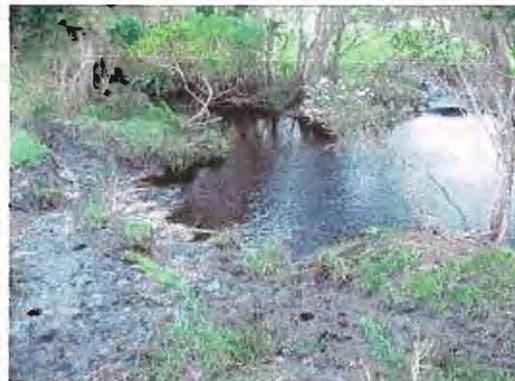
Photo Ten: Sediments and cattle effluent drain freely into five mile creek system.

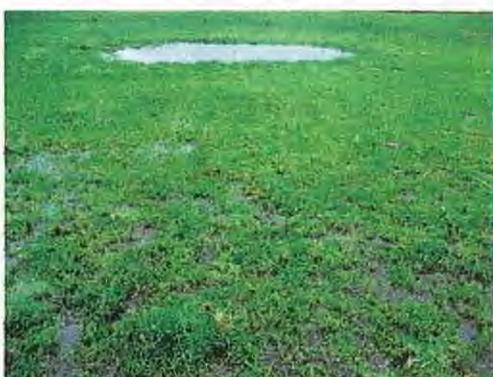
Areas from the aerial mapping showing water logging have been mapped and were confirmed with intensive sampling regime undertaken in late winter. These areas have been mapped on are a limitation in Section 7 Land Capability. Photographs Seventeen to Eighteen below show typical waterlogged areas across the site.

Photo Seventeen: Water logged area in northwest corner.

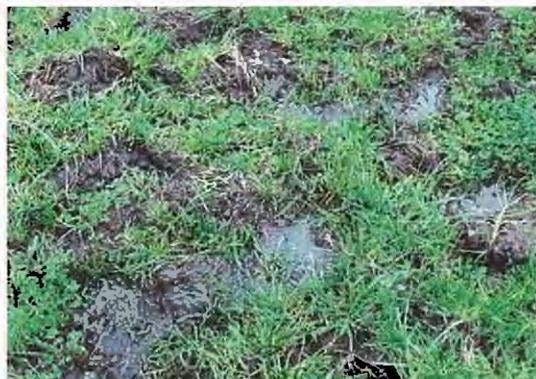
Photo Eighteen: Close up of waterlogged soils

Development should be excluded from these waterlogged areas and revegetation of provenance and endemic species. A weed management plan should be prepared to address the major infestations along the creek lines.

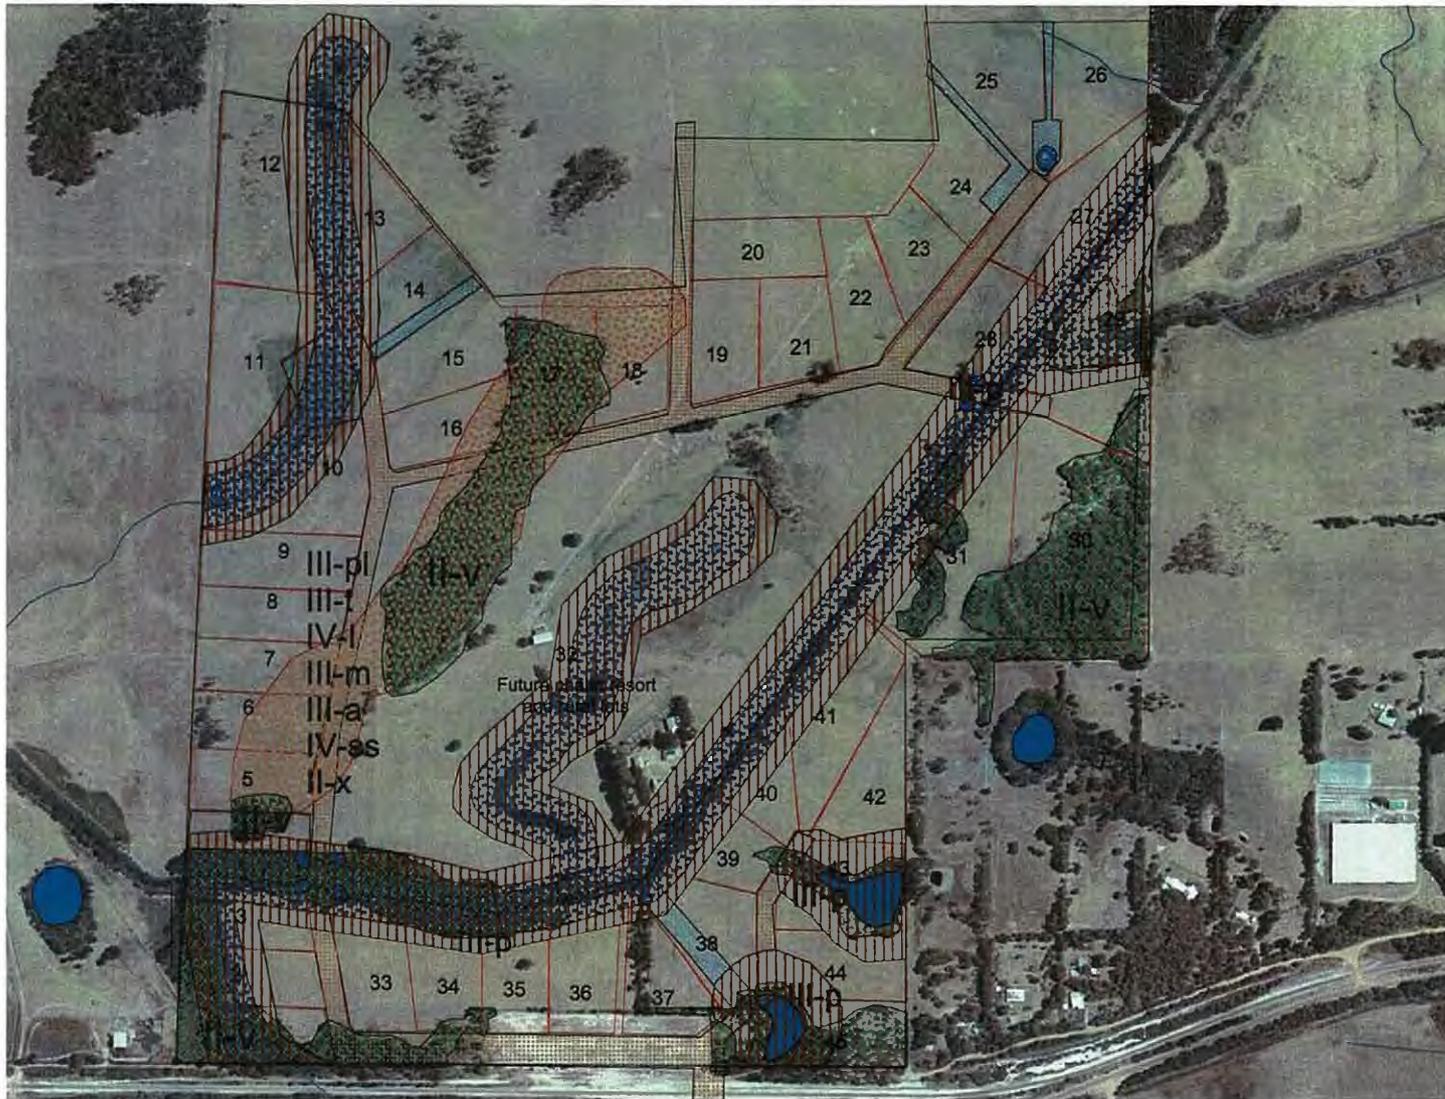
**Lot 800 South Coast Highway
Albany Green Stage Two
Map Unit C
Limitations**

- III-pl Plant Growth
- III-t Soil Trafficability
- IV-I Soil fertility status
- III-m Soil Moisture Availability
- IV-ss Shallow Soils
- II-x Ease of excavation

- Plant growth (III-pl) - poorly structured sandy soils with limited nutrients, low productivity, would require fertilizer application.
- Soil trafficability (III-t) – shallow rock, often close to surface.
- Soil fertility status (IV-l) - poorly structured sand soils with limited nutrients, low productivity, would require fertilizer application.
- Soil moisture availability (III-m) – sandy silty soils have limited ability to withhold moisture, only waterlogged areas able to retain moisture.
- Water availability (III-m) –High in landscape, low water availability.
- Shallow Soils (IV-ss) –shallow sands over rock often close to surface.

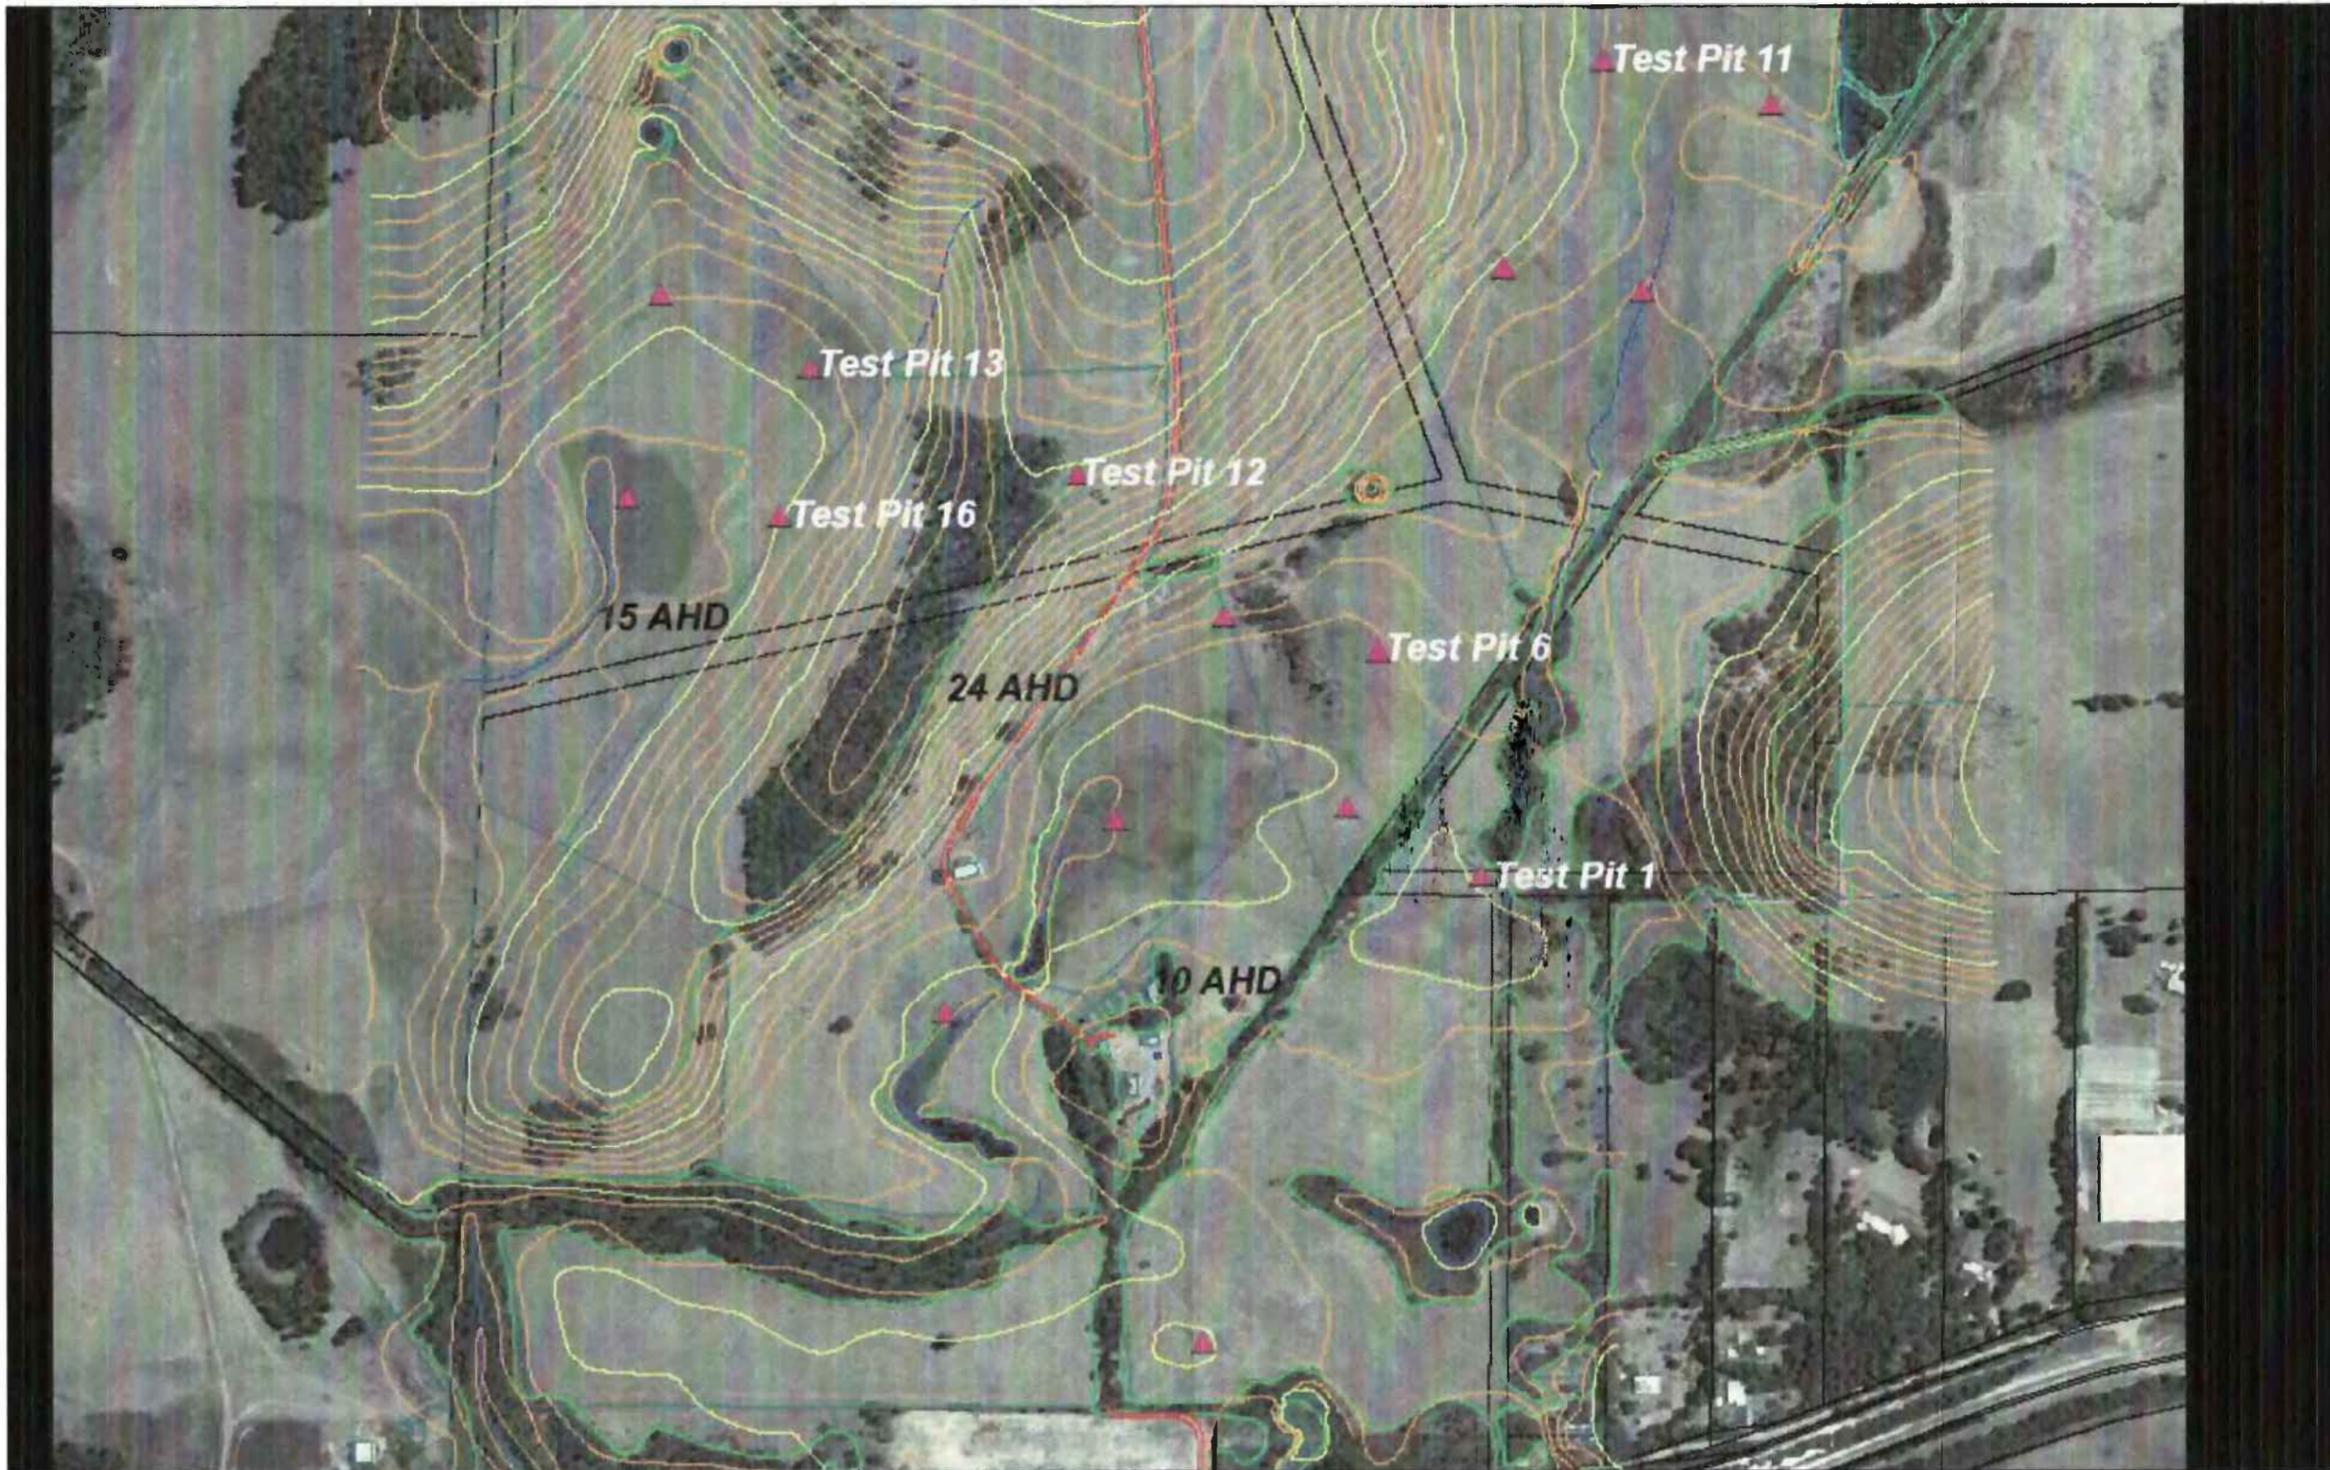
**Test Pit Identification**

▲ Test Pits

Test Pit ID January 2008 (ALS Client Sample ID)	Test Pit ID for the purposes of this report
TP 1	TP 21
TP 2	TP 22
TP 3	TP 23
TP 4	TP 24
TP 5	TP 25
TP 6	TP 26
TP 7	TP 27
TP 8	TP 28
TP 9	TP 29
TP 10	TP 30
TP 11	TP 31
TP 12	TP 32
TP 13	TP 33
TP 14	TP 34
TP 15	TP 35
TP 16	TP 36
