APPENDIX D | SITE SOIL EVALUATION

SITE SOIL EVALUATION

Lot 124 and 125 South Coast Highway
Marbelup, WA 6330

Title: Site Soil Evaluation – Lot 124 and 125 South Coast Highway, Marbelup

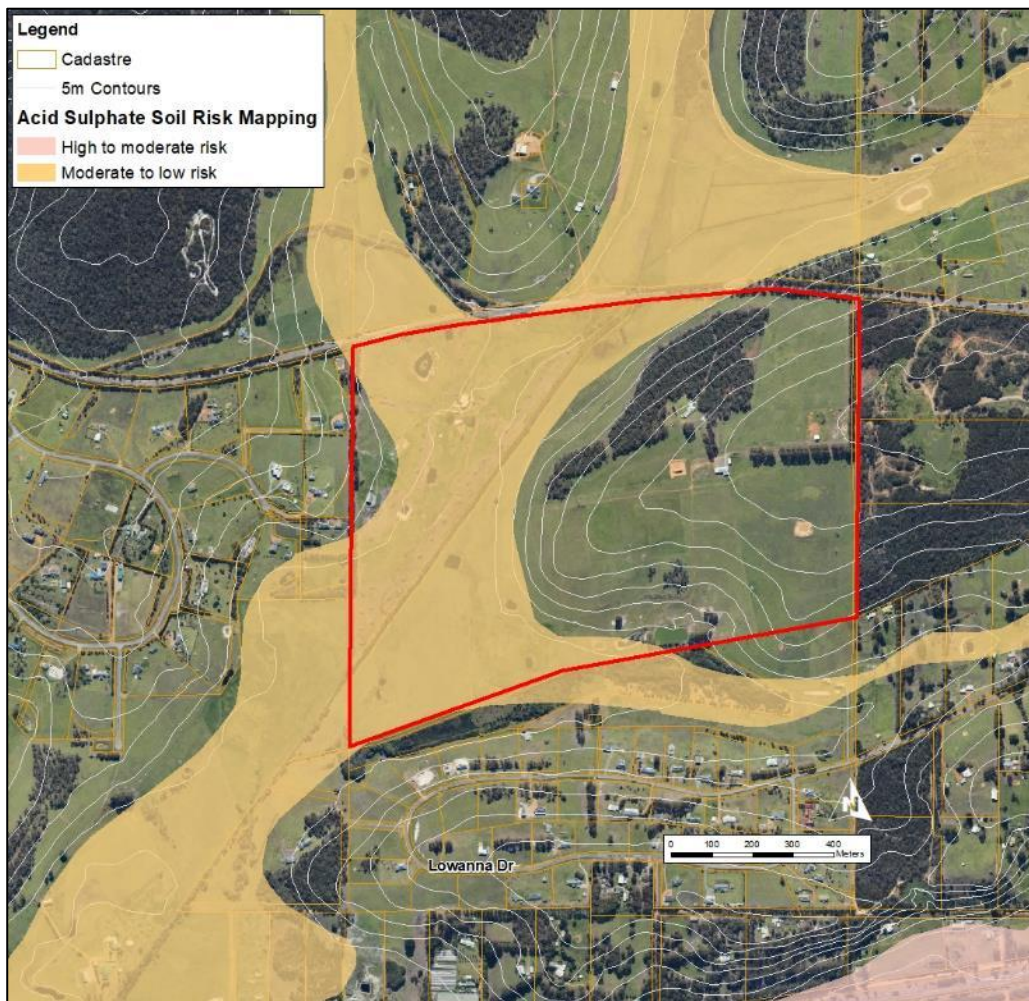
Figure 8: ASS Risk Mapping

Acid sulphate soils (ASS) are naturally occurring soils and sediments containing sulphide minerals, predominantly pyrite (an iron sulphide). When undisturbed below the water table, these soils are benign and not acidic (potential acid sulphate soils). If the soils are drained, excavated or exposed by lowering of the water table, the sulphides will react with oxygen to form sulphuric acid. ASS Risk Mapping indicates the low-lying areas within the Subject Site are located in an area classified as having a moderate to low risk of ASS occurring within 3 metres of natural soil surface (DWER, 2017). ASS Risk Mapping (DWER, 2017) is shown in Figure 8.

An ASS Preliminary Investigation was conducted on the property directly southwest of the Subject Site (Lot 9001 Lower Denmark Road, Cuthbert) on the 15th January 2008 as part of a Land Capability Assessment (Opus, 2007) for the site. In summary, the investigation found the peat layers investigated at Lot 9001 Lower Denmark Road, Cuthbert had acidity levels which exceeded DWER Guidelines, however the acidity was found not to be caused by sulfur and likely to be caused from the mobilisation of hydrolysed ions, likely attributed to iron or aluminium leaching through the soil profile (Opus, 2007).

Soil analysis showed the surface soils had high Electrical Conductivity (EC) and corresponding acidity, which Opus (2007) found is likely attributed to bicarbonate salts and not sulfur salts. Sulfur acidity (ASS) was detected in the soil layers from approximately 1000 m BGL (Opus, 2007).

Opus (2007) recommended that the site not be excavated deeper than 500 mm to avoid mobilisation and oxidation of ASS. The top 500 mm of soil will still require treatment with lime upon disturbance and ASS shall be managed in accordance with ASS guidelines (Opus, 2007).

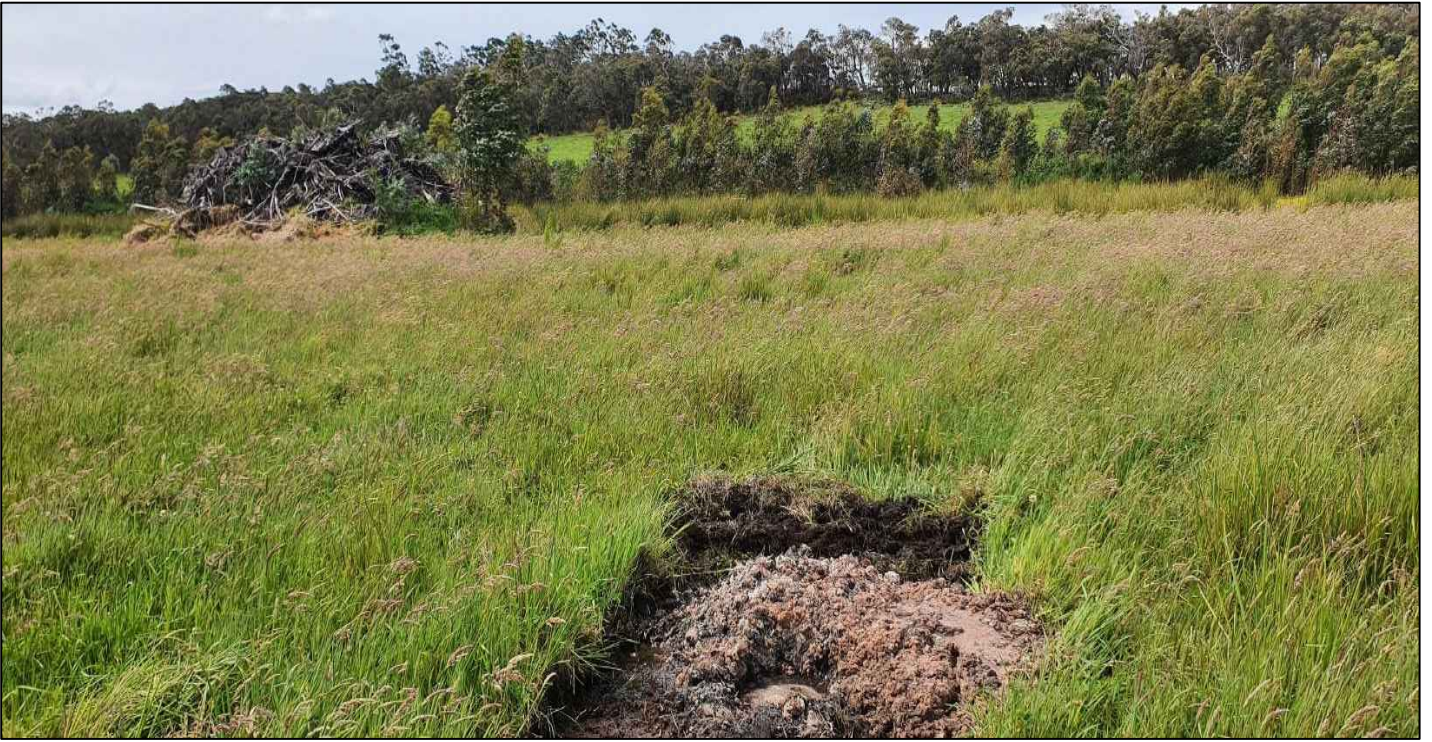
Test Pit No.1

Depth Below Surface (mm)	Layer Depth (mm)	Material Description SOIL TYPE, Plasticity, Colour, Particle characteristics, Secondary and other minor components	Moist. Condition	Consistency / Strength	Cementation	Water Table	Classification Symbol	Sample/Test
0 - 400	400	(Topsoil) SAND with silt: Grey/brown, fine to medium. Contains roots and root fibres.	W	L-M		Water table encountered @ ground level.		
400 - 1500	1100	SAND with silt: Grey to light grey, fine to medium.	W	L-MD				
1500 - 2000	500	SAND with silt: Light brown, fine to medium.	W	L-MD

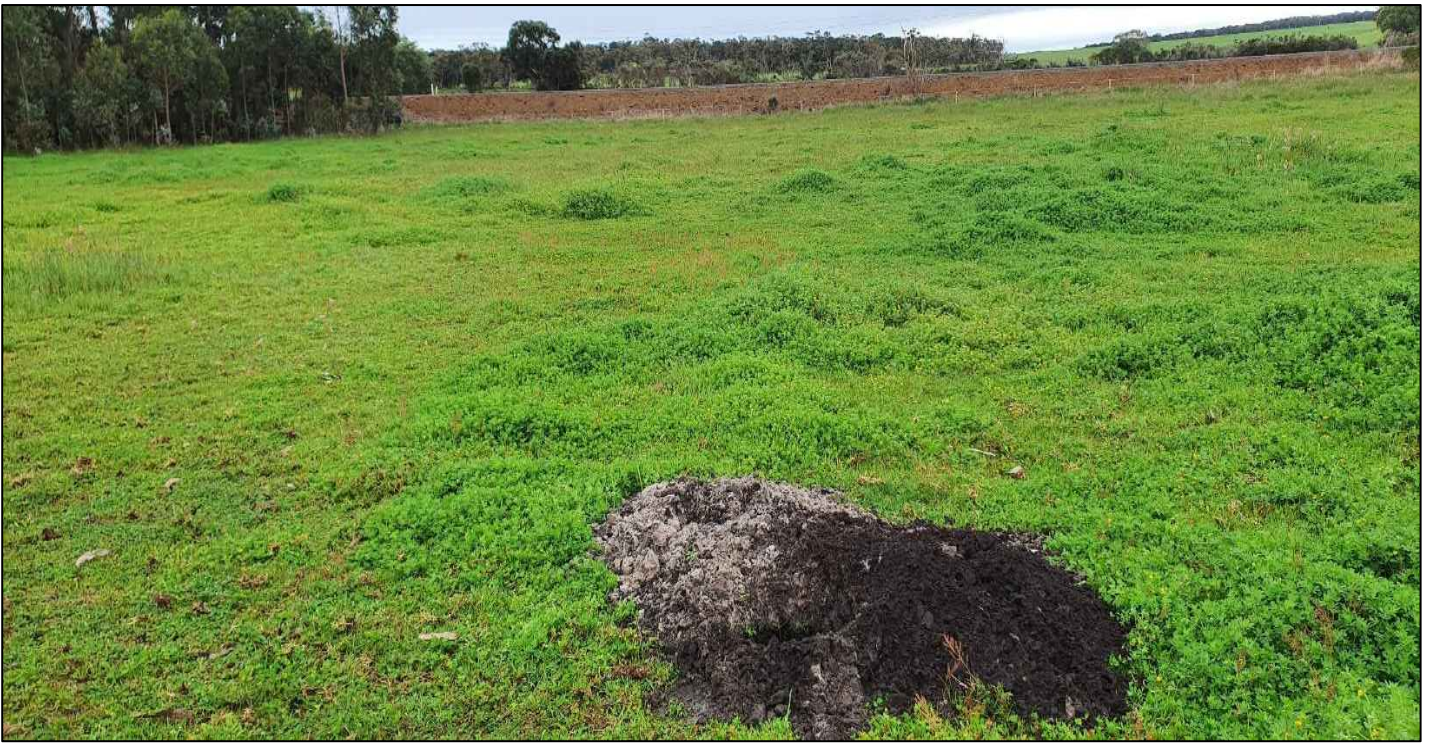
Test Pit No.2

Depth Below Surface (mm)	Layer Depth (mm)	Material Description SOIL TYPE, Plasticity, Colour, Particle characteristics, Secondary and other minor components	Moist. Condition	Consistency / Strength	Cementation	Water Table	Classification Symbol	Sample/Test
						Water table encountered @ 50mm below existing ground level.		
0 - 200	200	(Topsoil) SAND with silt: Dark grey, fine to medium.	W	L-MD				
		Contains roots and root fibres.						
200 - 1350	1150	SAND with silt: Grey to light grey, fine to medium.	M-W	L-MD				
1350 - 2000	650	SAND with silt: Dark grey/black, fine to medium. (*Refer to comments)	M	MD				
Samples Taken			Target Depth		✓	2000		
			Cave In					
			Refusal					
Comments			Near Refusal

* Moderately cemented from 1550 to 2000			Flooding					
			Lack of Reach					
Cohesive	Non-Cohesive	Rock	Cementation	General				
VS - Very Soft	VL - Very Loose	EL - Extremely Low	IN - Indurated	D - Dry M - Moist W - Wet				
S - Soft	L - Loose	VL - Very Low	PC - Poorly Cemented					
F - Firm	MD - Medium Dense	L - Low						
St - Stiff	D - Dense	M - Medium	MC - moderately Cemented	N/A - Not Applicable				
VSt - Very Stiff	VD - Very Dense	H - High		N/D - Not Determined				
H - Hard	CO - Compact	VH - Very High	WC - Well Cemented					
		EH - Extremely High

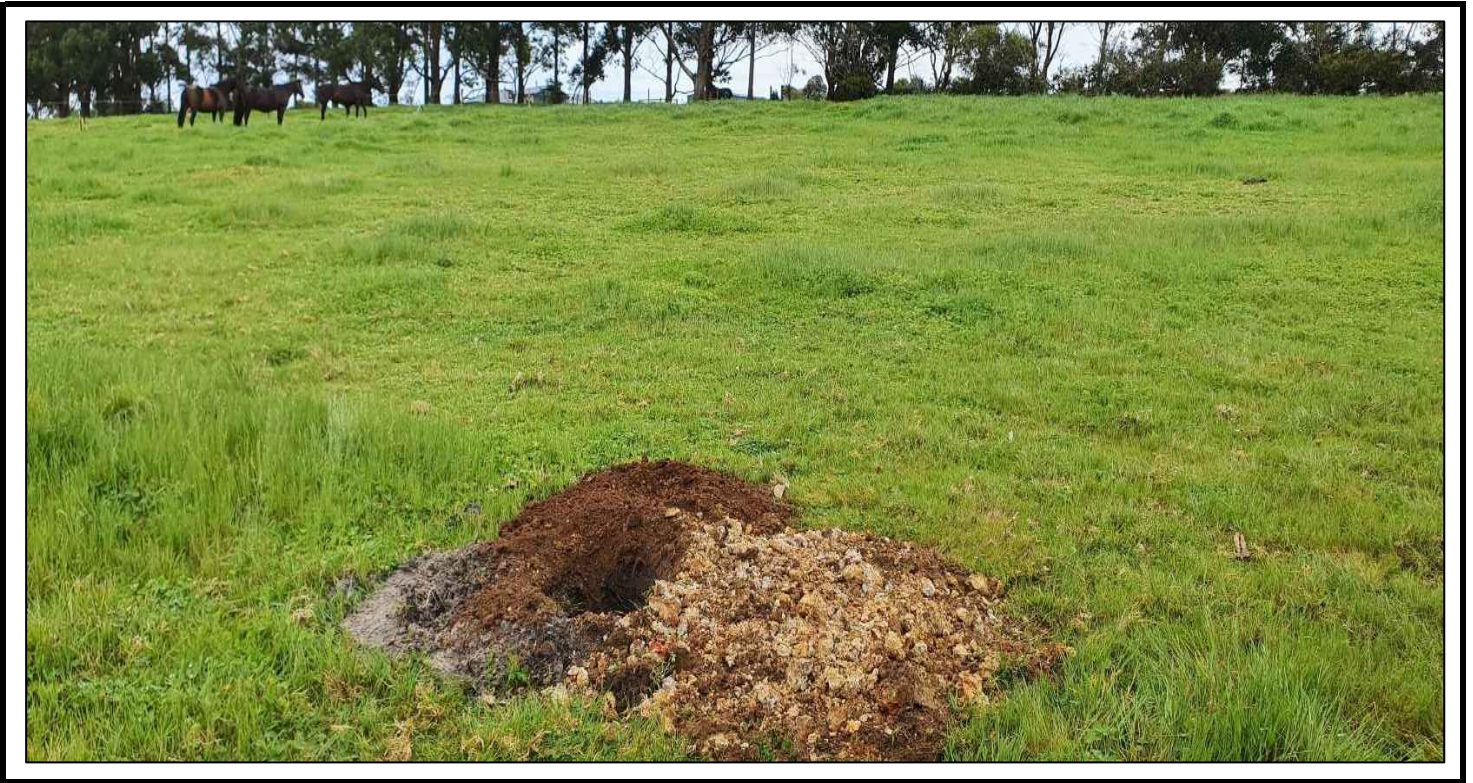
Test Pit No.3

Depth Below Surface (mm)	Layer Depth (mm)	Material Description SOIL TYPE, Plasticity, Colour, Particle characteristics, Secondary and other minor components	Moist. Condition	Consistency / Strength	Cementation	Water Table	Classification Symbol	Sample/Test
0 - 120	120	(Topsoil) SAND with silt: Dark grey, fine to medium. Contains roots and root fibres.	W	L-MD		Water table encountered @ 1020mm below existing ground level.		
120 - 500	380	SAND with silt: Grey to light grey, fine to medium.	M	L-MD				
500 - 1200	700	Sandy GRAVEL: Dark/light brown, fine to coarse, sub-rounded to sub-angular. Fine to medium grained sand. (*Refer to comments)	M	D-VD				
1200 - 2000	800	SANDY CLAY: Low to medium plasticity, light brown/grey with red and orange mottle. Fine to medium grained sand.	M	F-St				
Samples Taken			Target Depth	✓	2000			
			Cave In					
			Refusal					
Comments			Near Refusal

* Layer excavates as a Sandy GRAVEL, however consists of a conglomerate formation.			Flooding					
			Lack of Reach					
Cohesive	Non-Cohesive	Rock	Cementation	General				
VS - Very Soft	VL - Very Loose	EL - Extremely Low	IN - Indurated	D - Dry M - Moist W - Wet				
S - Soft	L - Loose	VL - Very Low	PC - Poorly Cemented					
F - Firm	MD - Medium Dense	L - Low						
St - Stiff	D - Dense	M - Medium	MC - moderately Cemented	N/A - Not Applicable				
VSt - Very Stiff	VD - Very Dense	H - High		N/D - Not Determined				
H - Hard	CO - Compact	VH - Very High	WC - Well Cemented					
		EH - Extremely High

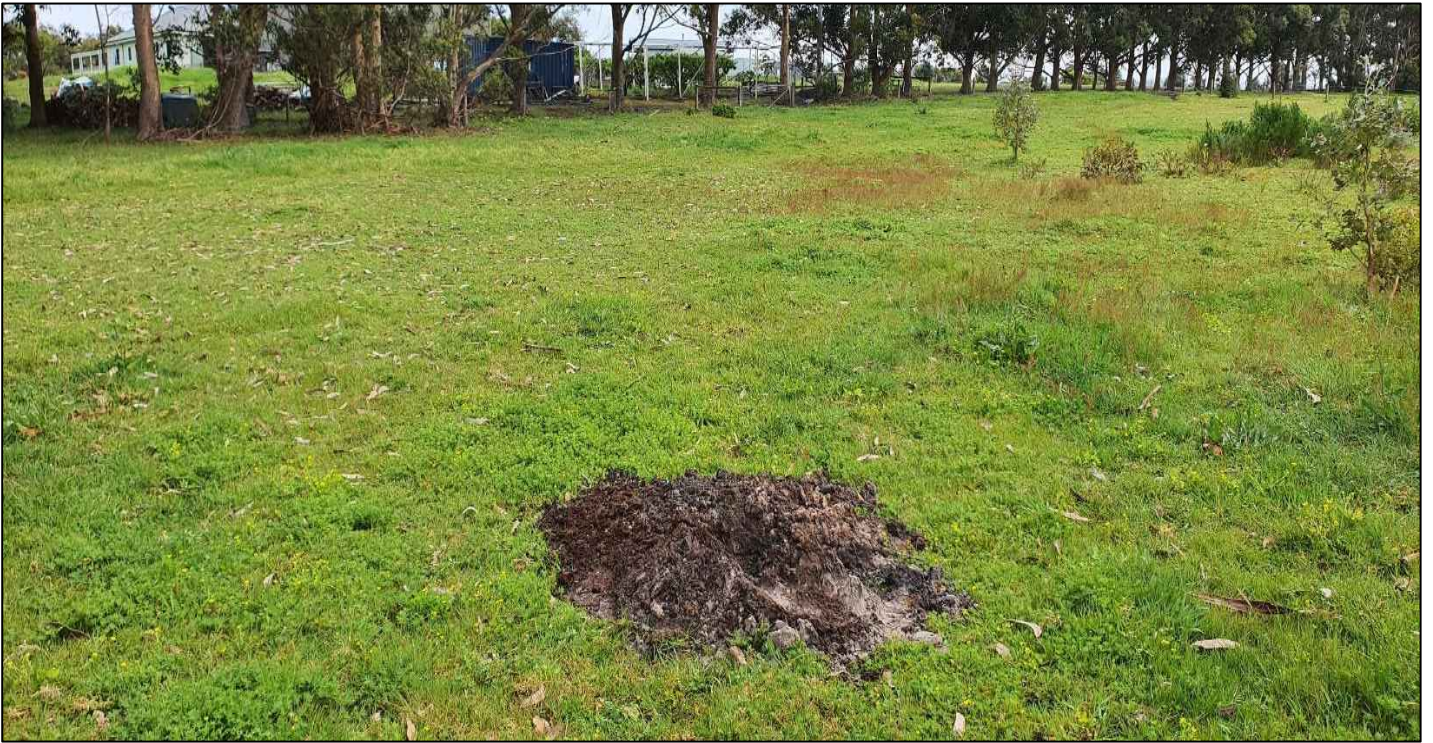
Test Pit No.4

Depth Below Surface (mm)	Layer Depth (mm)	Material Description SOIL TYPE, Plasticity, Colour, Particle characteristics, Secondary and other minor components	Moist. Condition	Consistency / Strength	Cementation	Water Table	Classification Symbol	Sample/Test
						Water table encountered @ 350mm below existing ground level.		
0 - 160	160	(Topsoil) SAND with silt: Dark grey, fine to medium.	W	L-MD				
		Contains roots and root fibres.						
160 - 1050	890	SAND with silt: Grey to light grey, fine to medium.	M	W				
1050 - 1680	630	Sandy GRAVEL: Dark/light brown, fine to coarse, sub-rounded to sub-angular.	M	MD	PC			
		Fine to medium grained sand.						
1680 - 2000	320	SAND: Light brown/grey, fine to medium.	W	L-MD				
Samples Taken			Target Depth		✓	2000		
			Cave In					
			Refusal					
Comments			Near Refusal					
			Flooding					
			Lack of Reach					
Cohesive	Non-Cohesive	Rock	Cementation	General				
VS - Very Soft	VL - Very Loose	EL - Extremely Low	IN - Indurated	D - Dry M - Moist W - Wet N/A - Not Applicable N/D - Not Determined

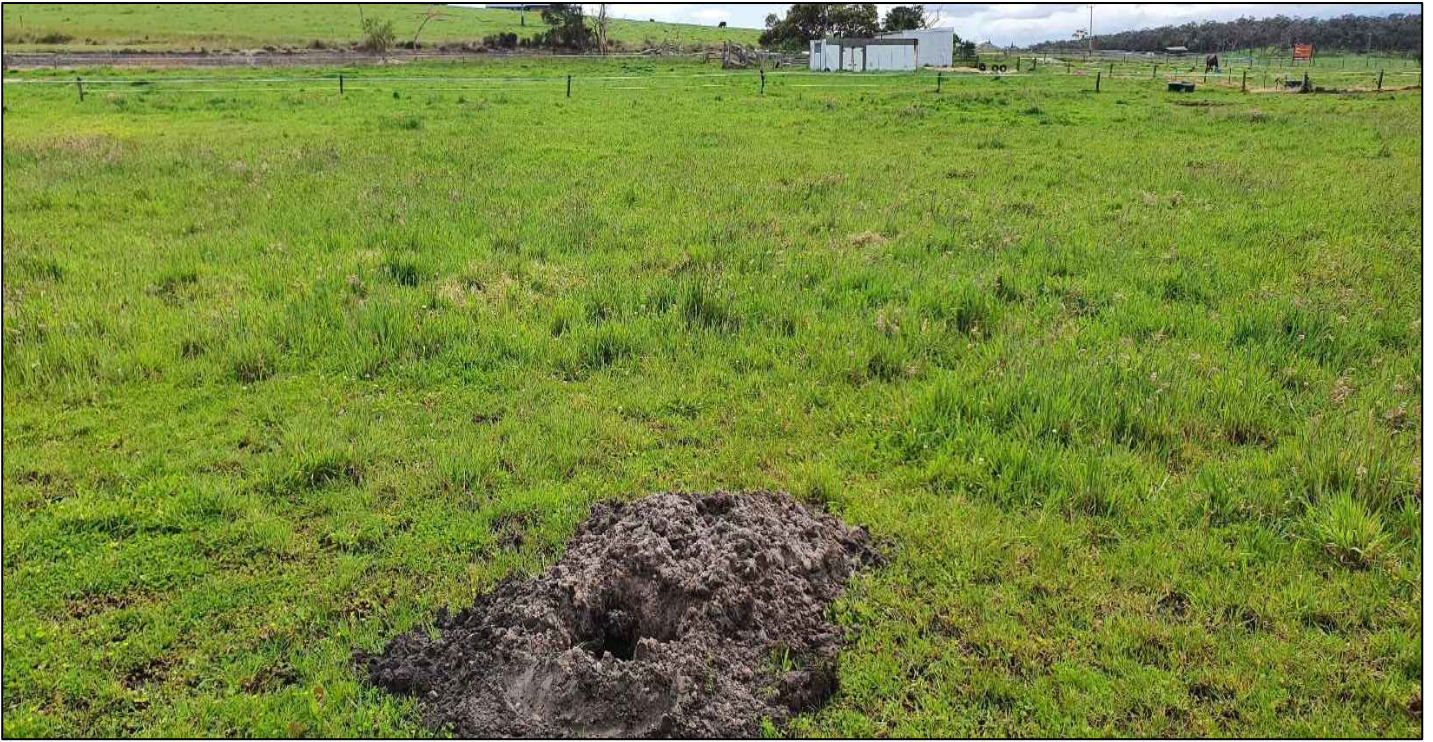
Test Pit No.5

Depth Below Surface (mm)	Layer Depth (mm)	Material Description SOIL TYPE, Plasticity, Colour, Particle characteristics, Secondary and other minor components	Moist. Condition	Consistency / Strength	Cementation	Water Table	Classification Symbol	Sample/Test
0 - 220	220	(Topsoil) SAND with silt: Dark grey, fine to medium. Contains roots and root fibres.	W	L-MD		Water table encountered @ 50mm below existing ground level.		
220 - 2000	1780	SAND with silt: Grey to light grey, fine to medium.	M-W	L-MD

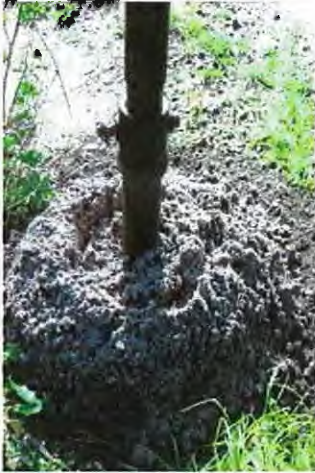
The top layer of the soil profile consisted of moist sand with silt which was light grey to dark grey in colour. The sand with silt layer extended from the surface to 2000 below the surface. The majority of the test pits across the site recorded this soil type on or below the 15m contour. Please see photographs below.

Photo One – Sand with Silt

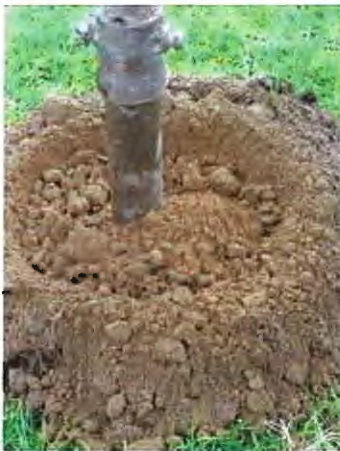
Test pit 2 and 19 recorded black sand to dark grey sand with silt over brown sand with gravel. These soils were found mid slope along the ridge, with the gravel layer varying from 100mm below surface level to 900mm. Test pit 19 had some silty clayey sand below the gravel layer. The presence of gravel soils indicates that there is the capacity of the soil to absorb phosphorous and nitrogen. Test pit 2 in the north west corner was the only test pit with gravel which encountered water table (in June 2007 sampling).

Photo 4: Sand over gravel
Test pit 19

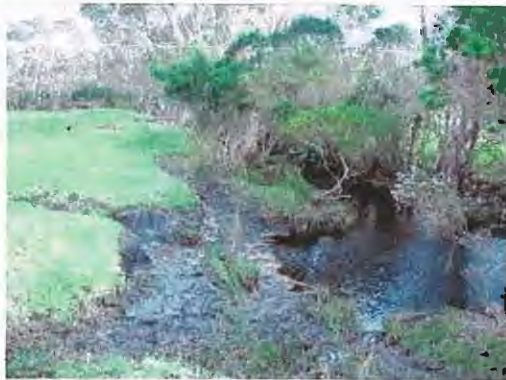
Stock (cattle) currently grazed on the property have access to all creek and wetland systems on the property. This is causing erosion to the creek lines and loss of vegetation to these areas. Please refer to photographs Nine and Ten below.

Photo Nine: Erosion to the banks of Five Mile Creek from cattle.

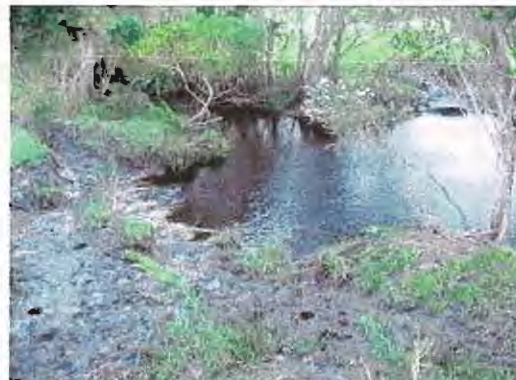
Photo Ten: Sediments and cattle effluent drain freely into five mile creek system.

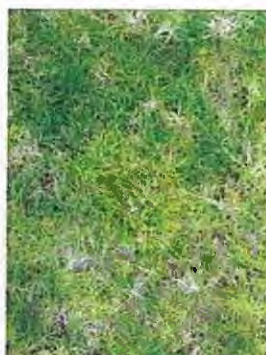
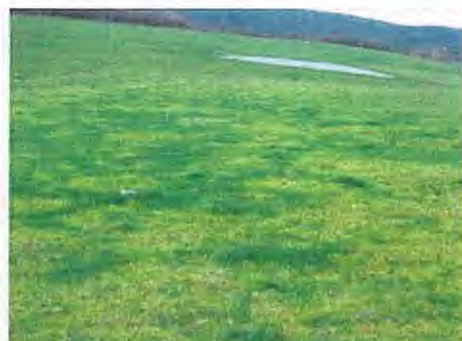
Photo Eleven (left): Pasture showing death and yellowing - nutrient deficiency.
Photo Twelve: (right) View of pasture showing nutrient deficiencies.

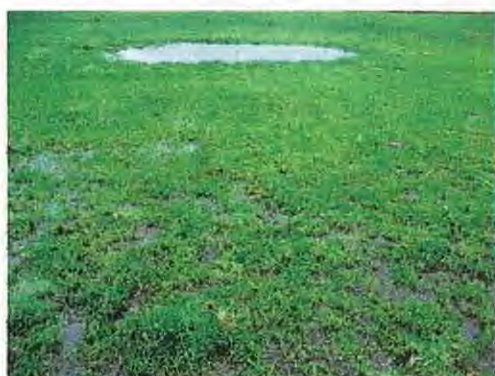
Areas from the aerial mapping showing water logging have been mapped and were confirmed with intensive sampling regime undertaken in late winter. These areas have been mapped on are a limitation in Section 7 Land Capability. Photographs Seventeen to Eighteen below show typical waterlogged areas across the site.

Photo Seventeen: Water logged area in northwest corner.
