FORESHORE MANAGEMENT PLAN

Emu Beach

EEL19265.001
Rev 0
04 June 2021

REPORT

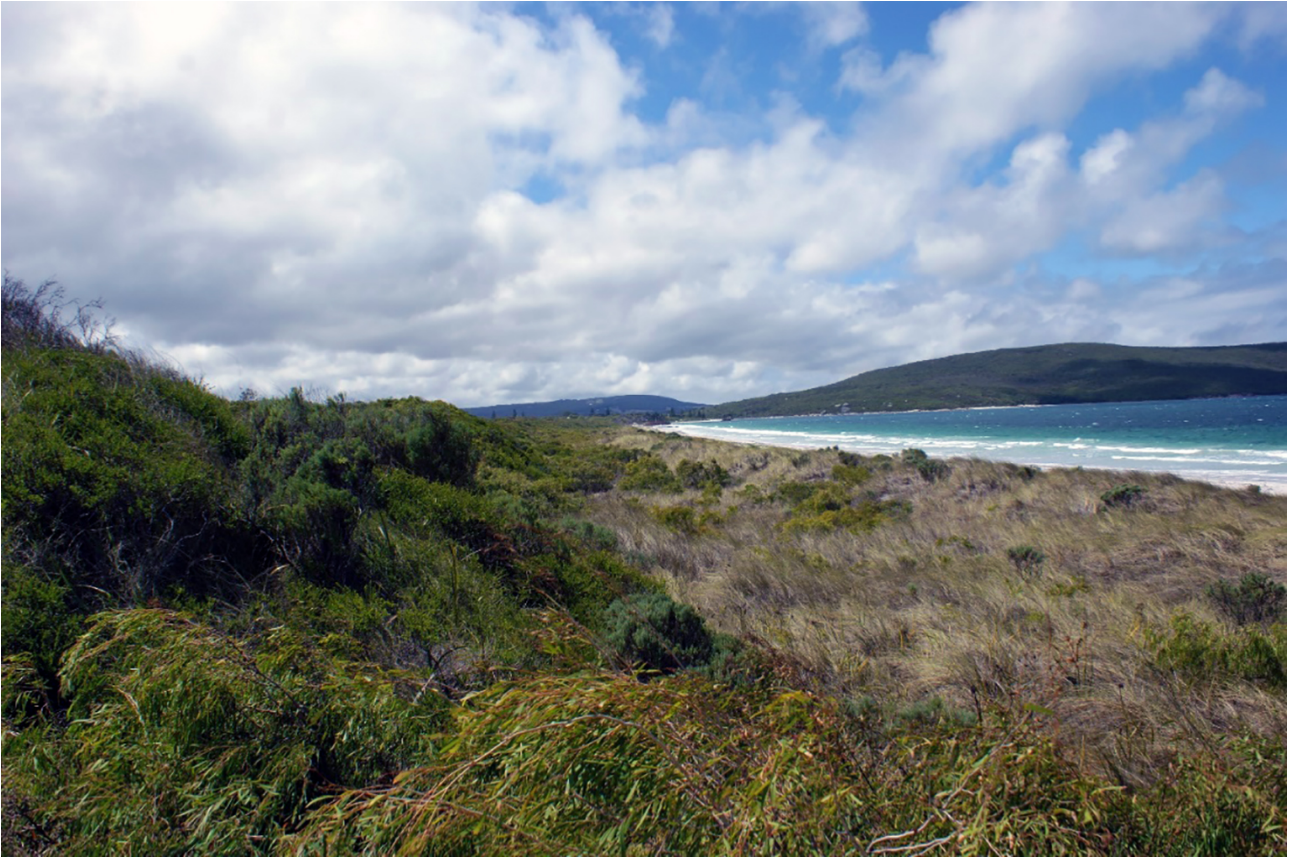
Plate 2: Peppermint Thicket and Littoral zone vegetation associations in the south of the FMP area

The site walk over confirmed the findings of Strategen (2007), and ATA Environmental (2006), that the peppermint thicket vegetation extends to the southern border of the FMP area (Plate 2) and to the north of the Hickman (2005) survey area to Firth Street (Figure H). The Littoral zone vegetation was also found to extend to the southern border of the FMP area (Plate 2) and approximately 150 m to the north of the Hickman (2005) survey area (Figure H).

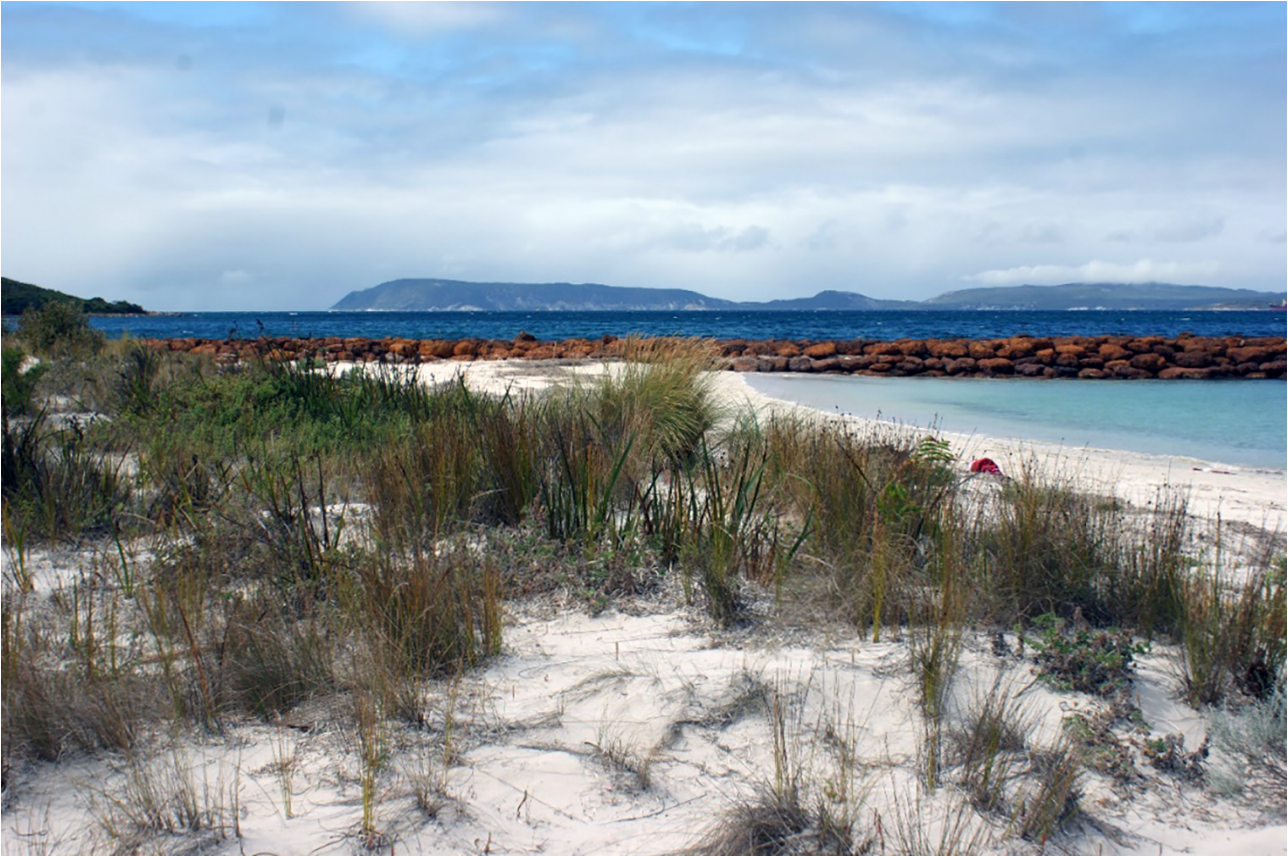
Plate 3: Rehabilitation of Littoral zone vegetation association at Emu Point beach

The Littoral Zone vegetation at Emu Point Beach and the fringing peppermint trees to the north of the beach have been subject to rehabilitation efforts (Plate 3; Figure H). Ongoing weed management is required to control introduced species, including sea spurge (**Euphorbia paralias*), within the rehabilitation areas. Section 7 identifies the approach to be implemented in rehabilitating Emu Point Beach foreshore environment.

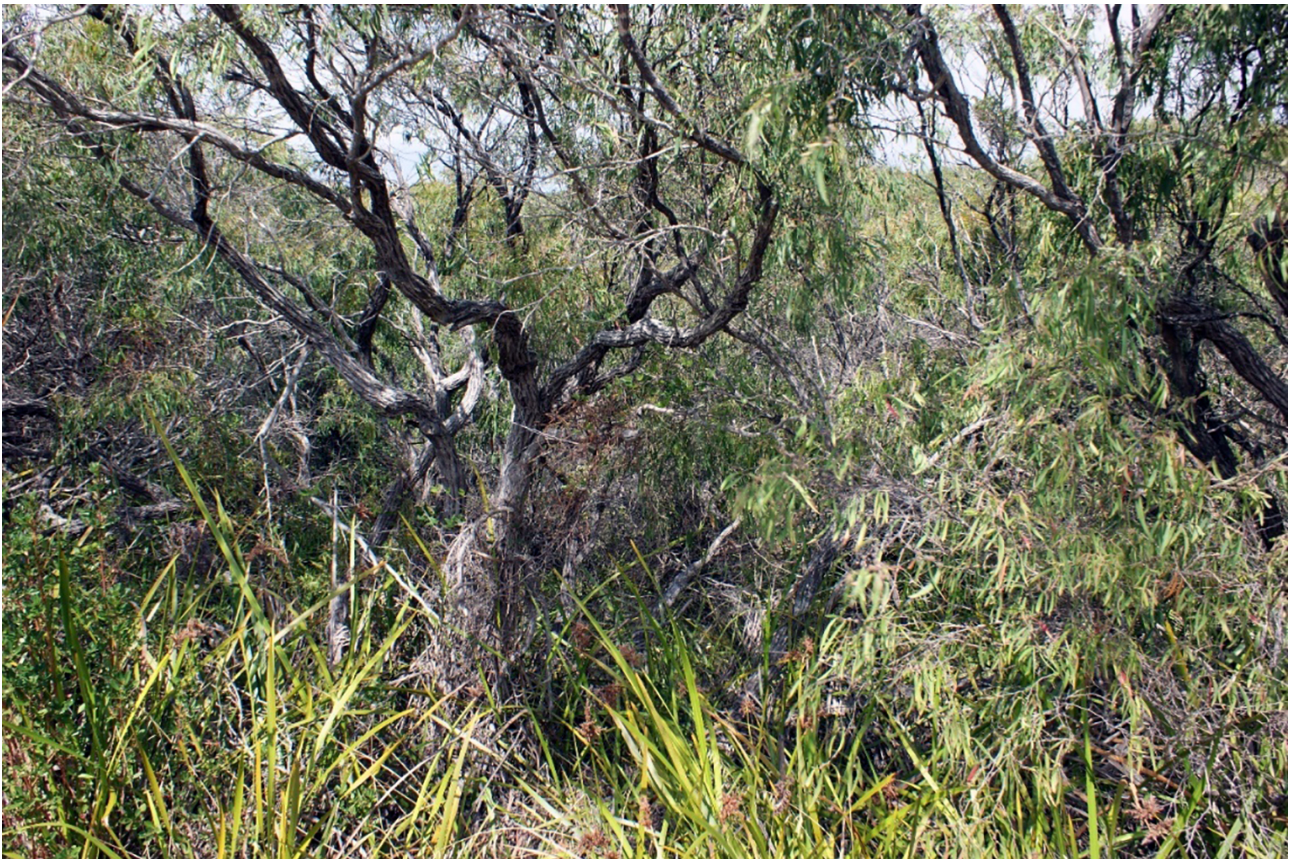
Plate 4: Closed peppermint (*Agonis flexuosa*) thicket over sedgeland habitat

The key western ringtail possum habitat type within the development site is the closed peppermint (*Agonis flexuosa*) thicket over sedgeland (Plate 4), which dominates the FMP area (Figure 1). The site walk over confirmed the extent of the key western ringtail possum habitat (i.e. peppermint Thicket vegetation) is consistent with the ATA Environmental (2006) fauna habitat mapping (Figure 1).

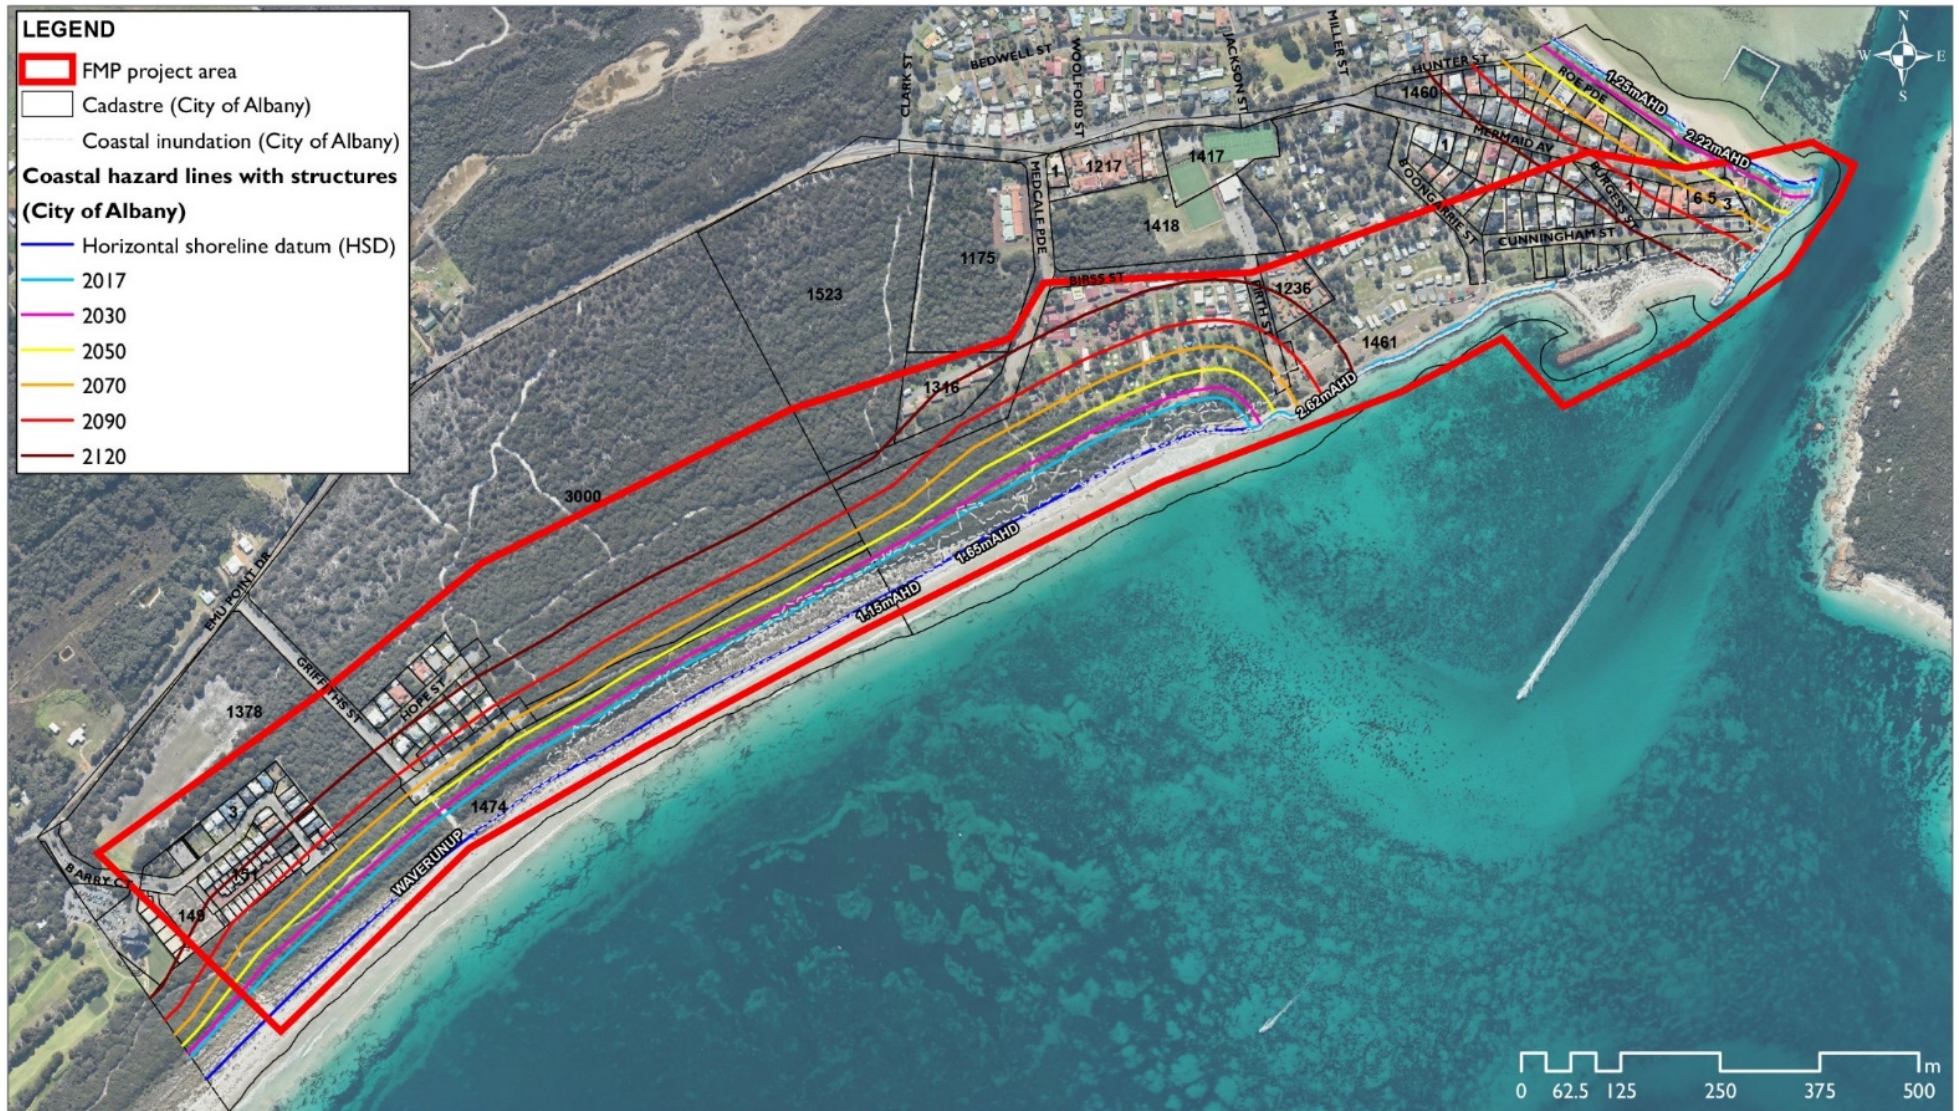
Figure 3: Coastal hazard risk for the FMP area over the 100 year planning period with coastal structures

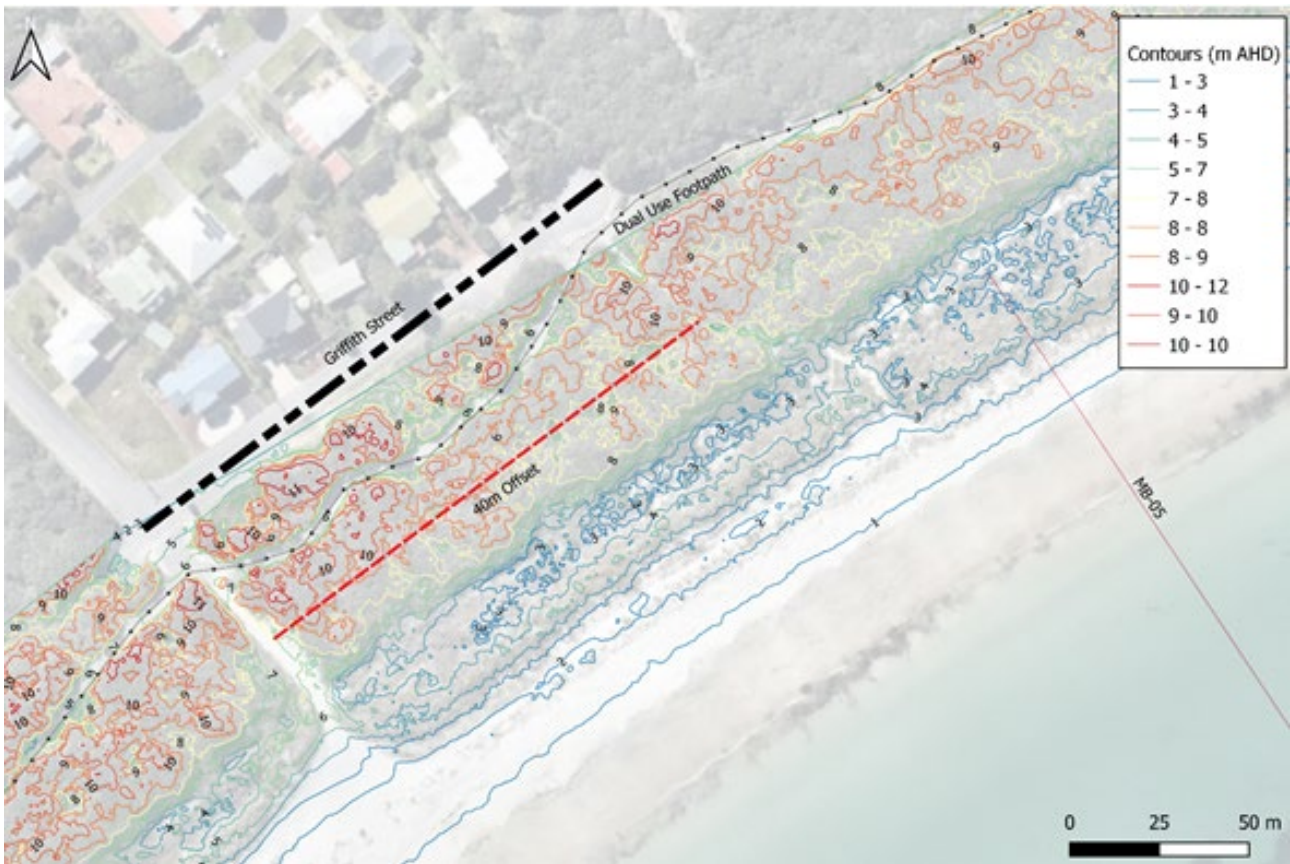
Figure 5: Topographic survey (March 2019) of the Griffiths Street foreshore and 40 m trigger value

A recent topographic survey (March 2019) established the 40 m trigger line landward of the foredune and at an approximate distance of 70m to HSD (Figure 5). Signs of long-term beach accretion in this location have been documented in Royal Haskoning DHV (2017). The trigger point is considered unlikely to be activated in a 1 in 100 year event (Bluecoast Consulting Engineers 2021). However should this occur, sand nourishment will be undertaken and monitored to ensure the long-term accretionary trend continues along this part of the beach (Bluecoast Consulting Engineers 2021).

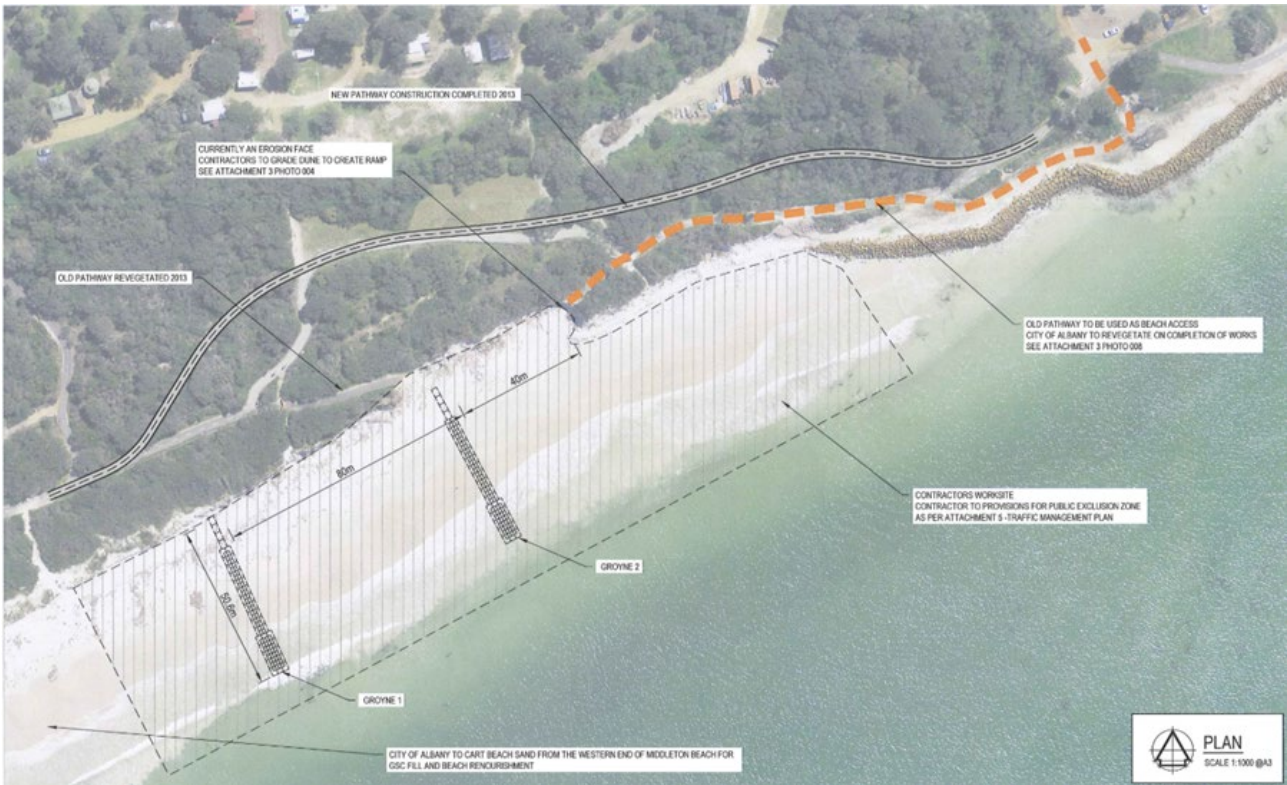
The GSC groynes were installed in 2014 as a trial to assess protection of Emu Point Beach (Figure 7). The GSC groynes have shown to be of benefit in the retention of sand, however due to their exposure to cyclic wave action and UV the condition of the groynes has deteriorated and now present as a risk to public safety (Bluecoast Consulting Engineers 2021).

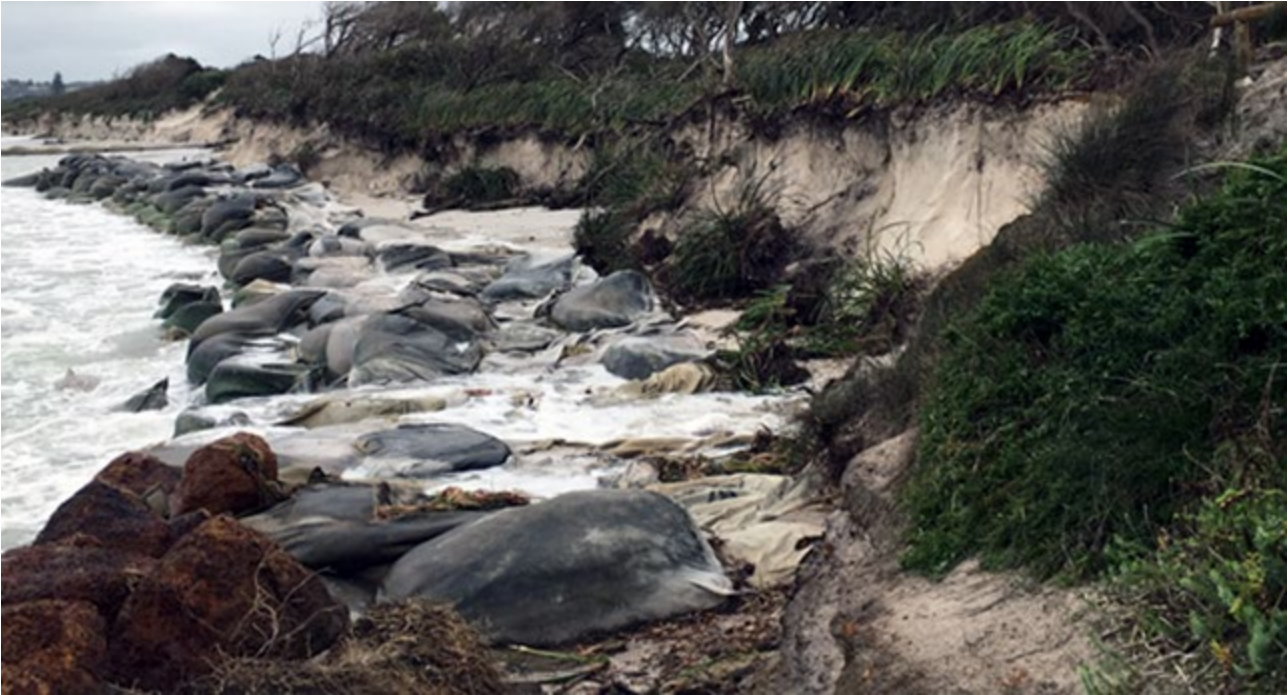
A large erosion scarp has formed on the beach immediately to the west of the Emu Beach ‘BIG4’ Holiday Park between the Emu Point rock revetment and GSC groynes. A GSC revetment has been established in this location and subsequently damaged, primarily due to cyclic wave action (Plate 5).

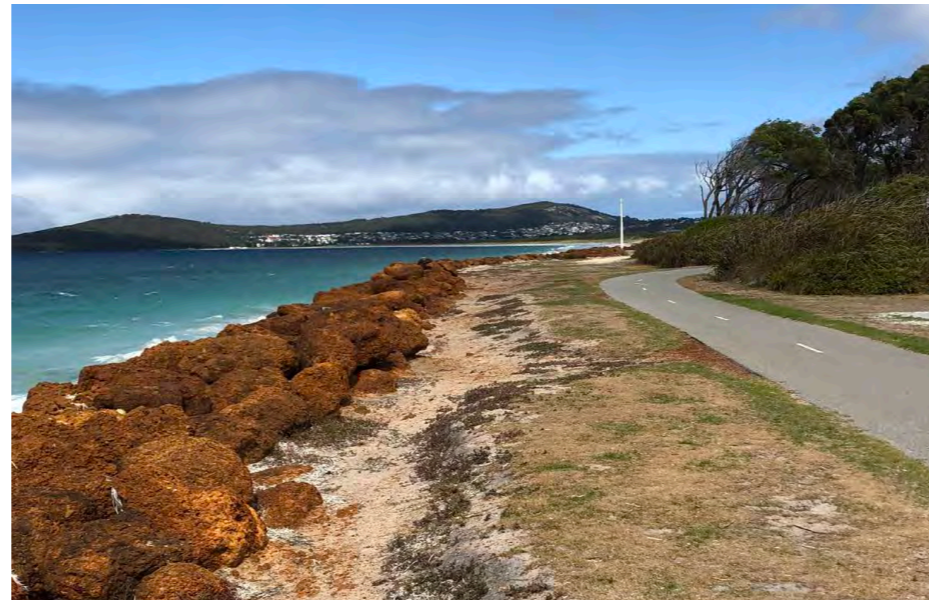
1. Existing coastal structure

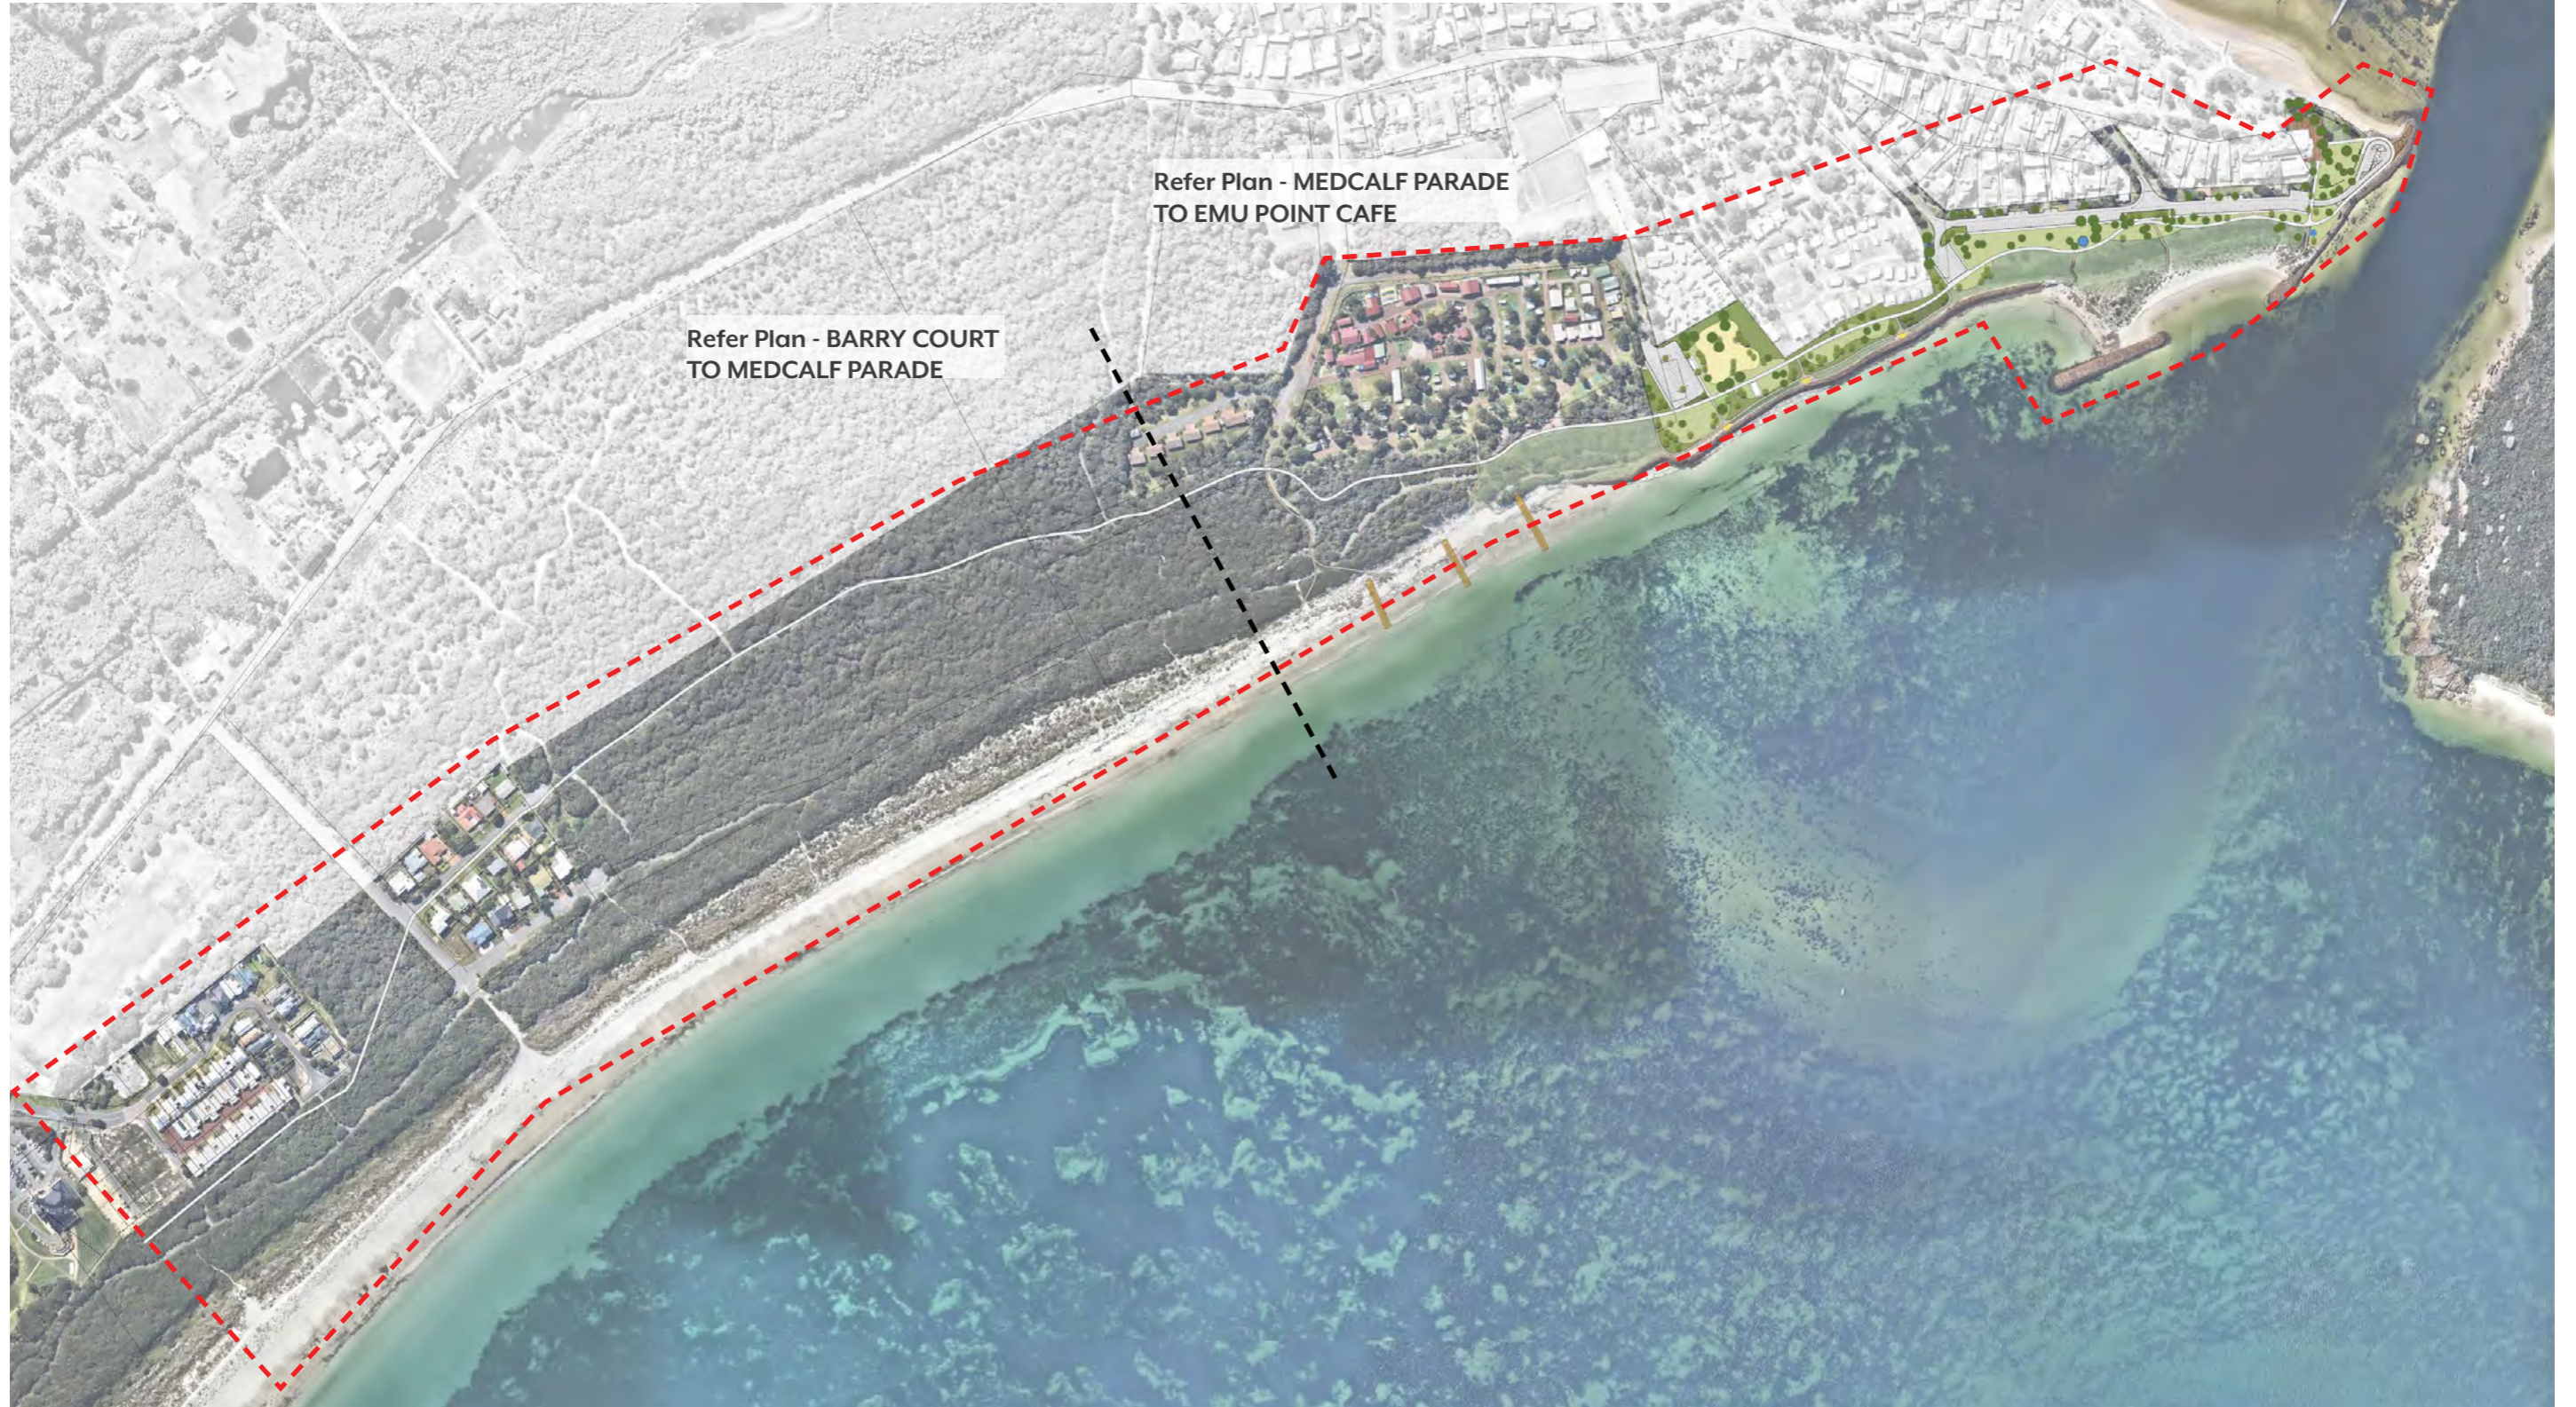
04. Overall Landscape Masterplan

BARRY COURT TO MEDCALF PARADE

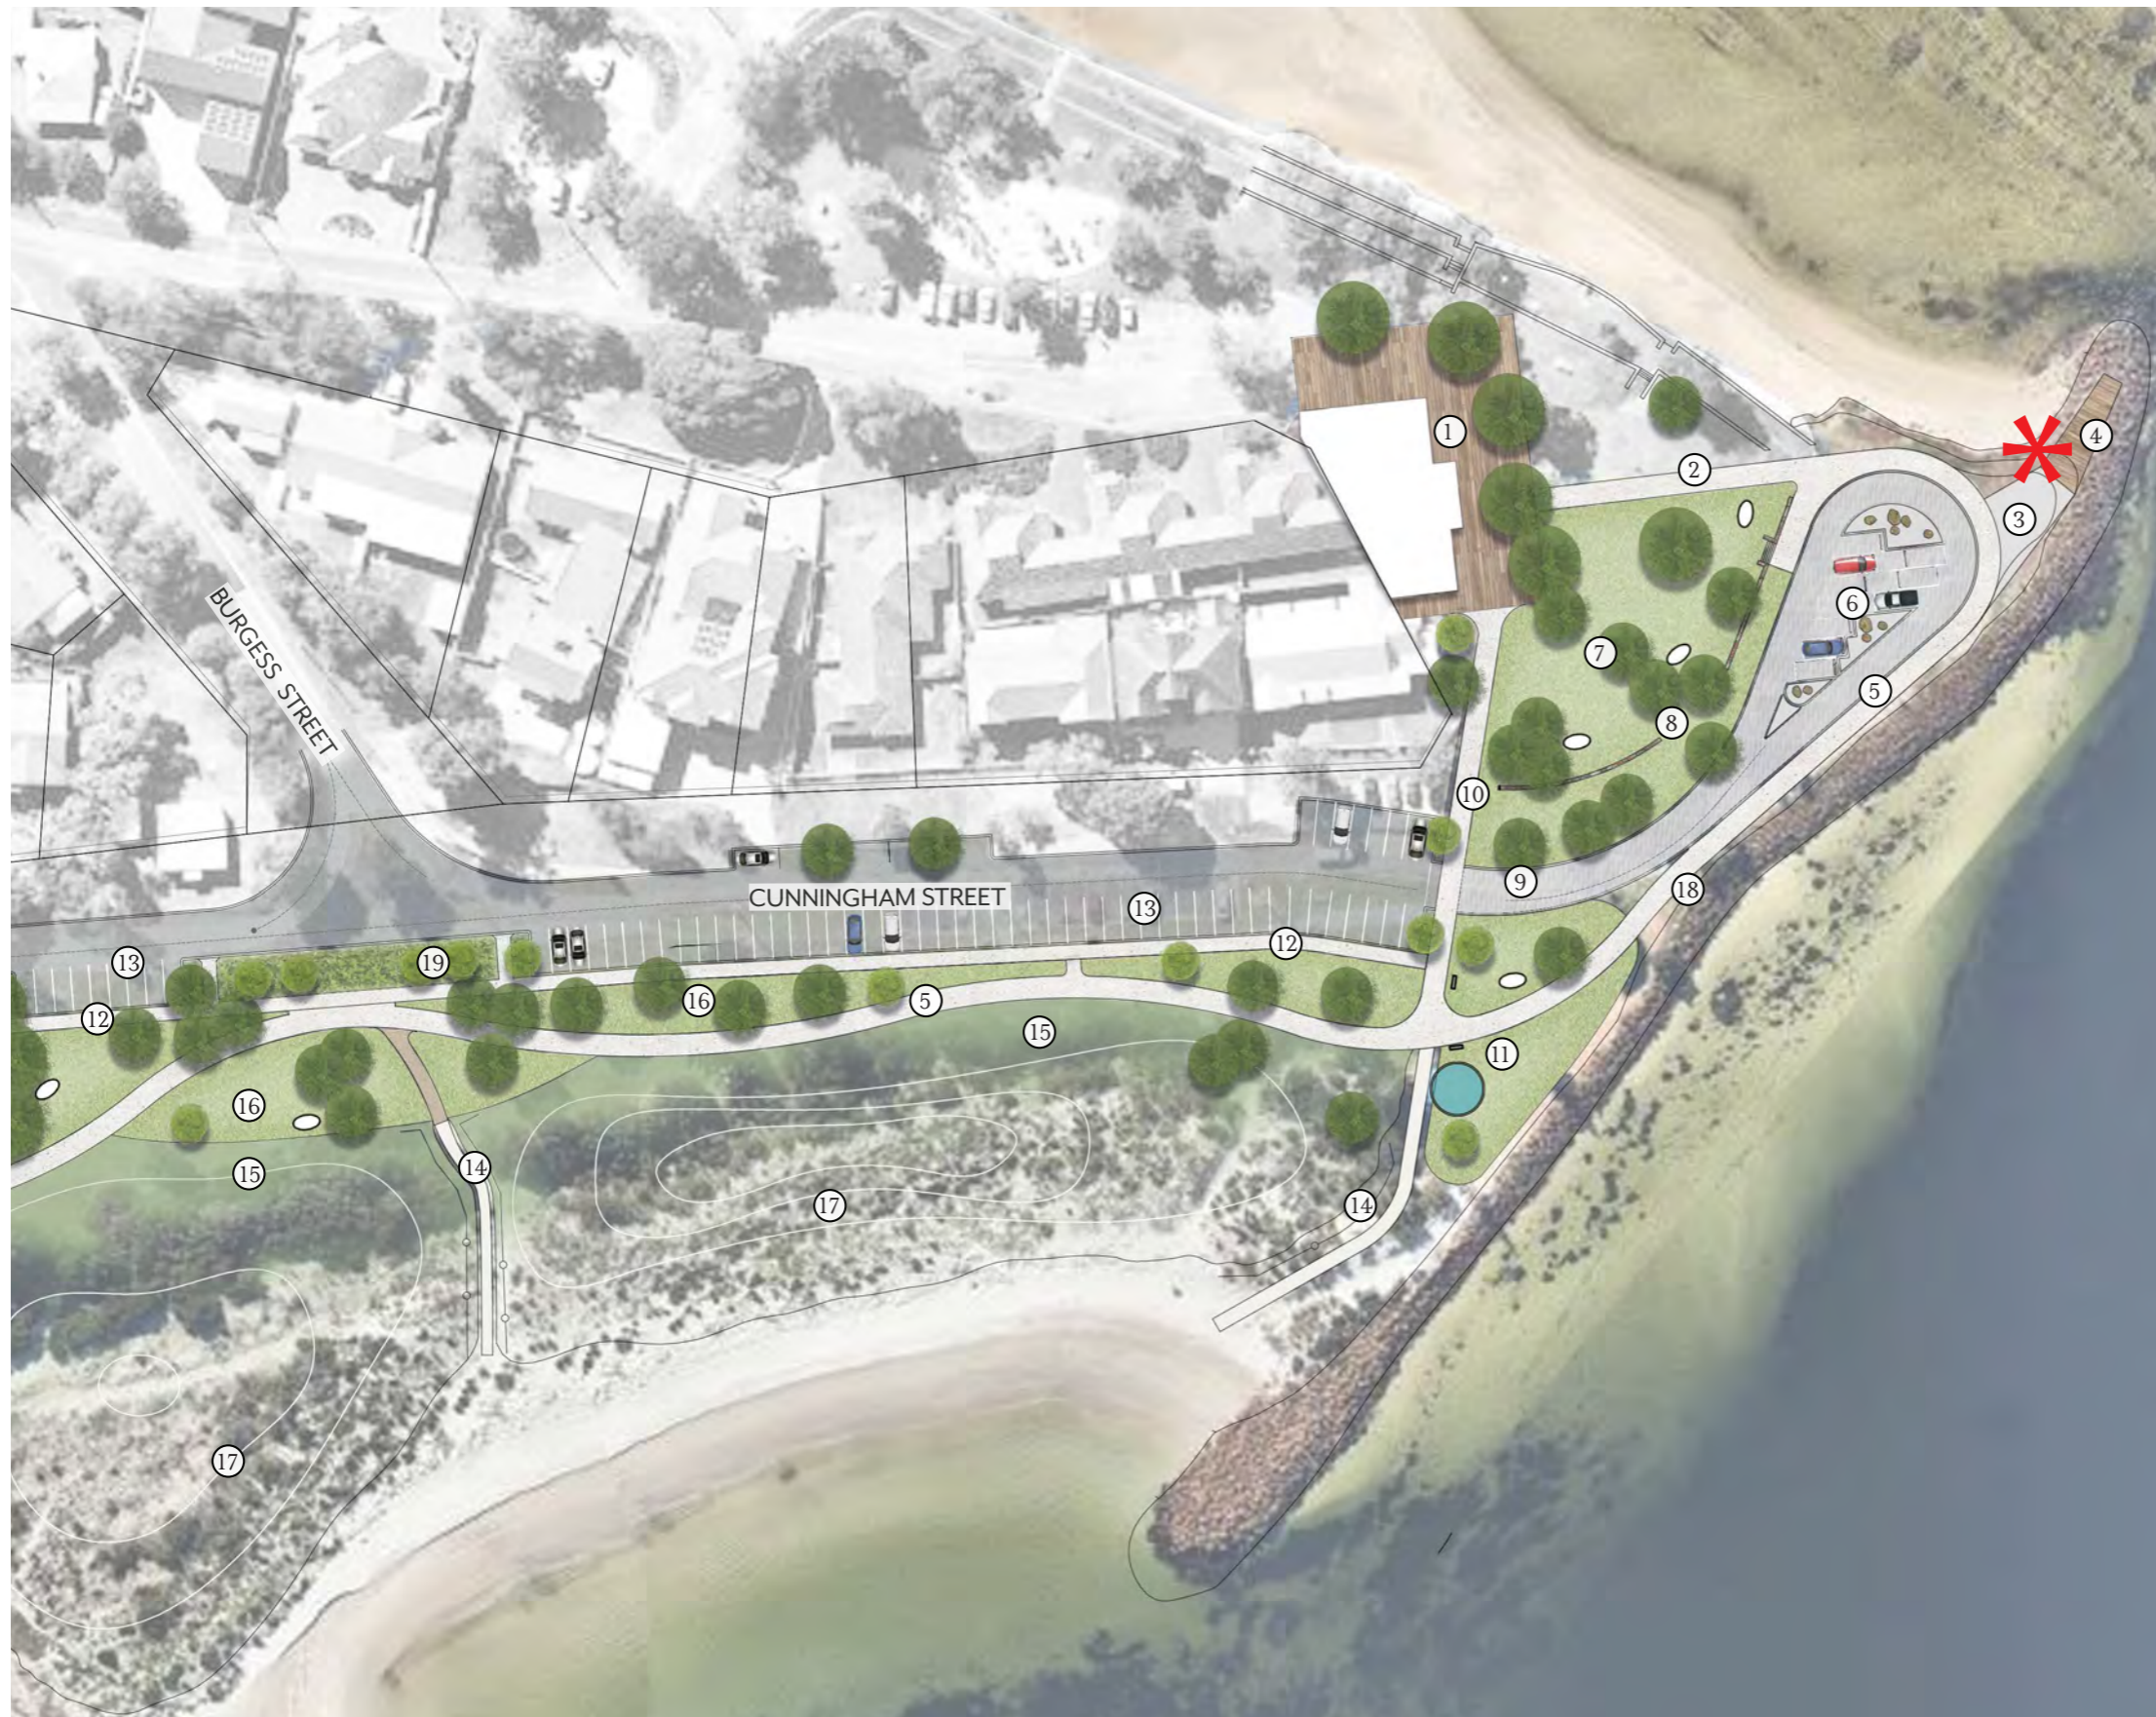
EMU POINT_DETAIL PLAN

1. Emu Point plaza and public realm to existing cafe and public toilets including the retention of existing shade trees.
2. Dual use path (3m)
3. Dual use path termination - Port to Point connection. Flexible event space and disabled access to platform

17. Existing coastal dune.
18. Coastal planting to base of existing coastal structure
19. Streetscape coastal planting

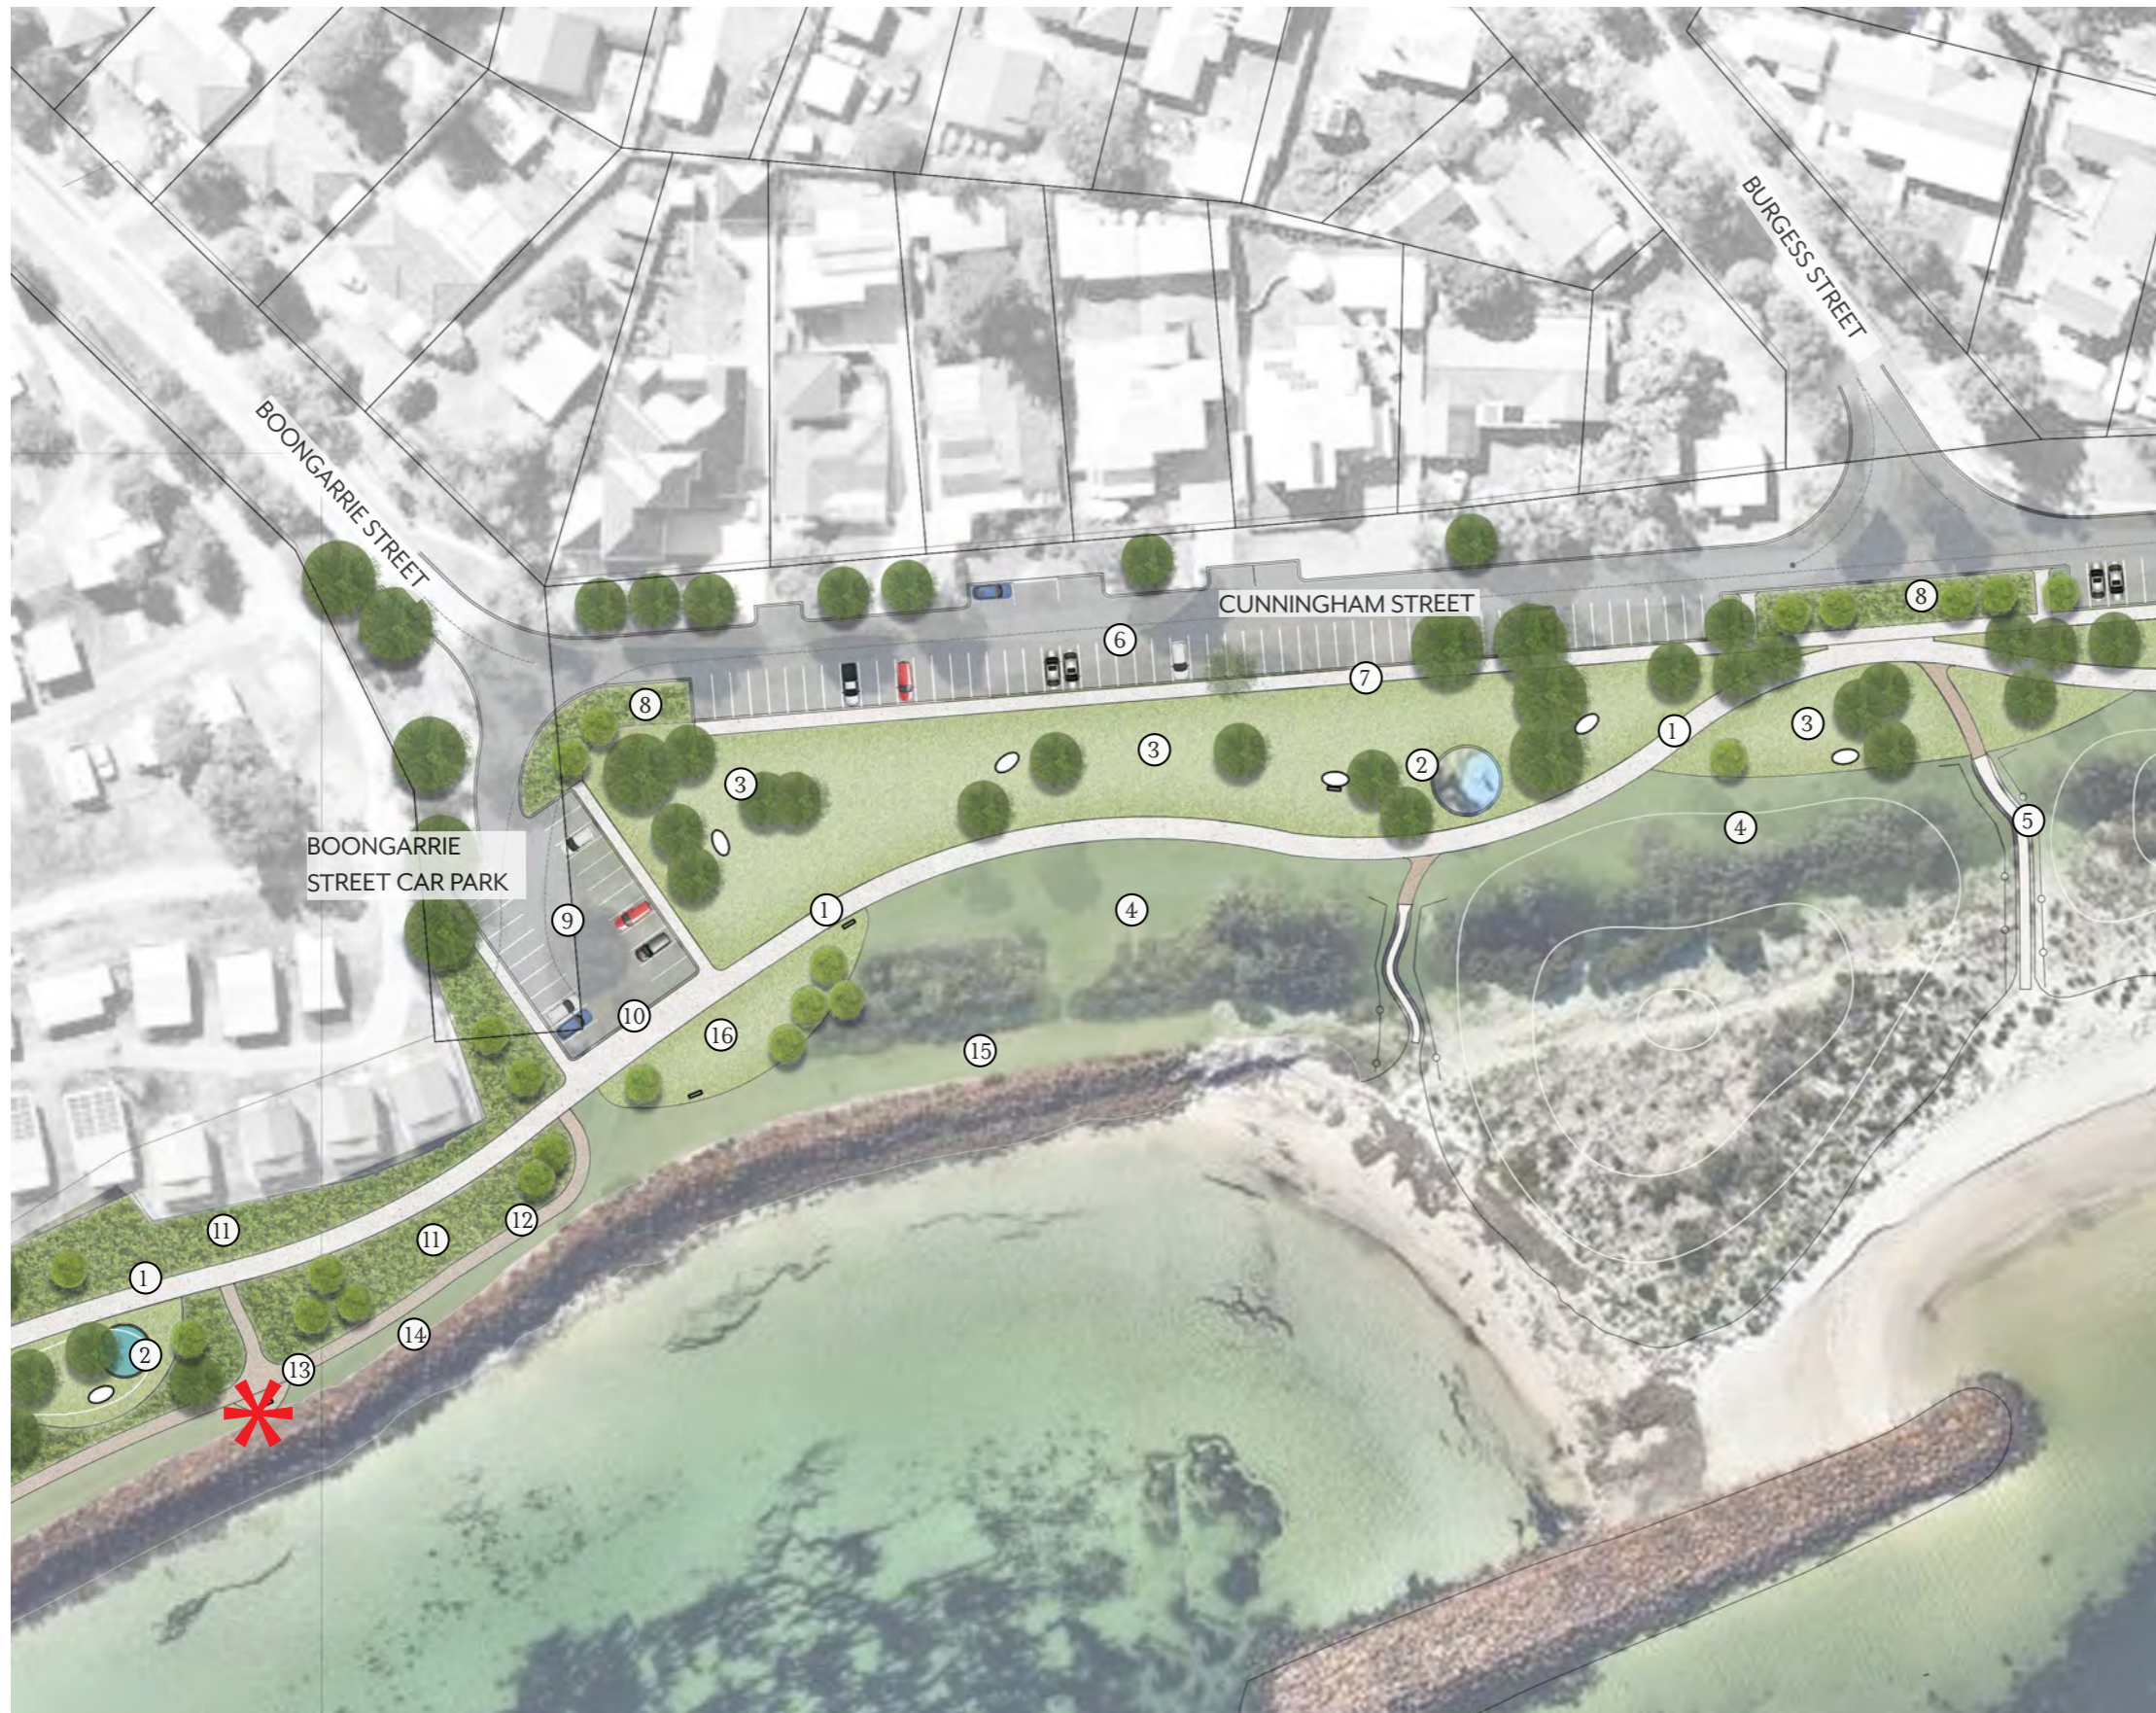
BOONGARRIE STREET DETAIL PLAN

1. Dual use path (3m) including seating opportunities.
2. Exercise node, including exercise equipment + seating and drinking fountains
3. Open turf space including updated amenities. (Shelters, BBQ, + Seating) Turf depressions to assist with protection of prevailing winds.

14. Coastal planting to base of existing coastal structure
15. Re-vegetation to existing beach access and coastal structure including fence protection.
16. Open turf offering emergency vehicle access and turnaround
