FORESHORE MANAGEMENT PLAN

Emu Beach

EEL19265.001
Rev 0
04 June 2021

REPORT

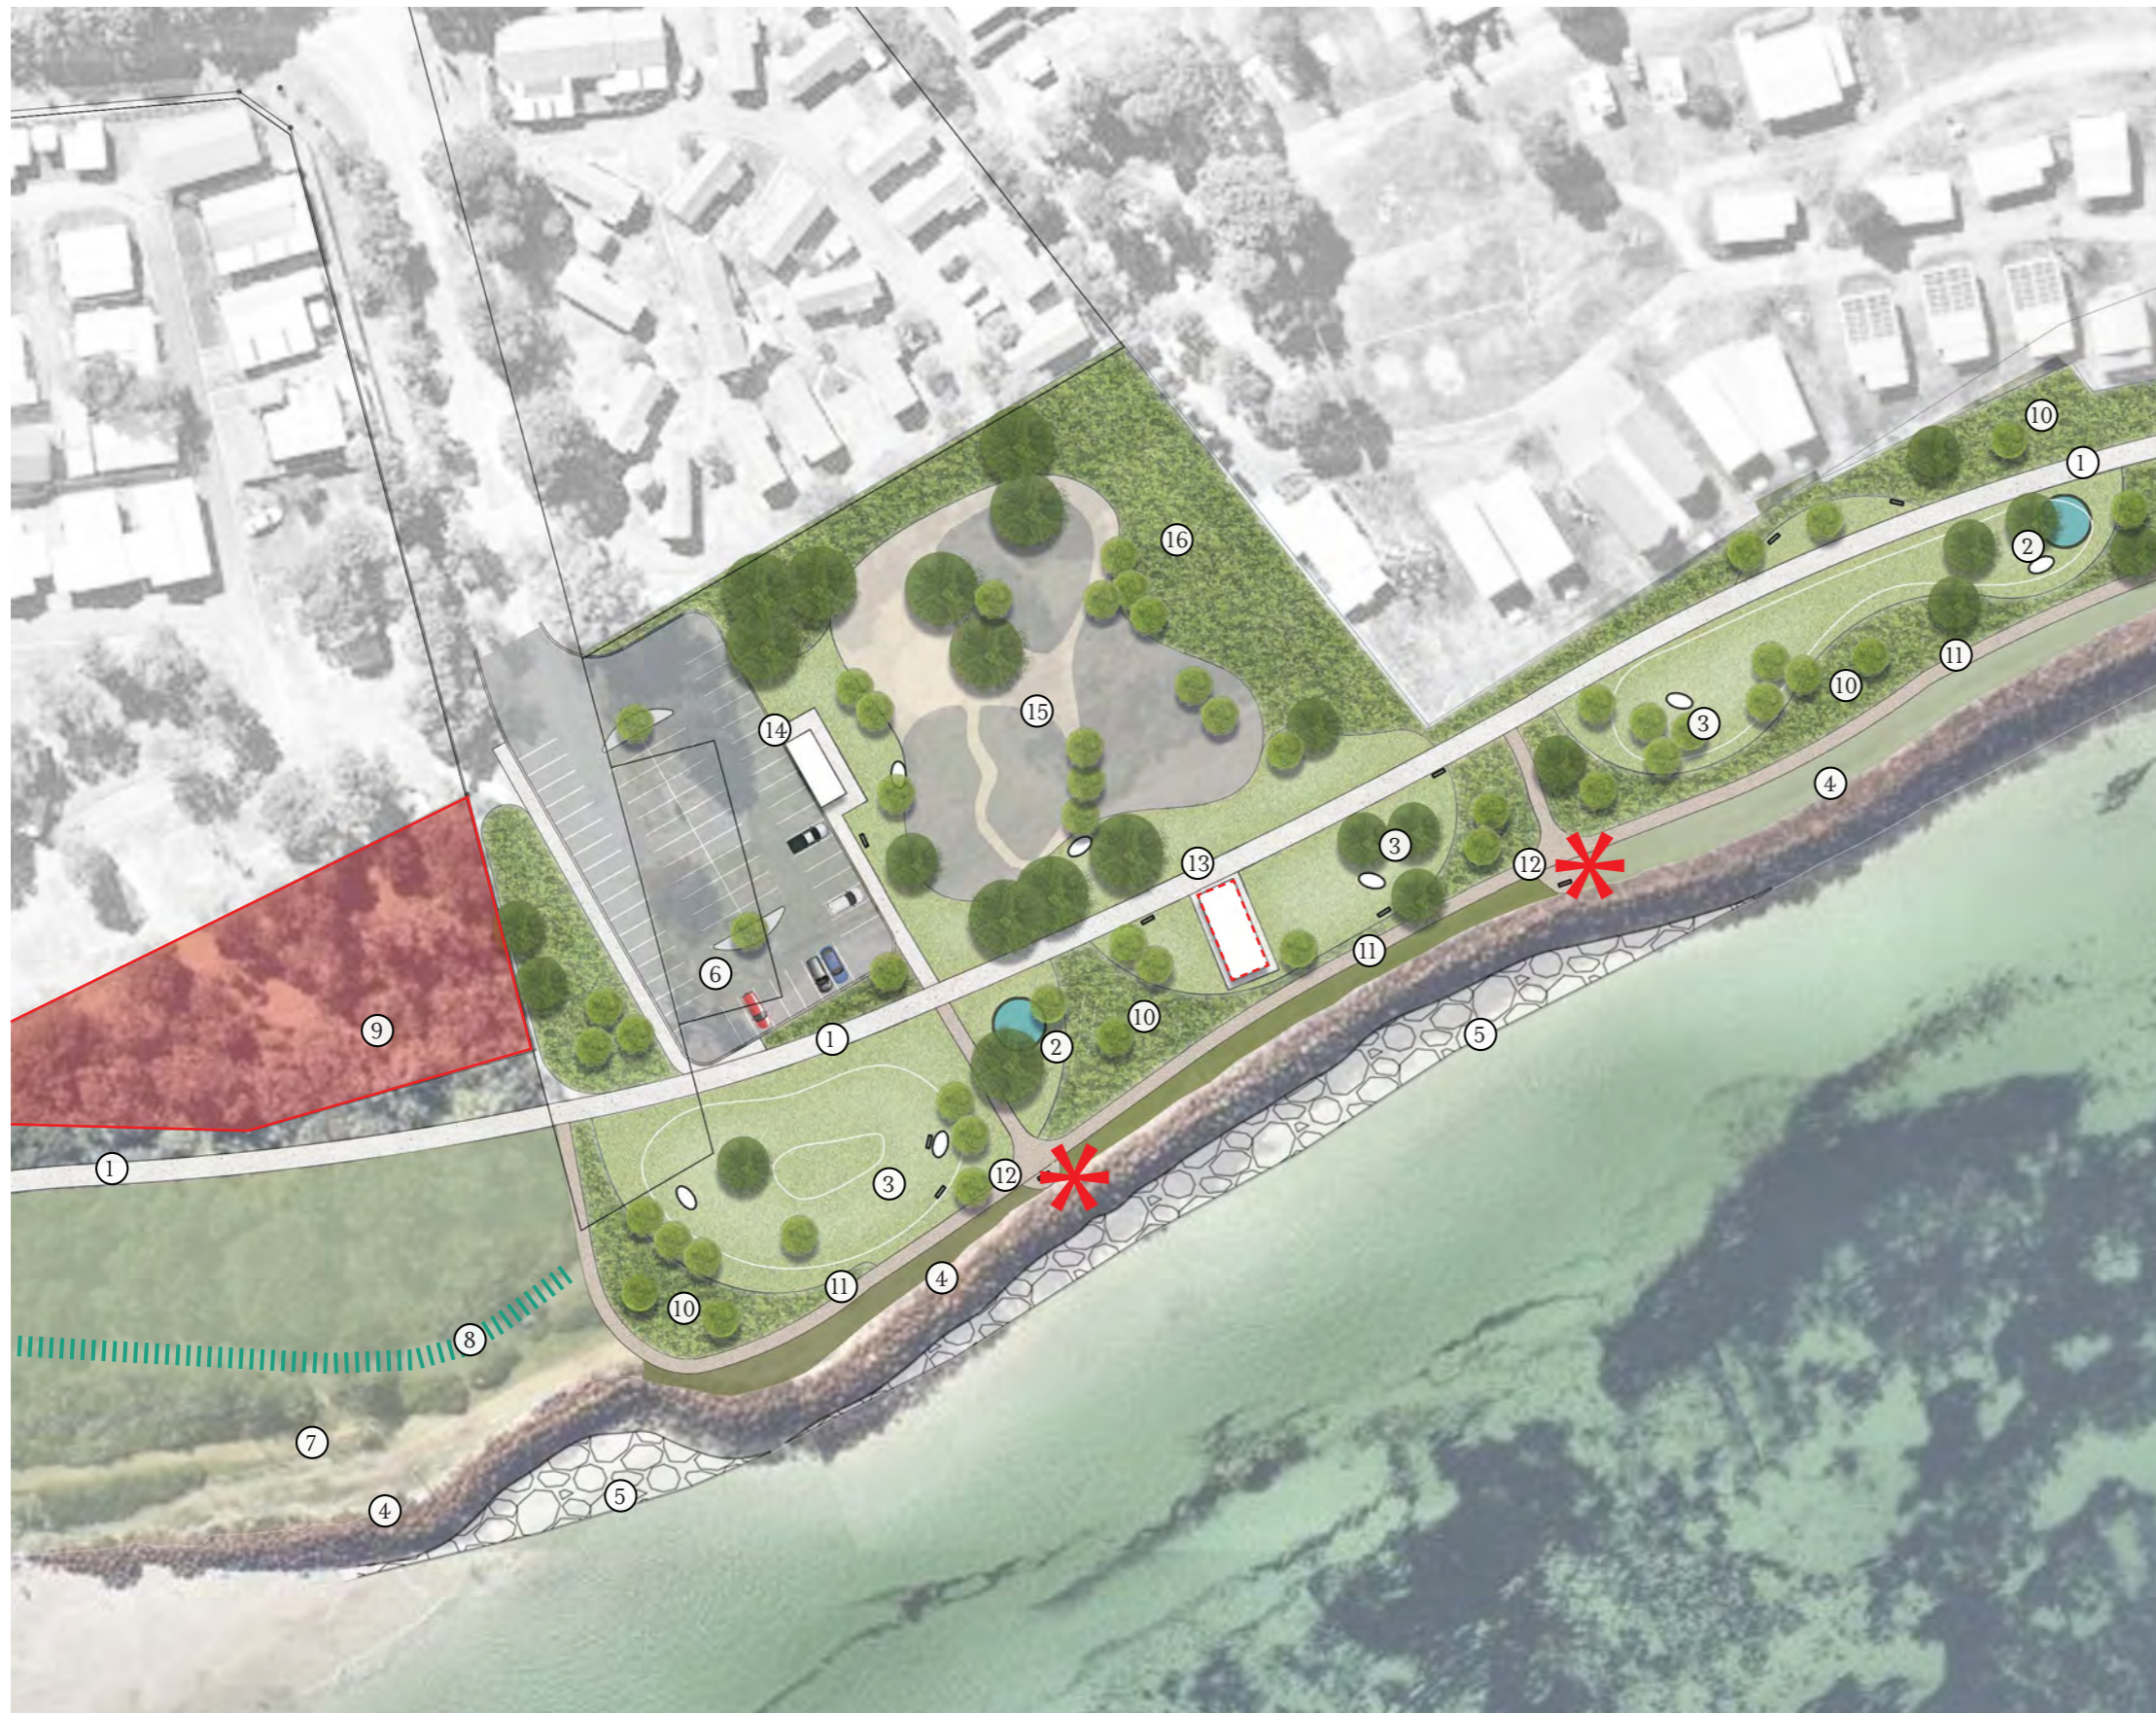
FIRTH STREET DETAIL PLAN

1. Realigned dual use path (3m) including seating opportunities.
2. Exercise node, including exercise equipment + seating and drinking fountains
3. Open turf space including updated amenities. (Shelters, BBQ, + Seating) Turf depressions to assist with protection of prevailing winds.

16. Existing and new vegetation offering screening to adjoining properties.

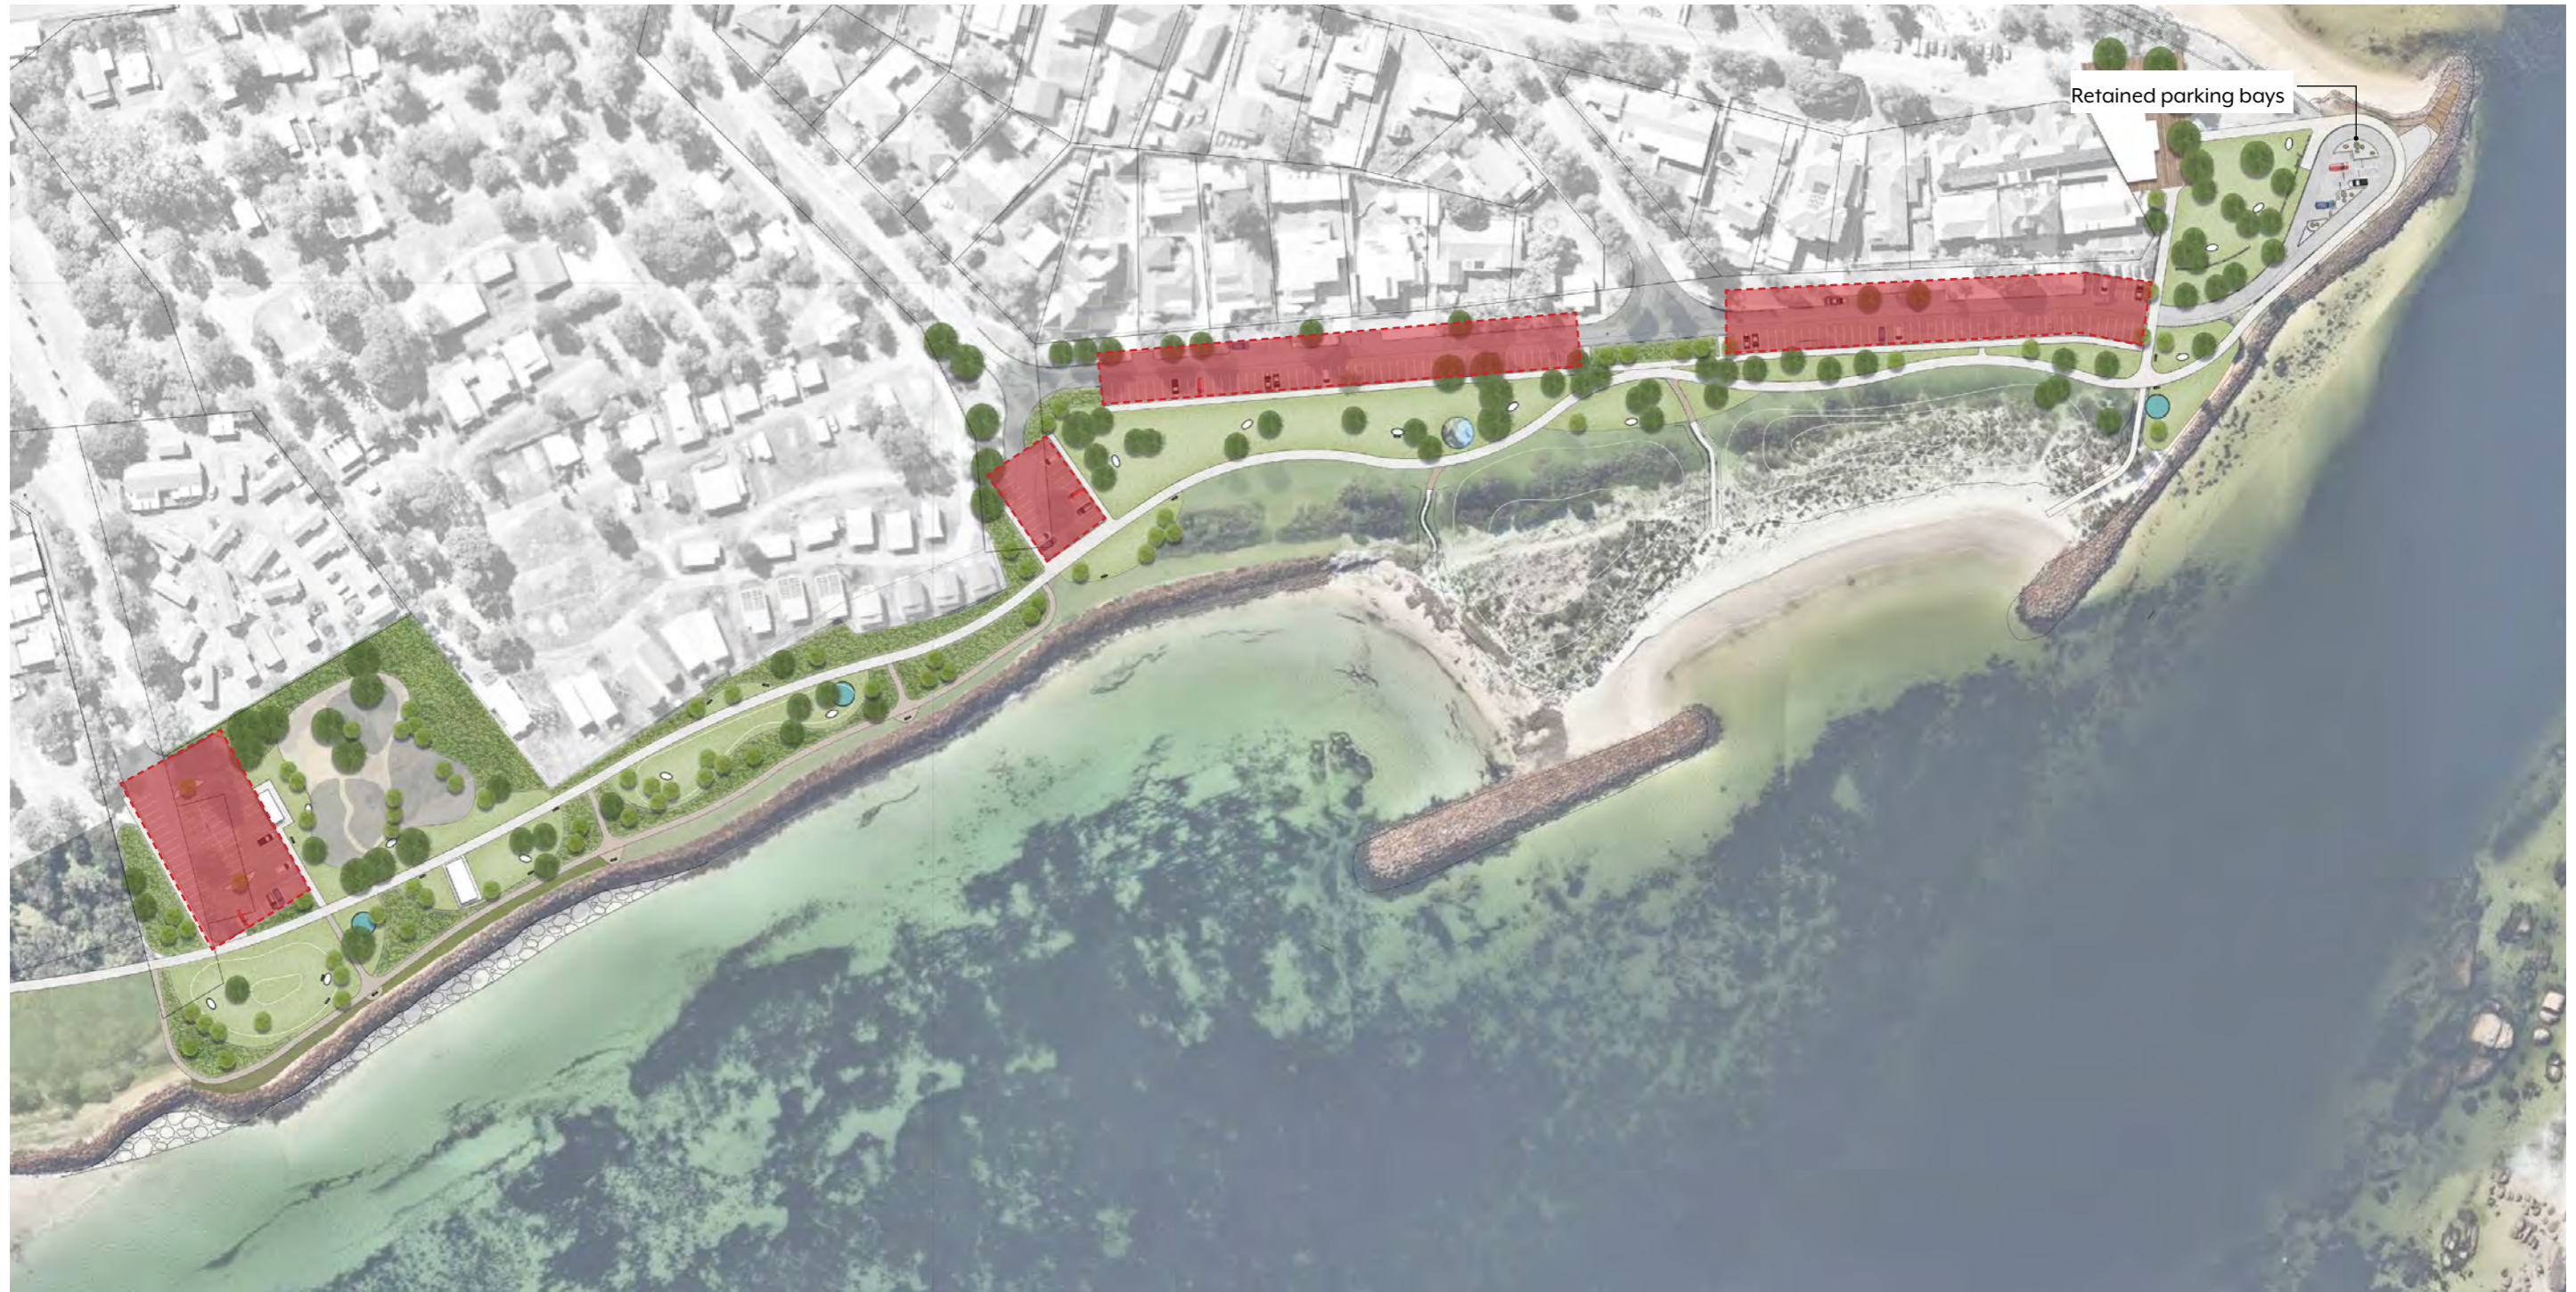
PROPOSED PARKING

The below diagram indicates the proposed formalised parking numbers and locations along Emu Beach.

Formal parking bays	210
Retained parking bays	9
TOTAL	219

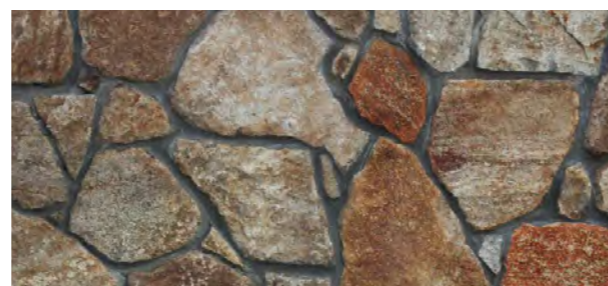
1. Local stone walling

Emu Beach is well known by locals and visitors for its granite terrace walling, these walls are to be enhanced and protected where required with the addition of new walling where deemed appropriate.

The use of readily available and robust materials is recommended in areas where new walling may be required. These materials to be utilised are to ensure the local granite is enhanced within the key public spaces.

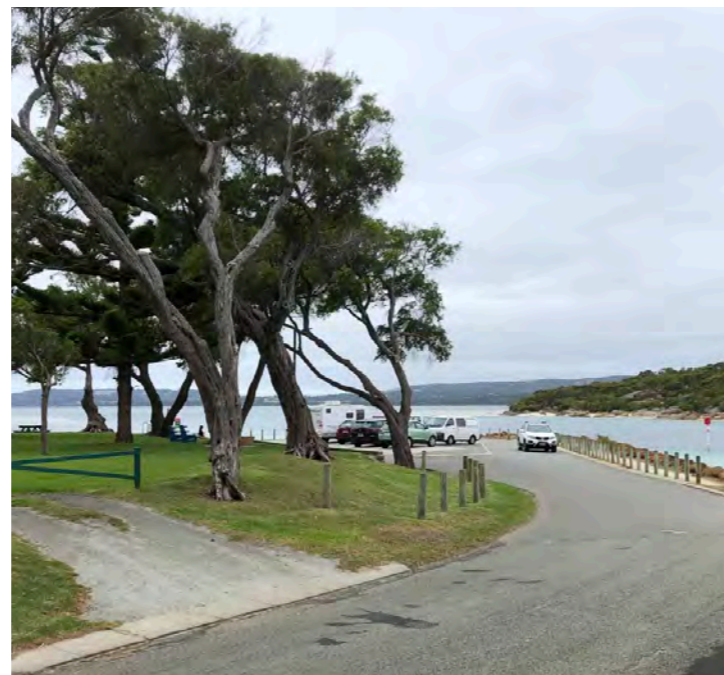
1

1. Vehicle access and car park adjacent coastal structure. Vehicles given priority whilst separating park land and waterfront.

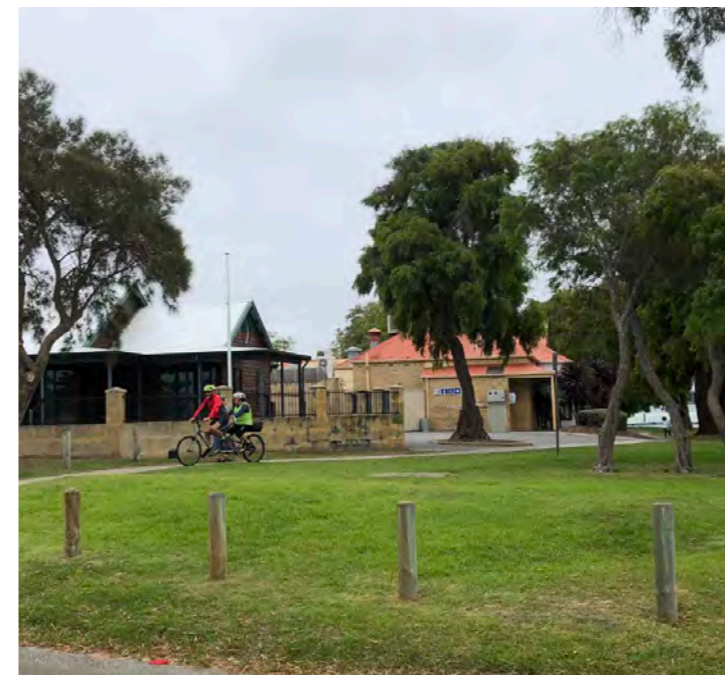
2. Connection to public toilets and cafe adjacent residential lots. Public toilets limited and often at capacity during peak times

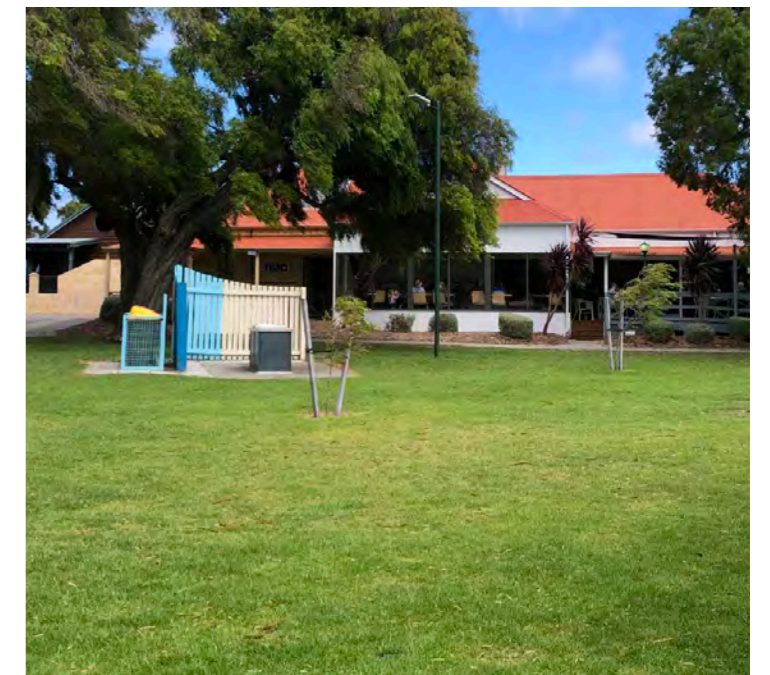
3. Minimal existing public amenities including limited weather protection.

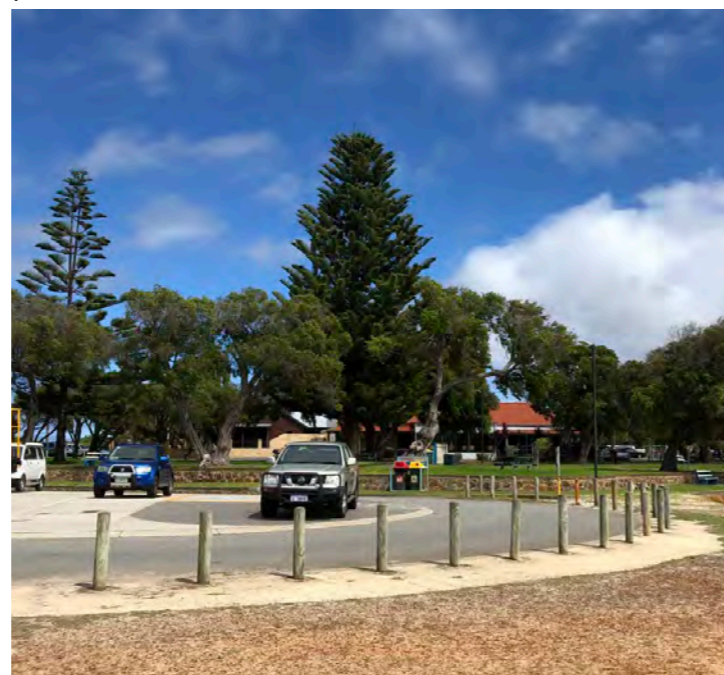
4. Car park and vehicle turn around. (Minimal bays x 8)

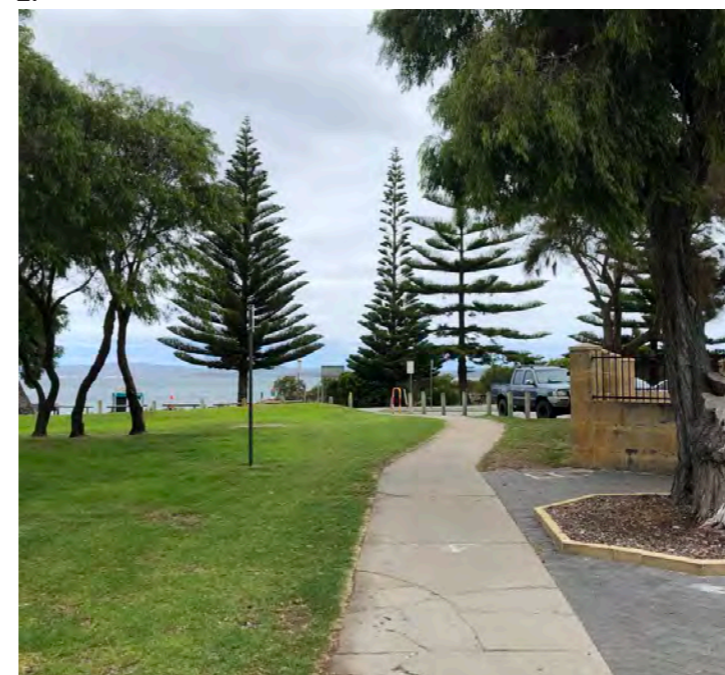
5. Minimal pedestrian access through park with pedestrians required to navigate various level changes. Dual use path terminates abruptly.

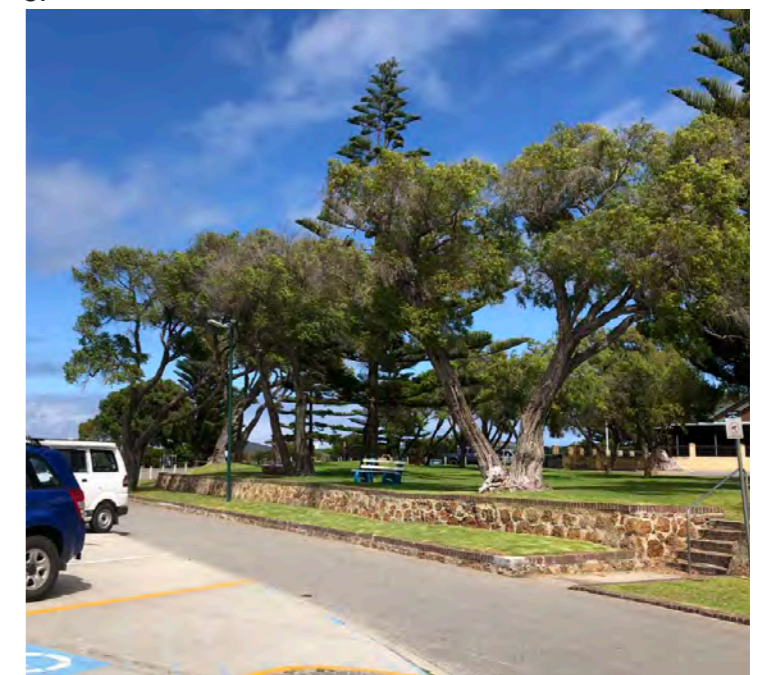
6. Existing terracing and level changes (limited universal access). Existing shade trees key feature through out parkland.

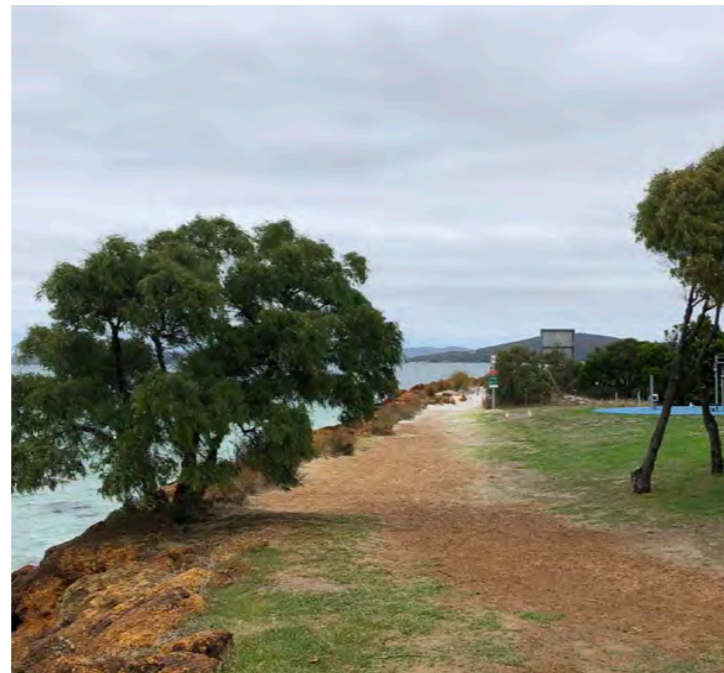
1

1. Informal and limited access path ways to beaches and public amenities.

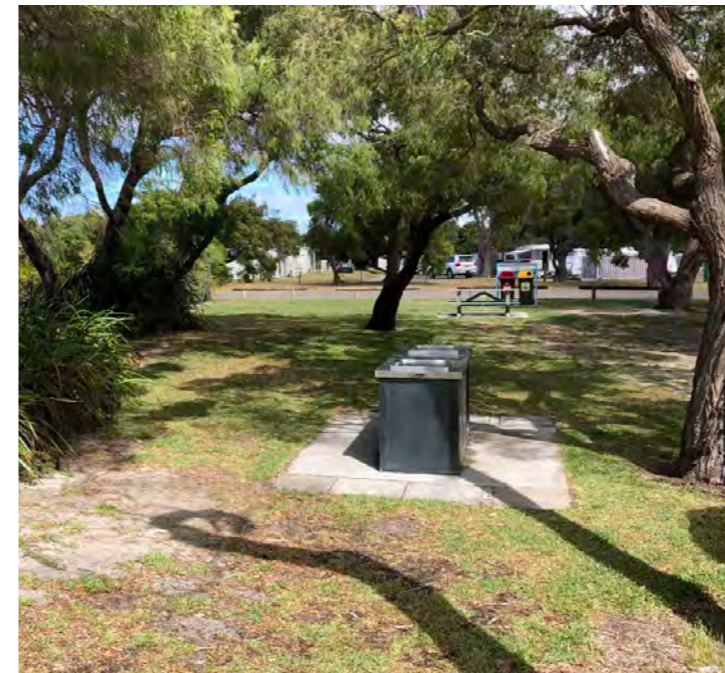
2. Existing amenities with limited weather protection, however utilising existing vegetation buffers for protection from prevailing winds.

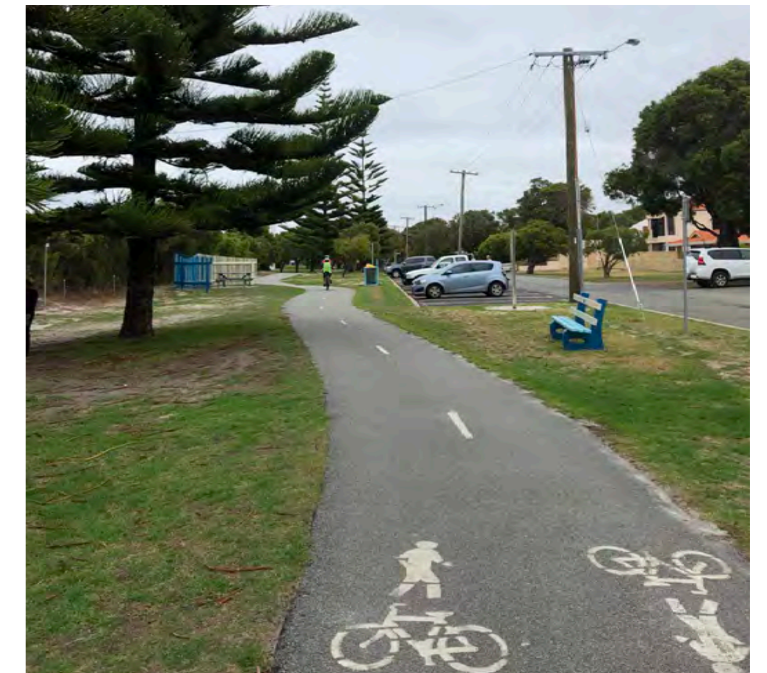
3. Dual use path coastal path starts/ends adjacent existing car parking. Potential to formalise parking along Cunningham street (south side) and extend dual use path and include formalised pedestrian access

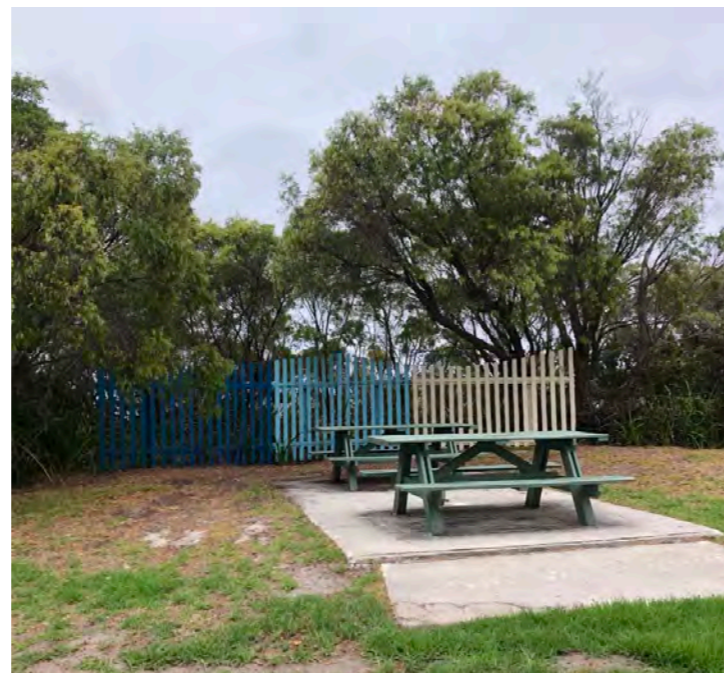
4. Limited and aging public amenities

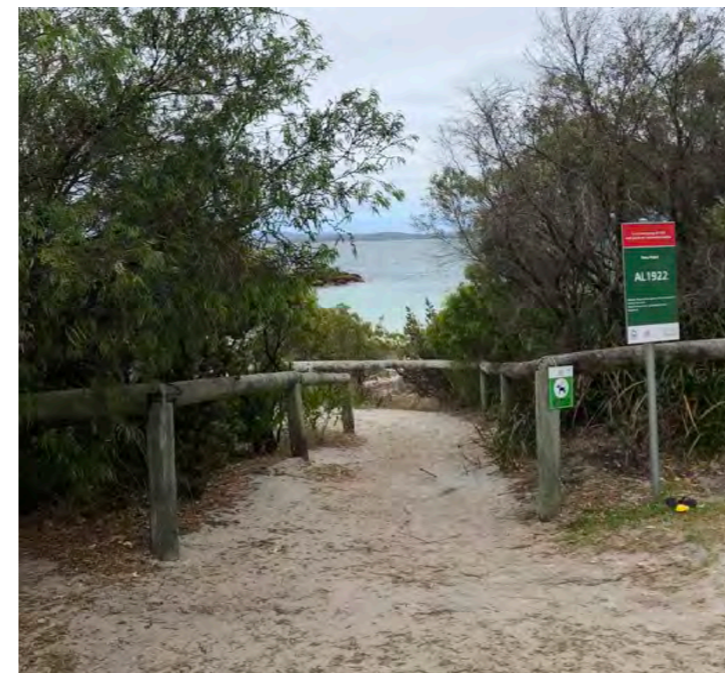
5. Informal and limited access path ways to swimming beaches

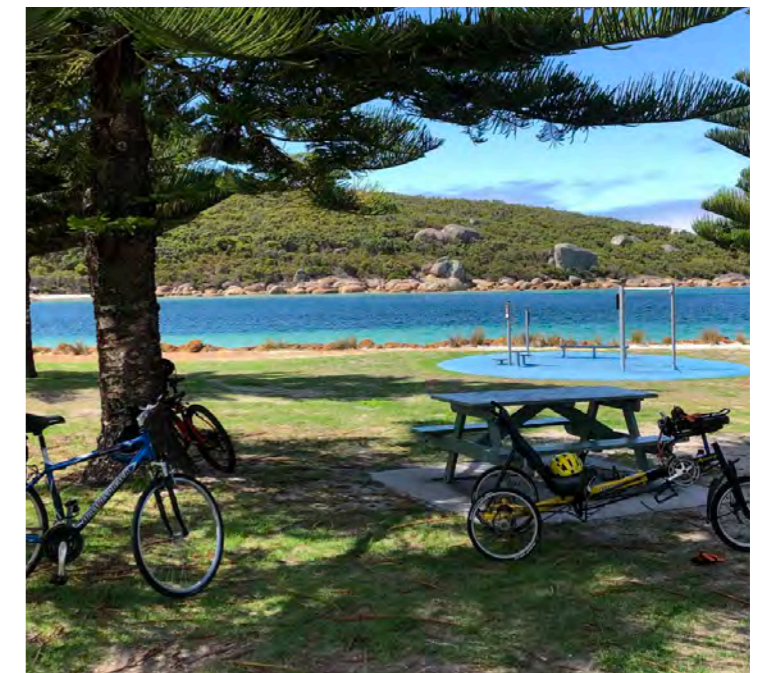
6. Existing public exercise equipment/ limited bike amenities noted across the site

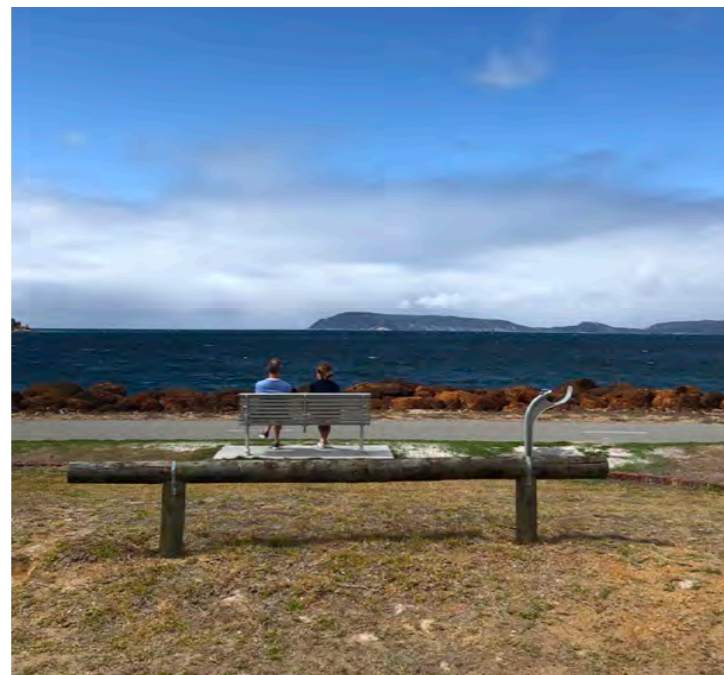
1. Key viewing opportunities along the waterfront, although minimal protection from sun and prevailing winds

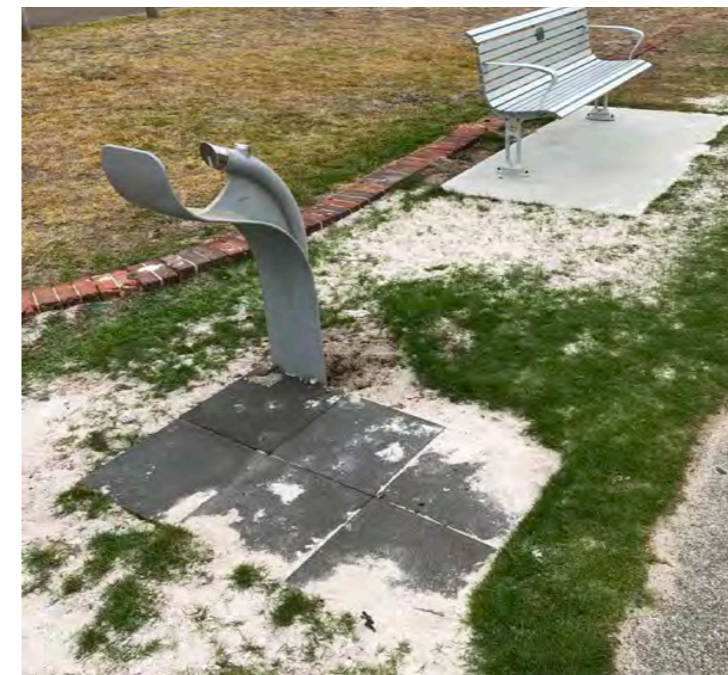
2. Inconsistent materiality across the site including hardscape, furniture and fixtures.

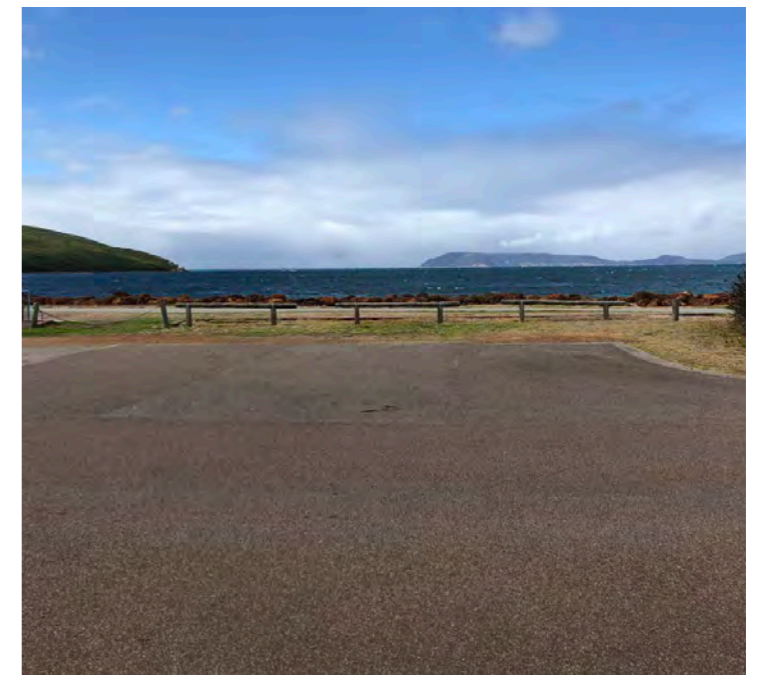
3. Large areas of hardscape (asphalt) offering minimal infiltration opportunities.

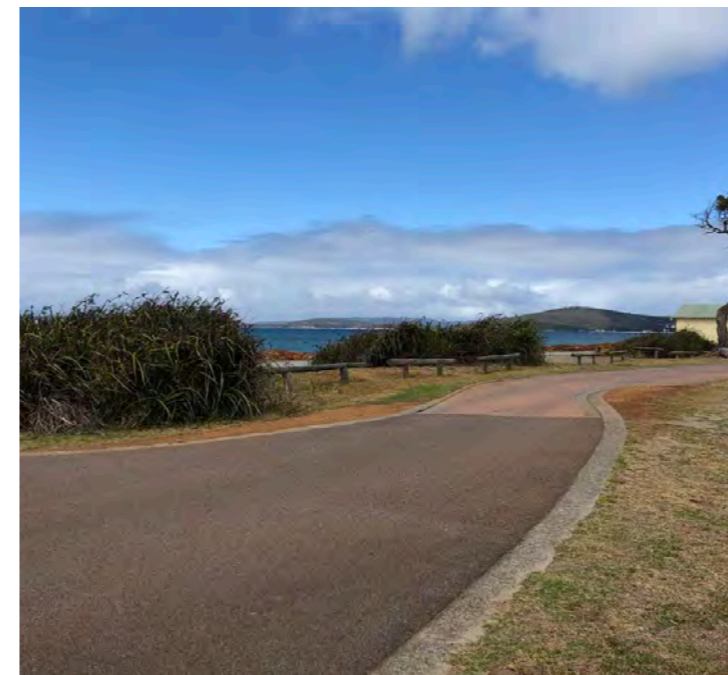
5. Large portions of zone 3 consists of in formal roads and car parking adjacent parkland and waterfront.

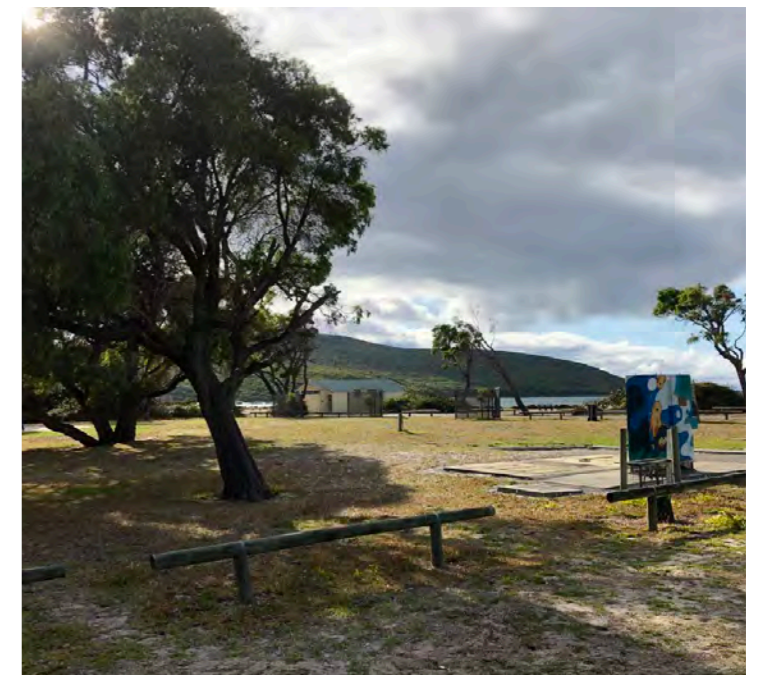
6. Underutilised existing public park

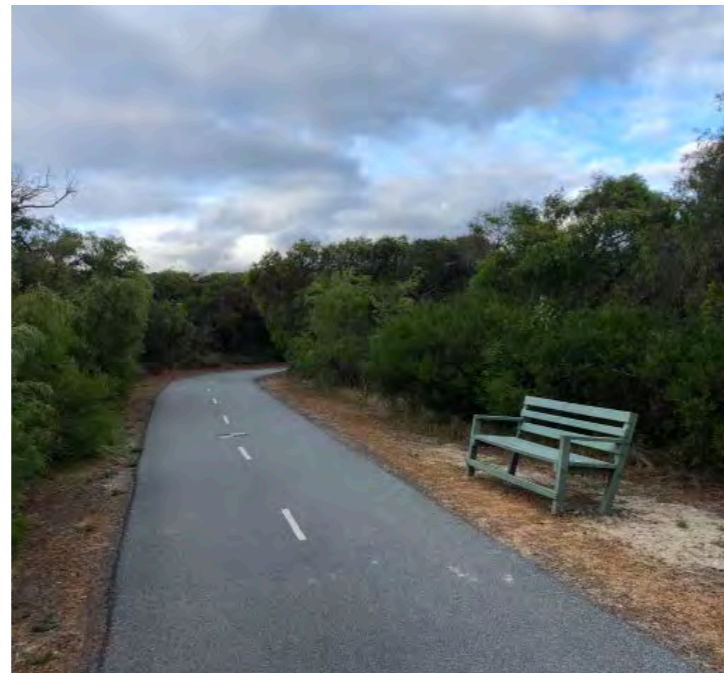
1

1. Existing coastal dual use path. Seating opportunities minimal with replacement required. (Note; many furniture elements 'commemorative/donated')

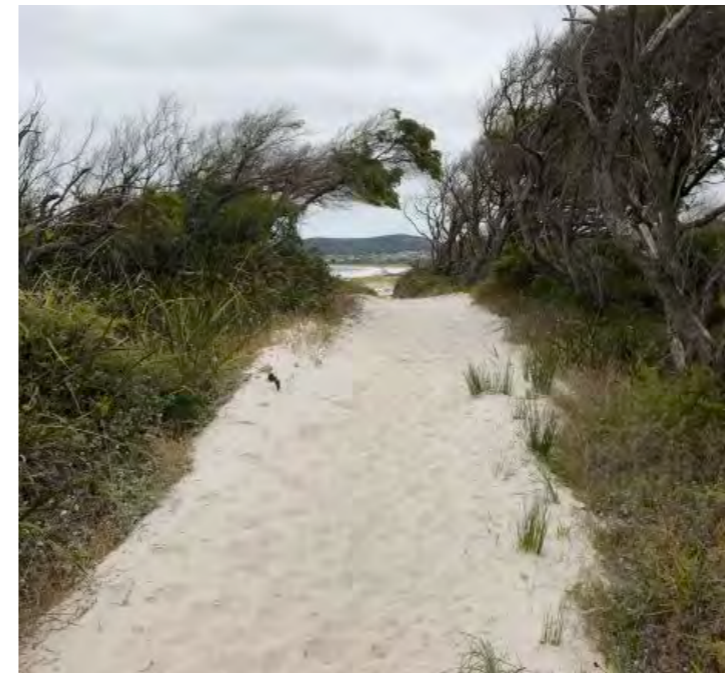
2. Inconsistent beach access, generally closer to adjacent accommodation sites

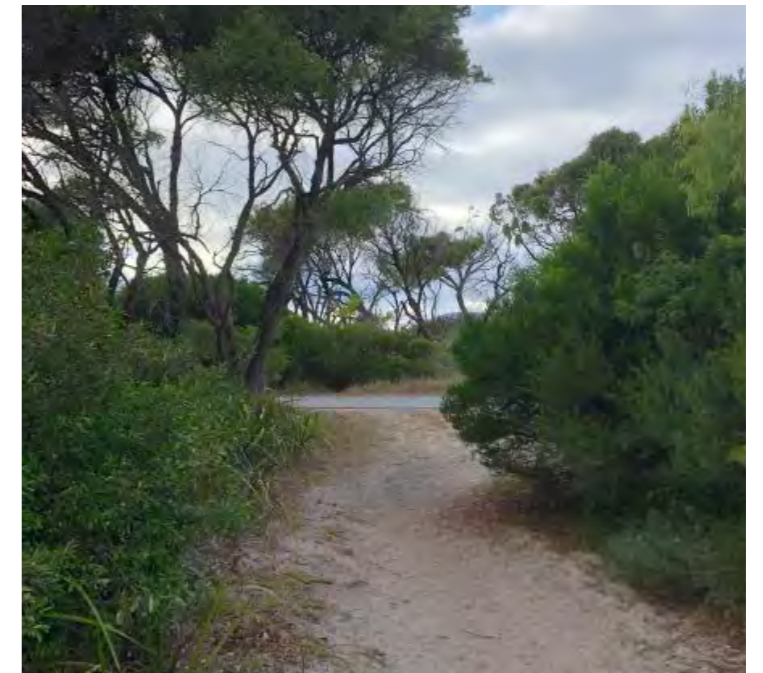
3. Access through vegetation to adjacent accommodation sites (CoA lease titles)

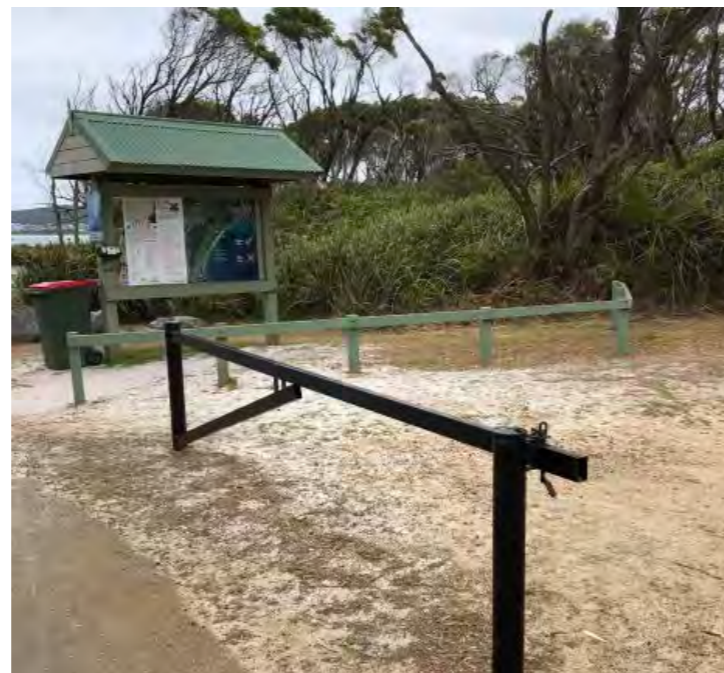
4. Signage and way finding inconsistent. Entry to remnant native vegetation area offers a key opportunity to educate the public regarding the site.

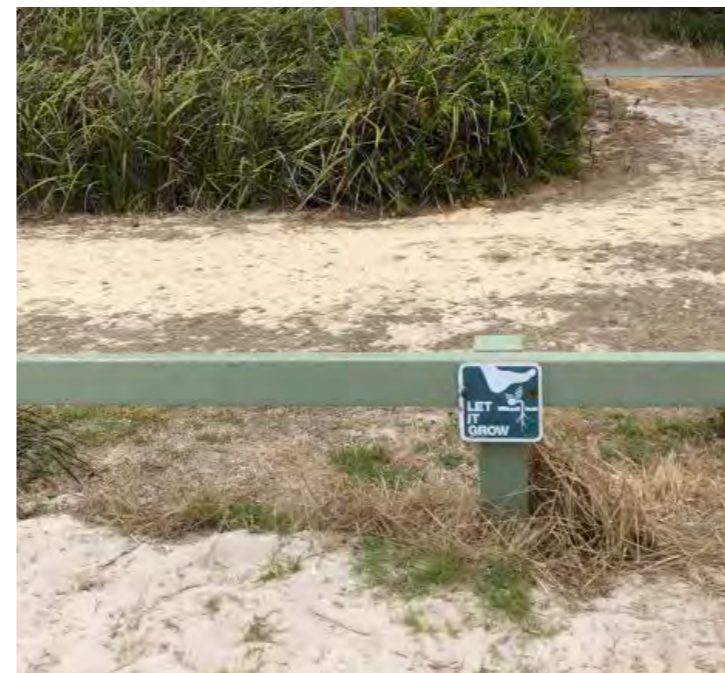
5. Issues regarding movement/access of public through fragile existing and re-vegetation areas.

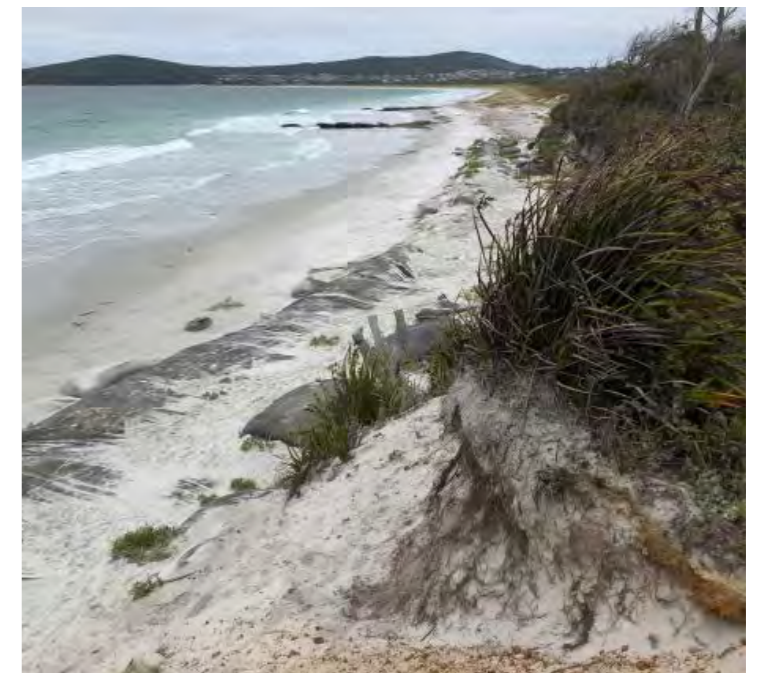
6. Existing coastal structure trials (groynes) and current erosion to coast line.

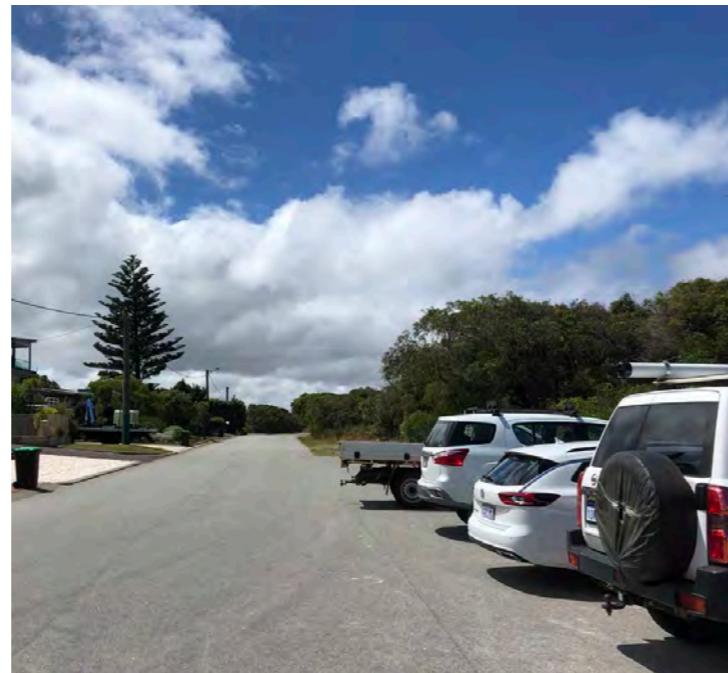
1. Existing Griffith's Street car park. Access to Horse exercise area (limited hours). Possible retreat of car park required due to CHRMAP recommendations.

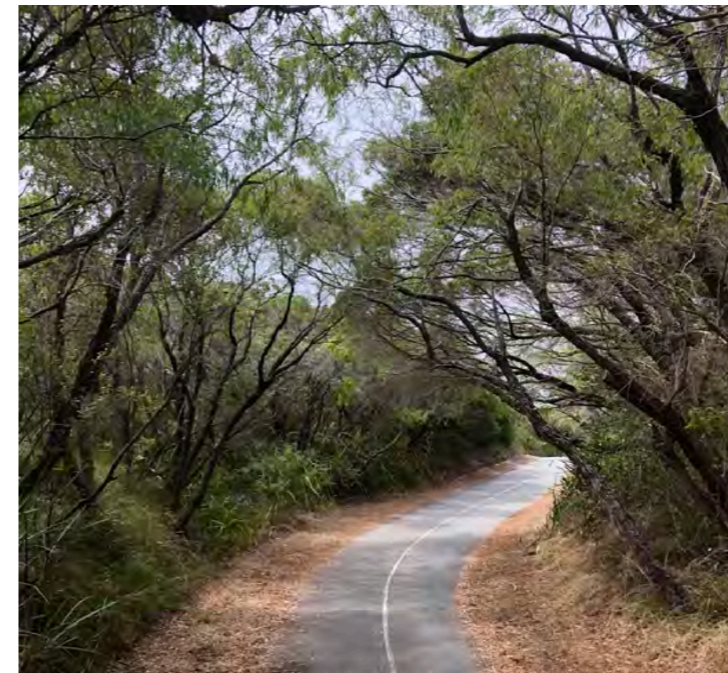
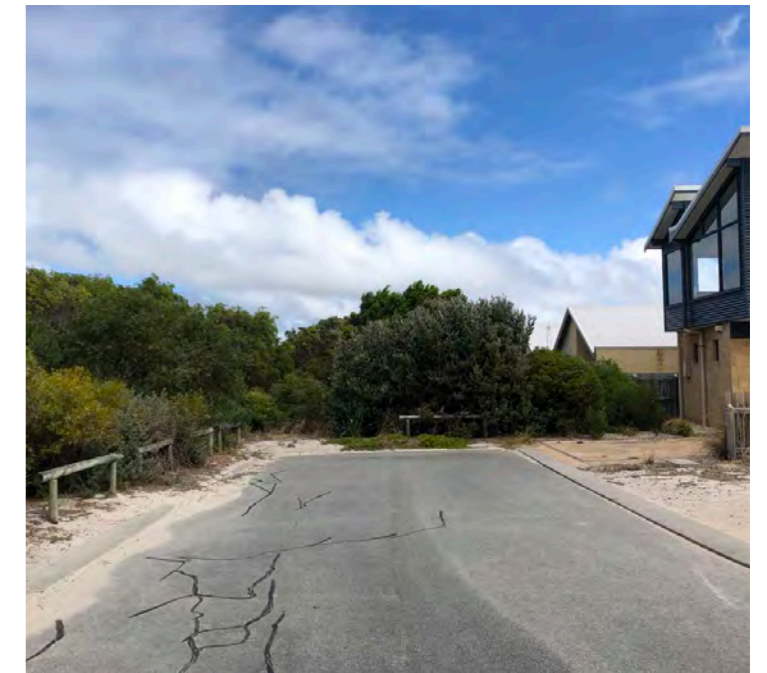
2. Large areas of remnant vegetation lines the coastal dual use path. Possible retreat of Dual path in some areas required due to CHRMAP recommendations.

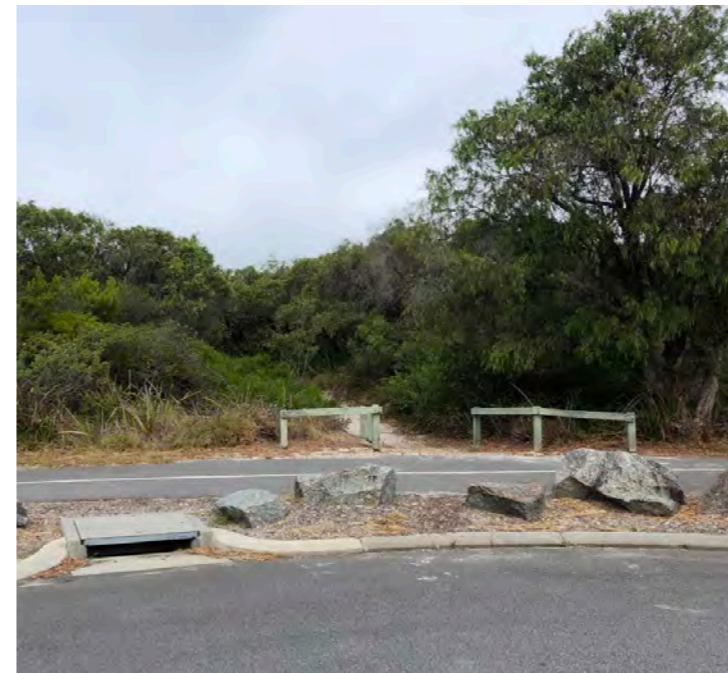
5. Informal vehicle barriers along Griffith's st car park and informal tracks through bushland. Existing tracks/fire breaks noted as possible future dual use path locations to limit existing vegetation disturbance.

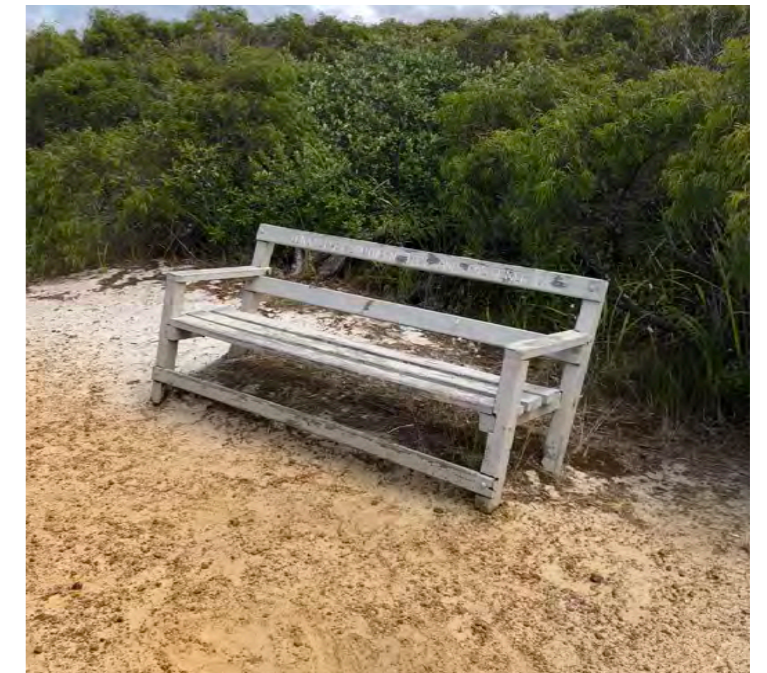
6. Seating opportunities minimal with replacement required. (Note; many furniture elements 'commemorative/donated')
