FORESHORE MANAGEMENT PLAN

Emu Beach

EEL19265.001
Rev 0
04 June 2021

REPORT

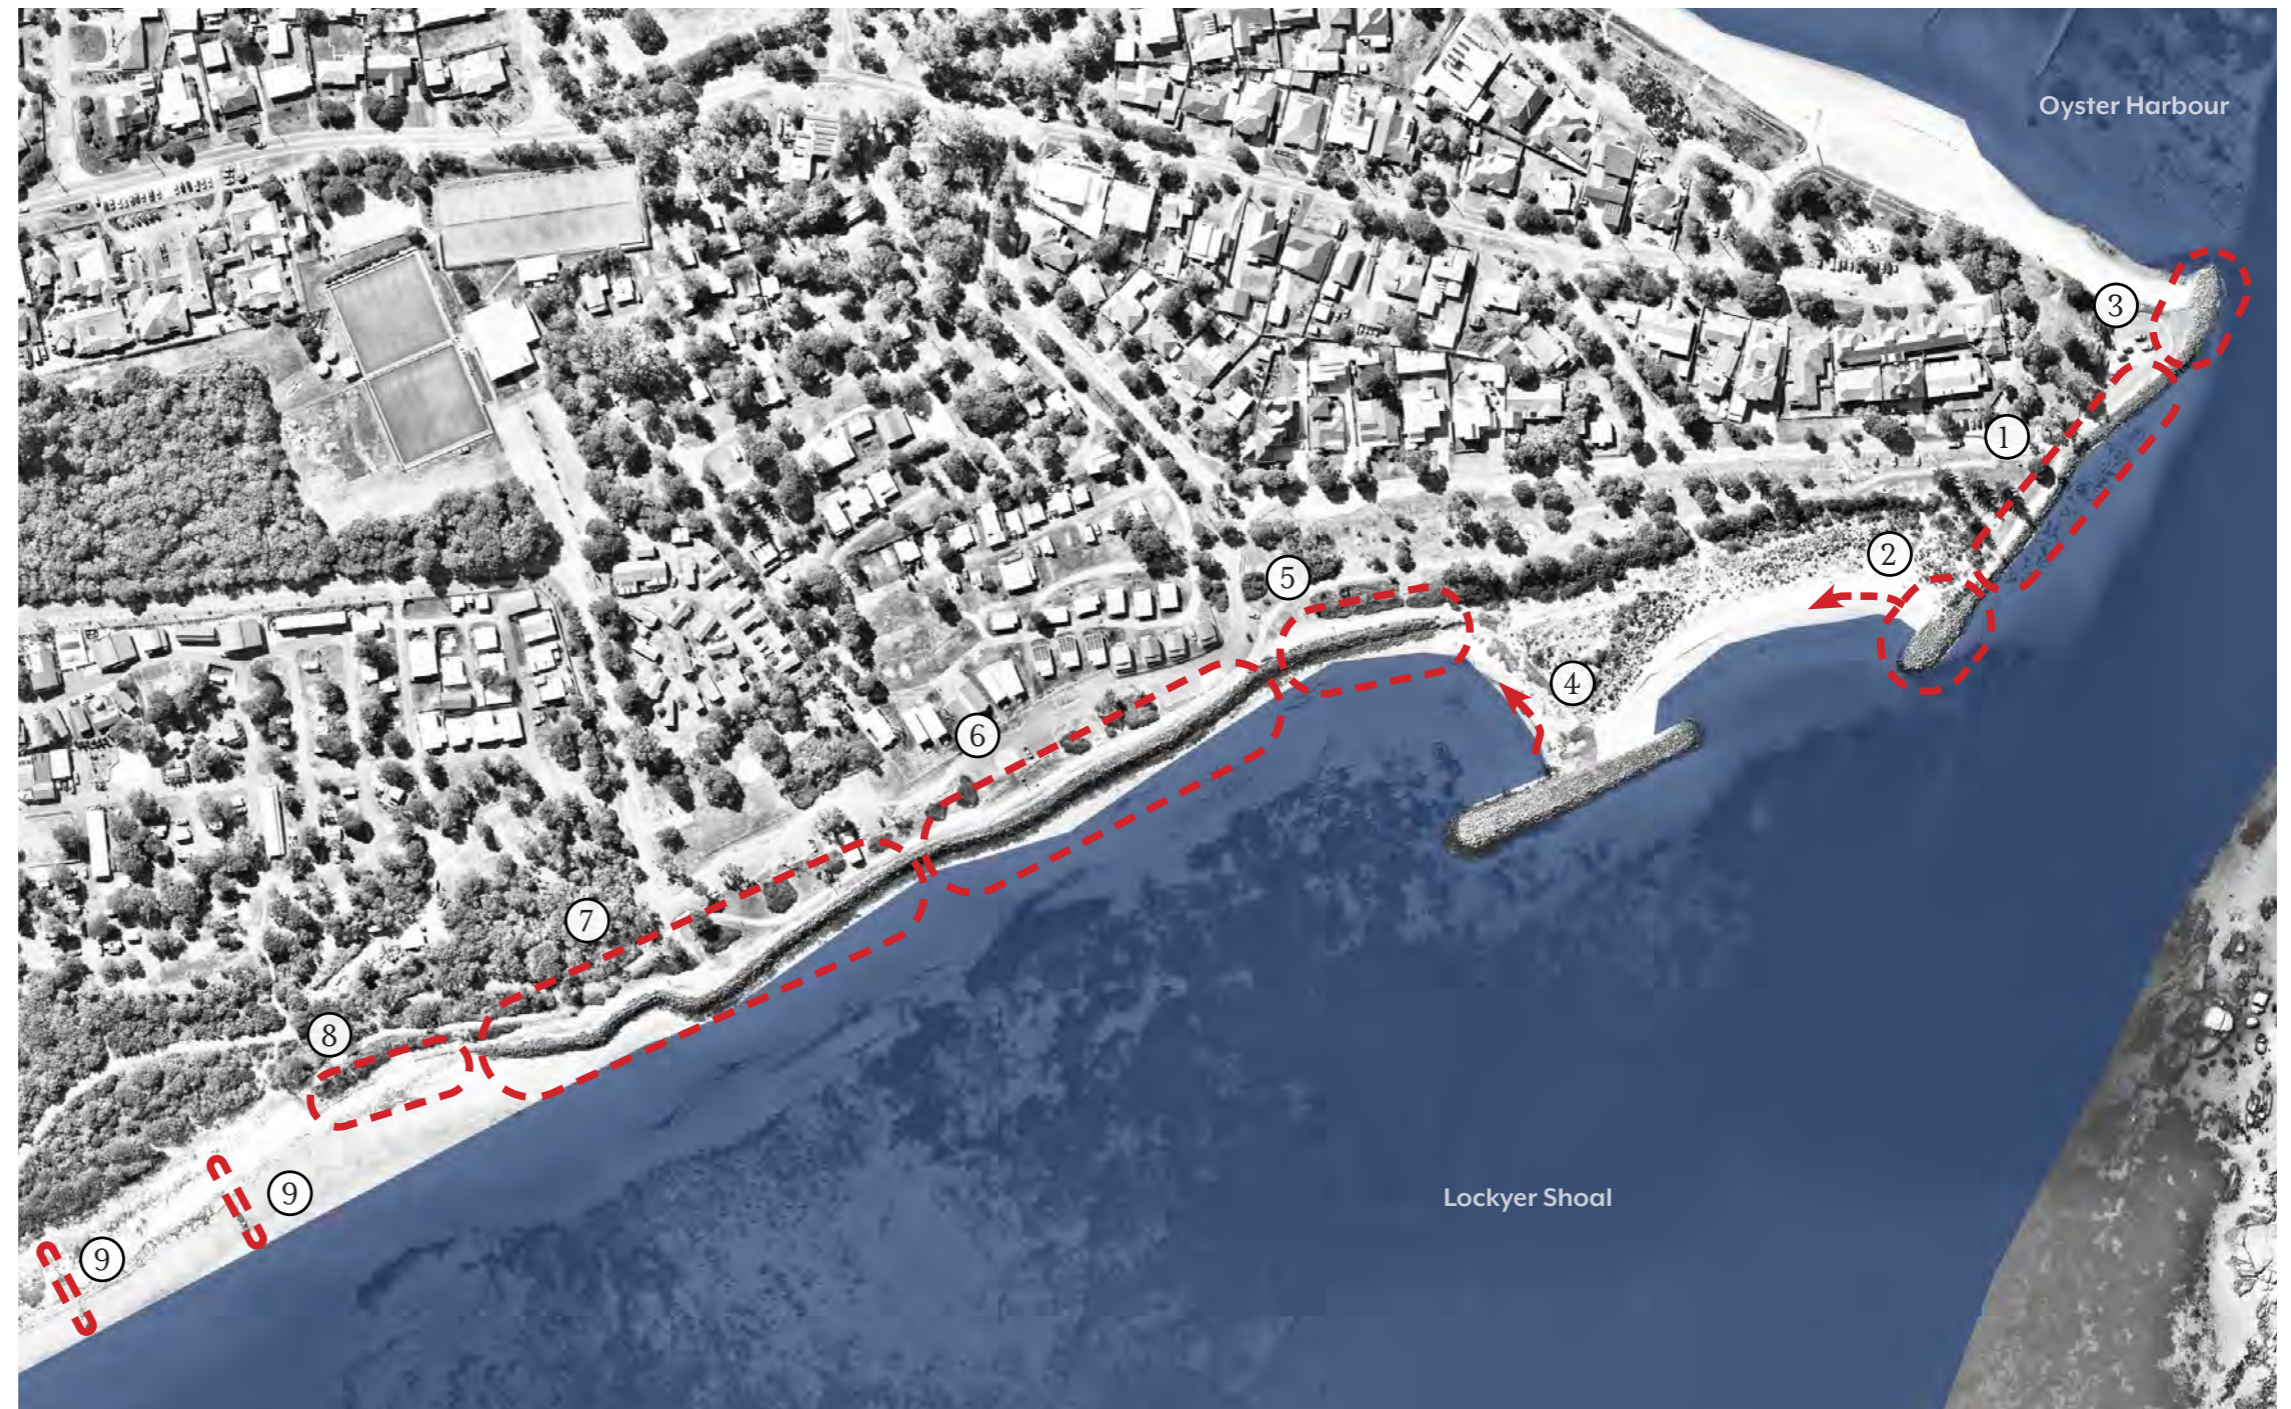
The following diagram indicates the time line and location of the various coastal structures along the Emu beach waterfront.

- ① Training Wall (mid 1980's)
- ② Southern groyne + sand re-nourishment (1989)
- ③ Northern groyne (1991)
- ④ Detached breakwater headland + sand Re-nourishment (1995)
- ⑤ Original 'Emergency' rock revetment (1999)
- ⑥ Rock revetment extension (2001)
- ⑦ Rock revetment extension (2005)
- ⑧ Sandbag revetment (2011)
- ⑨ Trial GSC groynes (2014)

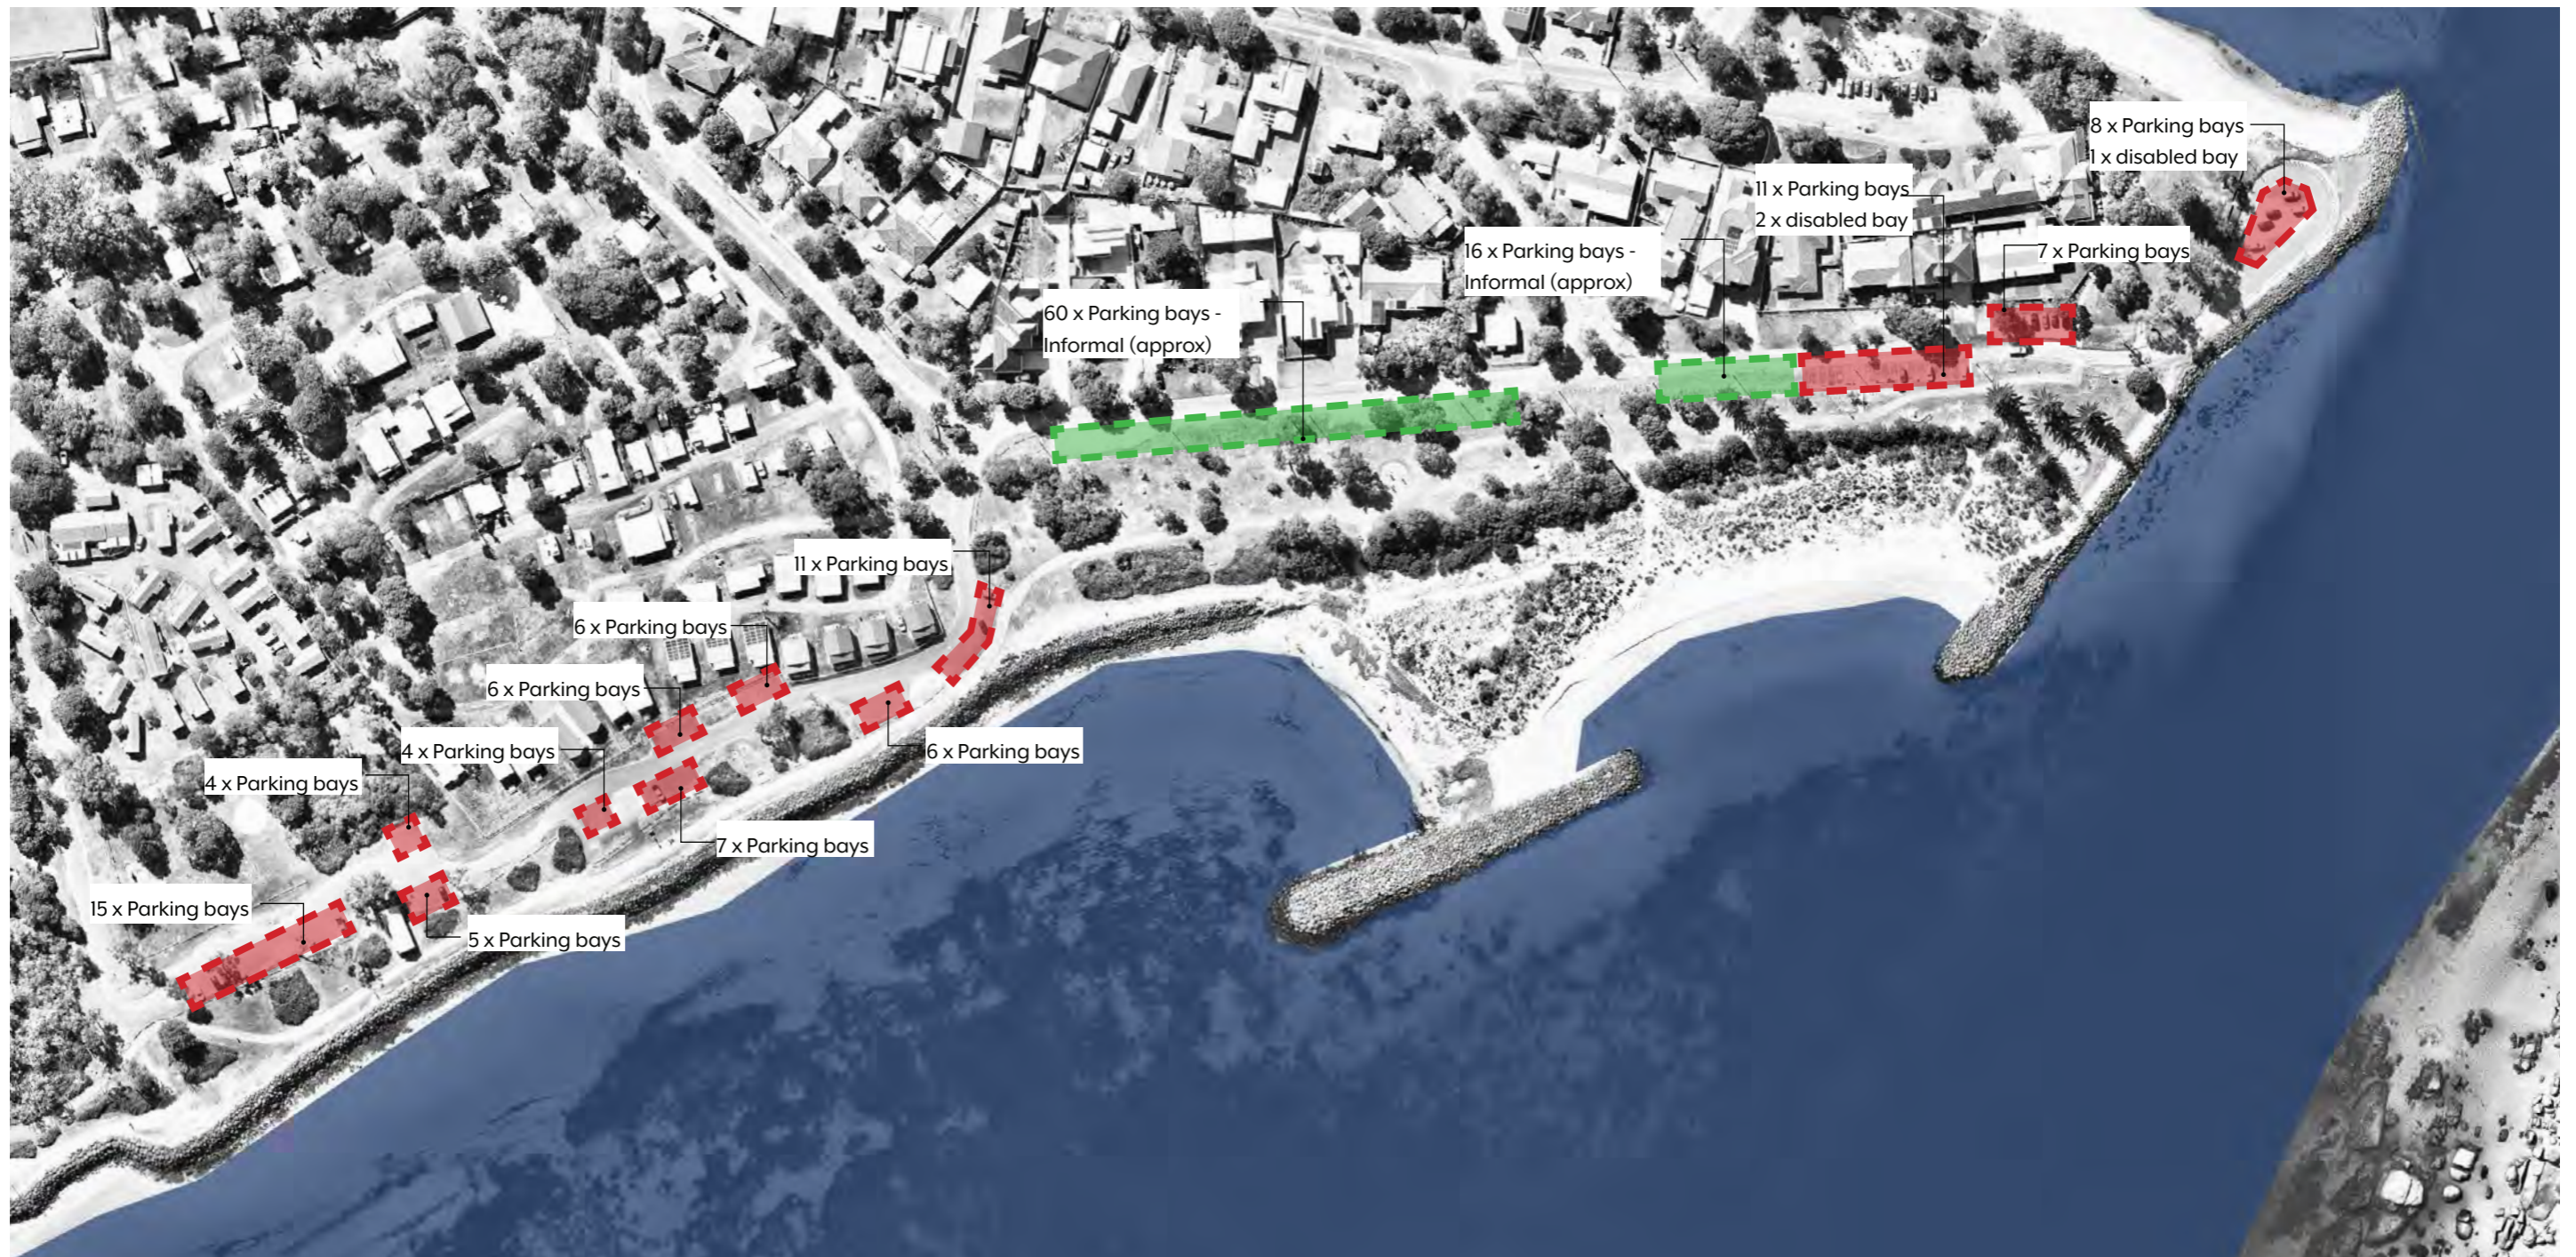
The following diagram indicates the existing parking numbers and locations along Emu Beach. In peak periods vehicles are often located on informal verge treatments with limited formal path access including minimal disabled access.

Formal parking bays	90
Informal parking bays	76 (approx)
Disabled bays	3

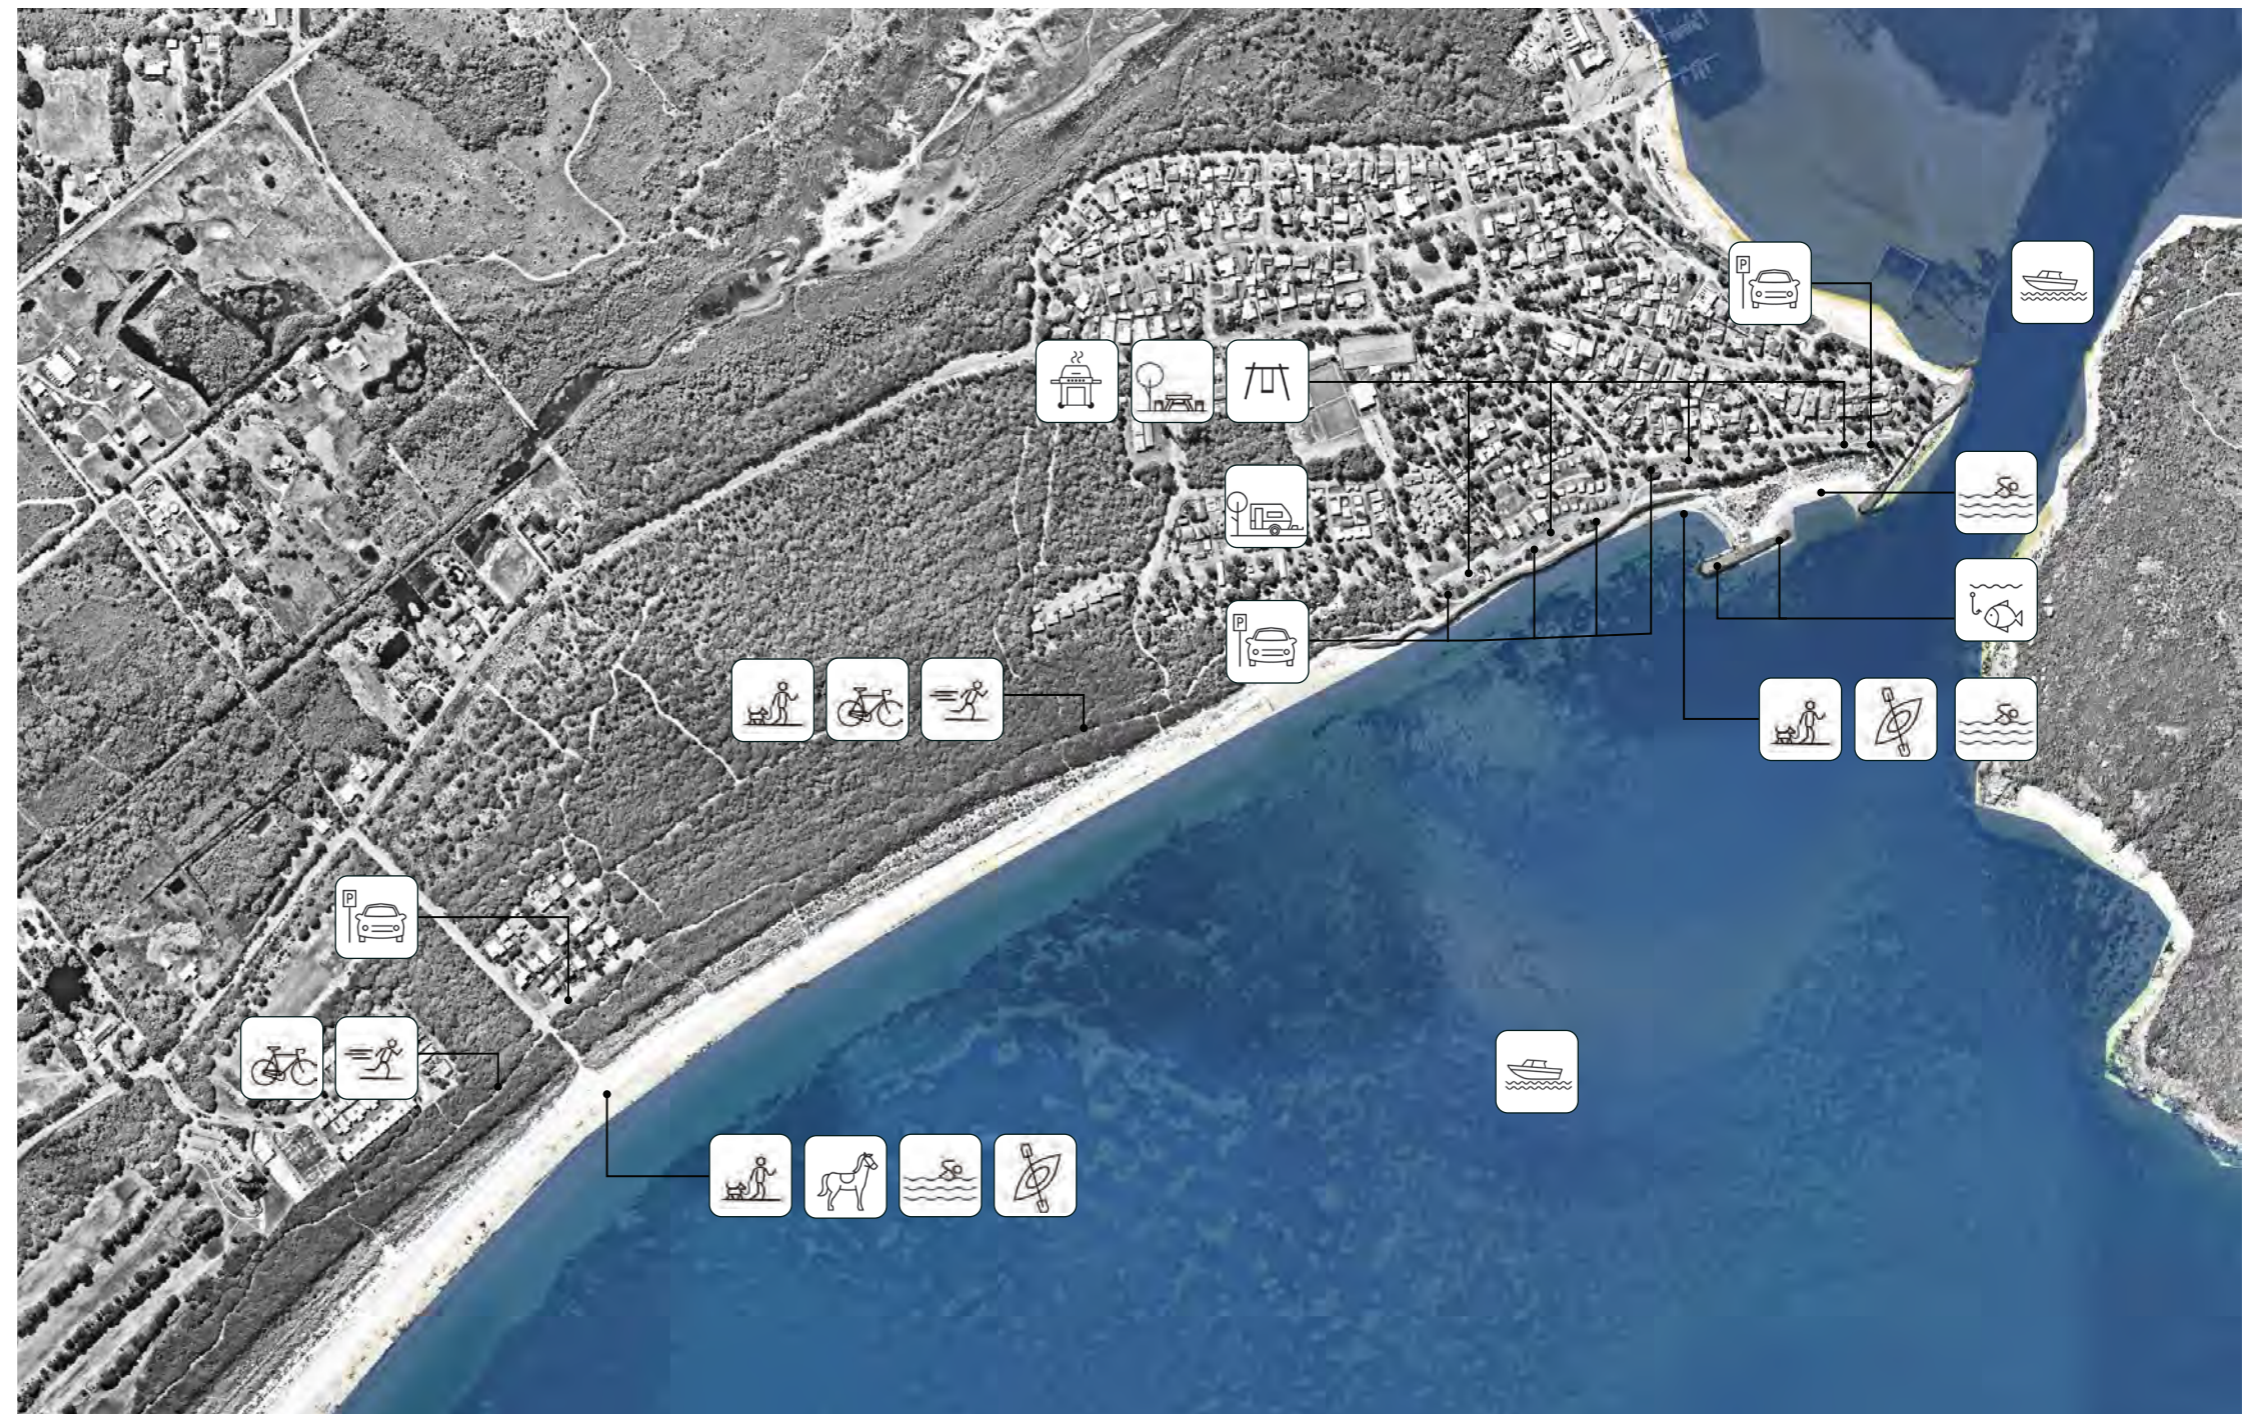
The following diagrams indicates the various locations and spread of existing activities along the Emu Beach site. These will assist the overall landscape masterplan to not only enhance but also increase the opportunities for new activities across the site.

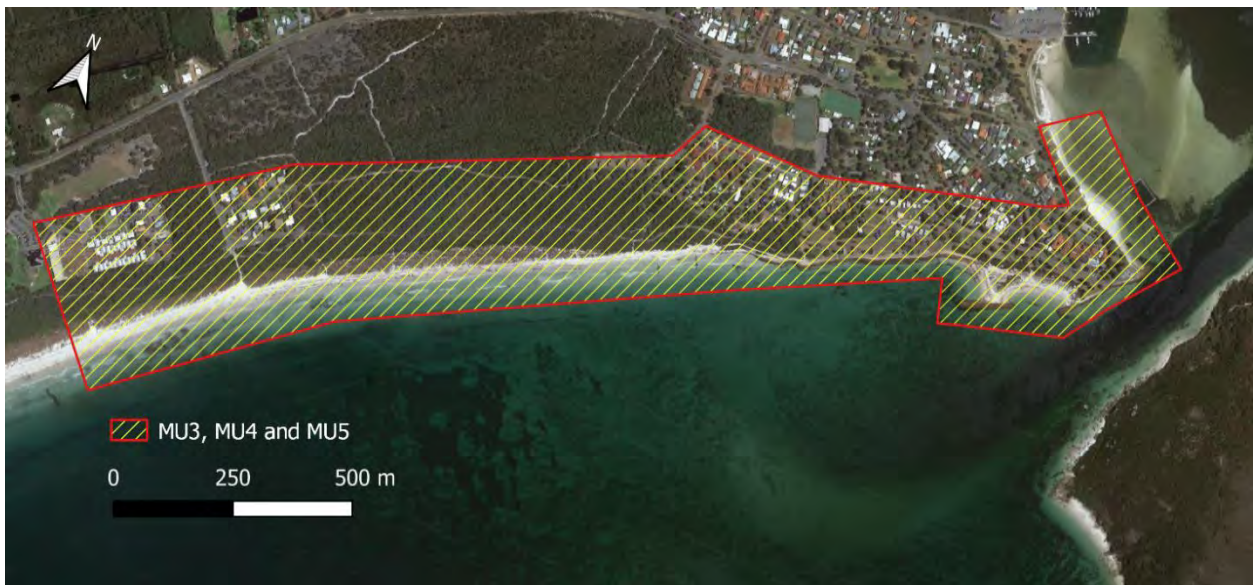
Figure 1: Emu Beach and Management Unit 3, 4, 5 (MU3,4,5) as defined in the CHRMAP (Aurora, 2019).

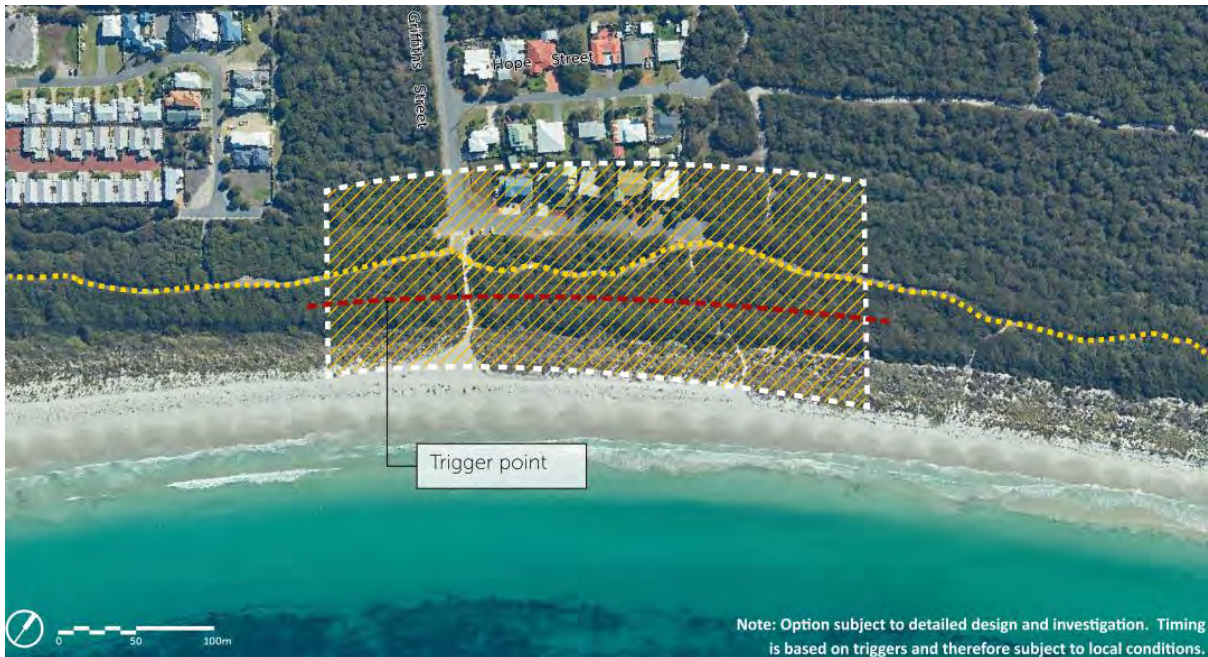
Figure 3: MU3 Griffiths Street Recommended Adaptation Option: Managed Retreat. Relocate properties from Griffiths Street

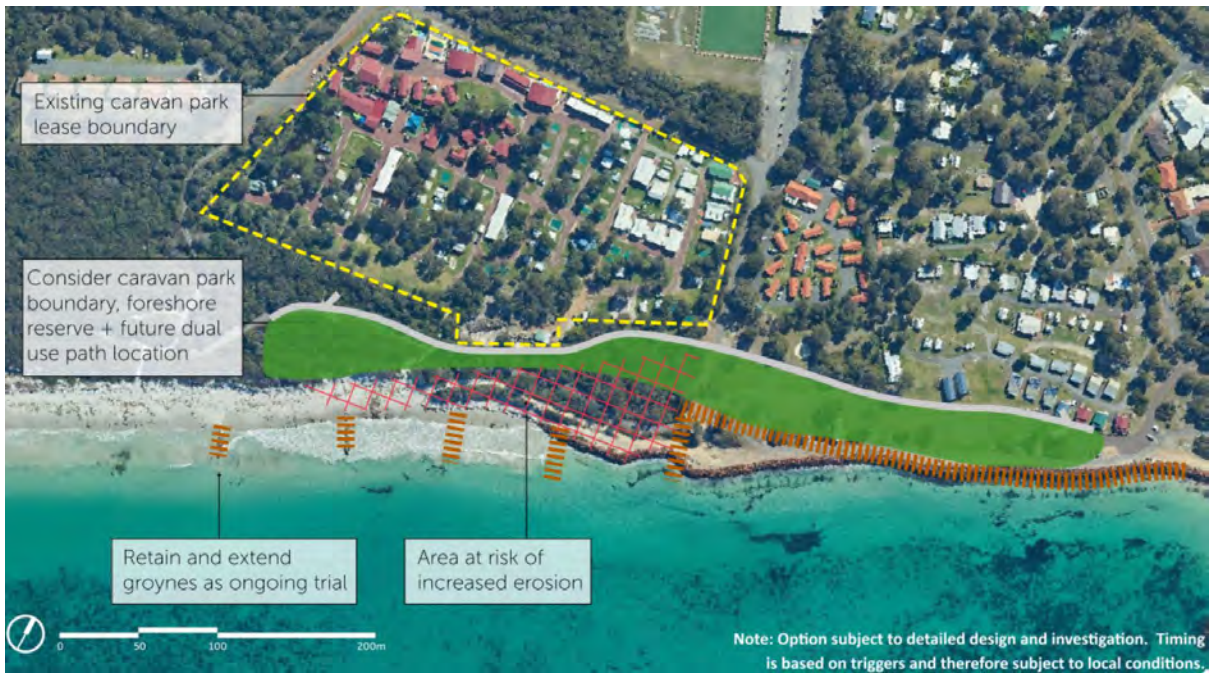
Figure 4: MU4 Emu Point Caravan Park CHRMAP recommendations 15: Emu Beach Holiday Park - Managed Retreat of assets in the southern portion and expansion of groynes (source: Aurora, 2019).

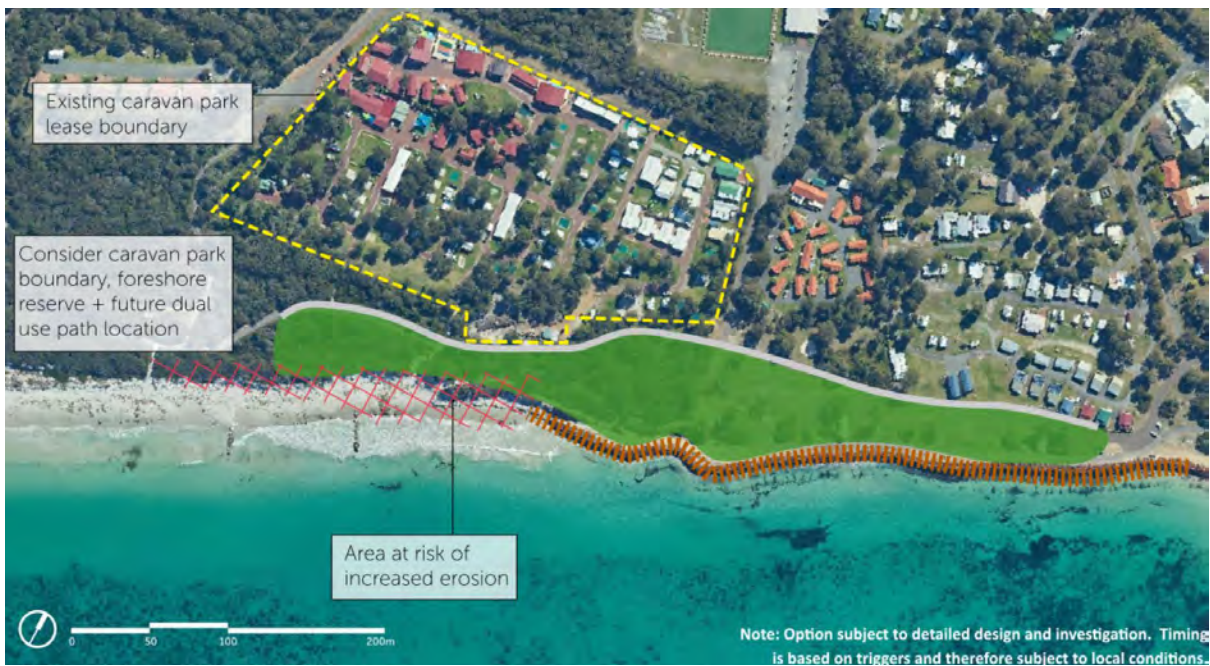
Figure 5: MU4 Emu Point Caravan Park CHRMAP recommendation 17 MU3: Emu Beach Holiday Park - Upgrade existing protection structure (source: Aurora, 2019).

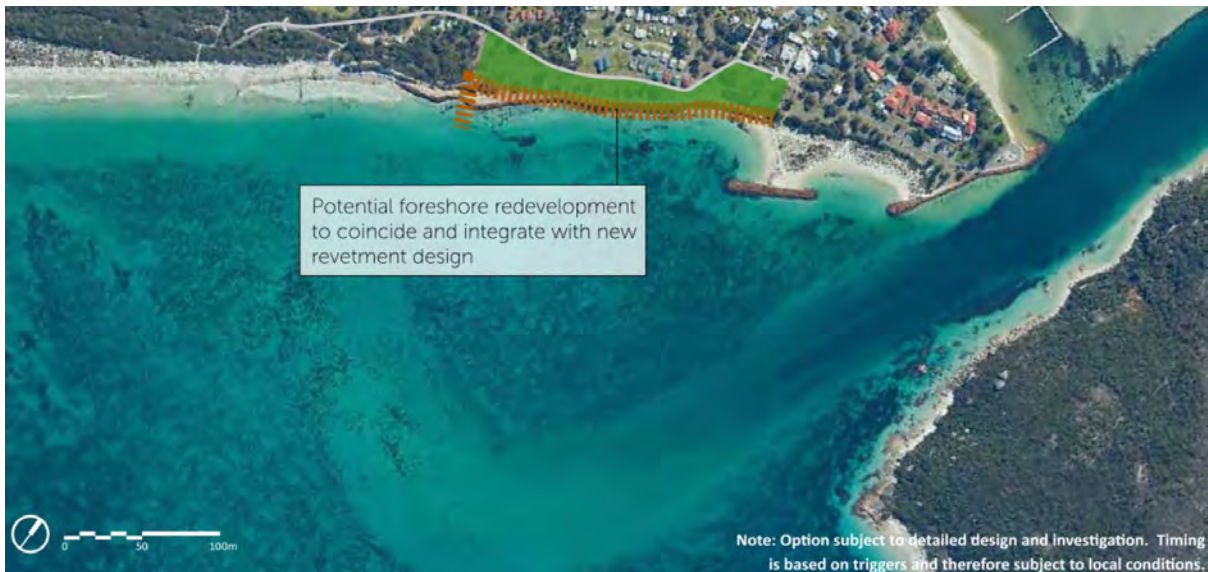
Figure 6: MU4 Foreshore Reserve CHRMAP recommendation19: Foreshore Reserve - Revetment be upgraded along with redevelopment of Foreshore park and removal of sandbag revetment (source: Aurora, 2019).

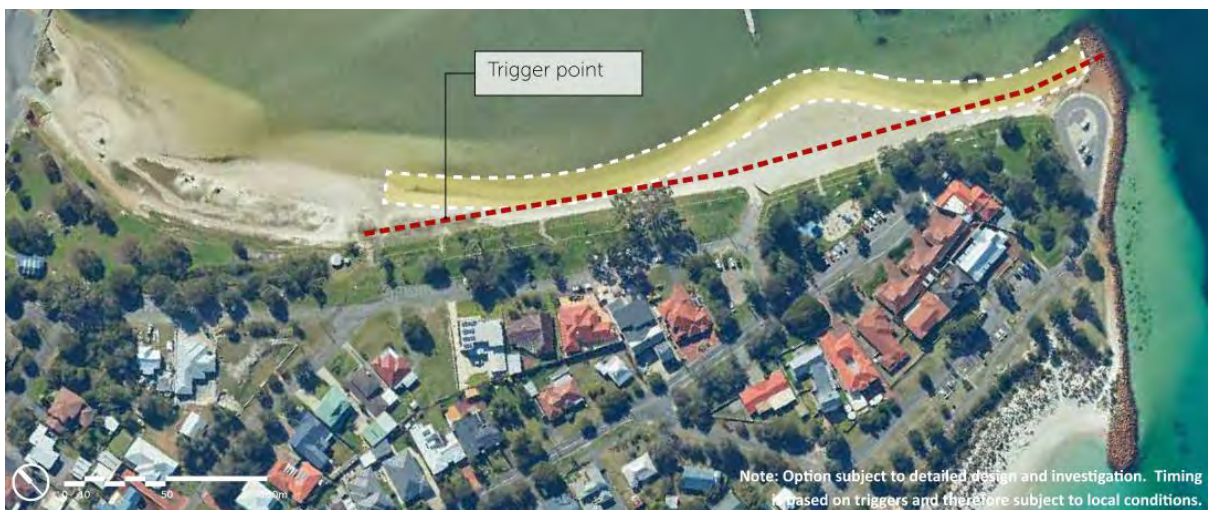
Figure 7: Recommendation 20: MU5 Oyster Harbour Beach - Sand Nourishment Eastern Oyster Harbour Beach (source: Aurora, 2019).

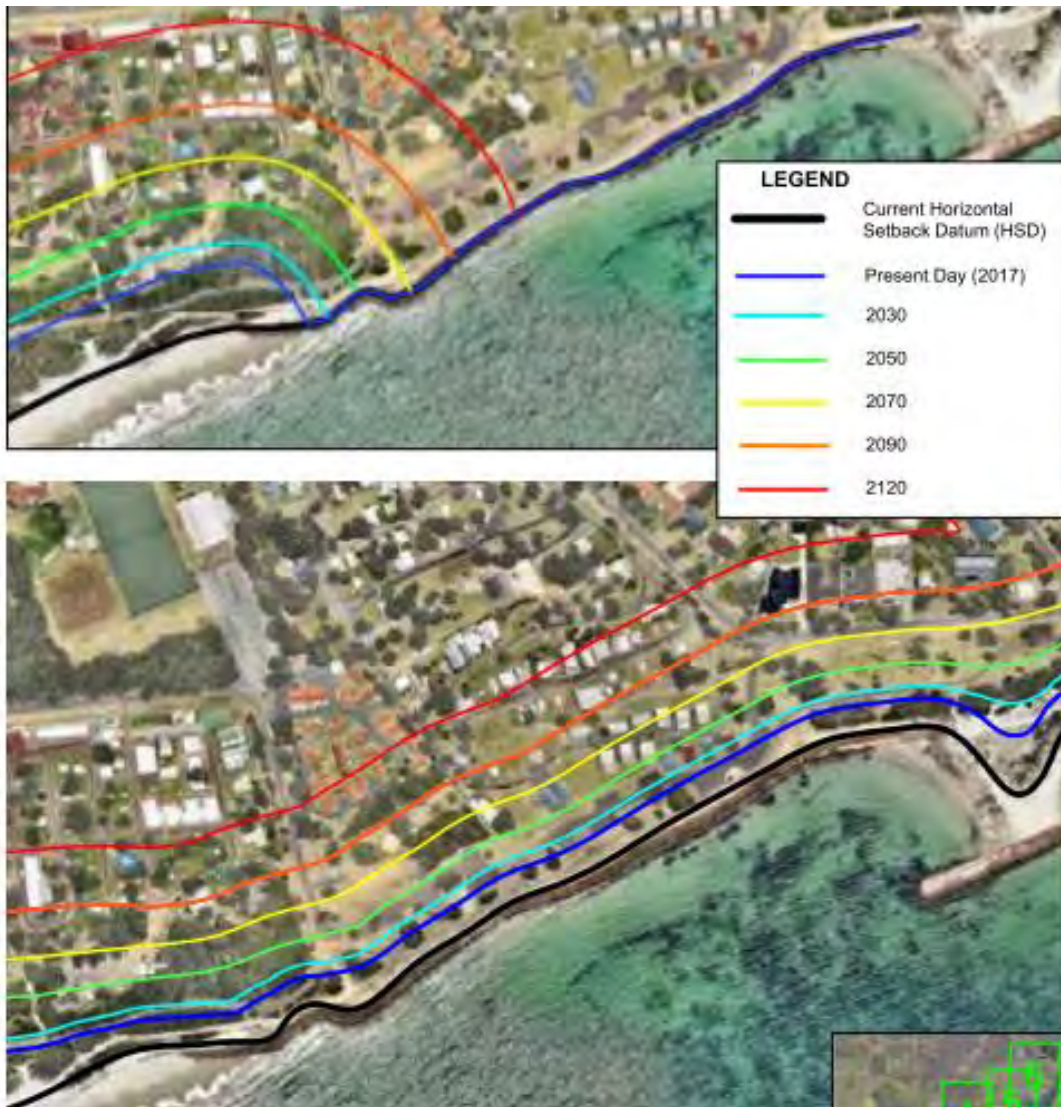
Figure 8: MU4 Hazard Map with existing structures (top) without existing structures (bottom). (Source: RHDHV, 2017).

The importance of the rock revetment structures along MU3 and MU4 at Emu Point and Emu Beach was identified in the CHRMAP Hazard Mapping process (RHDV, 2017). The CHRMAP hazard lines both with and without the rock revetment is seen in Figure 8. This structure can be seen as the last line of defence for the private and public infrastructure landward of it, in terms of inundation and coastal flooding. As such, appropriate design of any upgrade or realignment of these structures is required to ensure the risk of failure is minimised through to the selected planning horizon.

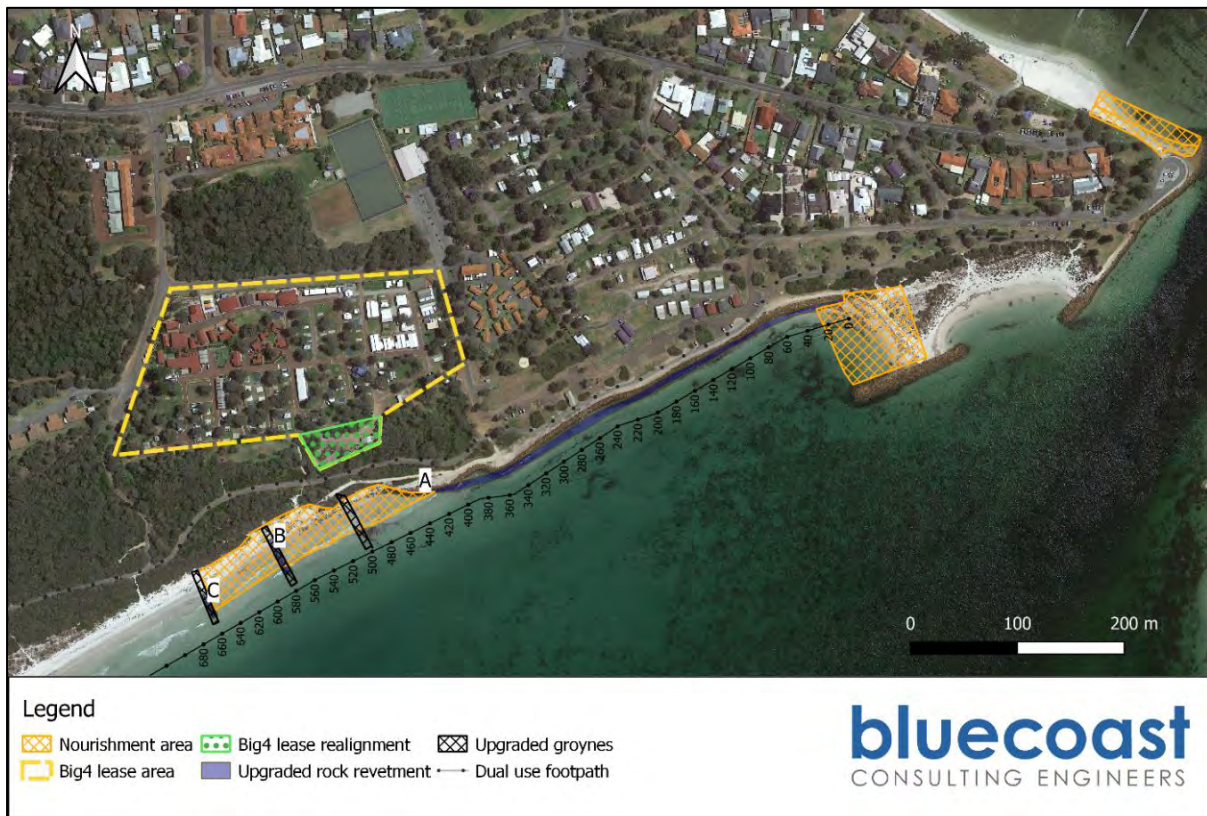
Figure 18: Coastal adaptation recommendations: rock revetment upgrade, upgrade of GSC trial groynes with beach nourishment and amendment of Big4 lease boundary.

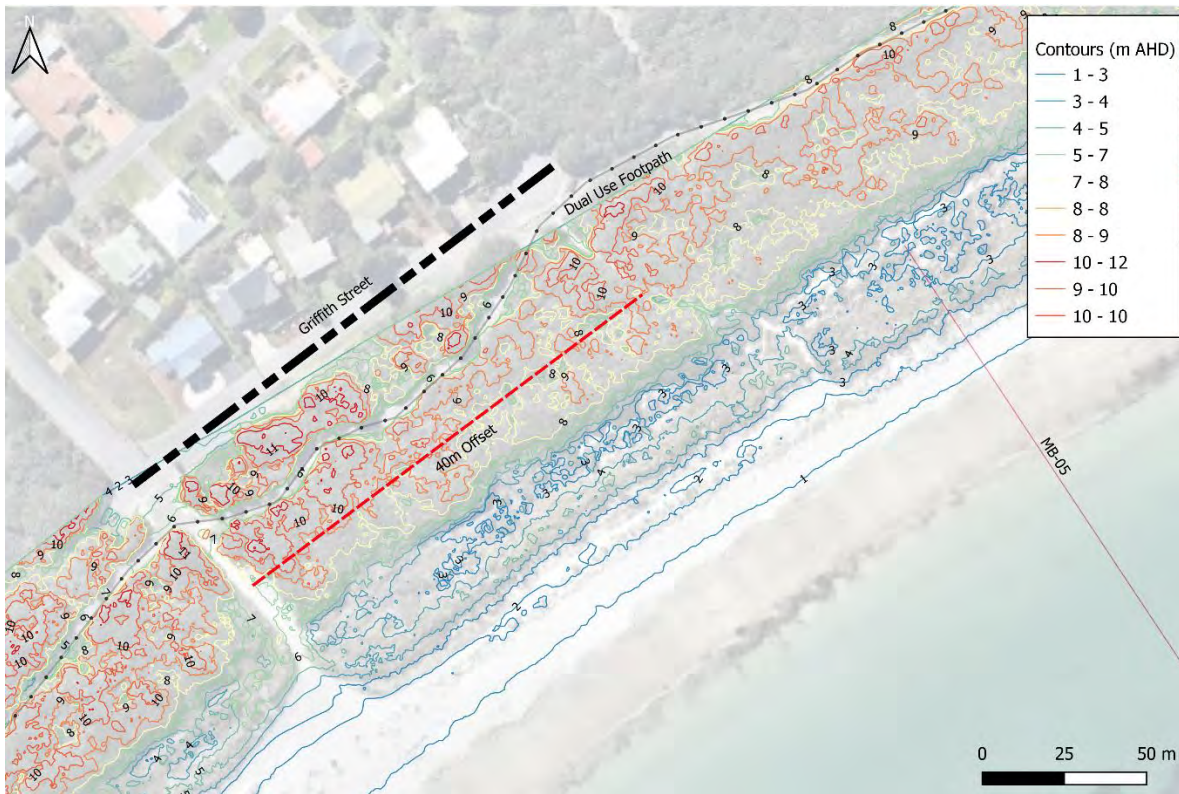
Figure 19: Contour map of the Griffiths Street foreshore from March 2019 showing the 40m seaward offset Coastal Adaptation Trigger Point and long-term beach transect MB-05

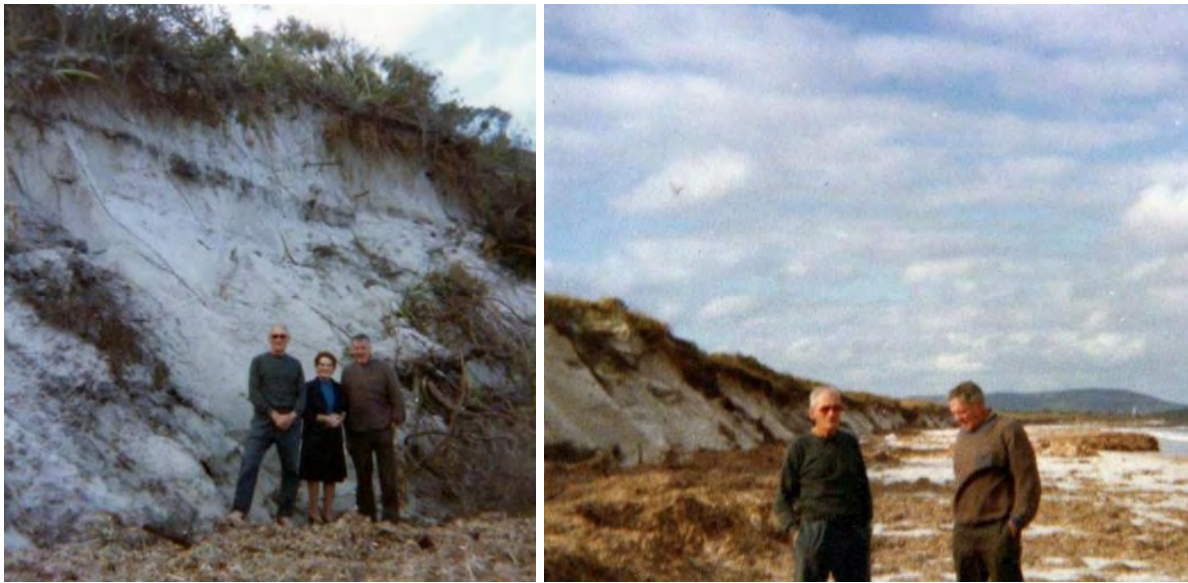
Figure 21: Photographs of erosion scarp following August 1984 storm event. (source: Briss family as reported in URS 2012).

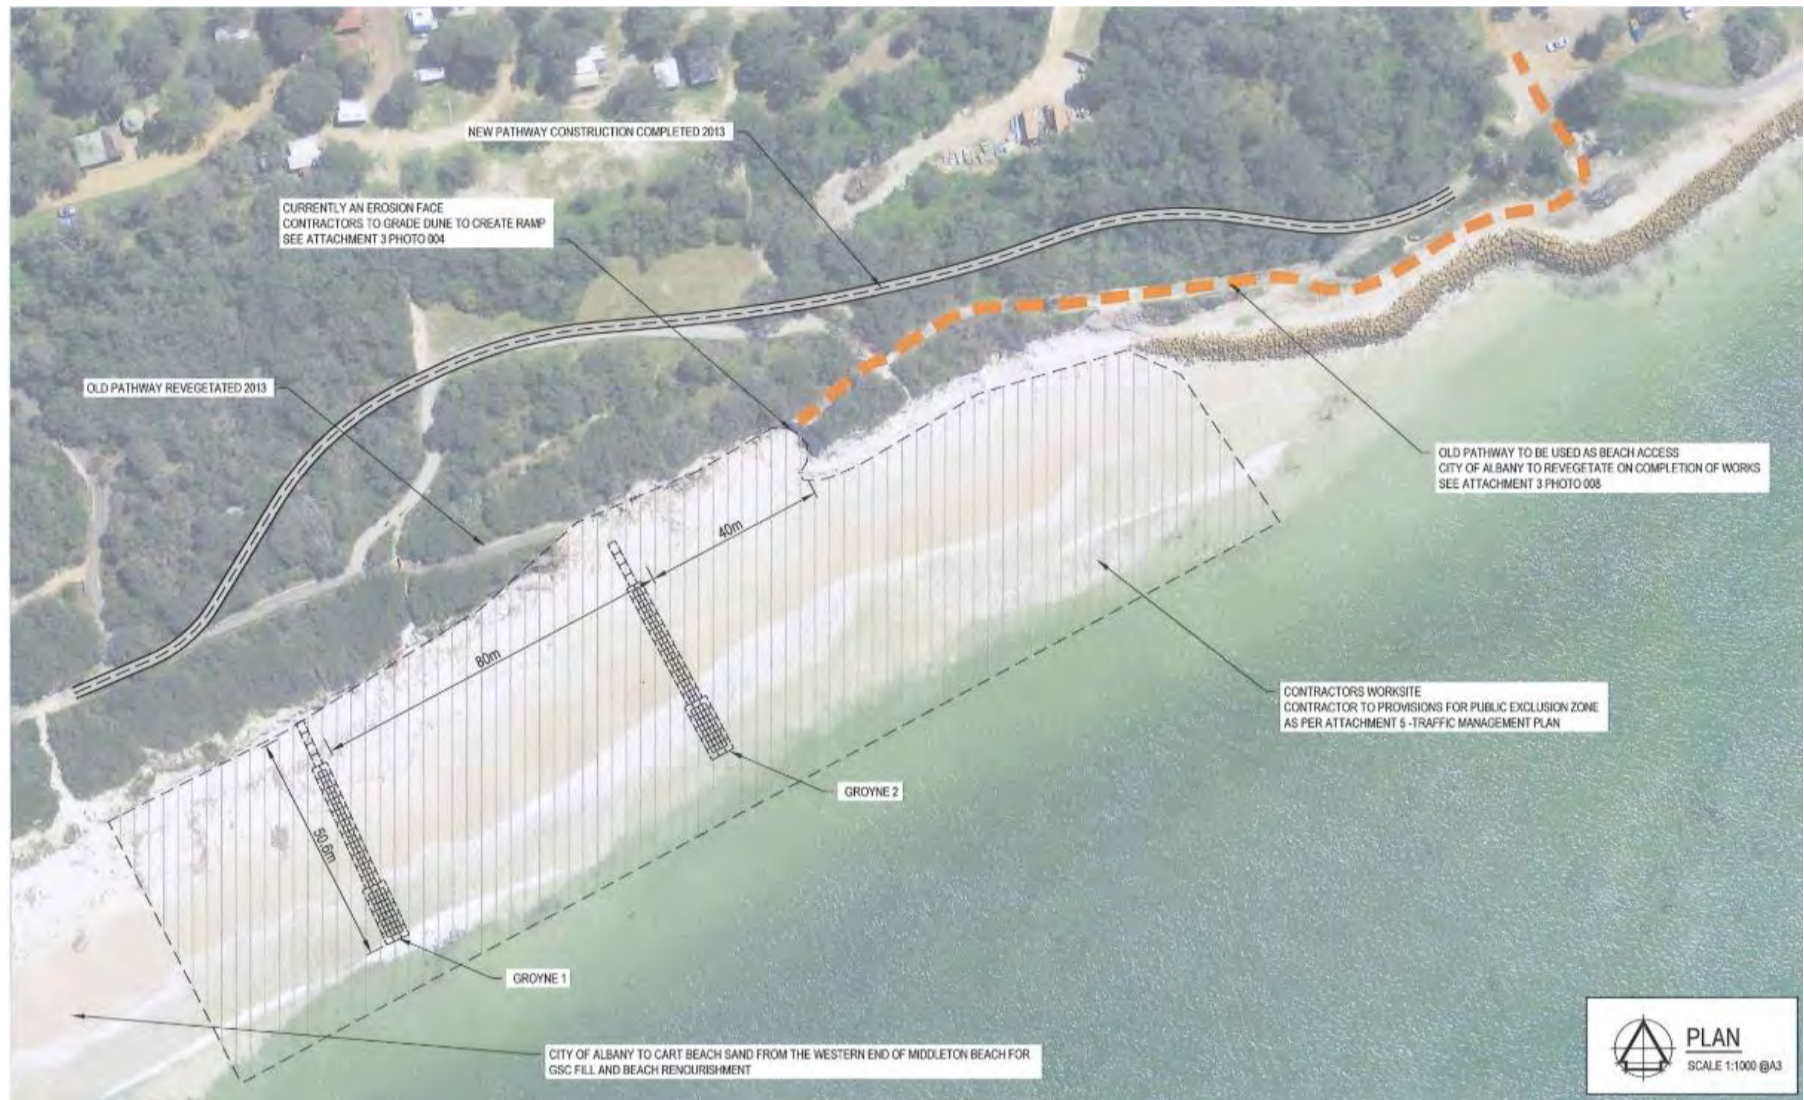
Figure 26: As-constructed drawings of the trial GSC groynes at Emu Beach (source: City of Albany)

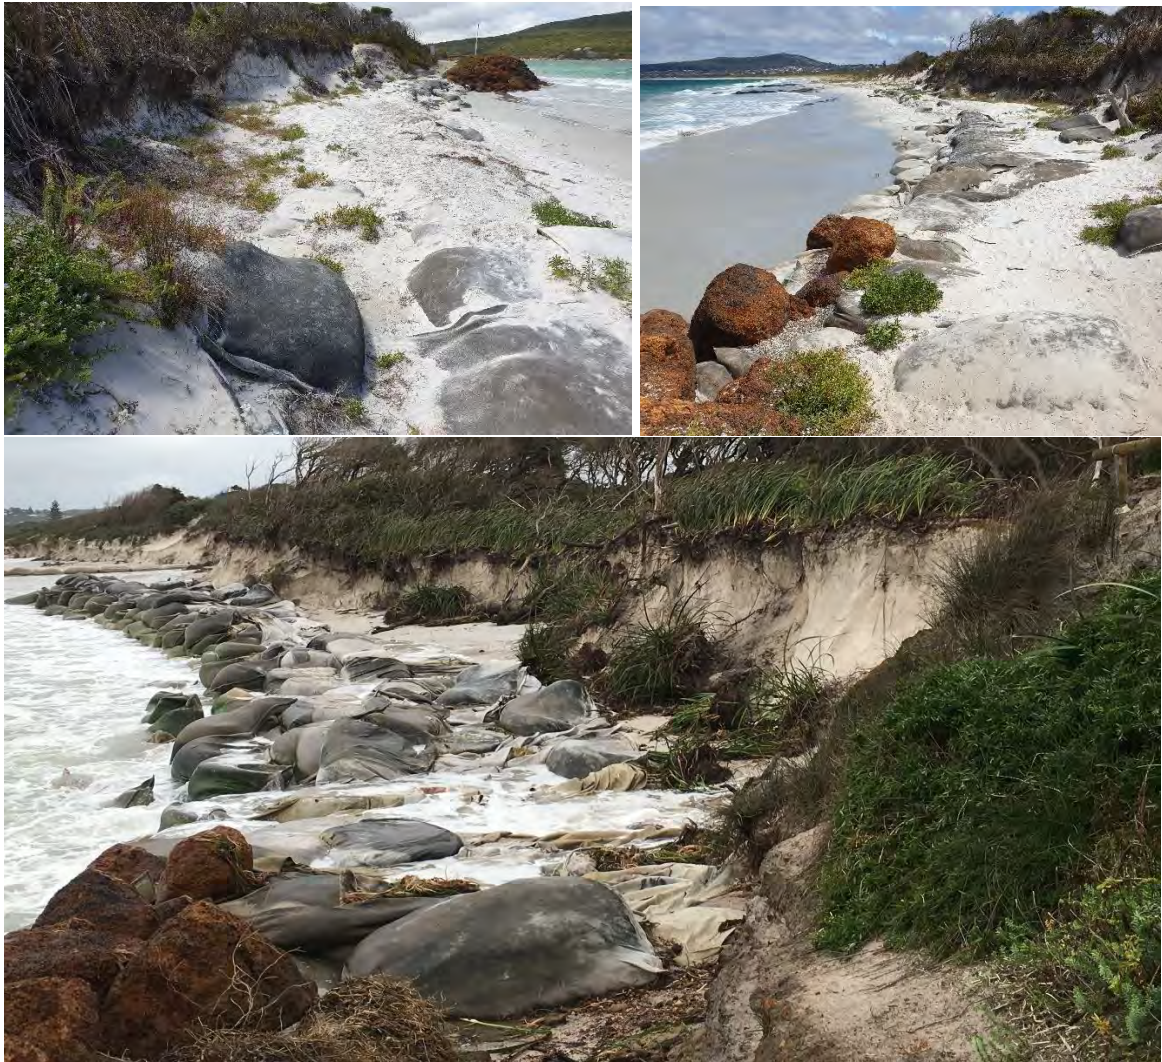
Figure 28: Erosion and state of the beach and GSC trial groynes and GSC revetment at Emu Beach, taken 26th February 2020 (top) and August 2020 (bottom).

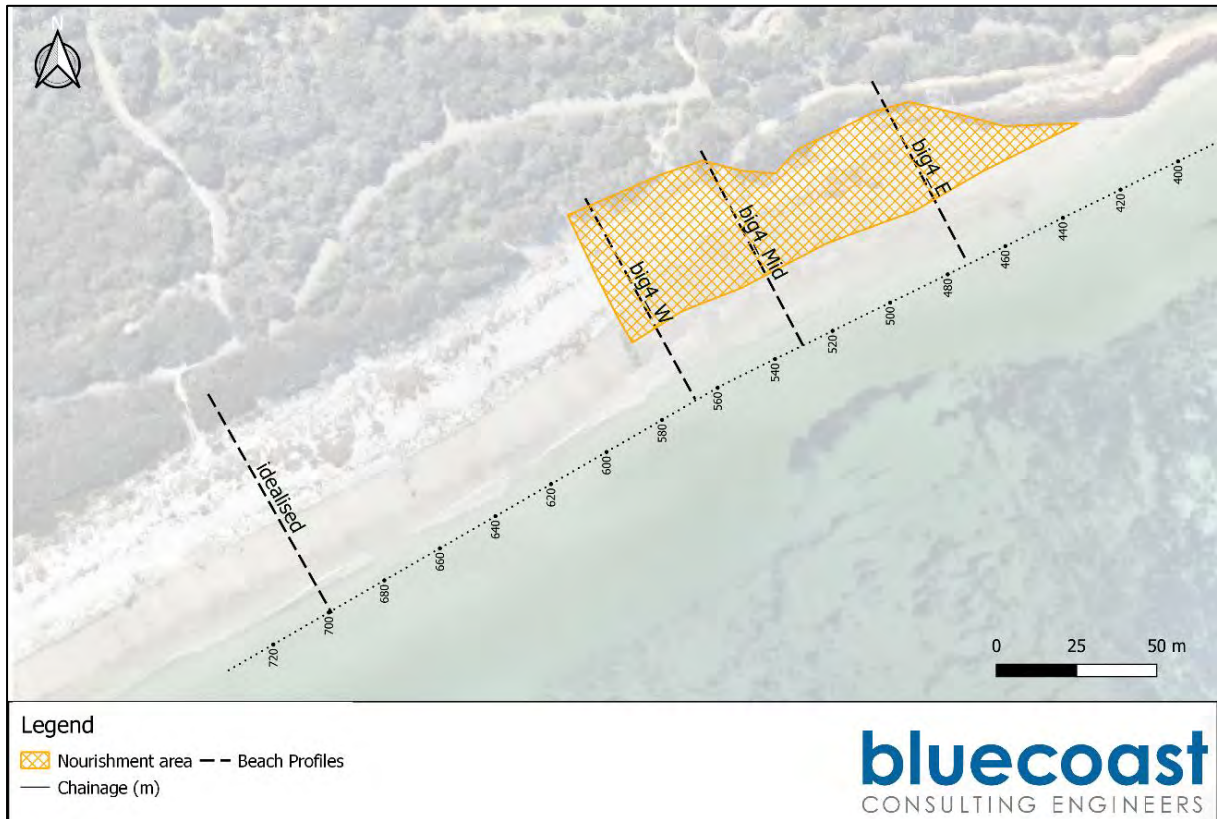
Figure 29: Proposed beach nourishment area (top) and analysis of existing beach profiles (below) taken from December 2018 beach survey

Figure 29 shows the extent of the proposed nourishment campaign, representative beach profiles through the proposed area as well as an 'idealised' extracted profile further to the west (at chainage 700). A comparison of the idealised profile as well as the three extracted profiles within the nourishment area (Big4_W, Big4_E and Big4_Mid) can be seen in the lower part of Figure 29. The profile analysis shows steep (1V:0.5H) escarpments at each of the representative profiles on the upper dune face from approximately 7m AHD, in comparison to the gentler slope (1V:3H) seen in the idealised profile further to the west. Using the idealised profile as a template for the re-nourishment program from the 7m AHD upper dune to the MHWS contour places an estimated beach nourishment volume at approximately 6,000m³ over the 190m distance between the upgraded western groyne and
