FORESHORE MANAGEMENT PLAN

Emu Beach

EEL19265.001
Rev 0
04 June 2021

REPORT

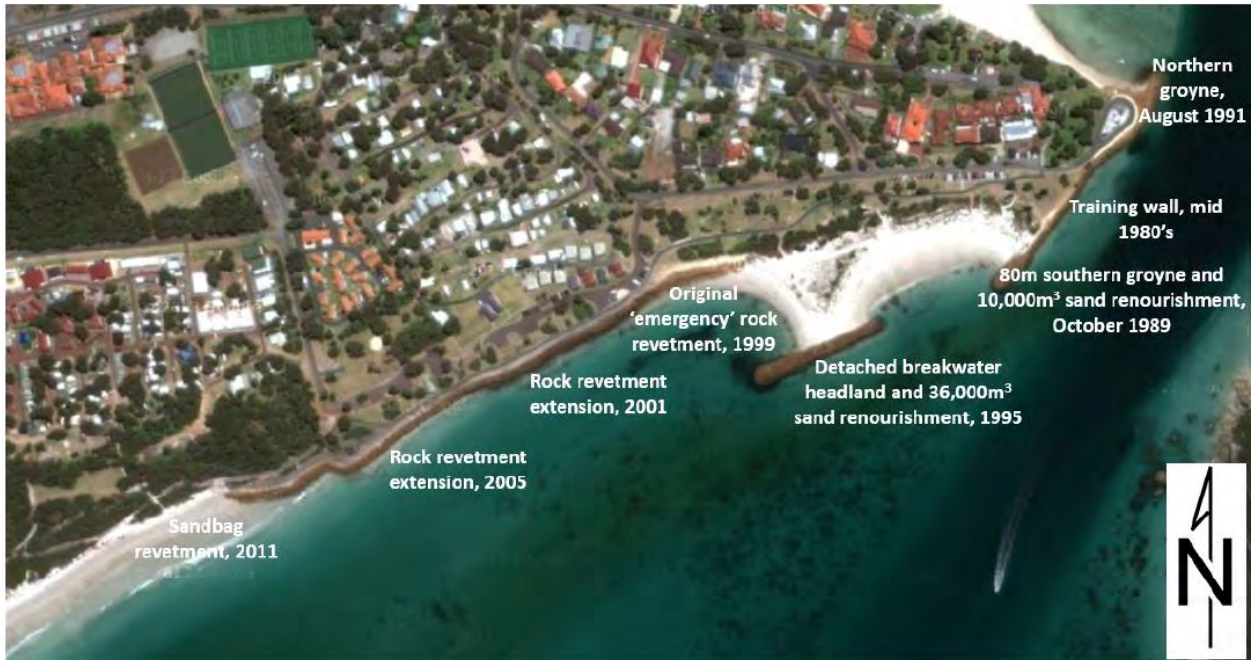
Figure 1: History of construction of coastal structures at Emu Point (source: RHDHV, 2017)

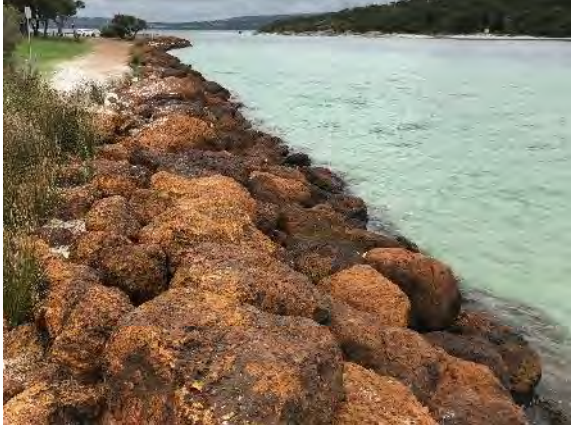
Moderate	Some defects – loss of crest elevation; loss of interlocking with some slumping probably due to loss of core/filter
Emu Point - south groyne	Rock groyne connected to training wall that stabilises western side of Emu Point channel and protects foreshore area from erosion

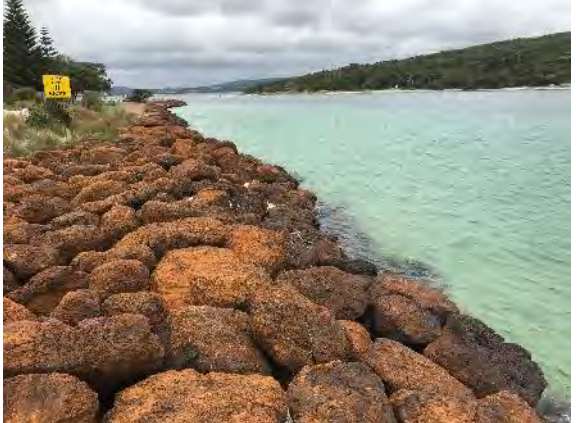
Good	No significant defects

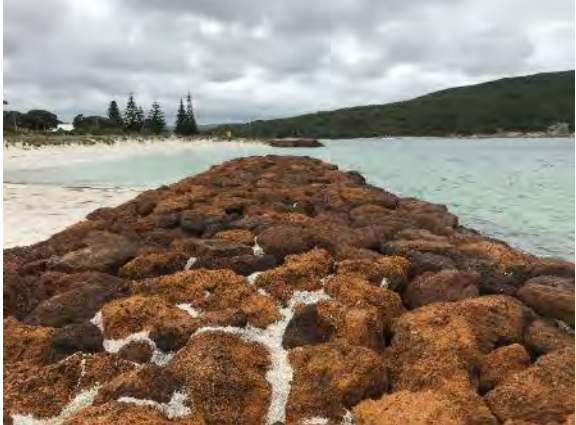
Very good	No significant defects
Emu Point - rock revetment	Sloping rock seawall that protects foreshore area from erosion

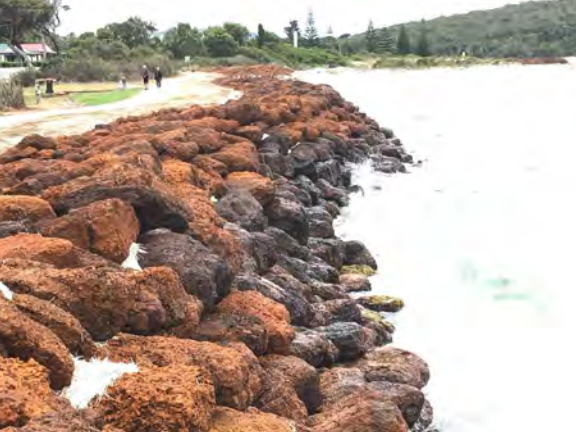
Poor	Some significant defects – significant slope steepening in some sections, likely due to settlement of toe, causing loss of interlocking between armour rocks and filter exposure; crest washout holes, likely due to overtopping

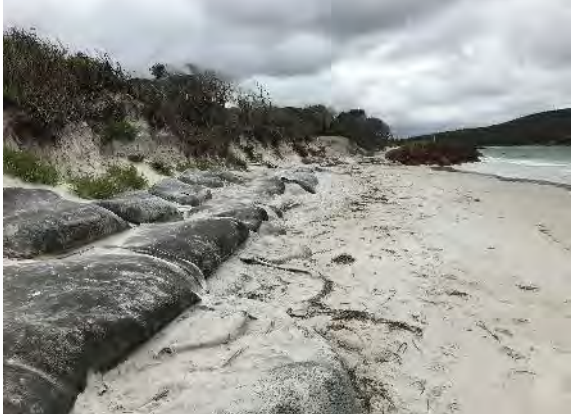
Structure name	Description & function	Photo	Condition	Condition notes
GSC revetment	Sloping sandbag seawall that provides some protection of foreshore area from erosion

Very poor	Structure has failed – bags have split open and washed away; significant reduction in crest height; overtopping has eroded foreshore behind structure
Sandbag groyne 1 (east)	Trial sandbag beach groyne which helps to stabilise beach and limit impact of erosion scour at end of seawall structures

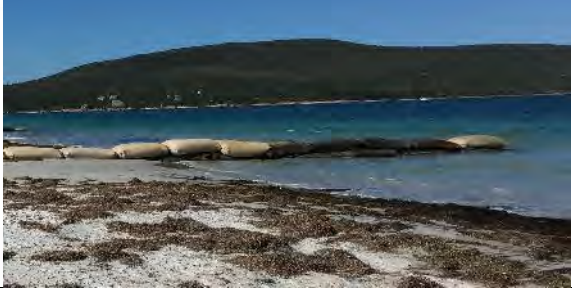
Moderate	<p>Some defects - Several sandbags have holes and several are deflated in size</p> <p>Note: Maintenance undertaken in Autumn 2017 to add bags to crest of structure</p>
Sandbag groyne 2 (west)	Trial sandbag beach groyne which helps to stabilise beach and limit impact of erosion scour at end of seawall structures

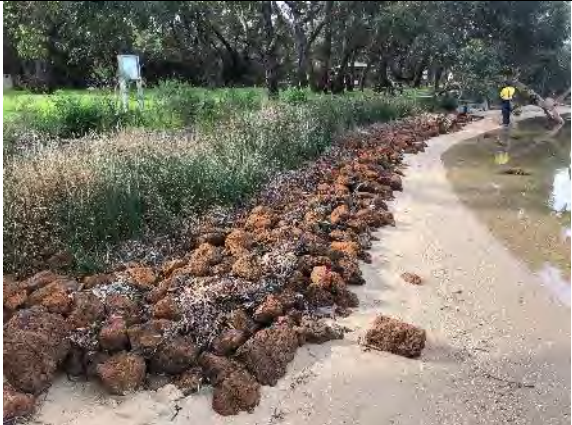
Good	Minor defect – several rocks located outside of structure footprint towards water

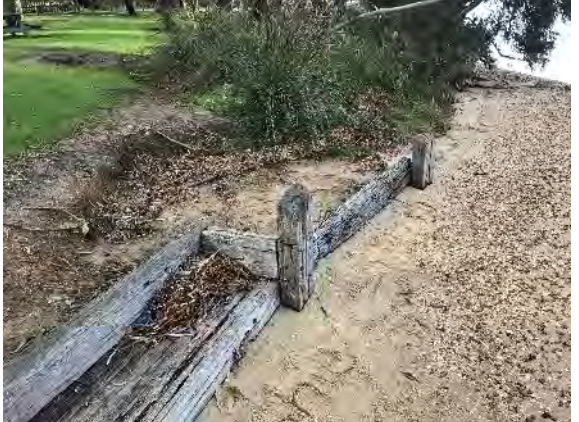
Very poor	Structure has failed - timber sections missing; connecting bolts rusted through; structure no longer retaining sand
Lower King - timber wall 2	Function is unclear - may have historically stabilised foreshore reserve for landscaping

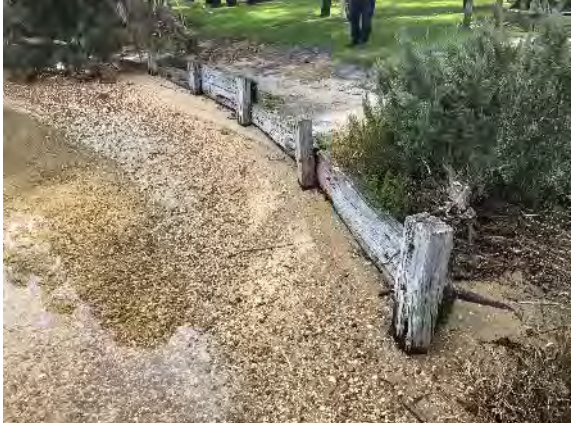
Very poor	Structure has failed - timber sections missing; connecting bolts rusted through; structure no longer retaining sand

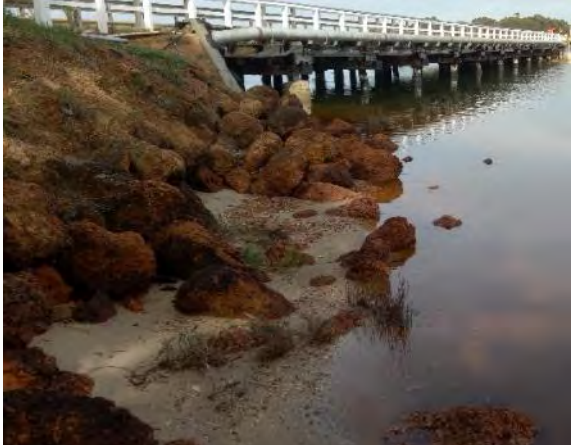
Very poor	Structure has failed - slope steepening, likely caused by slumping of toe; significant exposed core and fill; significant armour loss from slope
Lower King Bridge - SW abutment rock revetment (aka causeway)	Sloping rock seawall that protects bridge abutment and road from erosion

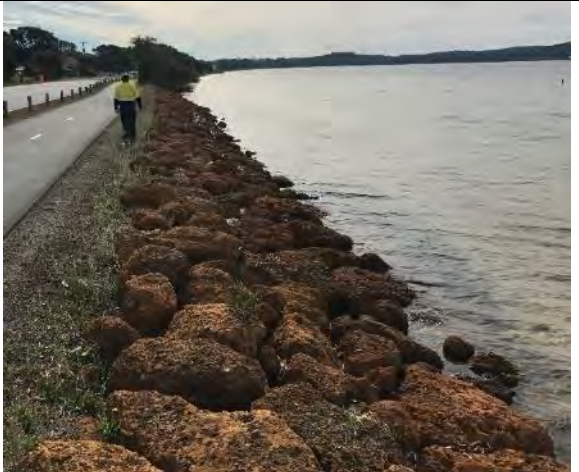
Moderate	Some defects - loss of interlocking at top of slope, likely due to settlement of toe; slope steepening; some washout at crest; large armour size range

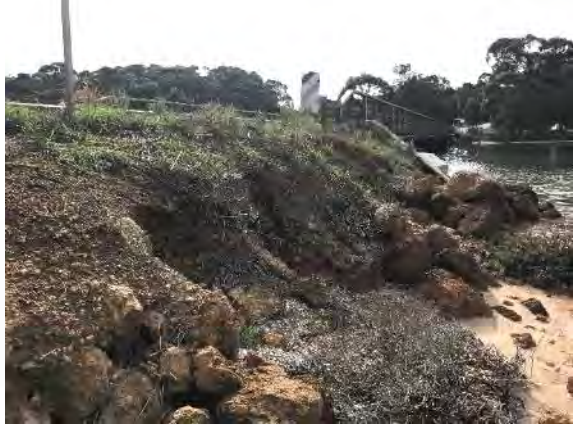
Very poor	Structure has failed - majority of armour lost; large sections of core and fill exposed
Lower King Bridge - NE abutment rock revetment	Sloping rock seawall that protects bridge abutment and road from erosion

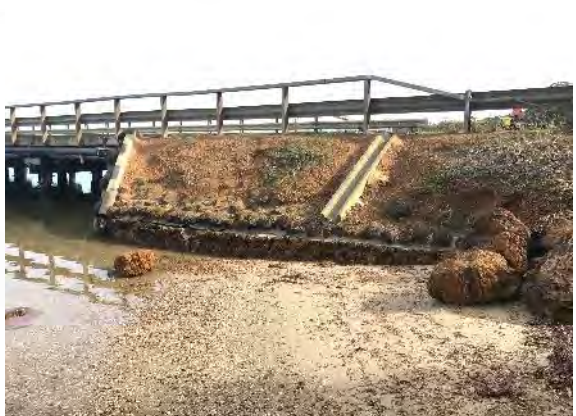
Moderate	Some defects - grouted section of structure has slumped ~50mm; slope steepening; displaced toe rocks; exposure of core and fill

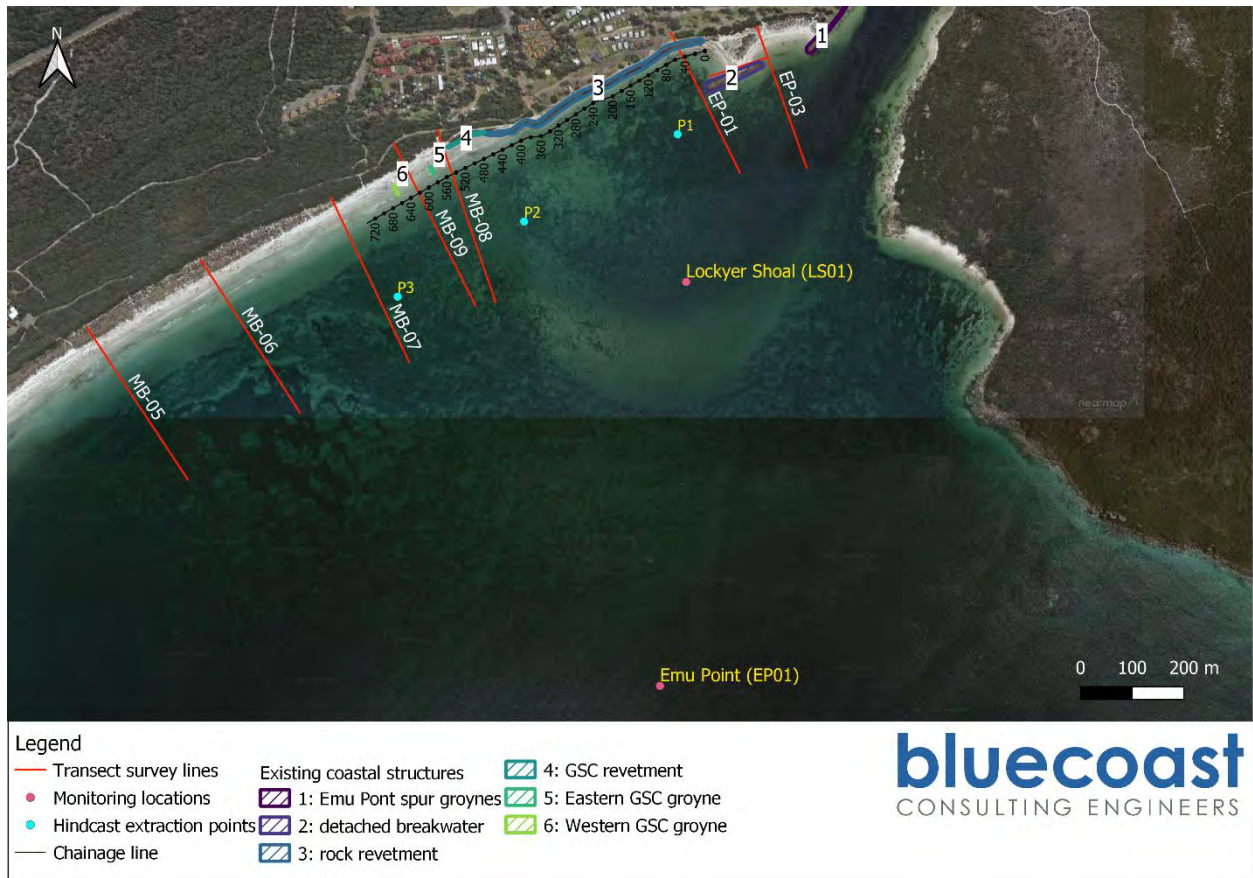
Figure 40: Emu point monitoring locations and hindcast model extraction location

measurements collected by an Acoustic Wave and Currents (AWAC) instrument deployed in 8m offshore of Emu Point by DoT. A subsequent hindcast wave model was calibrated to this data in 2020 with additional boundary data used to bring the duration of this simulation to 41 years (1979-2020) as part of the design studies for the Albany Artificial Surf Reef project (Bluecoast, 2020). To improve calibration and ensure precision, the model resolution was increased in the nearshore and further validation was undertaken against newly recorded data from an AWAC device placed in the lee of Lockyer Shoal, see Figure 40.

In order to gain an understanding of the wave climate in the nearshore at Emu Point to inform coastal protection activities, hindcast wave data was extracted from this model at three locations approximately 150m offshore of the rock revetment and trial GSC groynes at Emu Point, 250m apart from each other shown in Figure 40. A summary of the nearshore wave climate at each point can be seen in

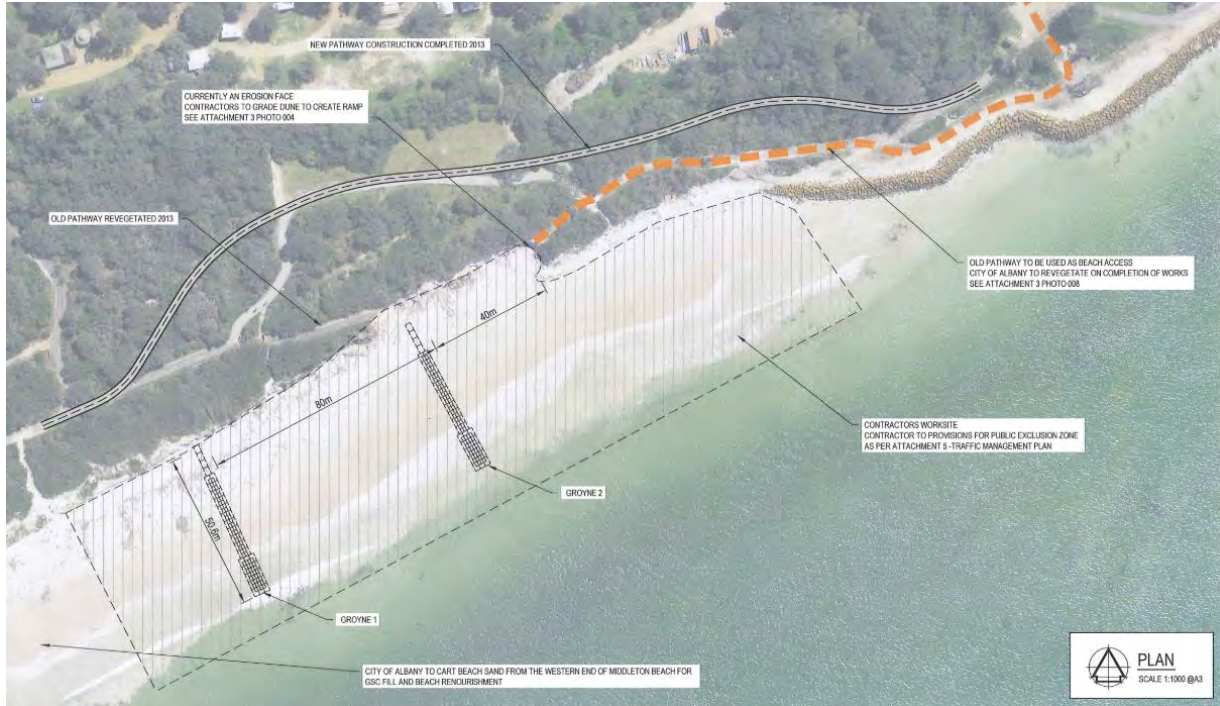
Figure 55: Geotextile and container groyne construction drawings, 07 April 2014 (Source: City of Albany)

The previous section showed the stability of the beach between the two GSC groynes since their construction. The exact volume of nourishment delivered to this section of the beach is unknown. However, from the City-supplied construction drawings of the GSC groynes (Figure 55) the proportion of fill area between the two GSC groynes (and the upper beach) accounts for approximately 34% of the nourished area in the design. This equates to approximately 3,400m³

of sand which has been successfully maintained between the groynes over the 7 years since construction.
