Development and Infrastructure Services Committee Meeting

PROPOSED FRENCHMAN BAY HERITAGE TRAIL

FEASIBILITY STUDY

Development Application for an Extractive Industries Licence (Lime Pit)

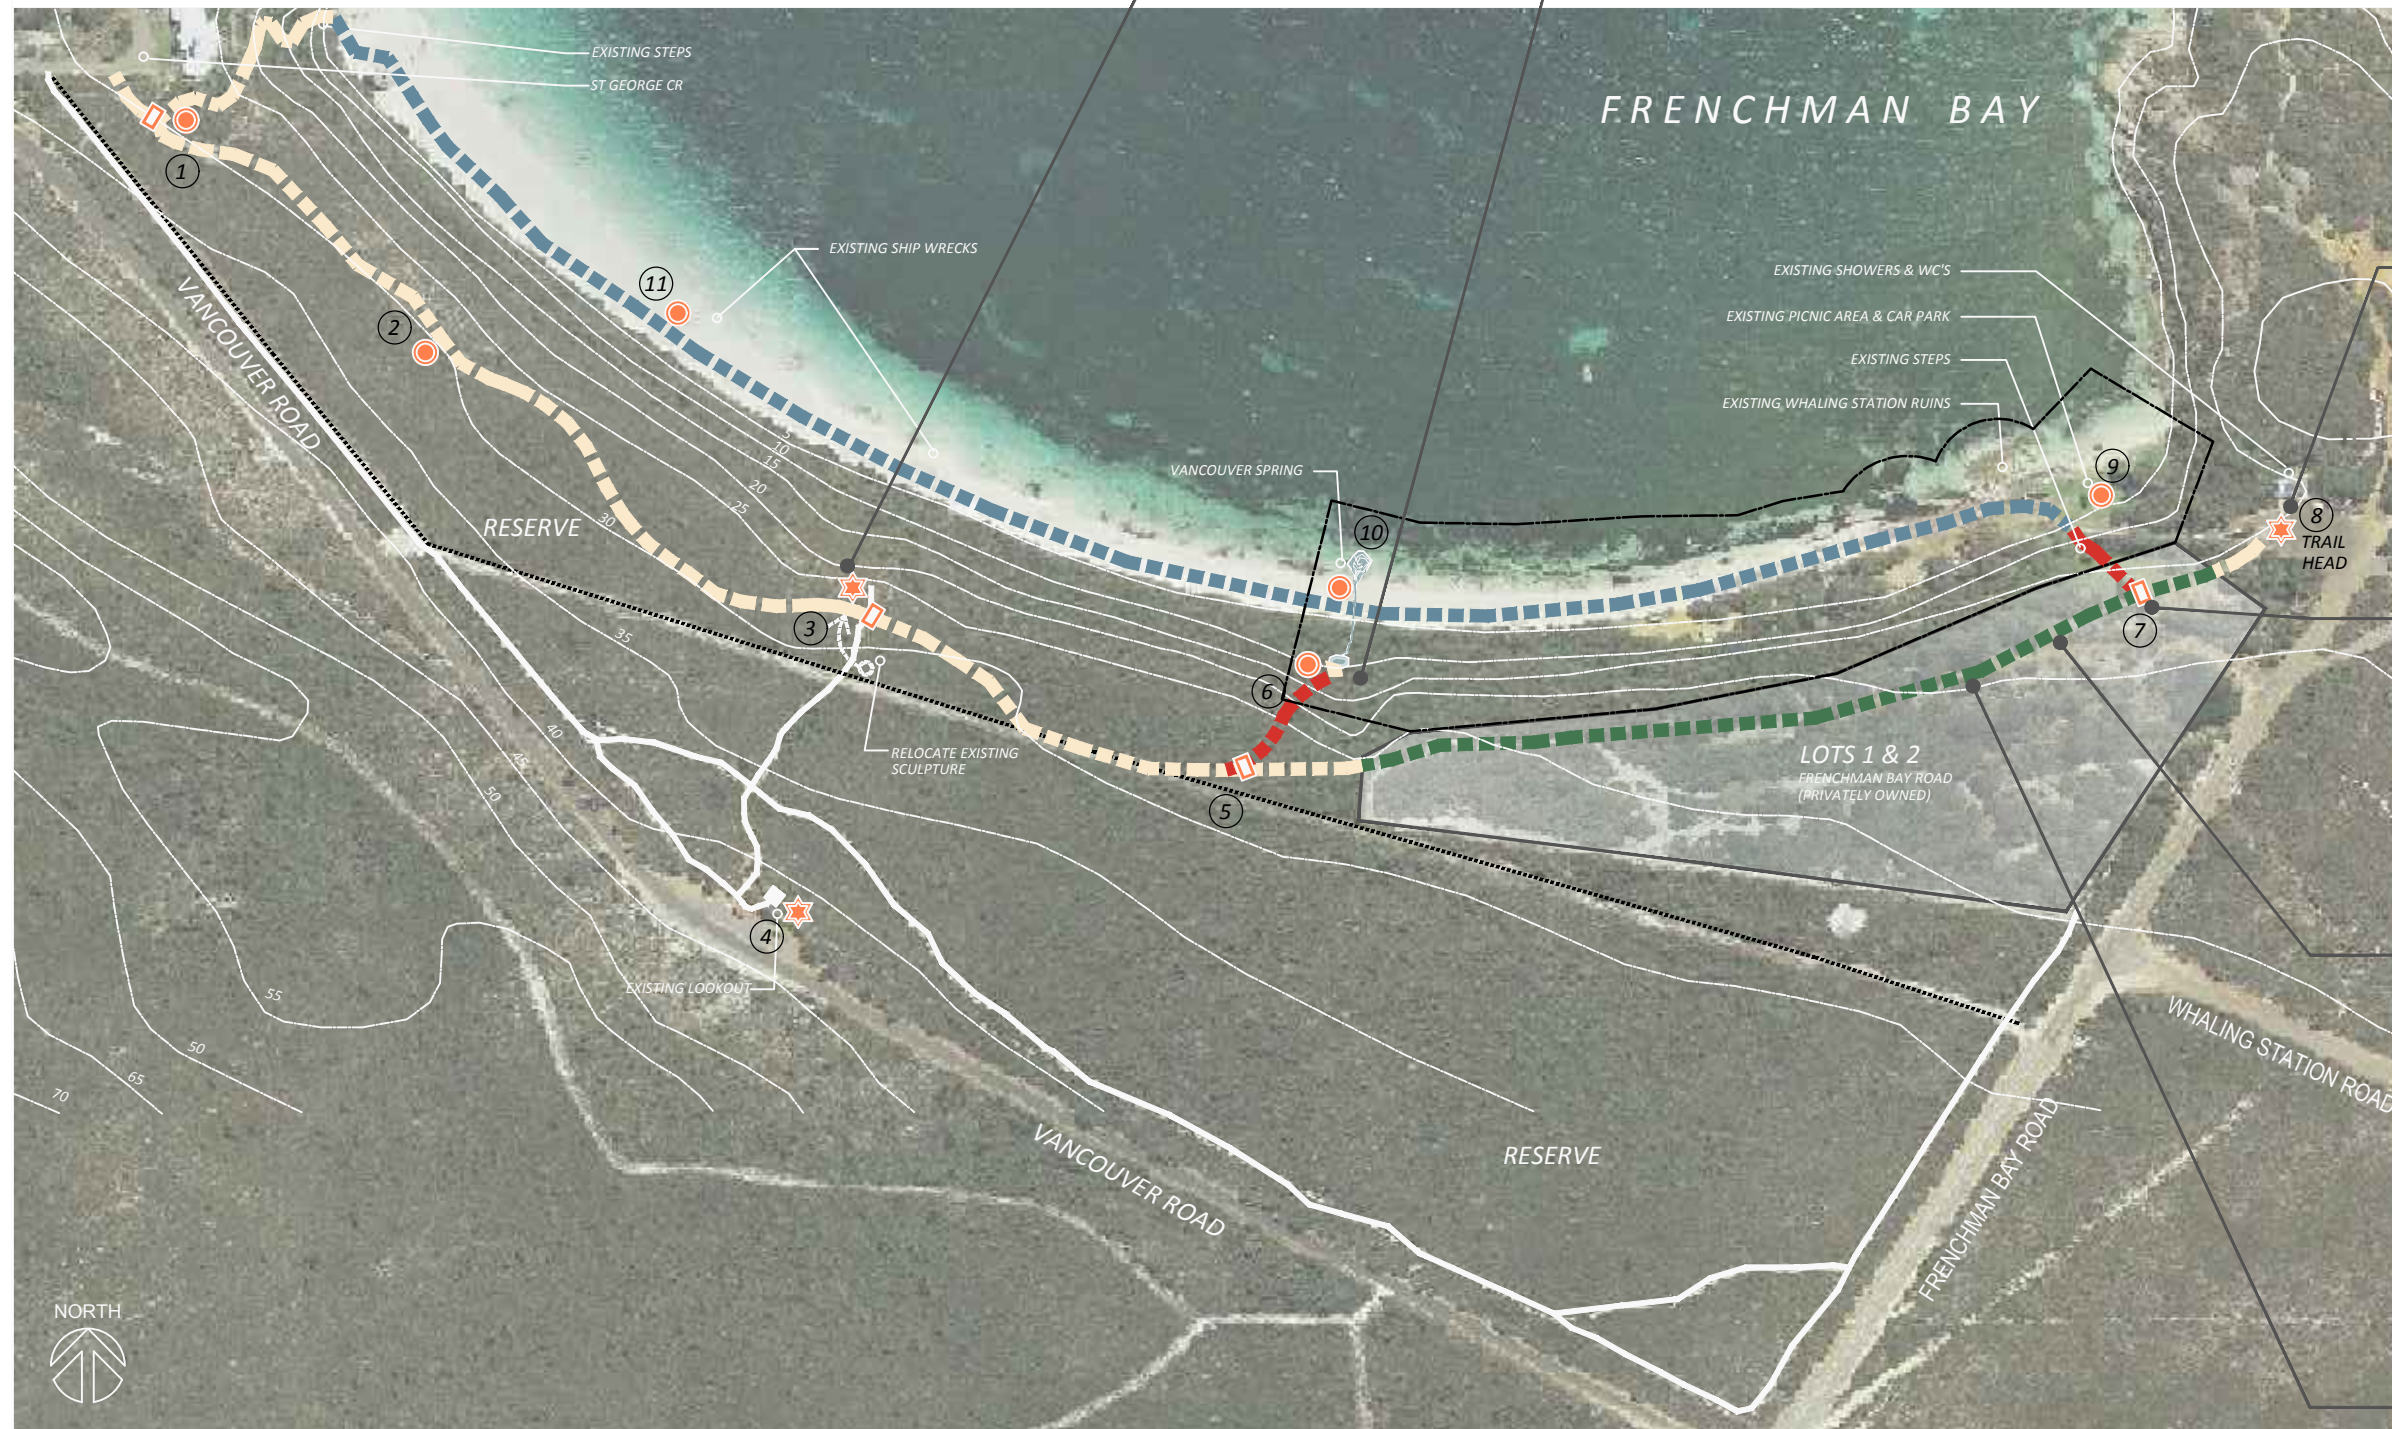
Proposed Concept Plan - Draft

WITH INDICATIVE STRUCTURES, MATERIALS AND INTERPRETATION OPTIONS

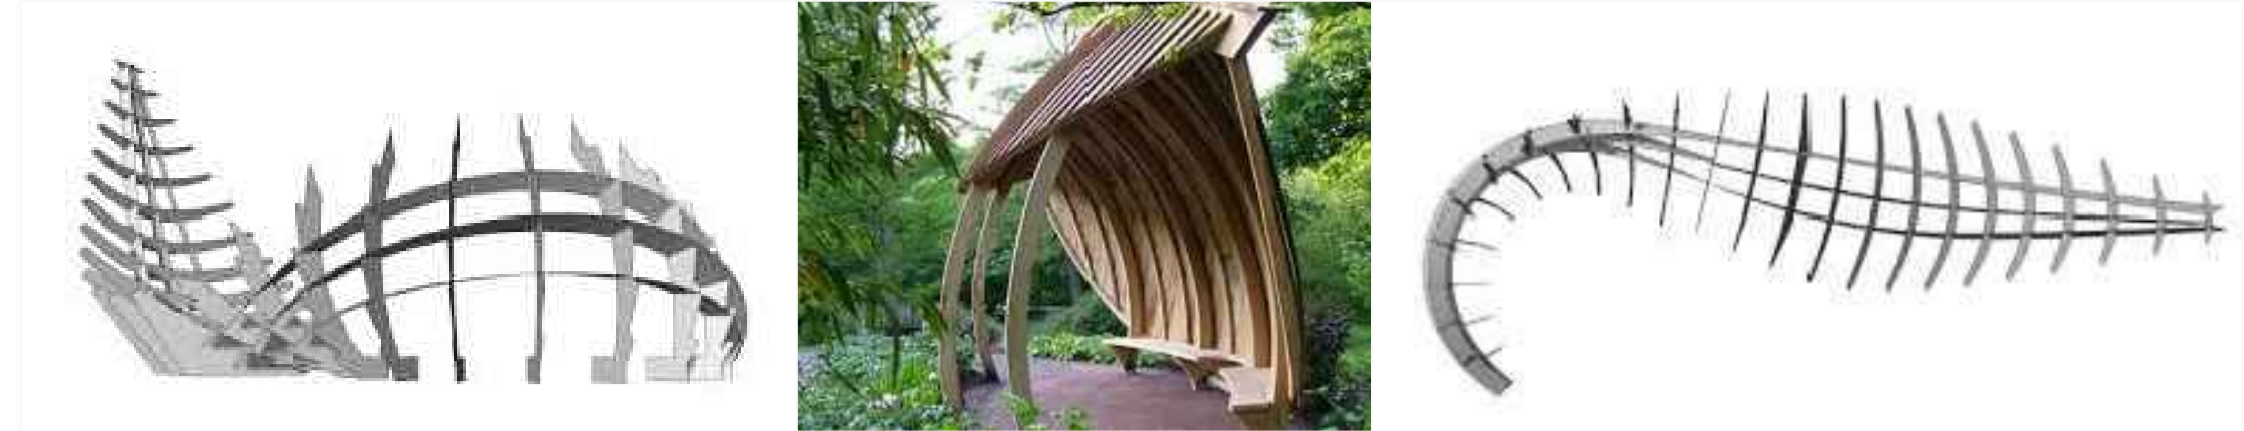
NEW INFORMATION NODE WITH INTERPRETIVE STRUCTURE & SEATING - VIEWING POINT AND A PLACE TO REFLECT

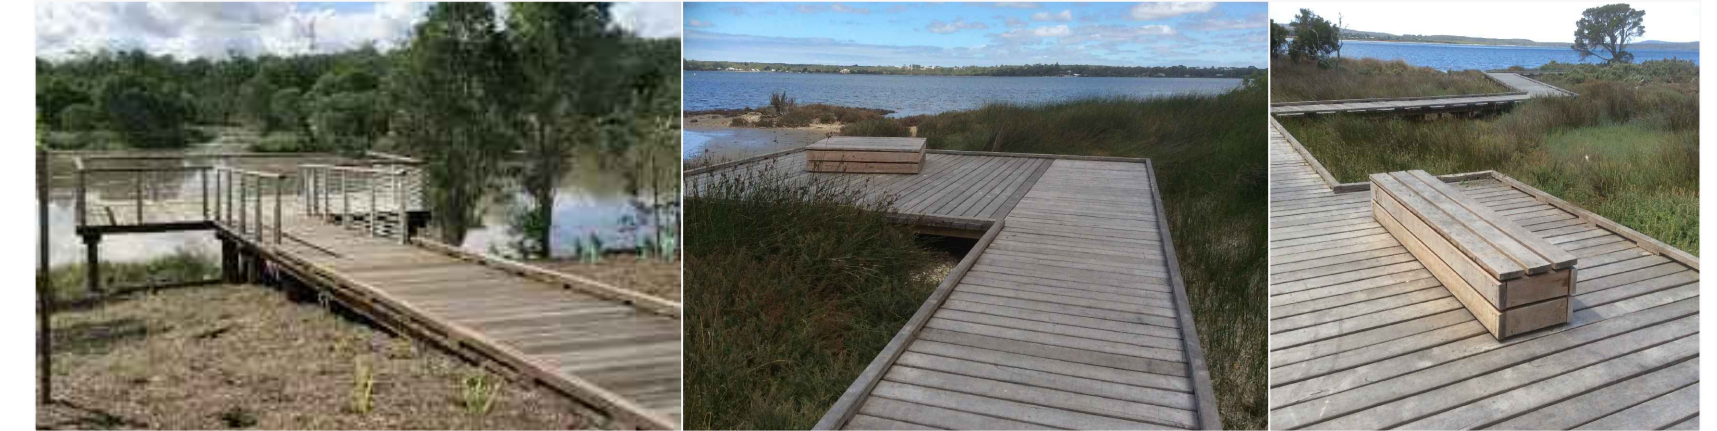
VANCOUVER DAM - NEW VIEWING PLATT FORM

TIMBER DECKED VIEWING PLATFORM WITH TIMBER SEAT AND A TIMBER BOARD WALK FORMING THE TRANSITION TO NEW LIMESTONE PATHWAY

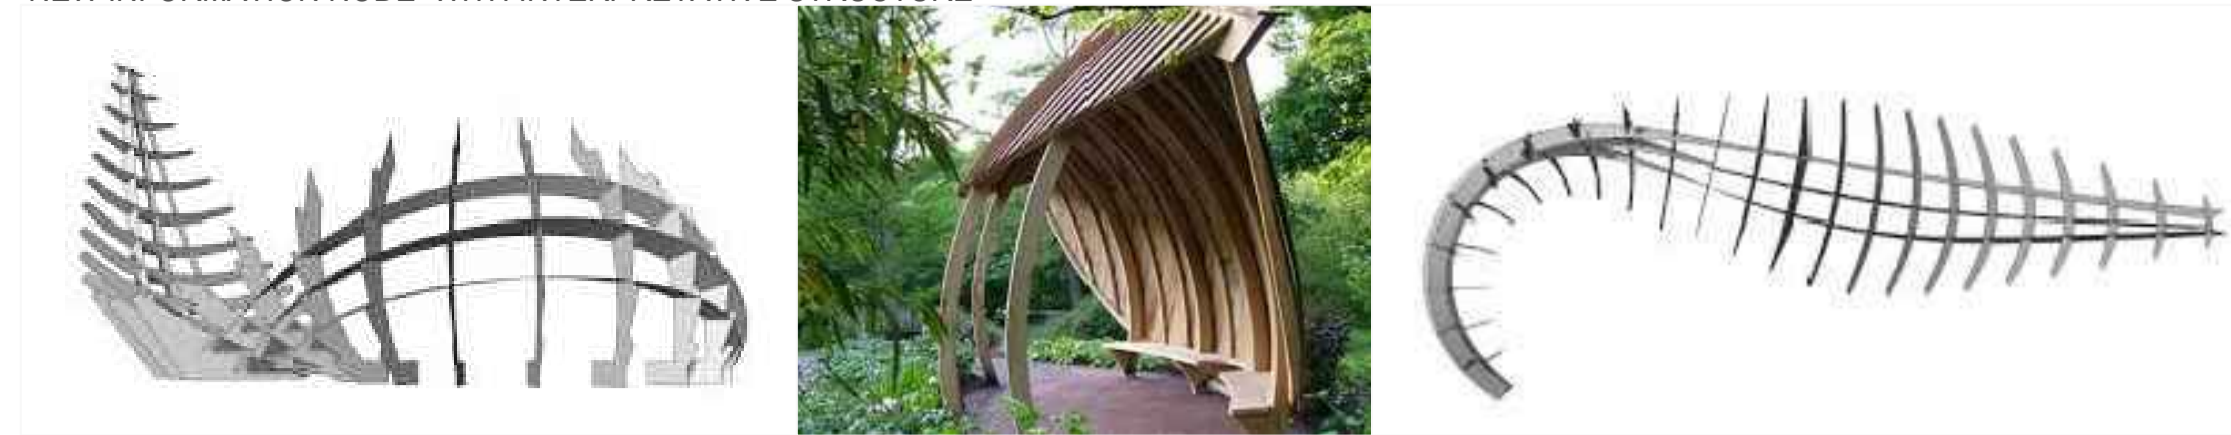
NEW INFORMATION NODE WITH INTERPRETIVE STRUCTURE & SEATING - VIEWING POINT AND A PLACE TO REFLECT

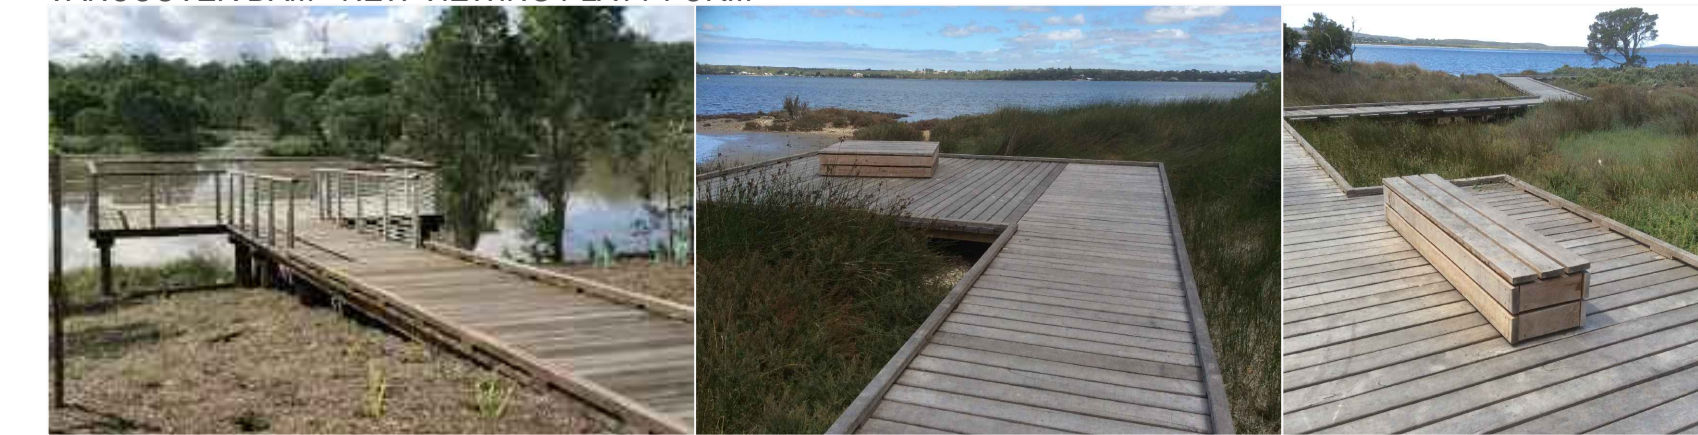
TIMBER DECKED VIEWING PLATFORM WITH TIMBER SEAT AND A TIMBER BOARD WALK FORMING THE TRANSITION TO NEW LIMESTONE PATHWAY

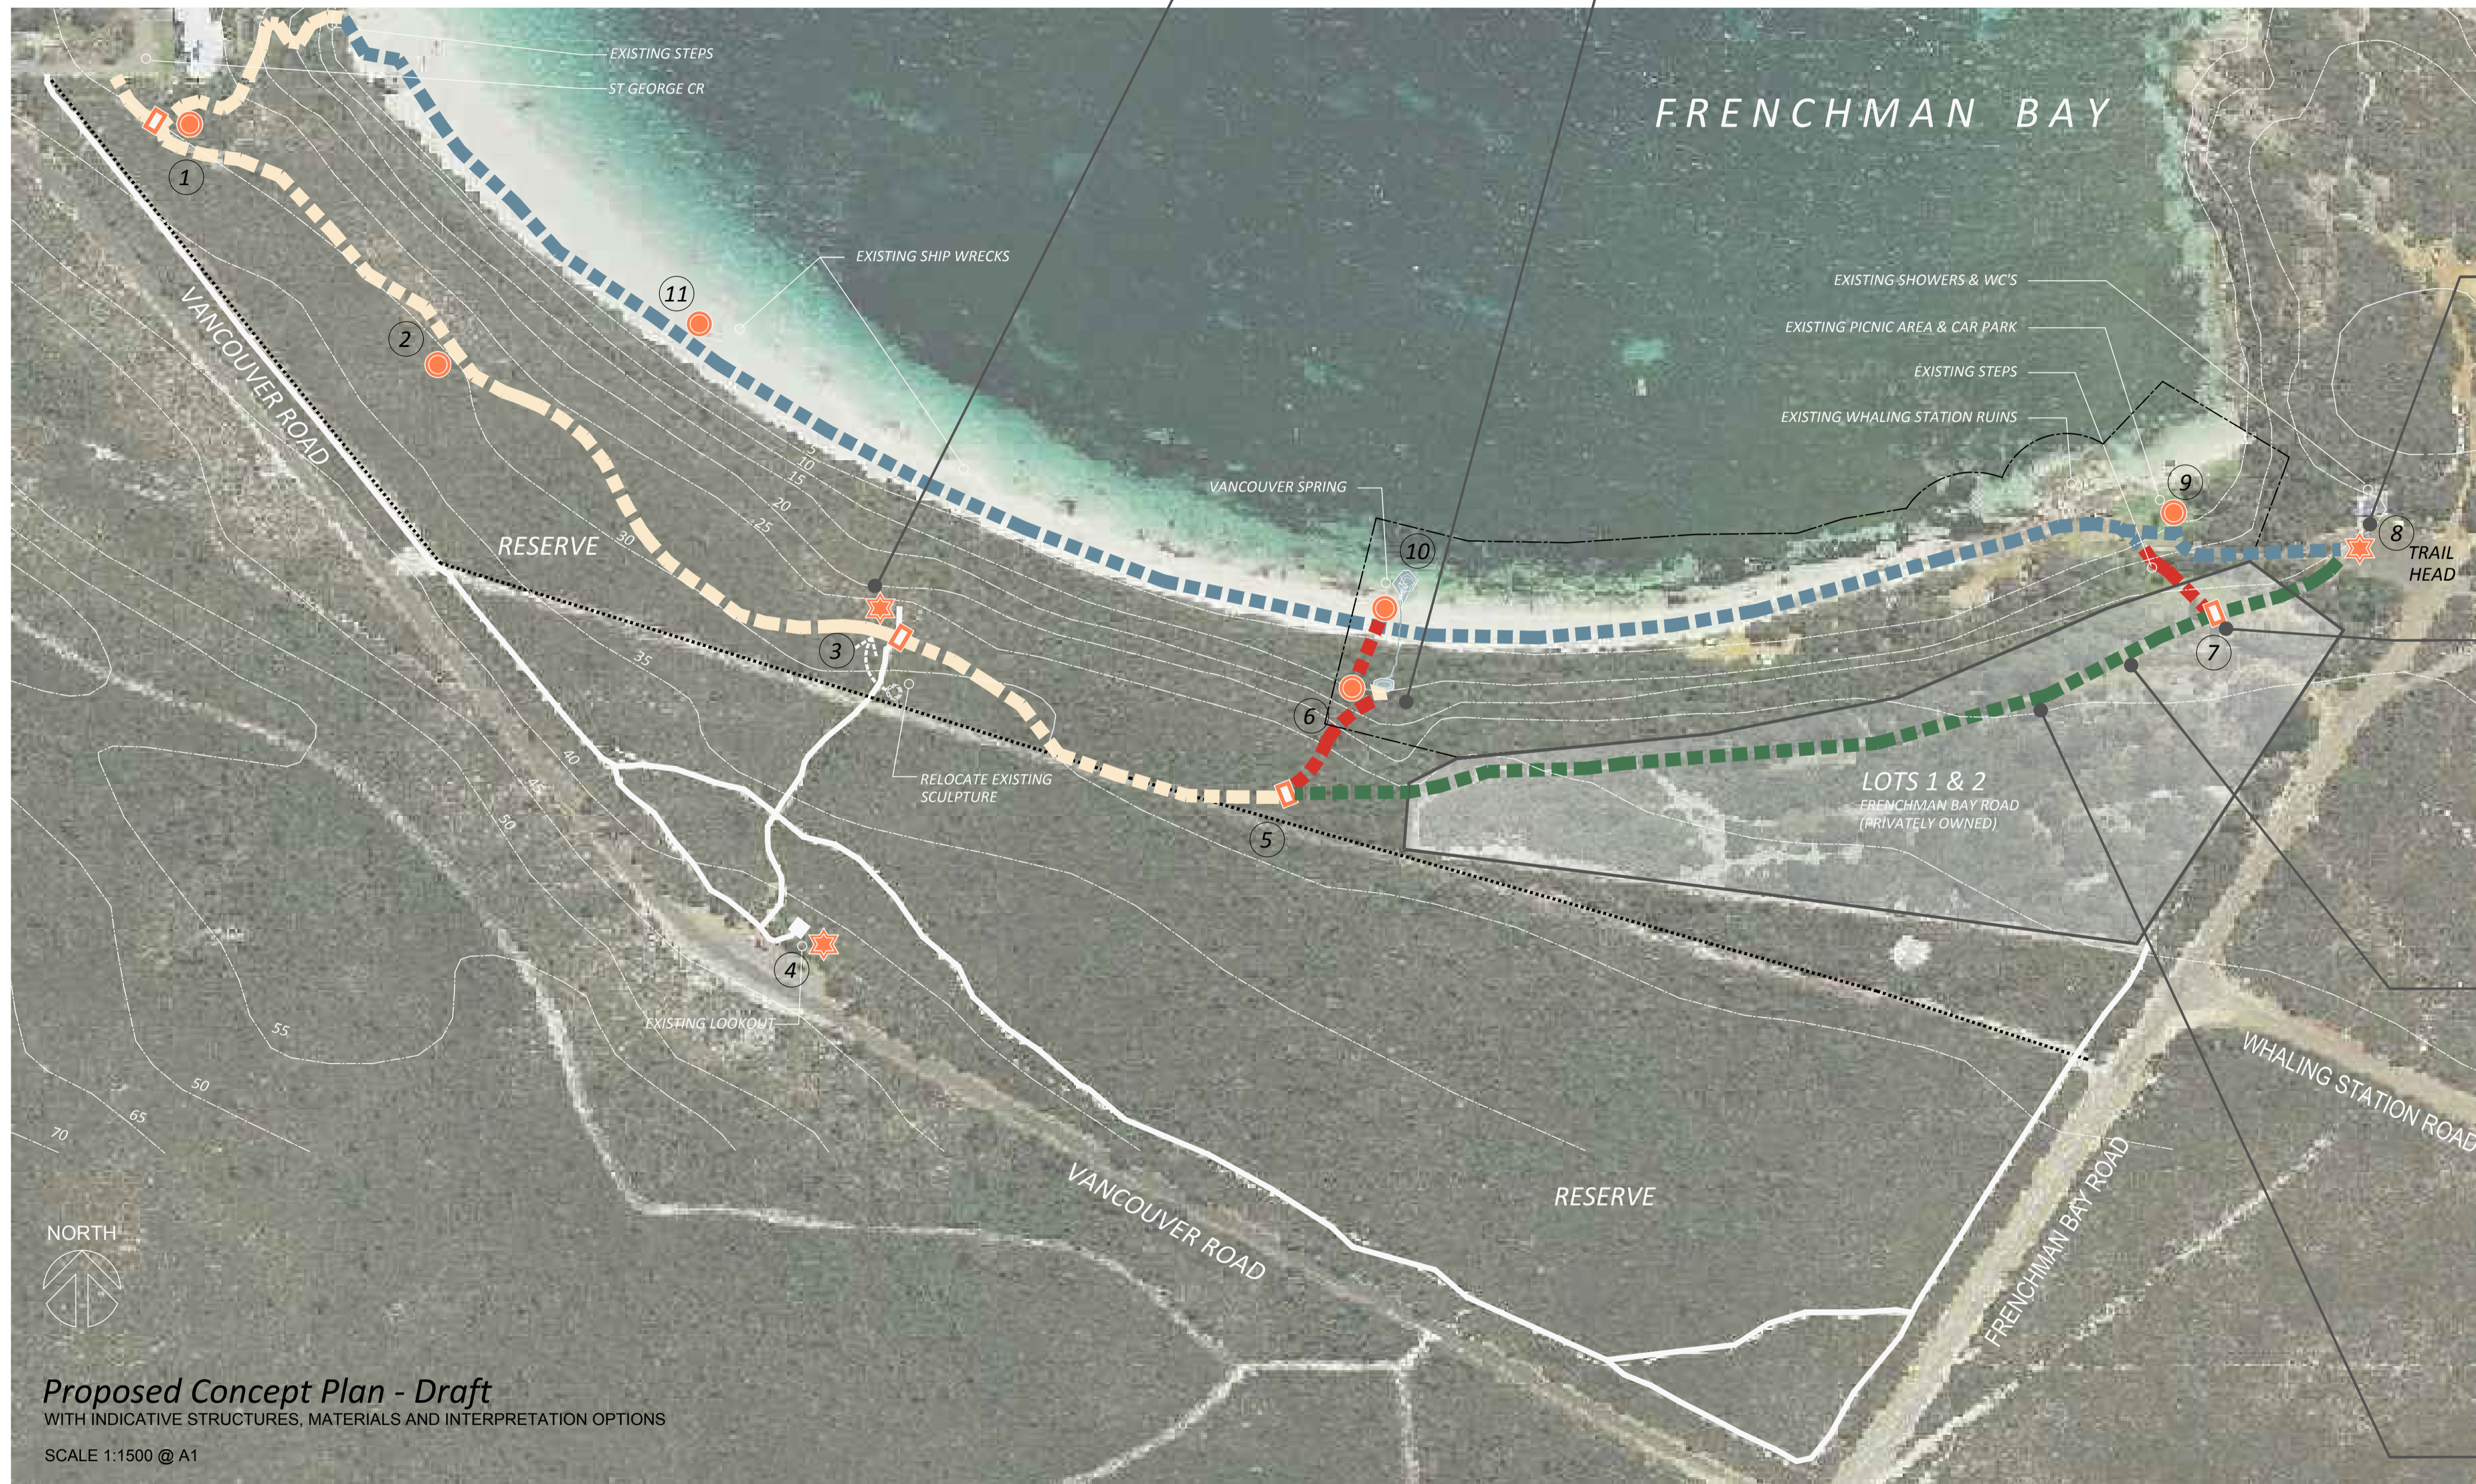
Proposed Concept Plan - Draft
WITH INDICATIVE STRUCTURES, MATERIALS AND INTERPRETATION OPTIONS
SCALE 1:1500 @ A1

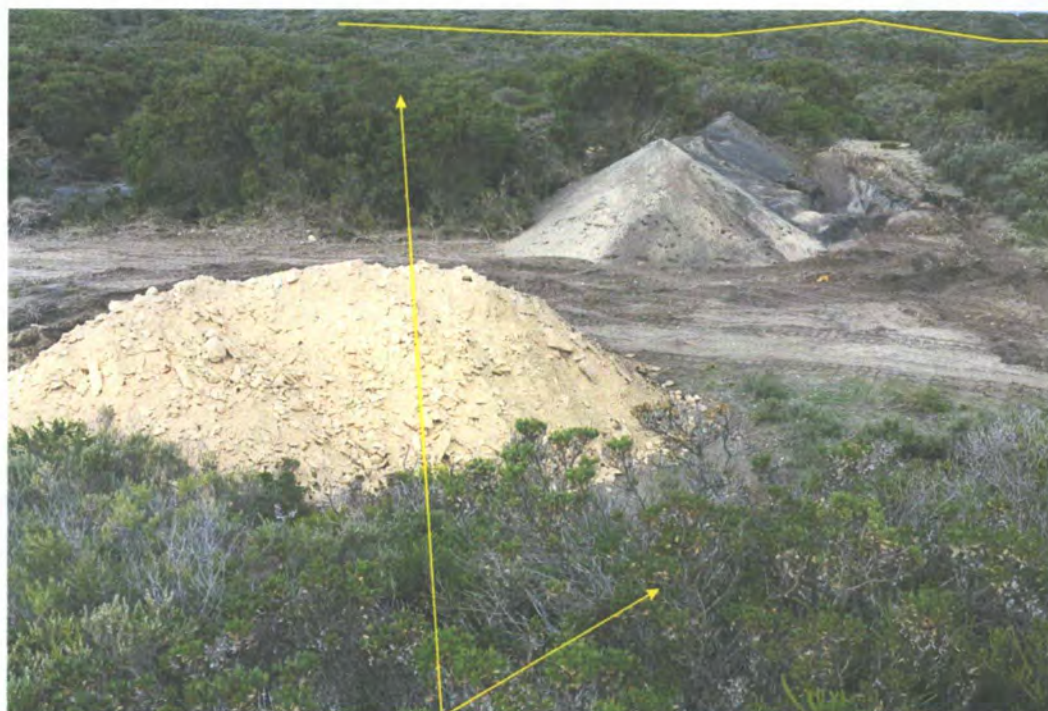
Rehabilitation at the old limestone pit

Figure 8 Rehabilitation that has been cleared for new testing of limestone

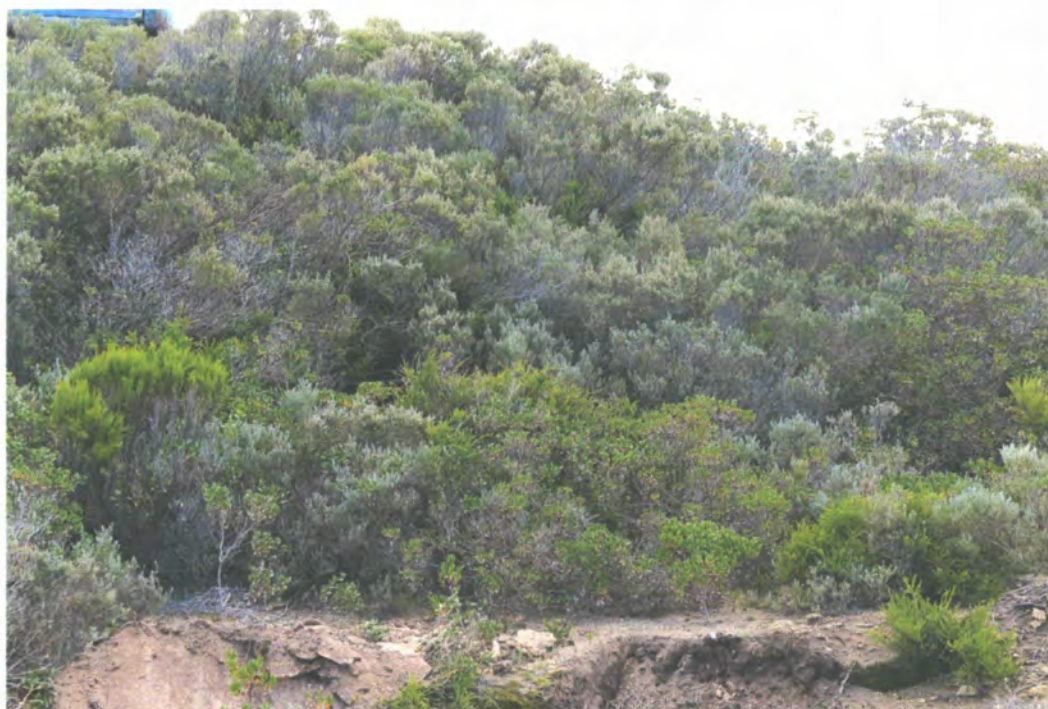
Figure 9 Rehabilitation of a steep slope on the access road to the pit

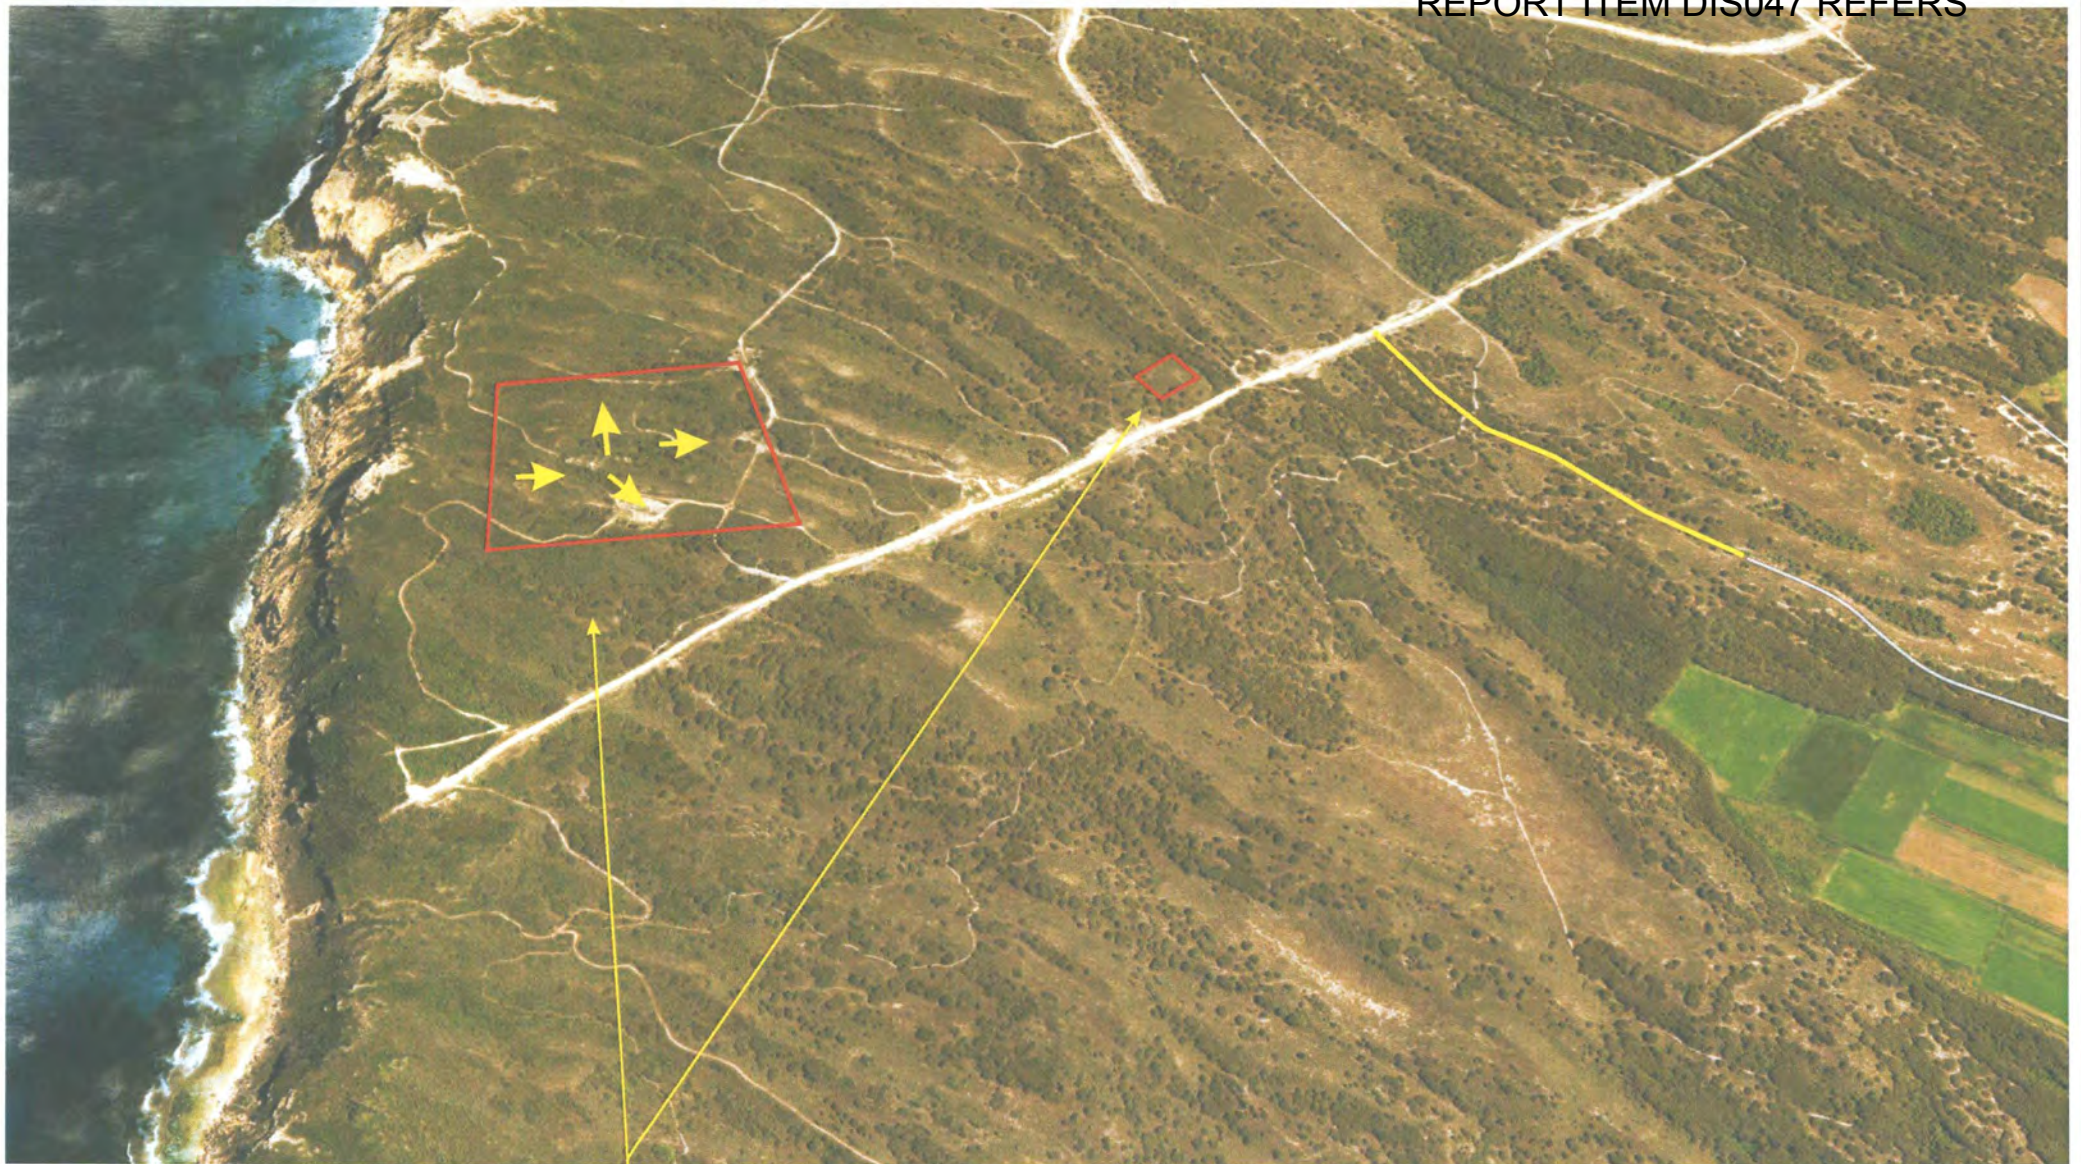
Aerial - Oblique view from the east showing the pit location and stockpile area

PROPOSED LIMESTONE QUARRY LOT 9005 NULLAKI PENINSULA, DENMARK	
AERIAL PHOTOGRAPH - OBLIQUE VIEW	
Landform Research	Scale - See Plan
June 2016	Figure 13

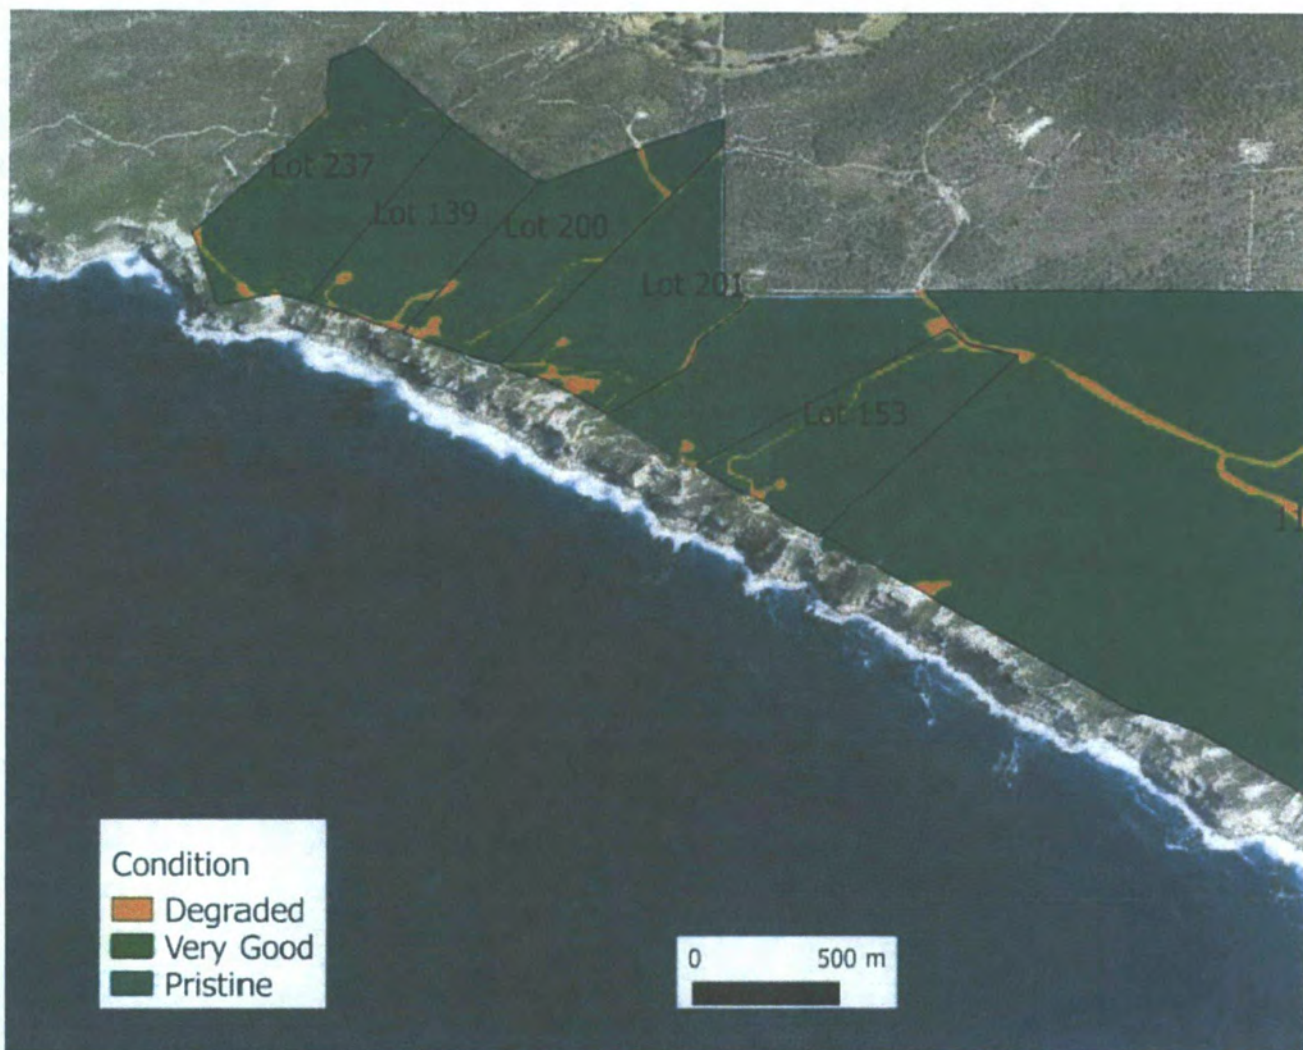
Figure 3: Vegetation condition mapped within survey area

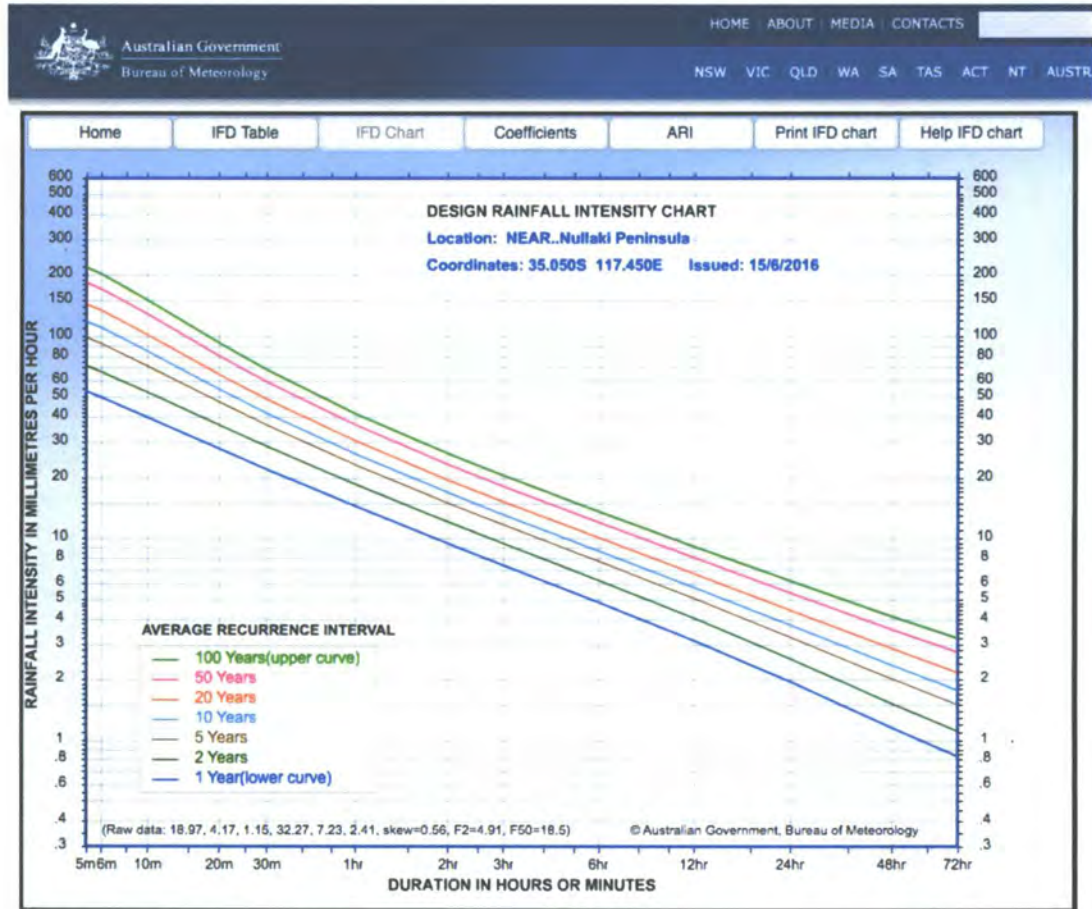
Figure 1 Rainfall Intensity Chart

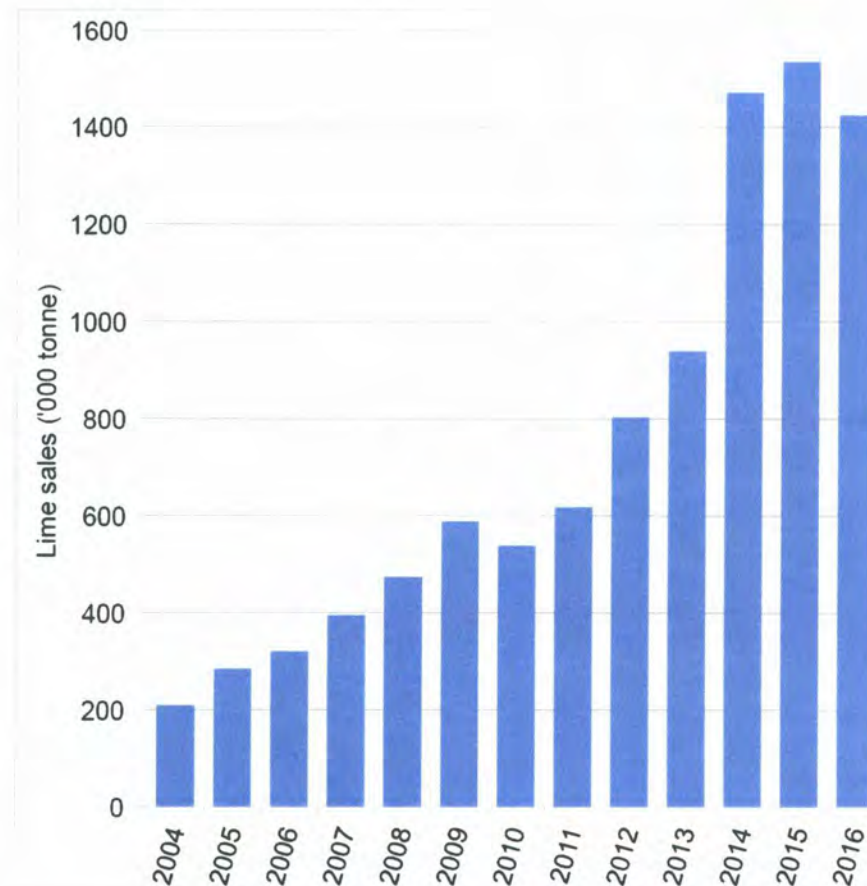
Figure 1. Lime use in Western Australia to treat acidifying soils, 2004–2016. These data represent the aggregate agricultural lime sales figures for each year for Lime WA Inc. members. It is estimated that these current members represent approximately 80 percent of the total market share.
