R1782 Rev 1

December 2023

City of Albany

**Whalers Beach Public Infrastructure
Coastal Hazard Risk Management & Adaptation
Plan**

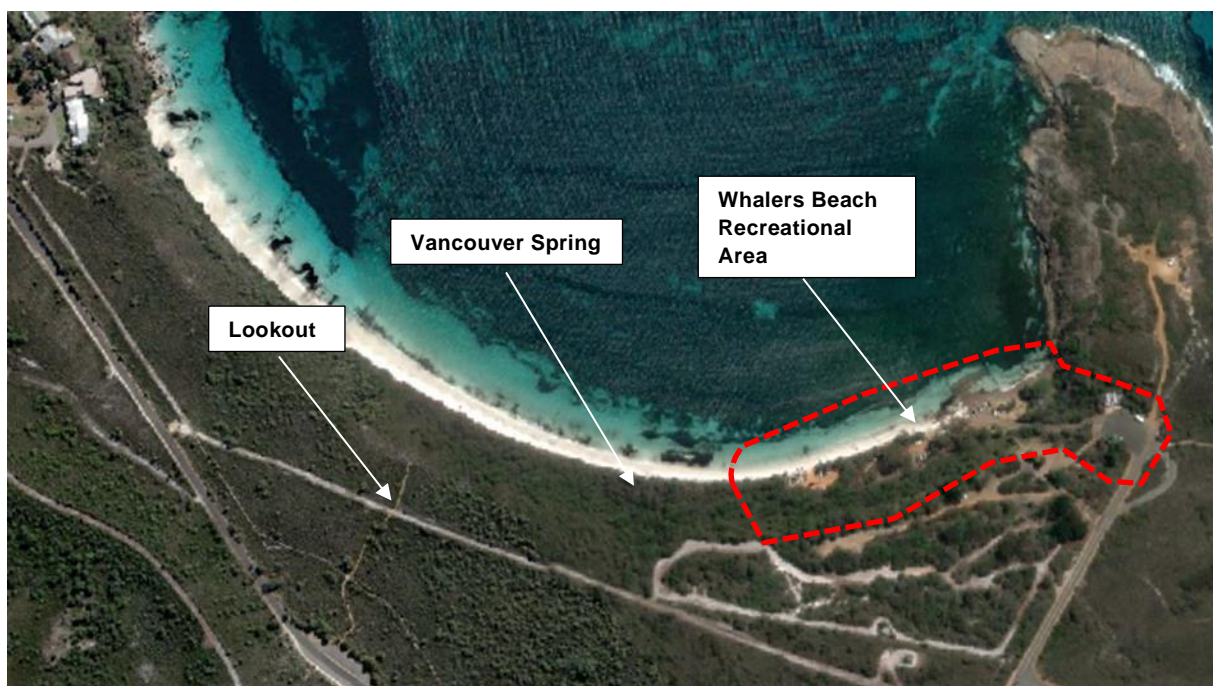
Figure 2.2 Public Assets within the Whalers Beach Area

Key assets within the study area and surrounds have been summarised in Table 2.1 and their location shown in Figures 2.2 and 2.3. The risk assessment will focus on these assets to identify their vulnerability and consequently the requirement for risk management. These assets have been broken down into their key components and further refinement would not be beneficial to the CHRMAP. For this type of assessment, it is the vulnerability of the overall assets that is the important factor.

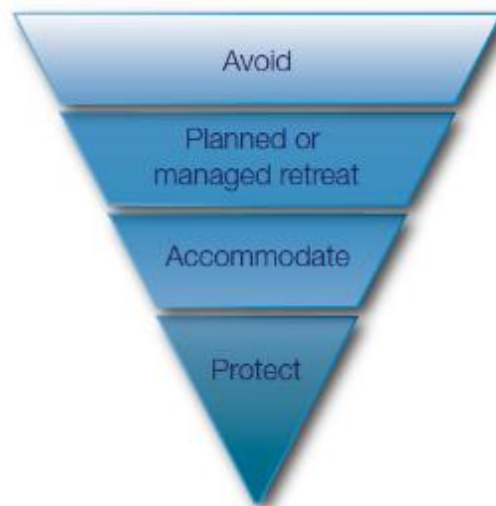
Figure 7.1 Risk Management & Adaptation Hierarchy

Risk adaptation and mitigation strategies are required for the city to address the coastal hazard risks and asset vulnerabilities identified in Sections 5 and 6. SPP2.6 outlines a hierarchy of risk adaptation and mitigation options, where options that allow for a wide range of future strategies are considered more favourably. This hierarchy of options is reproduced in Figure 7.1.

These four broad option categories are generally outlined below.

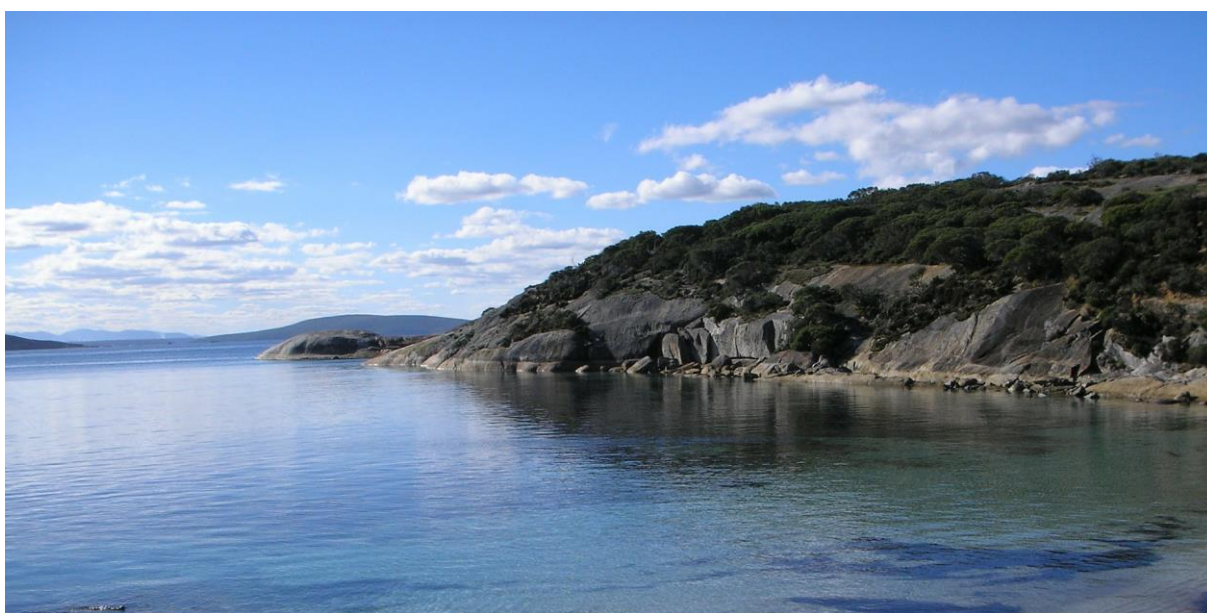
Figure 2.2 View of Granitoid Outcrop that Forms Waterbay Point

In 2008, Landform Research completed geotechnical drilling within Lots 1 and 2 to further review the local geology. The drilling determined that there was a deep layer of sand which was underlain by a siltier material. Significantly, none of the boreholes intersected the granitoid rock basement despite drill depths down to -1.7 mAHd in some areas. Whilst this drilling assessment was limited to the areas within Lots 1 and 2, it is anticipated that similar geological conditions would be encountered over the full extent of Whalers Beach. As a result, assessment of the shoreline will be based on a sandy coastline classification.

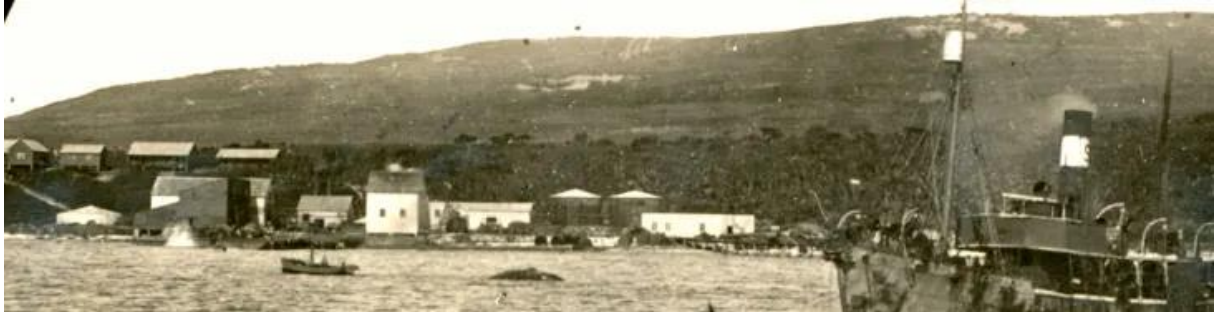
Figure 2.4 Image of the Norwegian Whaling Station from 1913 (Frenchman Bay Association, 2021)

The Norwegian Whaling Station was originally constructed in 1913, but was ultimately closed in 1915. At its peak, the whaling station boasted a range of different buildings, as shown in Figure 2.4.

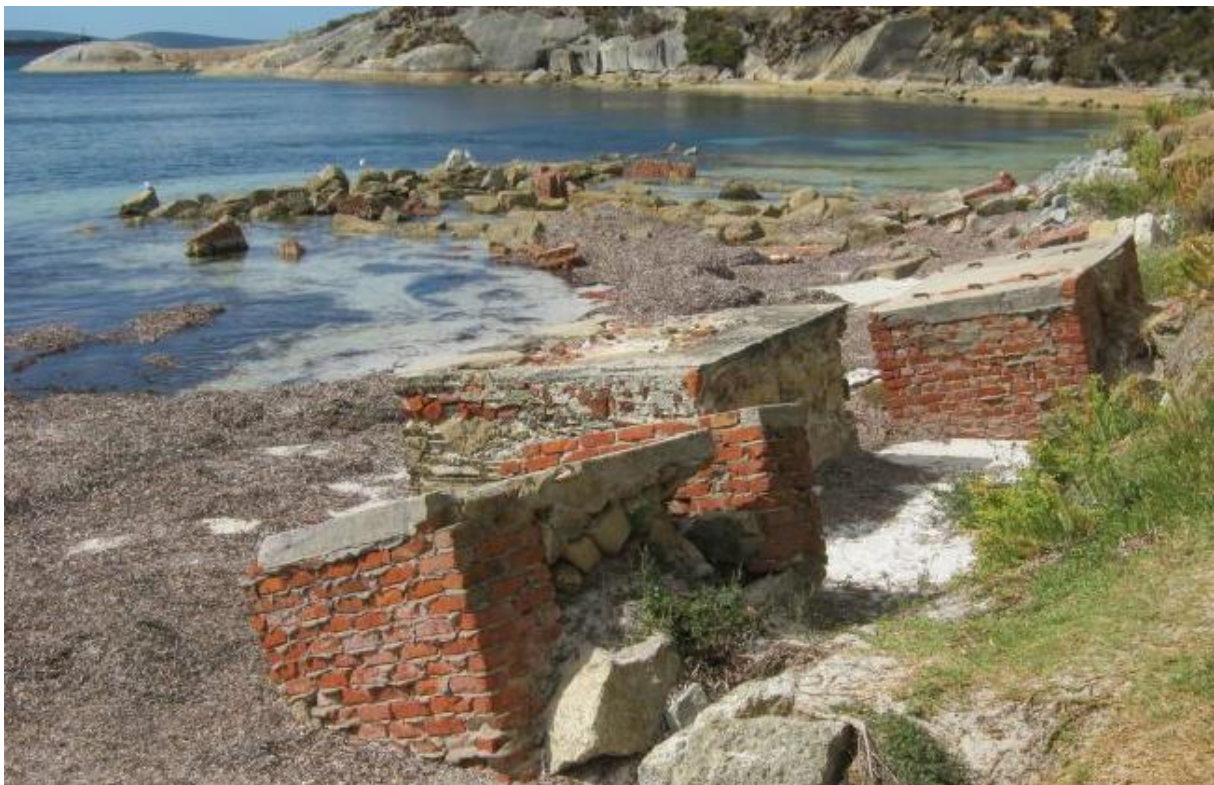
Figure 2.5 Remnant Material from the Norwegian Whaling Station (Frenchman Bay Association, 2021)

The Frenchman Bay Association (2021) provides a succinct summary of the history of the site. In particular, it is noted that following closure of the station the owners disassembled much of the machinery and relocated it to the site of their new facility at Point Cloates. However, it is noted that a large storm in 1921 wrecked the remaining slipway and loading jetty and eroded the seawall that protected the foundations of some buildings, causing them to topple. Whilst an amount of material was salvaged or removed, some of the material remained on site. An image of the remaining material is shown in Figure 2.5. This figure shows the remnants footings of some of the buildings as well as what is understood to be the remains of the initial seawall.

Given their location on the beach, the remains of the Whaling Station have impacted the local coastal processes along the eastern portion of Whalers Beach. It is currently understood that the City of Albany are reviewing heritage preservation opportunities and requirements for these relics. It must be acknowledged that any changes to the location or configuration of these relics could further influence the local shoreline dynamics. This will be discussed further in latter sections of this report.

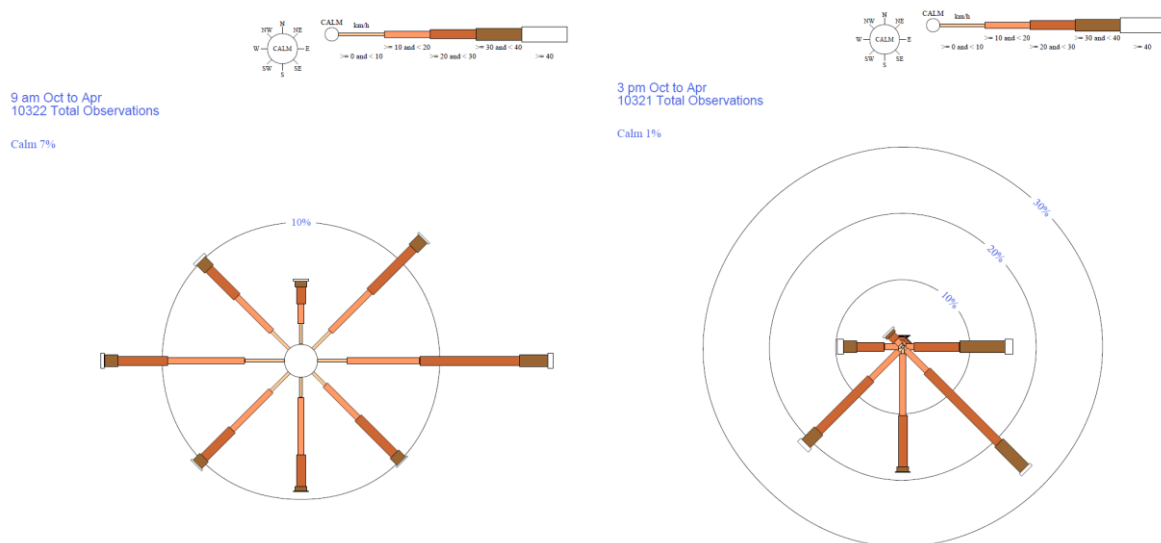
Figure 2.7 Albany Wind Roses for the Expanded Summer Period (BoM, 2014)

The wind roses for summer, Figure 2.7, shows the common wind directions in summer as southeast and southwest. The detailed wind records show the land sea-breeze effect with the summer morning winds typically from the east and southeast at 20 to 40 kph, while the afternoon winds in summer tend to be of slightly stronger and generally from the southeast to southwest.

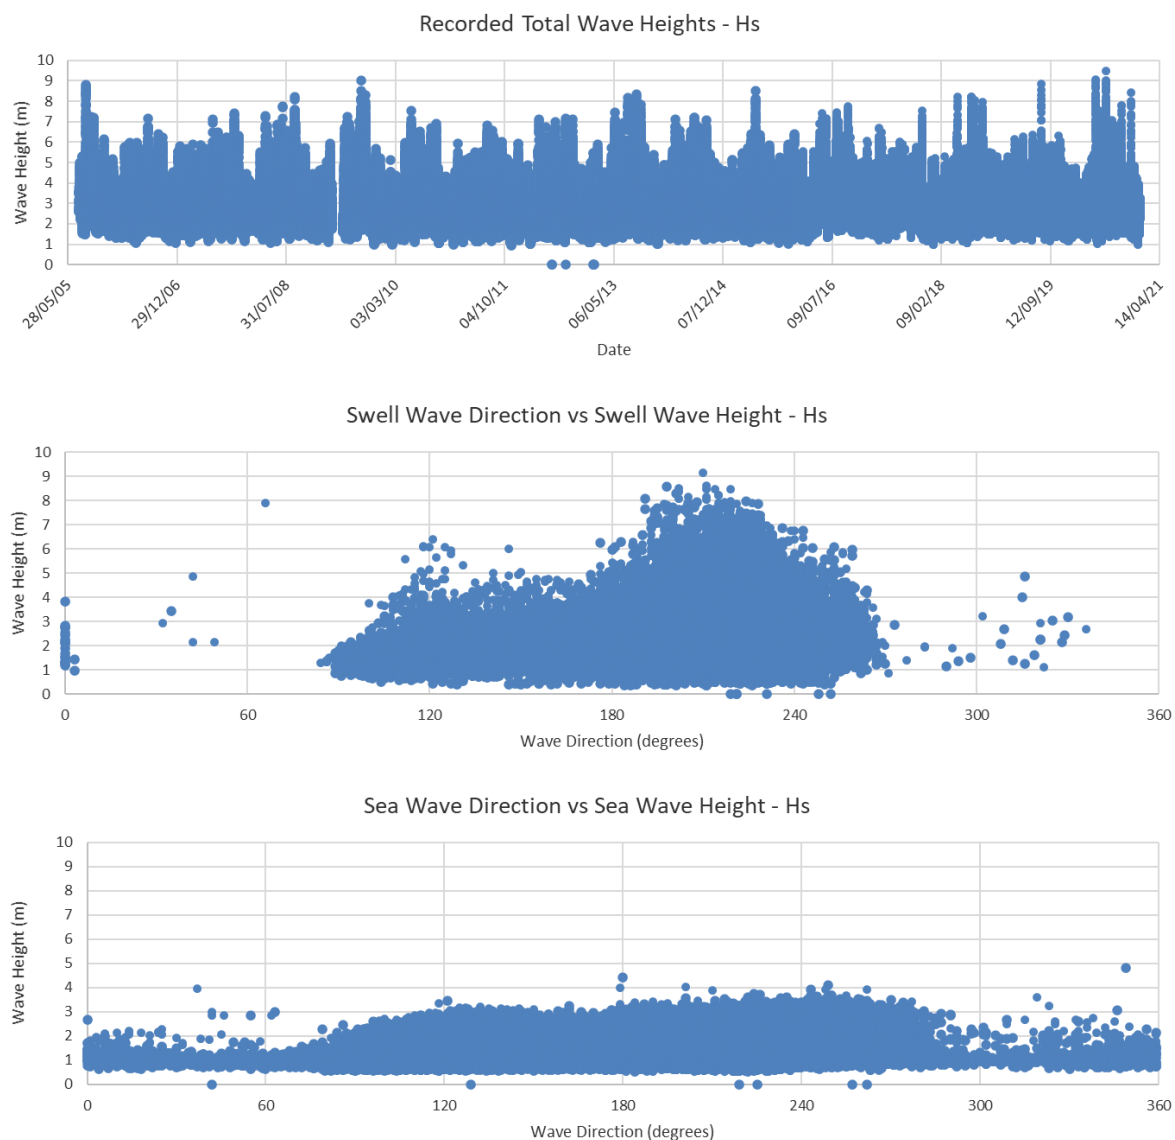
Figure 2.9 Wave Data Recorded from the Albany Waverider Buoy

The data recorded from the Albany Waverider is plotted in Figure 2.9. This figure shows both the time history of recorded wave heights as well as cross plots of the sea and swell wave heights verses their associated directions.

Figure 2.9 shows that the most common direction for these offshore waves is from the southwest, but they also approach King George Sound from the south and occasionally the southeast. The severity of the wave heights also mirrors the persistence, with the most severe waves from the south through west. Interestingly, the plot of recorded wave heights shows that the winter of 2020 was relatively severe, with a cluster of higher wave heights than previously observed within the data record. This may explain some of the erosion pressures that have been experienced at Whalers Beach over the past couple of years.

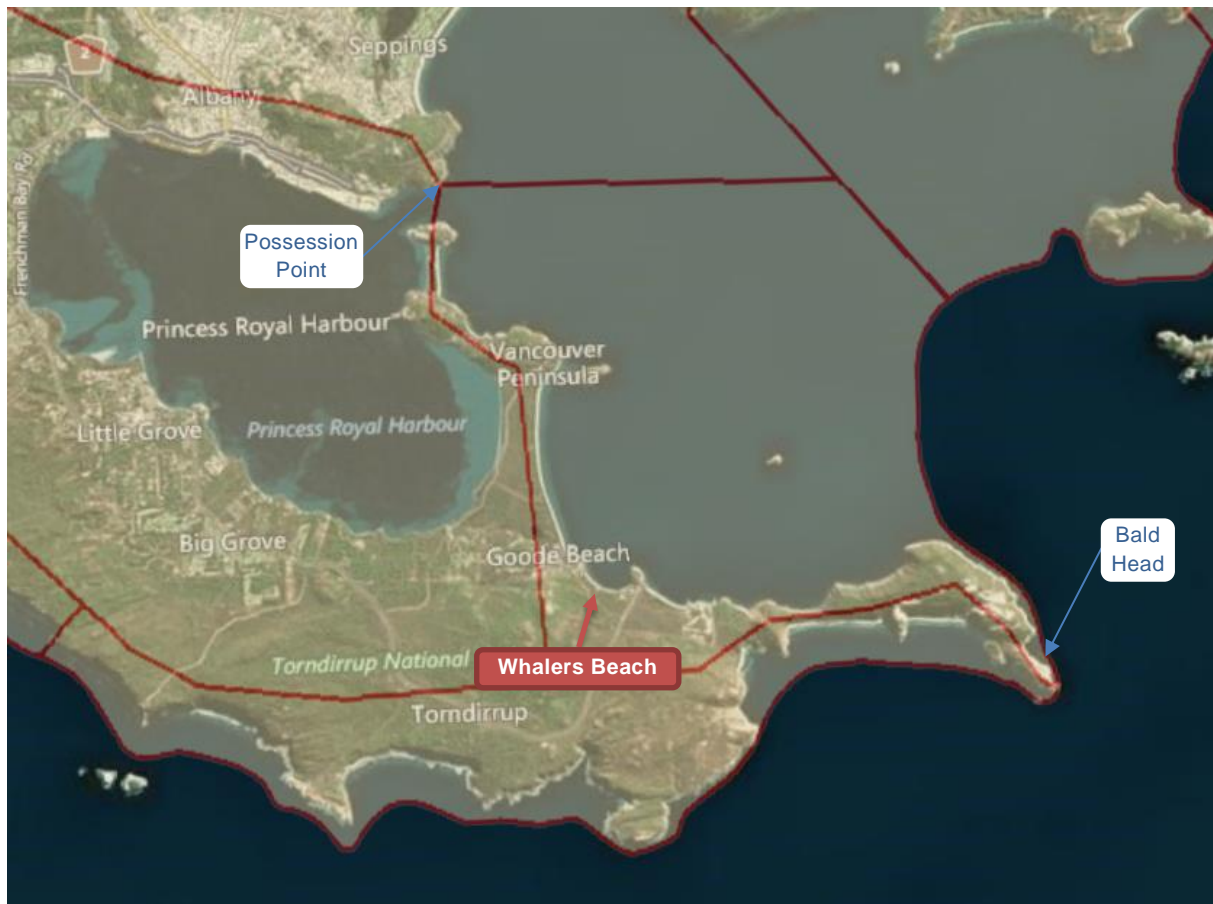
Figure 2.10 Extent of Coastal Sediment Cells

Over the planning horizons considered in this assessment (up to 100 years) Whalers Beach can be treated as a closed sediment cell. This is due to the fact that Vancouver and Waterbay Points essentially restrict sediment transport into or out of the Bay.

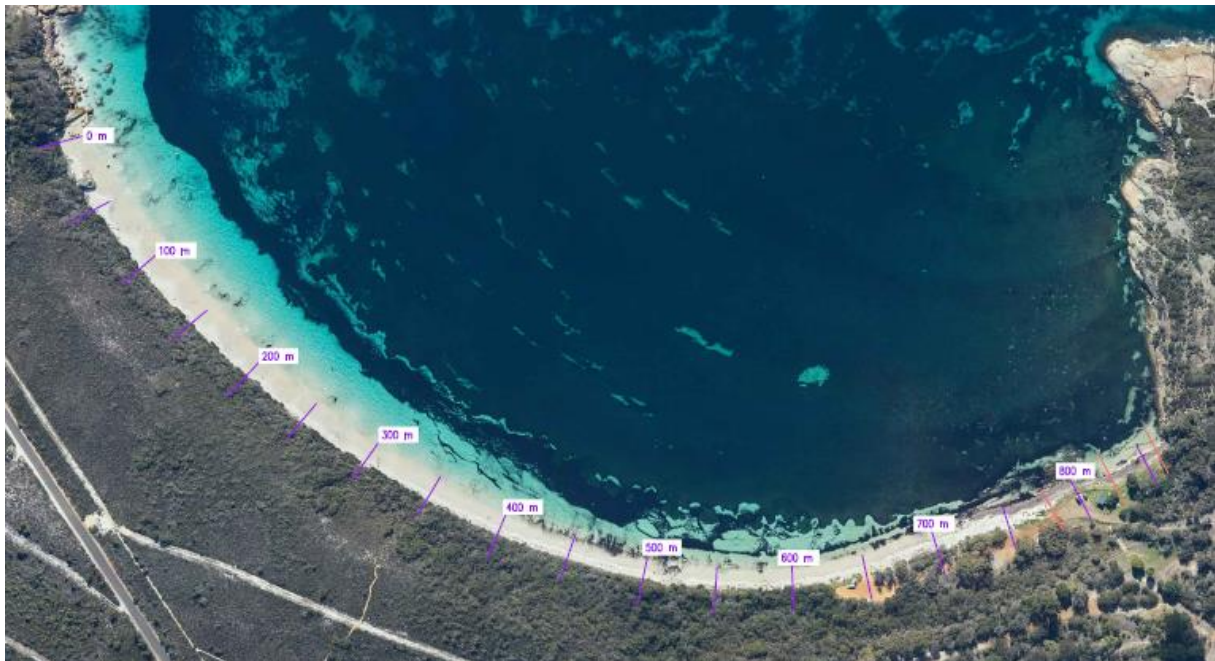
Figure 3.9 Intervals for Measurement of Shoreline Movement

Using the mapped vegetation lines, the position of the shoreline was determined at intervals of 50 m or less along Whalers Beach. The chainage intervals for the measurement of shoreline change are shown in Figure 3.9. The position of the shoreline relative to the 1977 location was determined at each interval from the shoreline movement plan, with results presented in Figure 3.10.

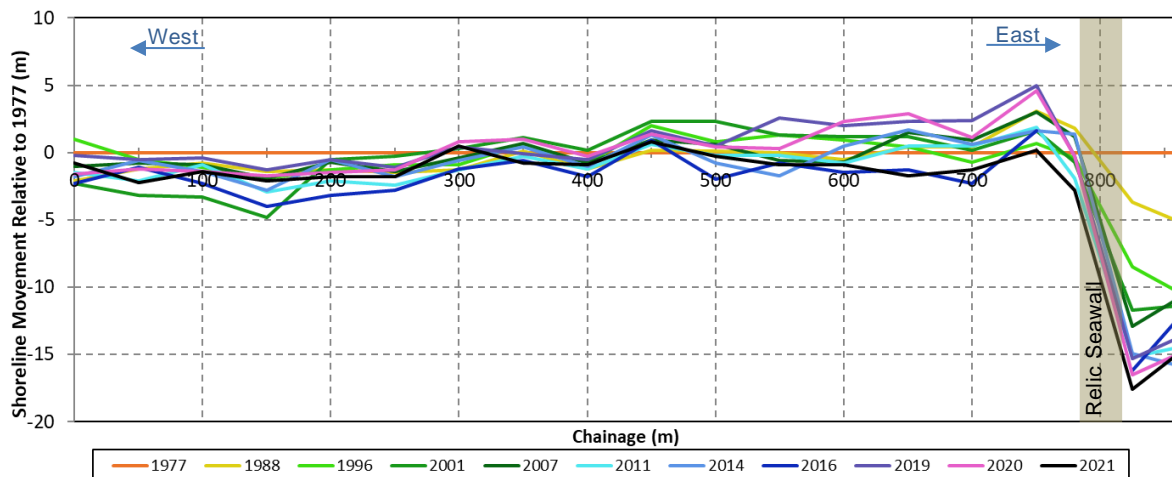
Figure 3.10 Historical Shoreline Movement Relative to 1977

The historical shoreline movement plot shows a stark difference between the behaviour of the majority of the Whalers Beach shoreline and the small section of shoreline to the east of the relic seawall. The area to the east of the relic seawall has experienced erosion in the order of 15 to 20 metres since 1977, whilst the remainder of the bay has experienced a slight rotation, with a general accretion at the eastern end and erosion at the western end. Nevertheless, total movement of the shoreline across the majority of the Bay has been less than plus or minus 5 metres from the 1977 position.

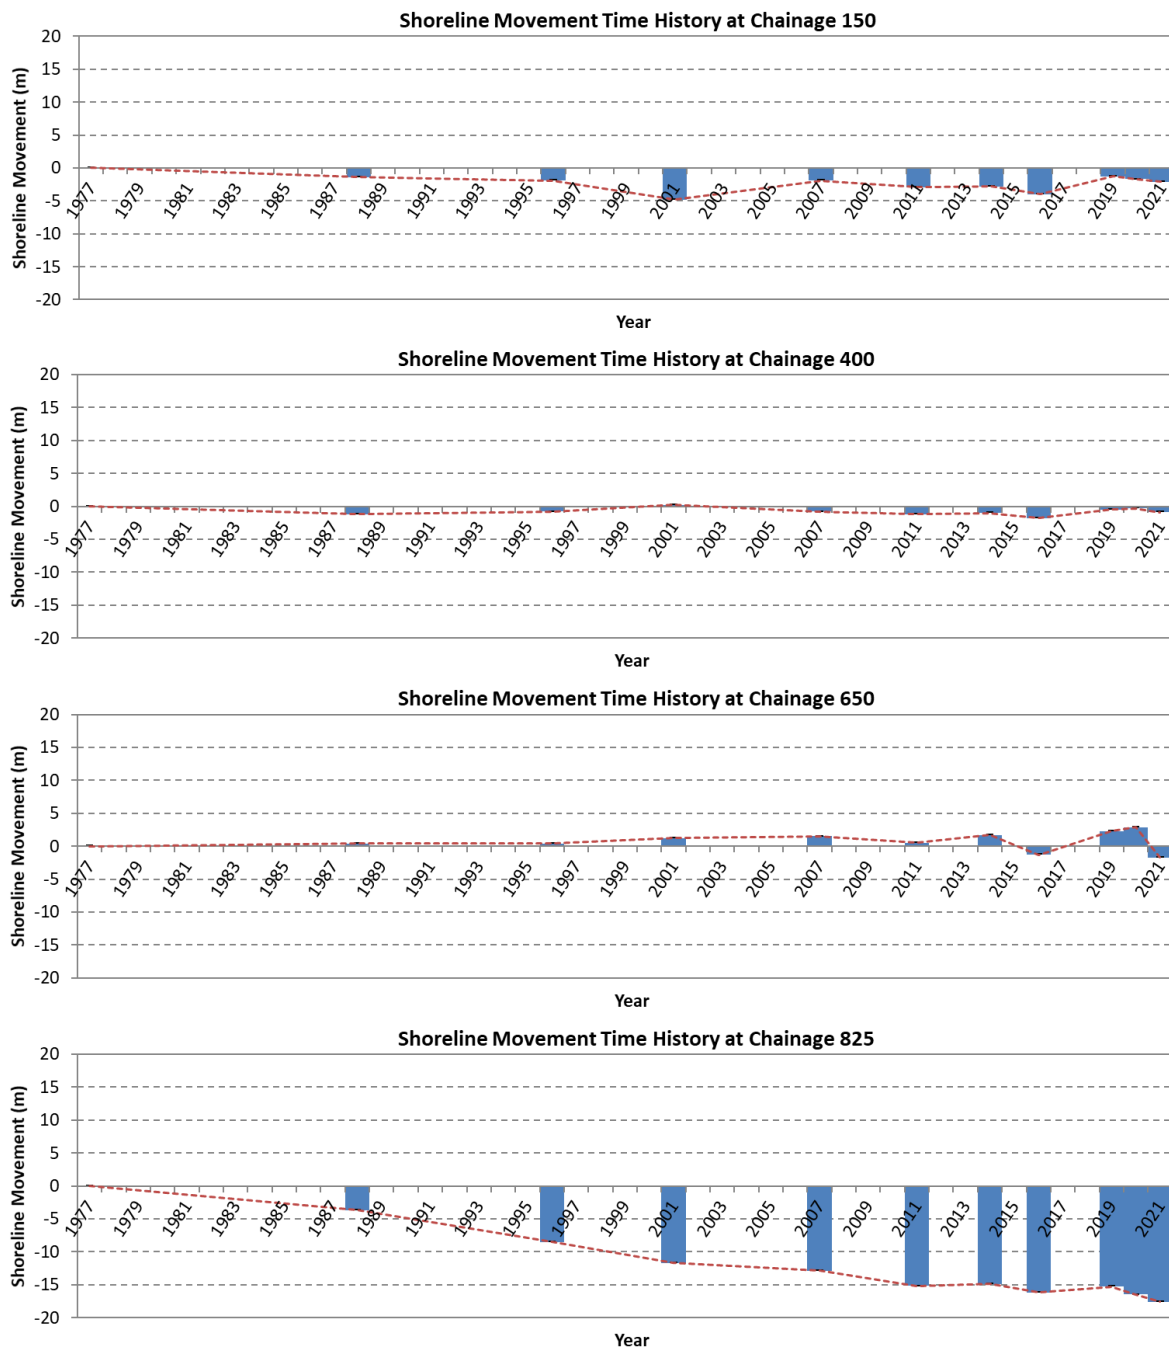
Figure 3.11 Time History Plots of Shoreline Movements at Selected Chainages

To better illustrate the trends in shoreline movement over time, time history plots have been prepared for selected chainages. These time history plots are shown in Figure 3.11.

The time history plots show generally consistent trends across the duration of the record at each location. In particular the time history plots show the following.

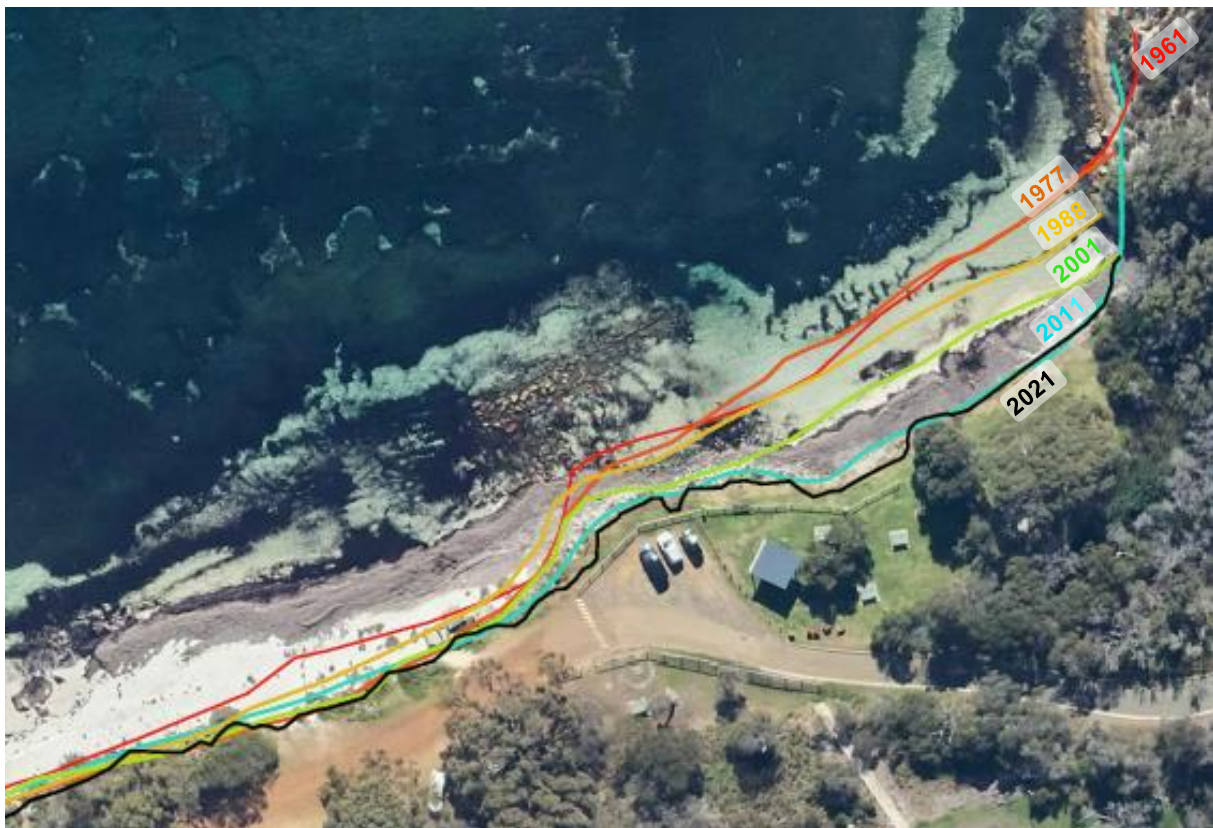
Figure 3.12 Shoreline Positions Adjacent to the Relic Seawall

Figure 3.12 shows a zoomed in view of a selection of mapped shoreline positions adjacent to the relic seawall. The figure shows an obvious disparity between the historical positions of the shoreline to the west and east of the structure. Note that this figure also includes a coastal vegetation line from 1961 which was mapped for this project but ultimately not used due to issues at the western end of Whalers Beach.

The figure shows that the shoreline position to the east of the seawall was very similar between 1961 and 1977, though this position was significantly further seaward than the shoreline to the west of the seawall. Thereafter the shoreline east of the structure began to experience the observed erosion, although in some areas this erosion hasn't really continued beyond 2011.

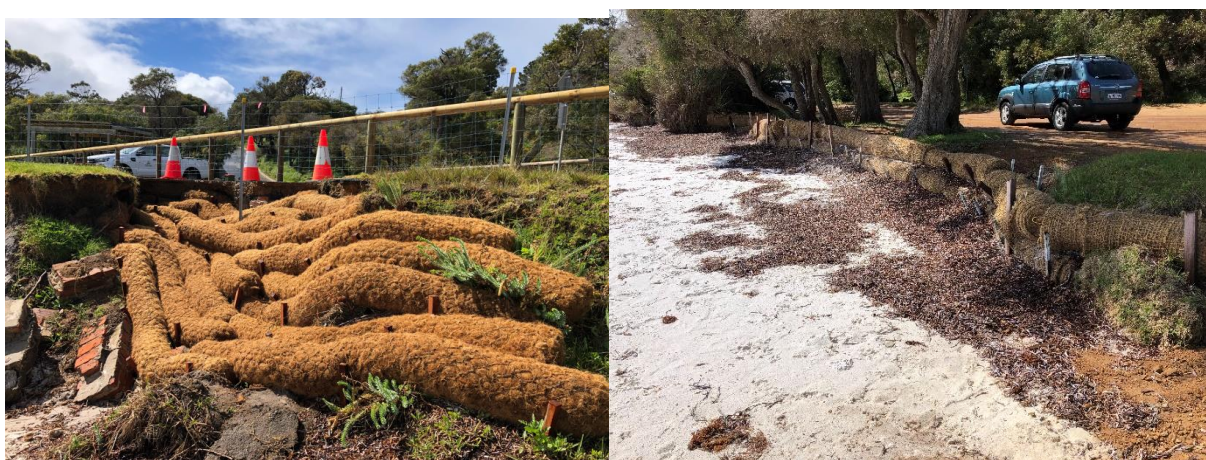
Figure 3.13 Coir Logs Installed by the City of Albany in 2021 to Combat Erosion

Regardless of the cause of the change to the seawall, and its associated level of shoreline control, it appears that the shoreline east and west of the structure are now better aligned and as a result, it is anticipated that chronic movement of the shoreline in this area would reduce in the future. Nevertheless, the fact that between 15 and 20 m of foreshore has been lost in this area means that the existing foreshore does not interface well with the adjoining beach. The absence of a dune system, or the mechanism for the natural formation of a dune system, in this area therefore further exacerbates the issue as it means that the foreshore is prone to impacts from severe storm erosion events and high water levels. This has been observed over the winter of 2021, with the City of Albany installing coir logs (refer Figure 3.13) to try and combat erosion of the foreshore area.

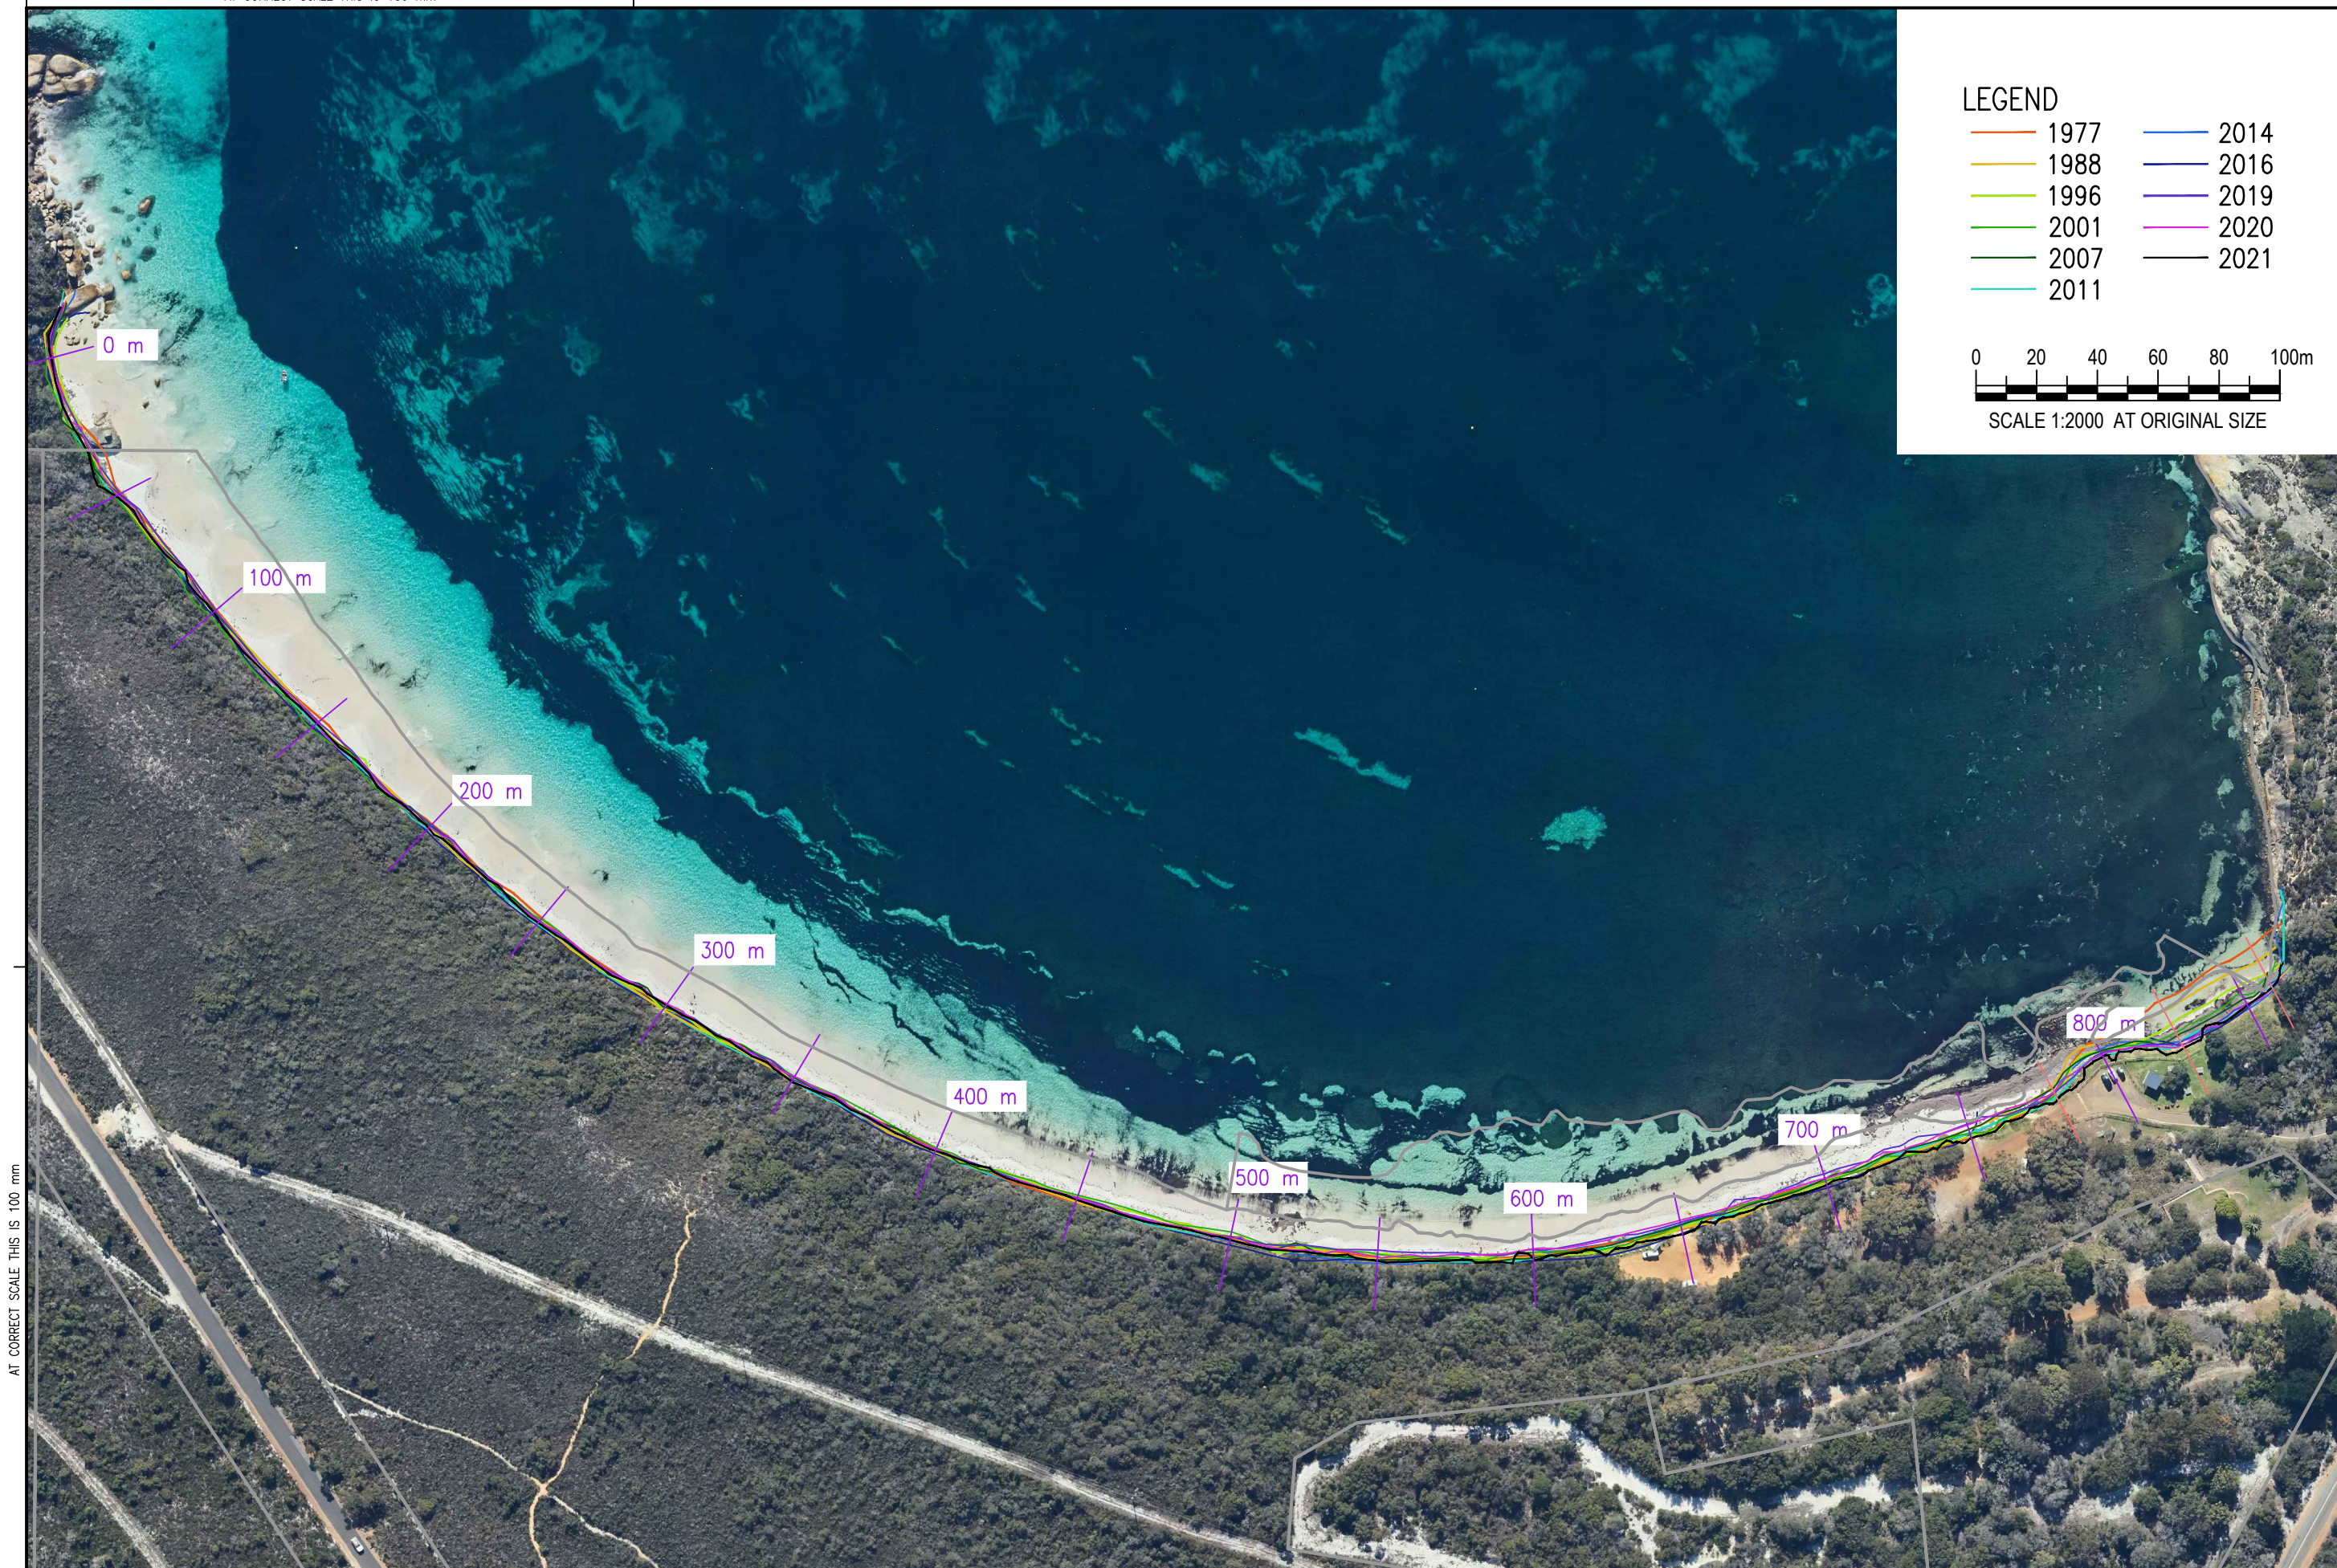
Appendix B Shoreline Movement Plan

- 1977
- 1988
- 1996
- 2001
- 2007
- 2011
- 2014
- 2016
- 2019
- 2020
- 2021
